Non-destructive testing of a Garmin memory module, case CEN21FA150

Summary and Conclusions

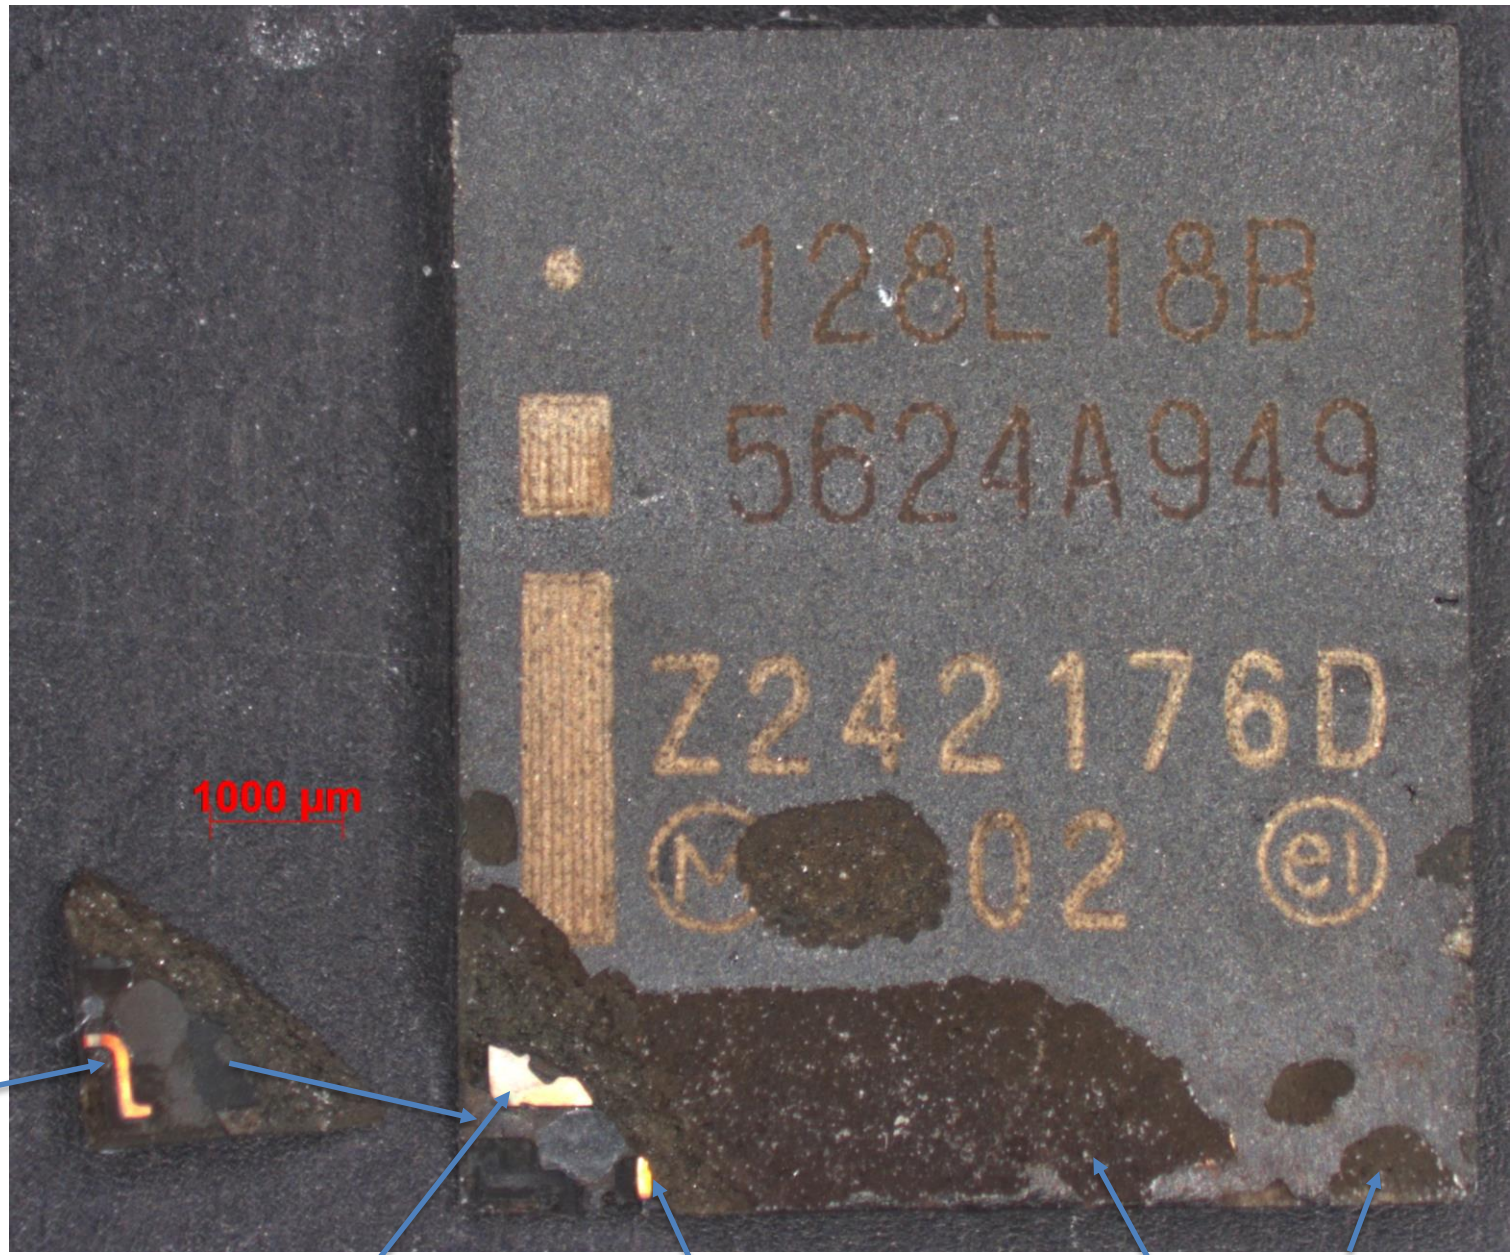
Front side

Separated piece from the damaged corner with a broken Cu line

Interior parts of the package are exposed

Mold is damaged

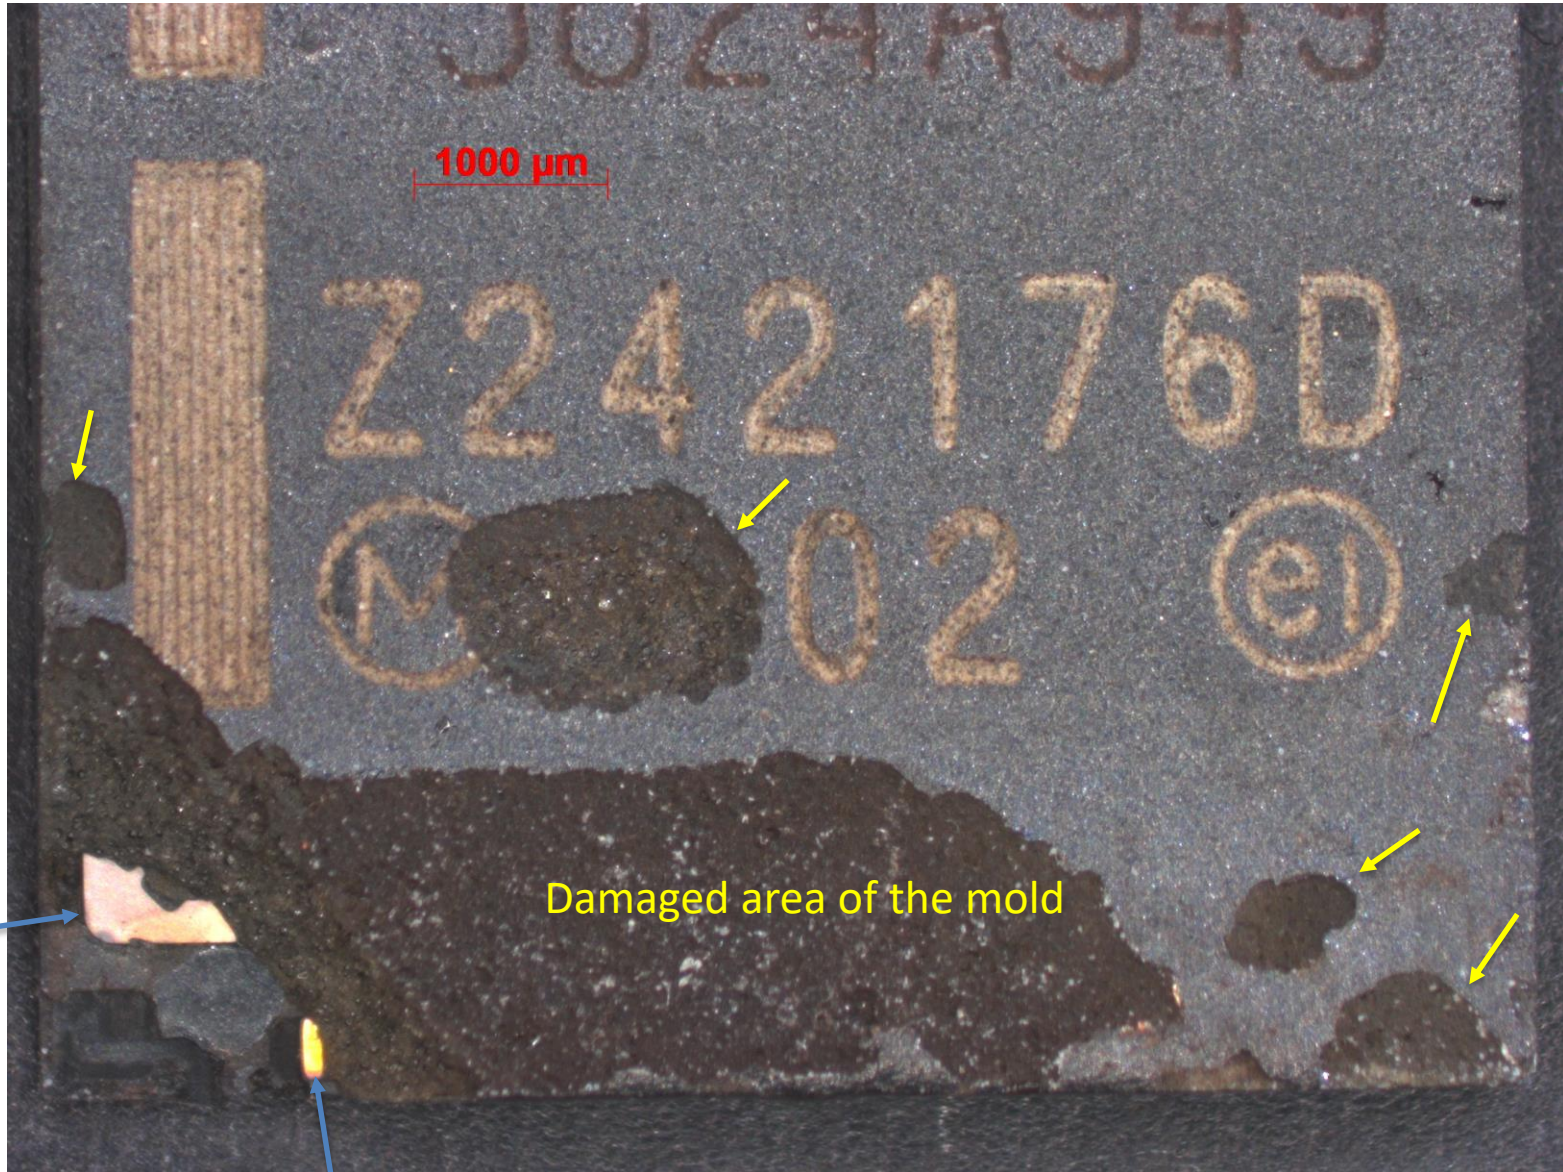
Front side

Exposed Cu plane of the substrate

Damaged area of the mold

Exposed wire bond

Damaged corner

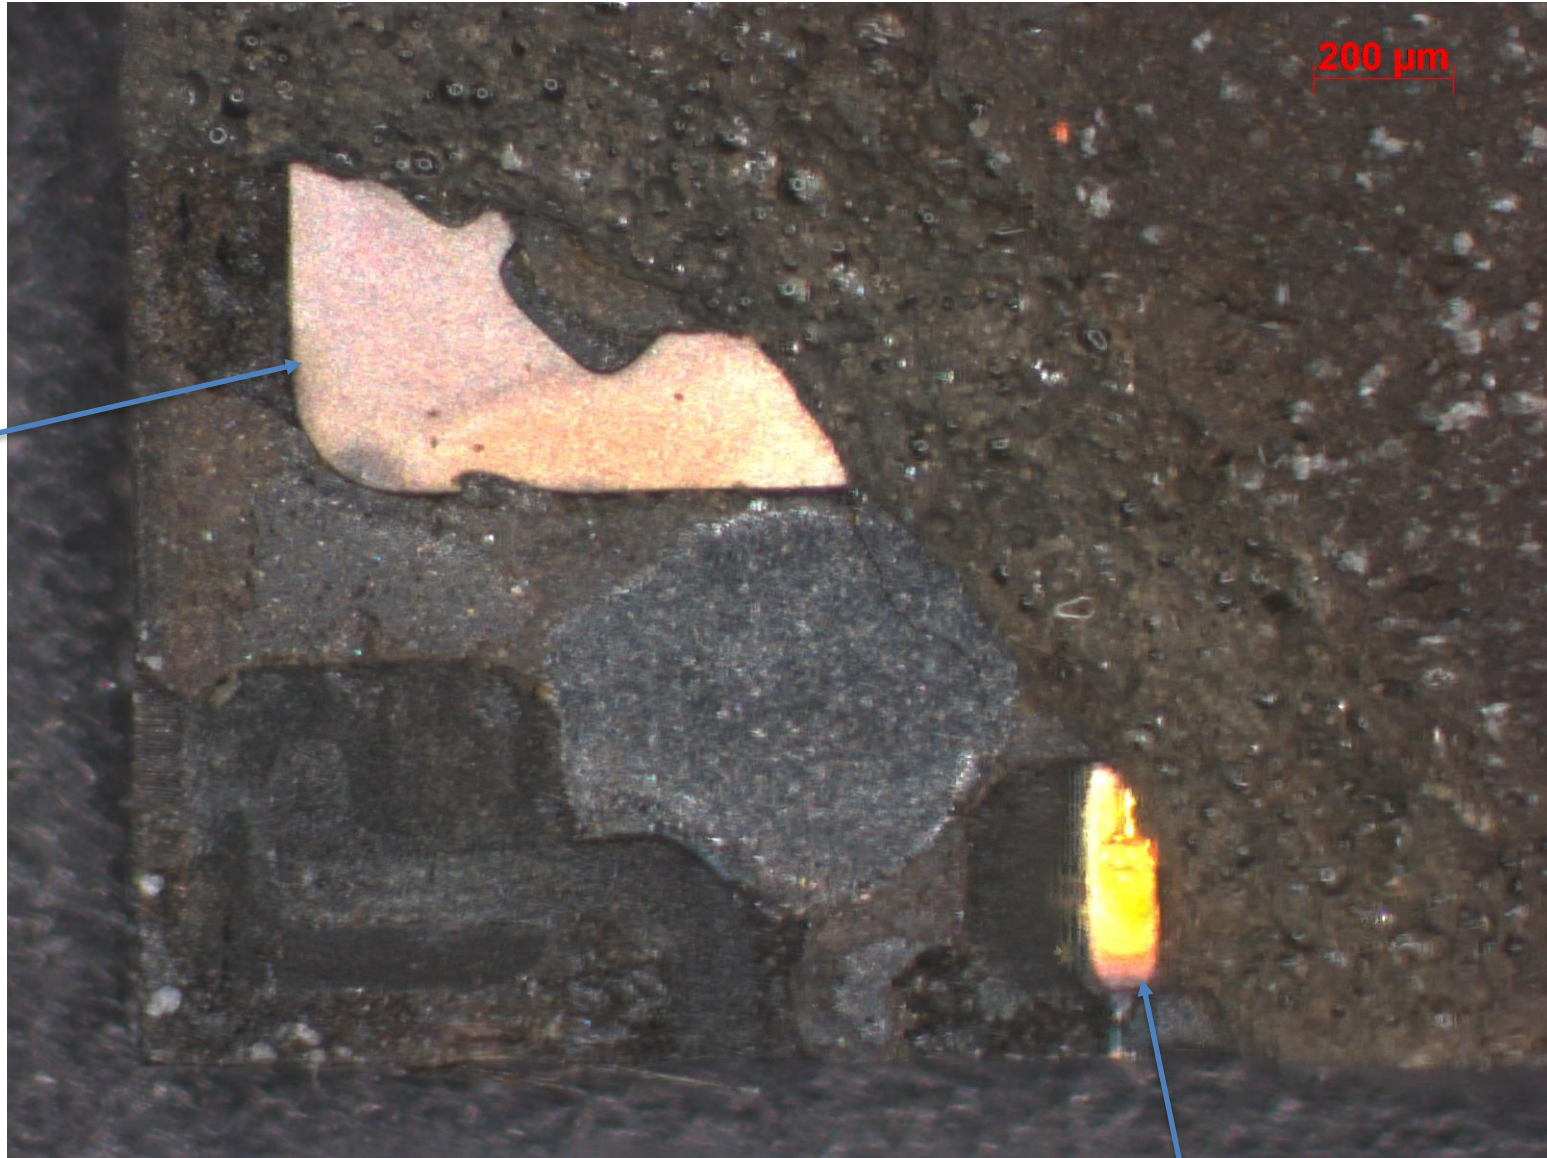
Exposed Cu
plane of the
substrate

Exposed wire bond

Damaged corner

Exposed Cu plane of the substrate

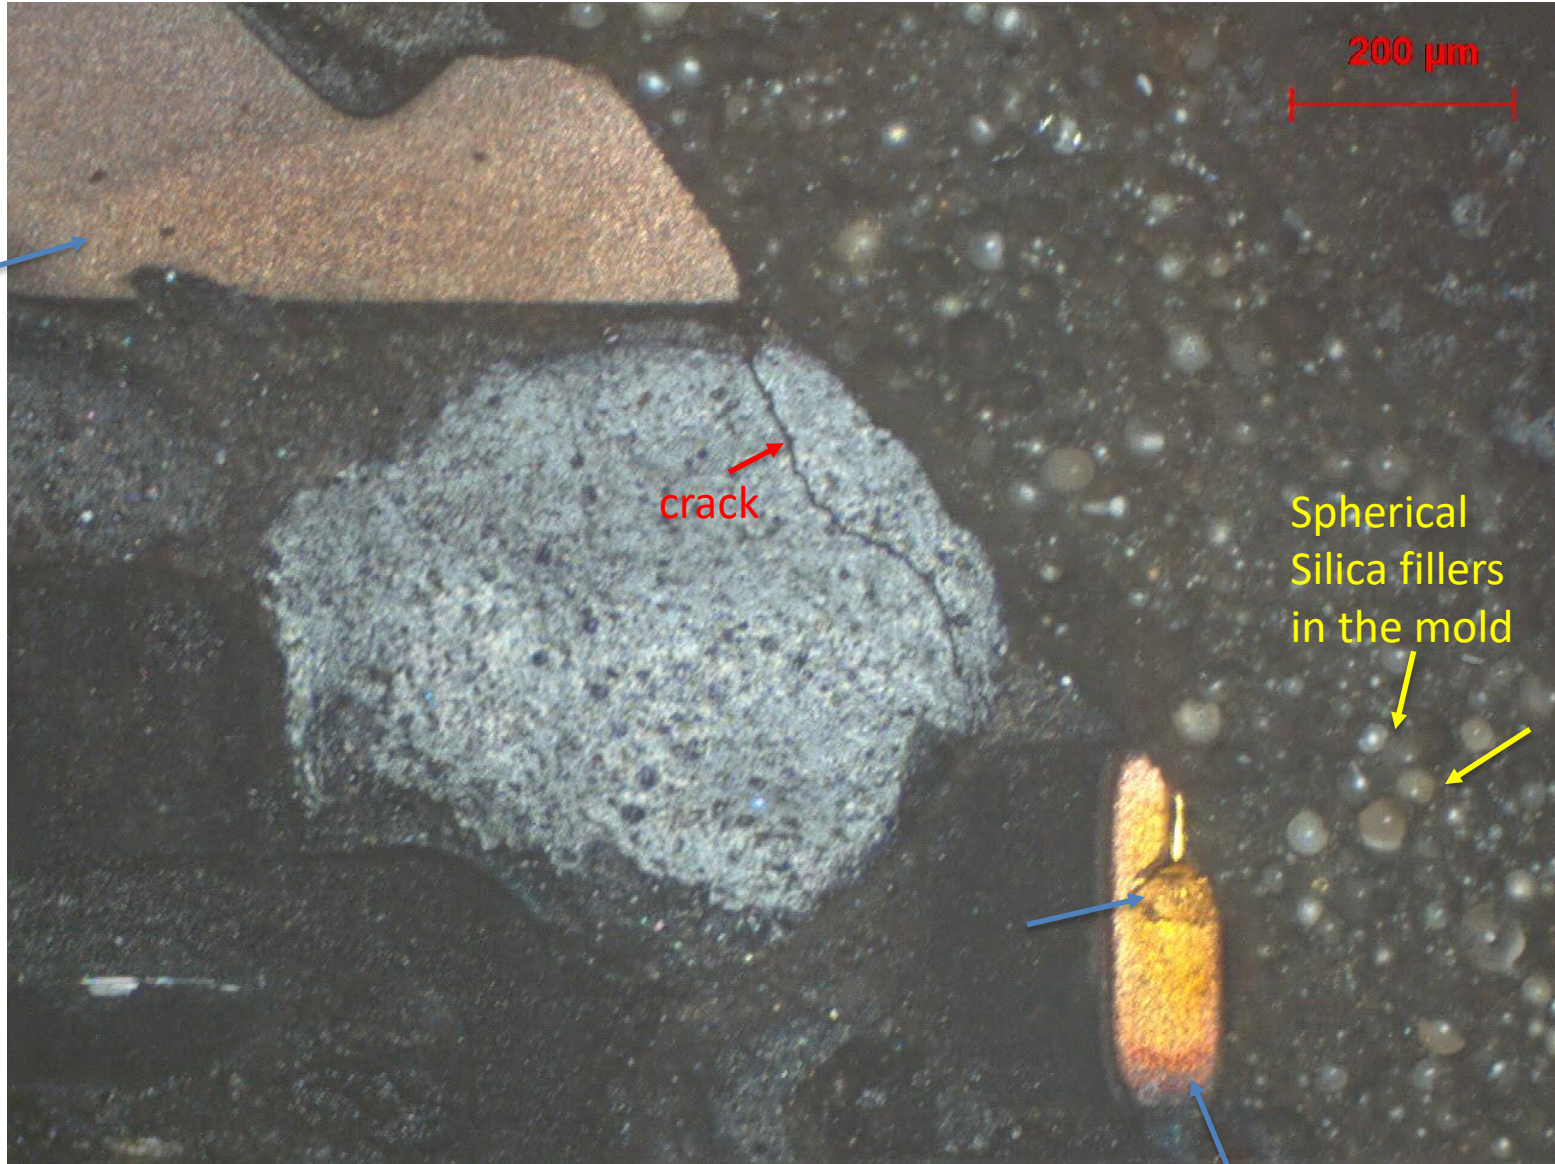
crack

Exposed wire bond on the substrate

Exposed wirebond

Exposed gold wire with wedge bond on the substrate

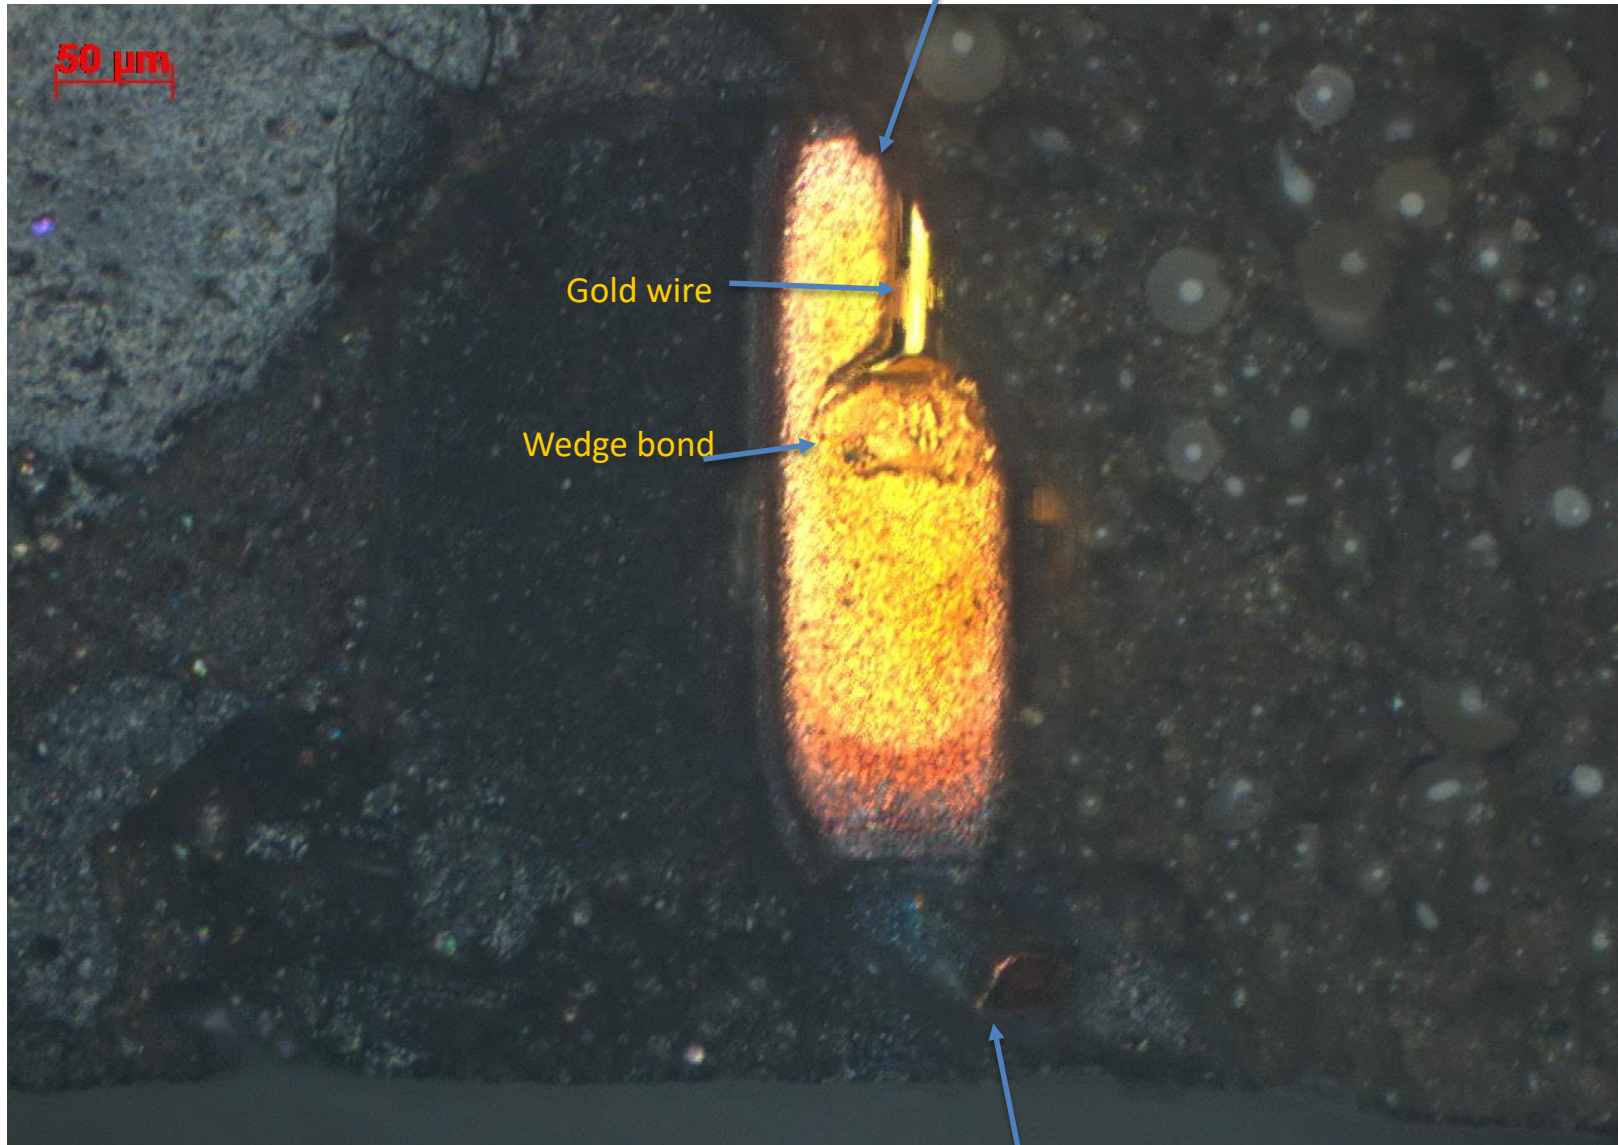
Gold wire

Wedge bond

Damaged Cu line

Damage to the mold

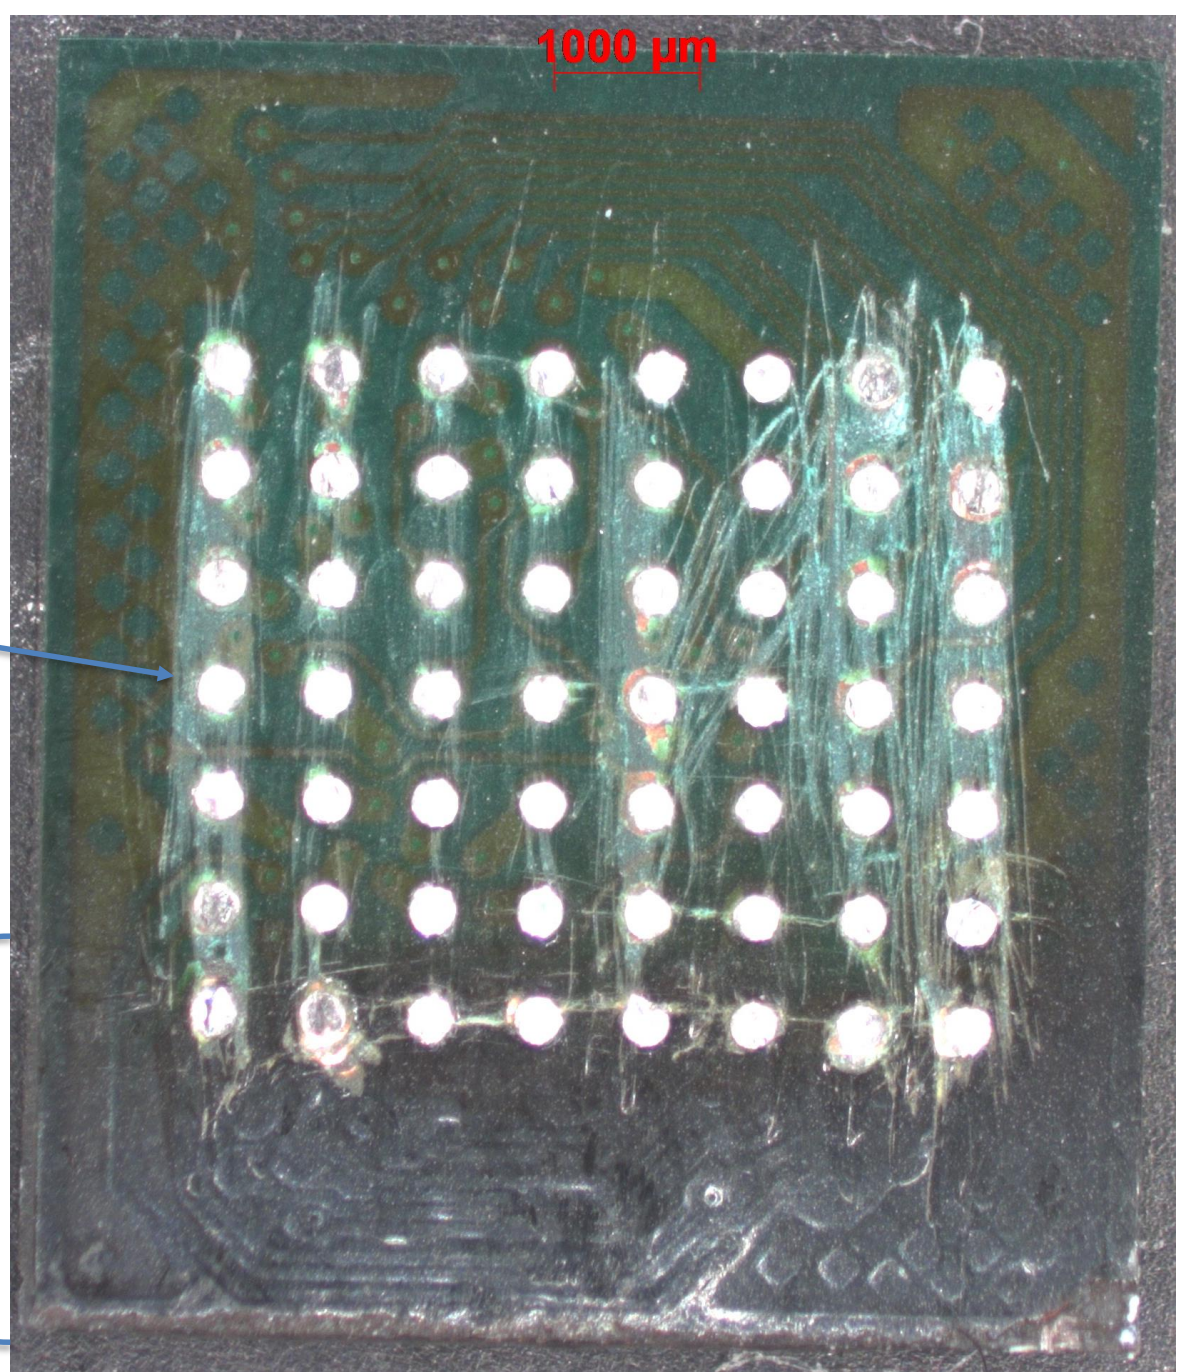
Backside: Damaged area

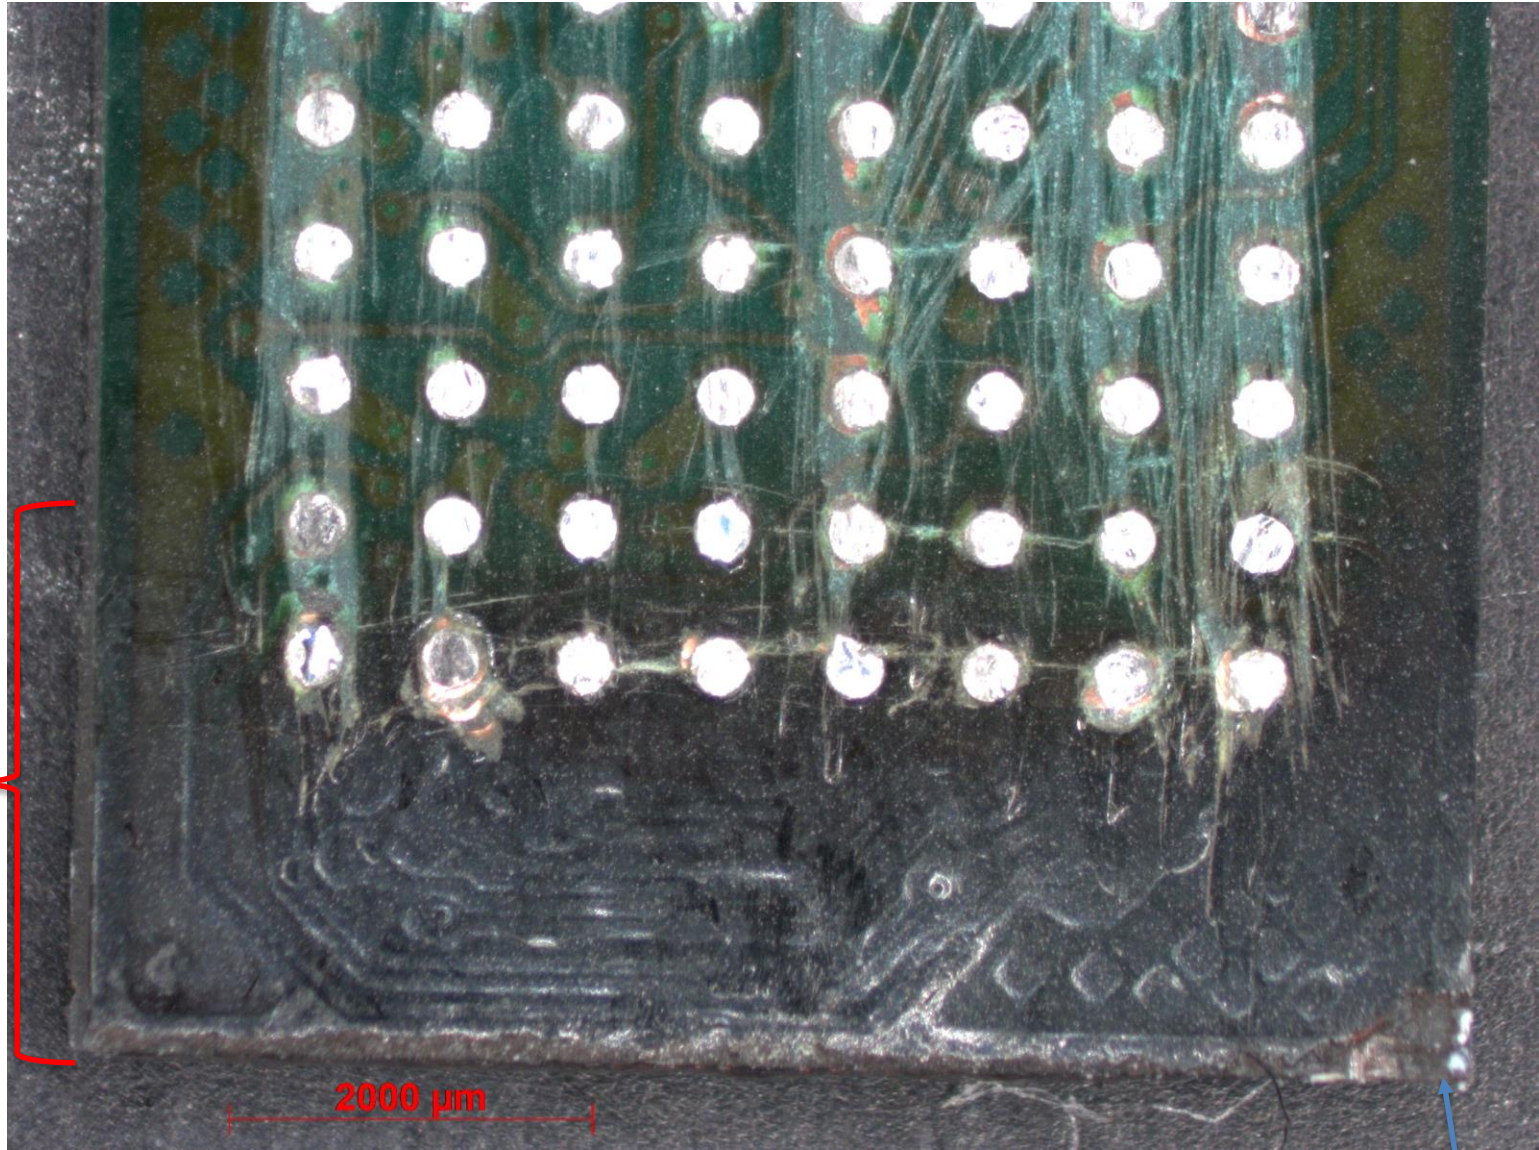
Discoloration of the substrate material.

Damaged corner¹¹

Backside: Damaged corner and edges of the package

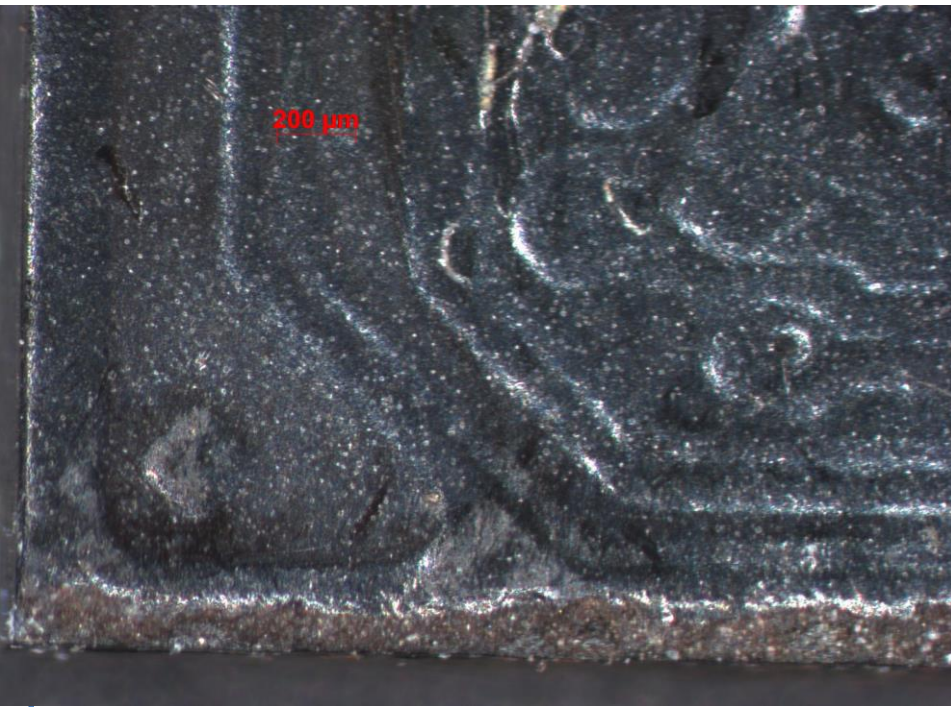
Damaged edge of the package

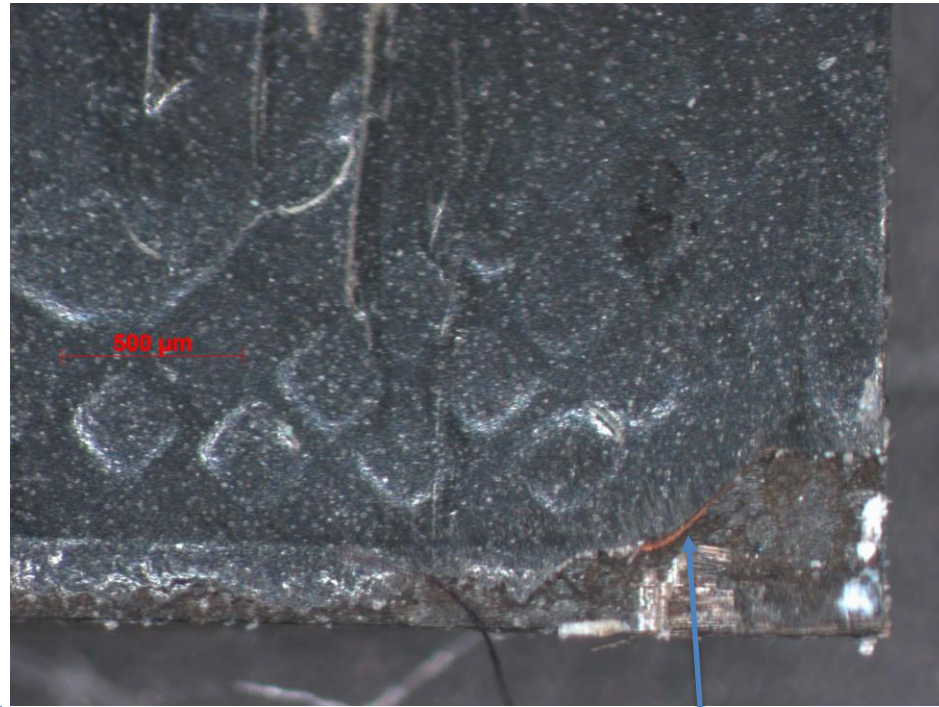
Damaged corner with exposed Cu plane

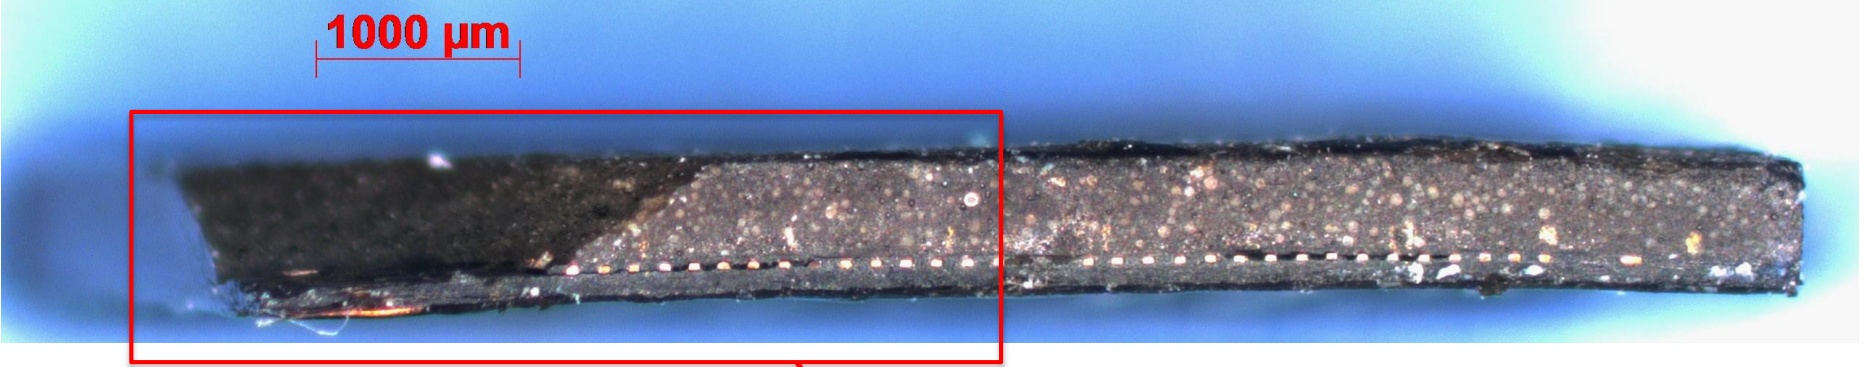
Side view of the package: side 1

Package is bent.

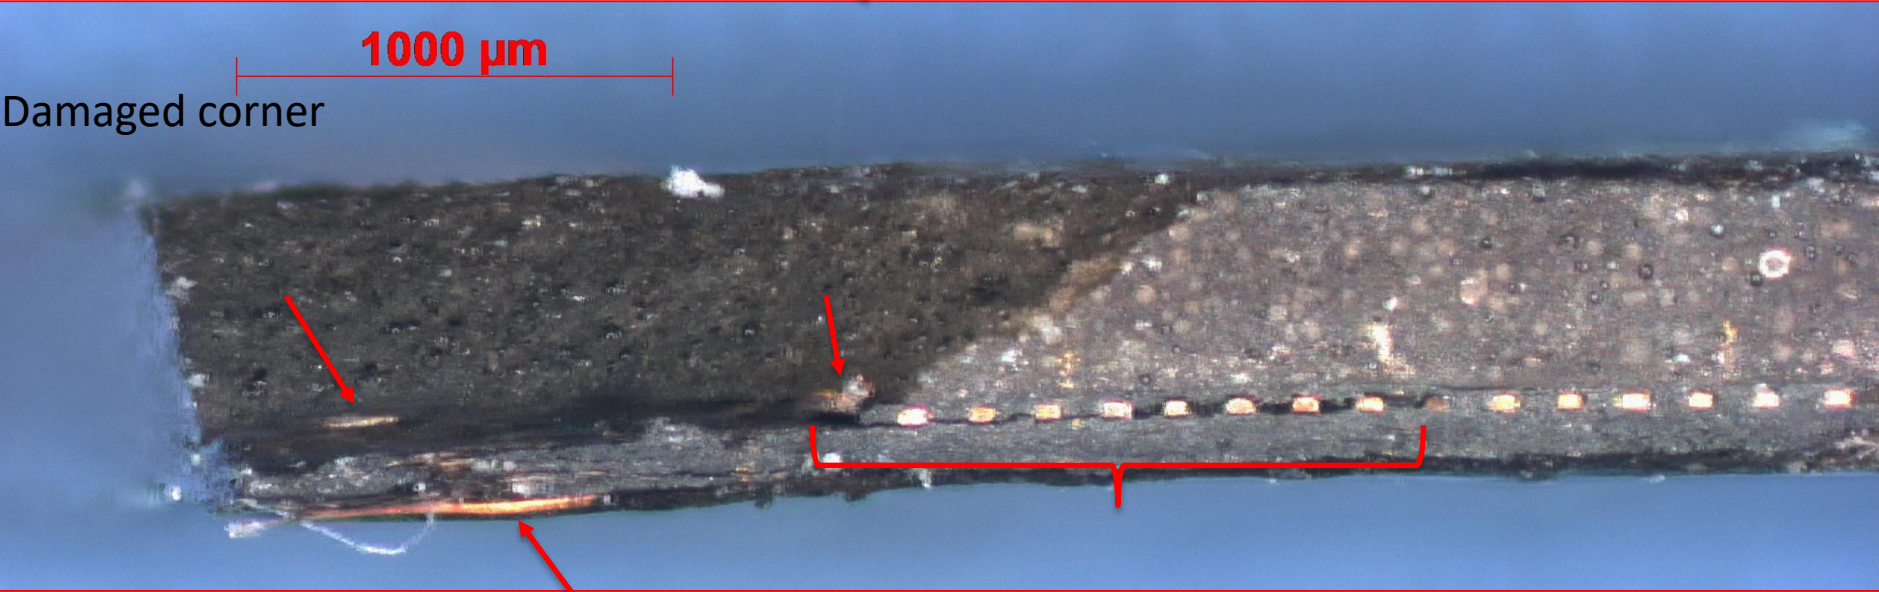
Side view of the package: side 1

Exposed Cu planes

Cracks/separation of Cu lines in the substrate

Cu line of the exposed wire bond, is lifted off

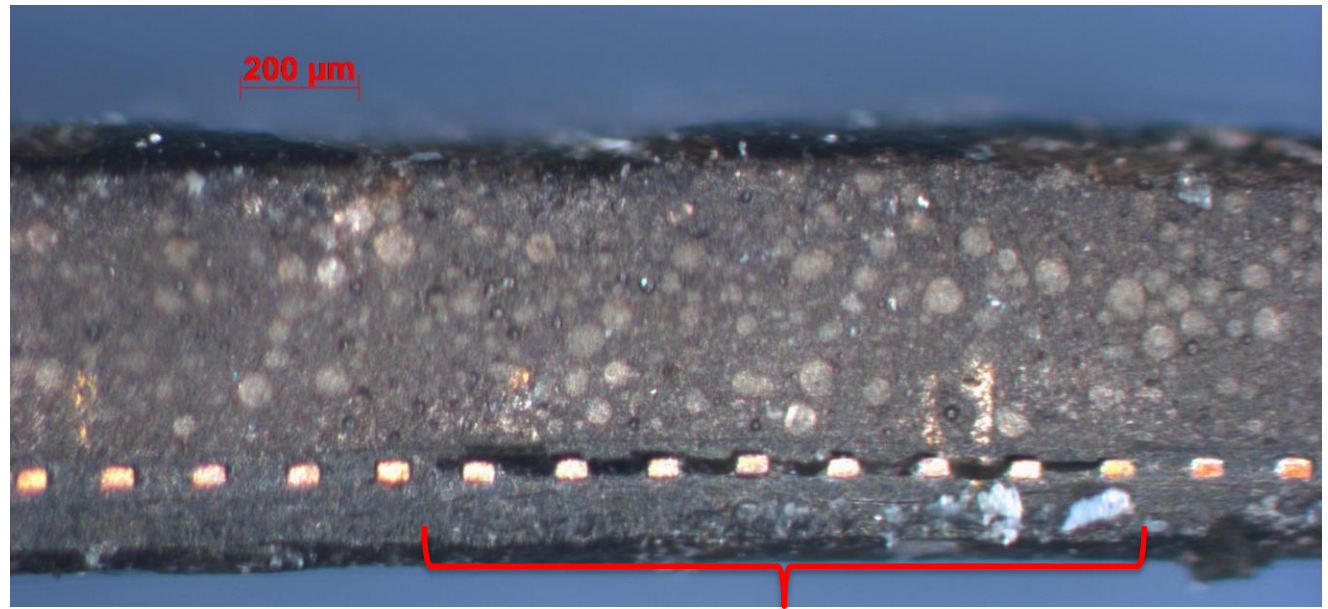
Cracks/separation of Cu lines in the substrate possibly due to bending of the package

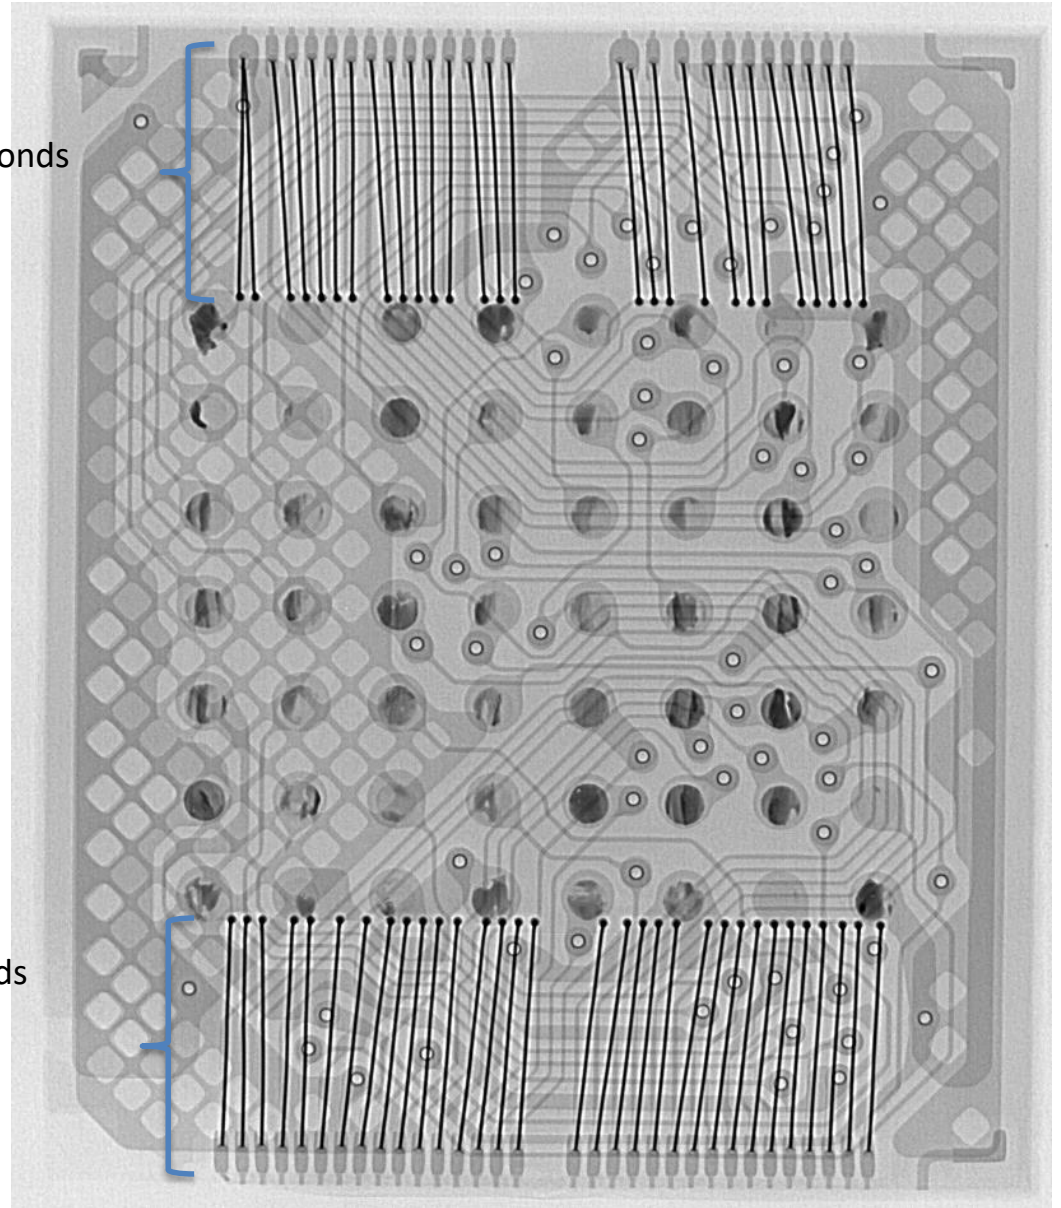
X-ray image of the entire package

The memory module has a single die with wire-bonds on two sides

Damaged corner

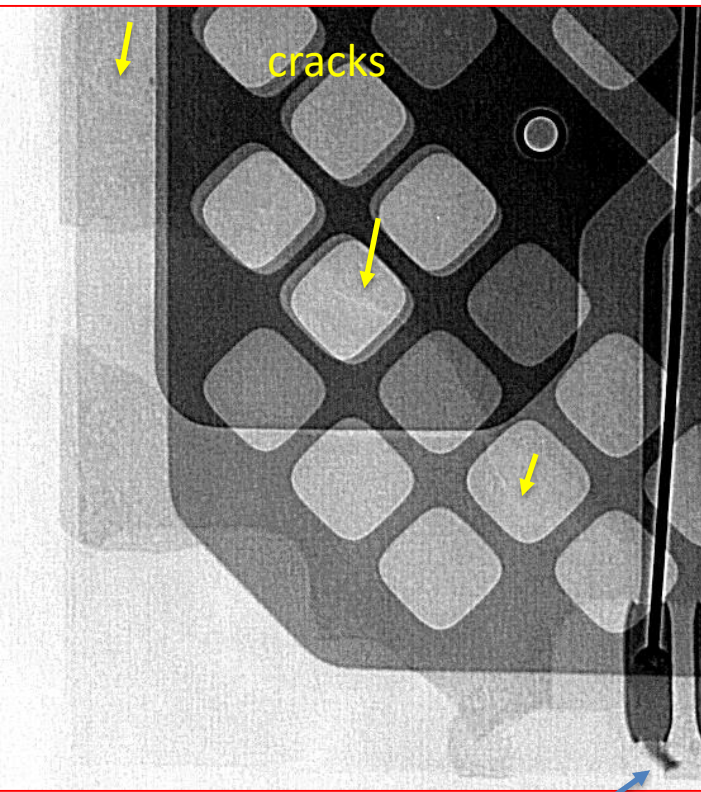
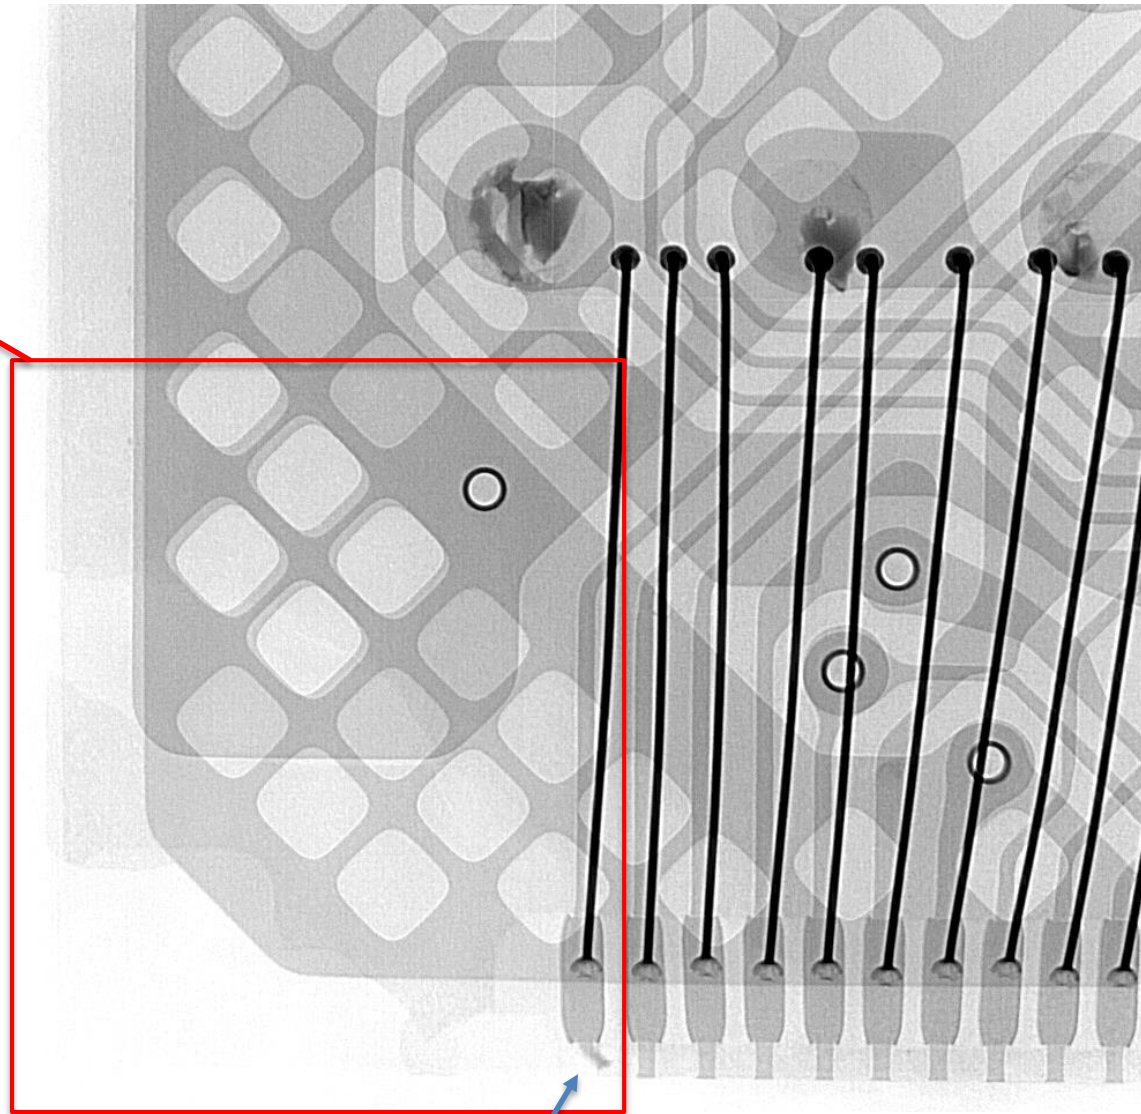
X-ray image of the damaged corner

Exposed wirebond with damaged Cu line

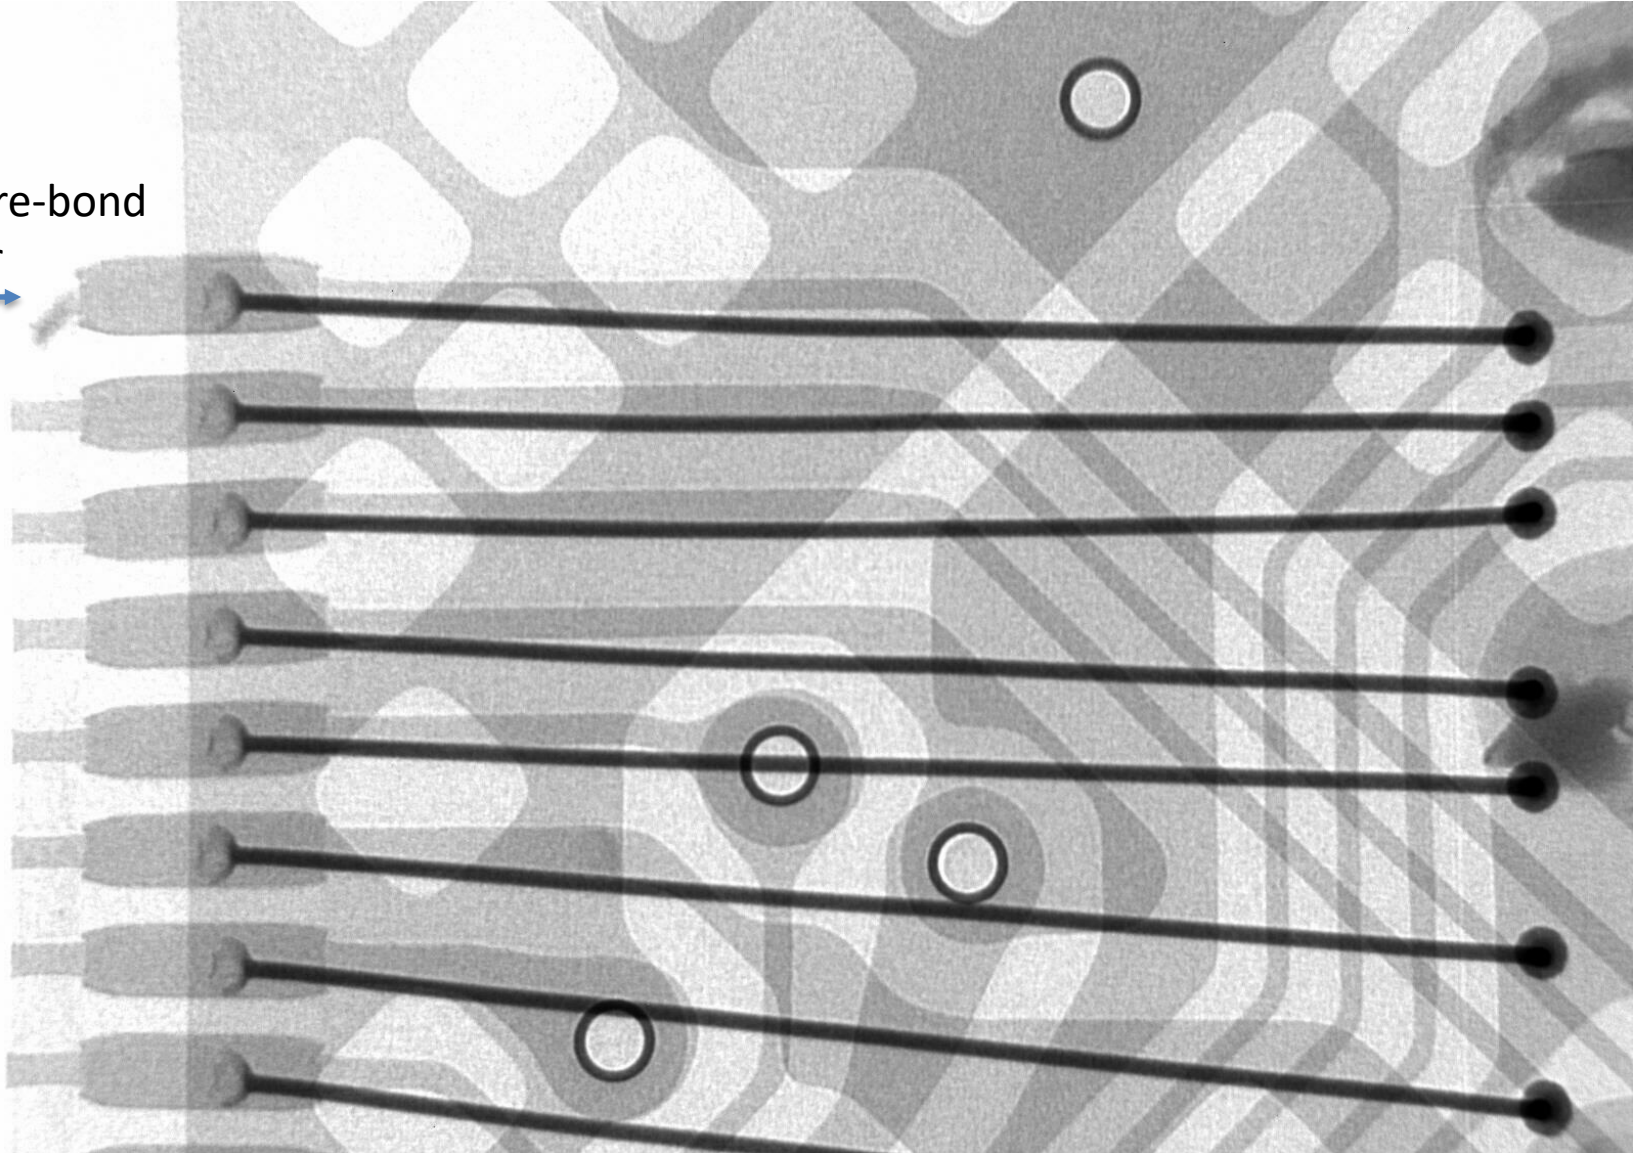
X-ray image of the wire-bonds

Damaged wire-bond
at the corner

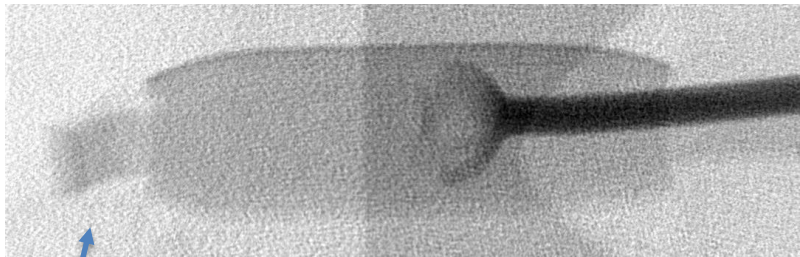
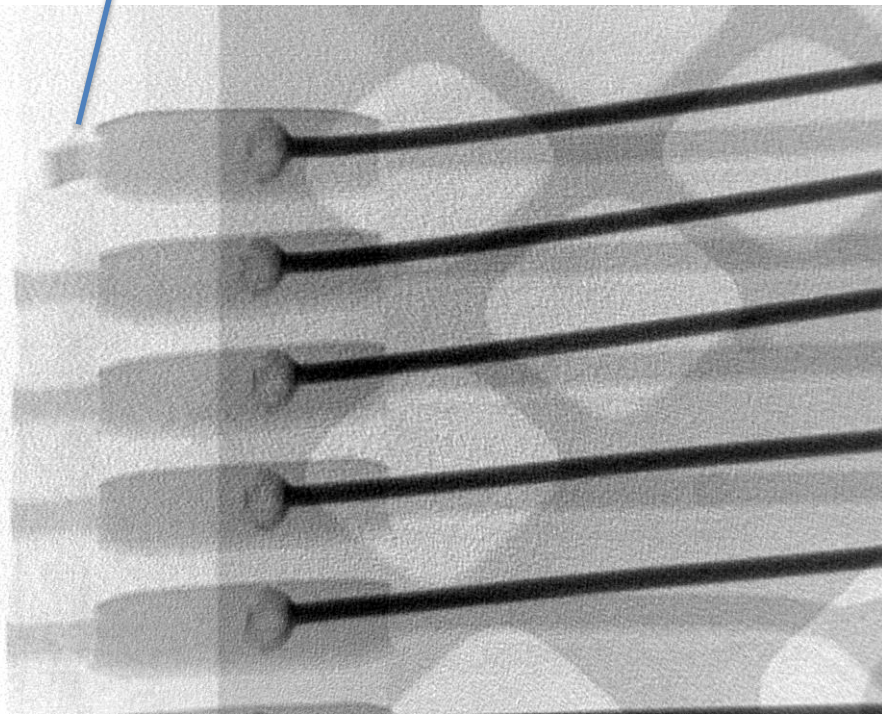
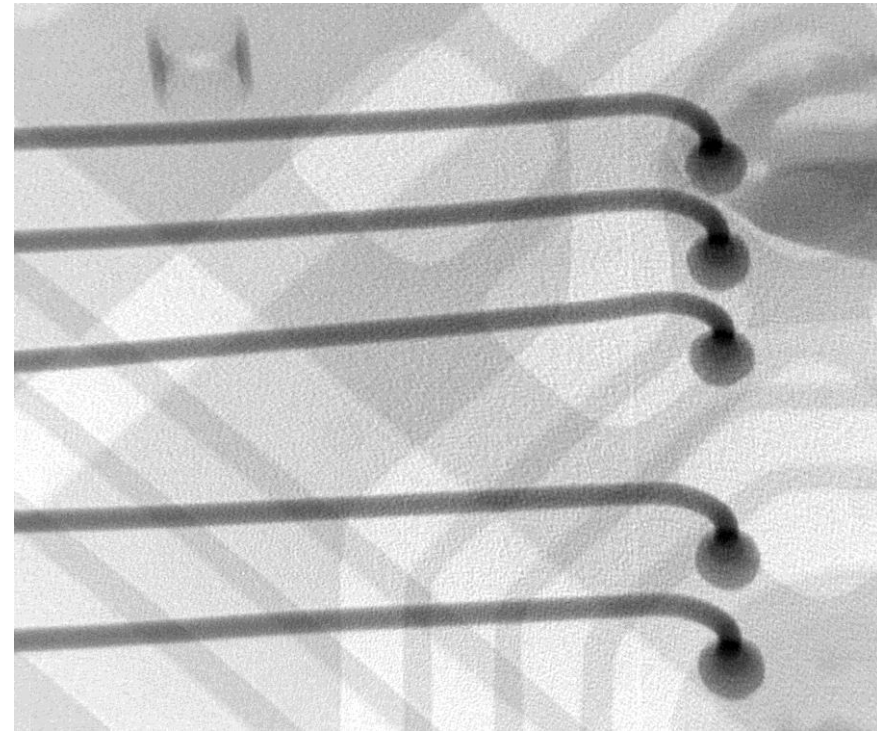
X-ray image of the wire-bonds: Oblique view

No broken wires seen except for the damaged wedge bond at the corner.
