Non-destructive testing of a Garmin memory module, case CEN21FA150

Summary and Conclusions

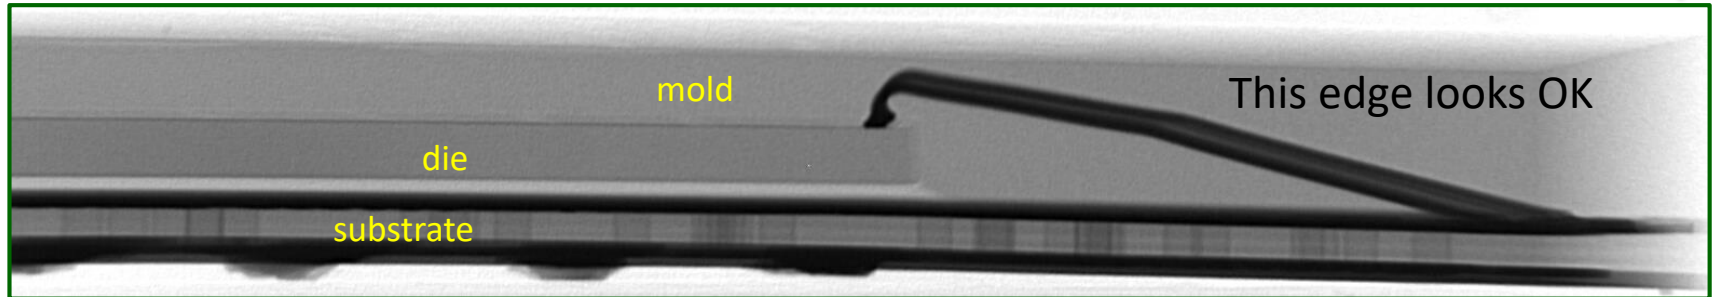
X-ray image of the side of the package

There is separation between the mold and the die which extends to the edge where wire-bonds are located. Wire-bonds are likely lifted off the bond pads.

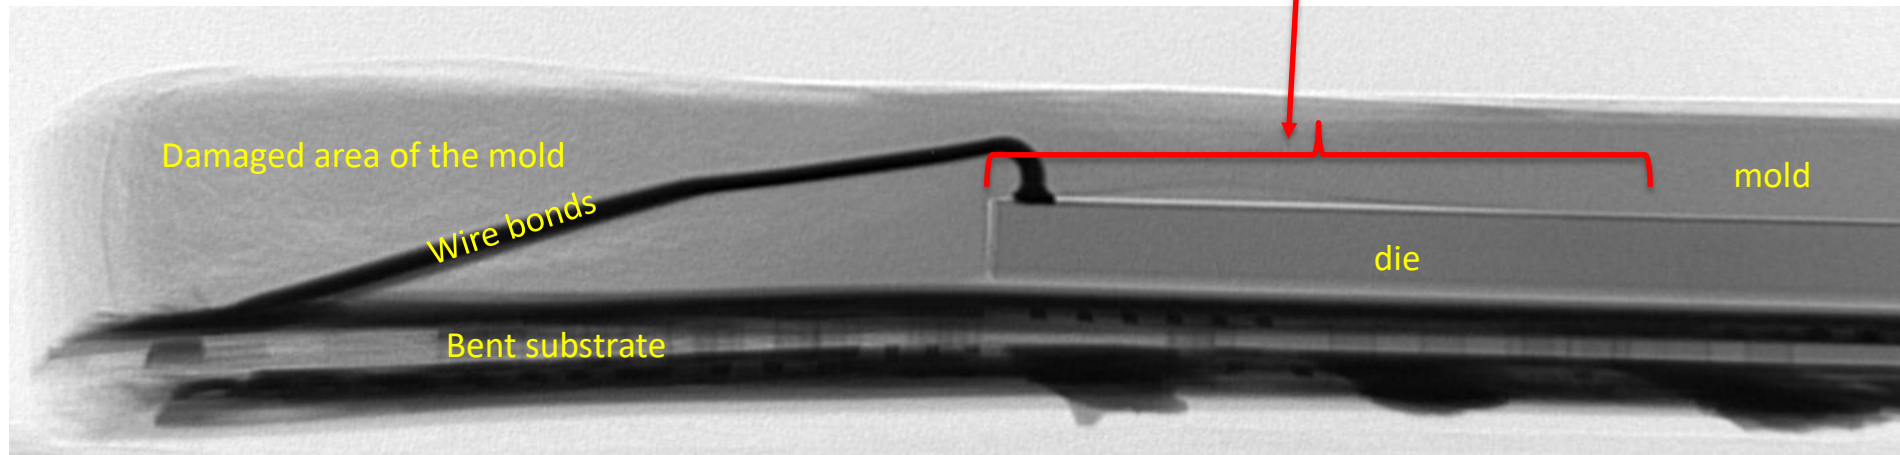
X-ray image of the damaged side of the package

There is separation between the mold and the die which extends to the edge where wire-bonds are located. Wire-bonds are likely lifted-off the bond pads possibly resulting in discontinuities.

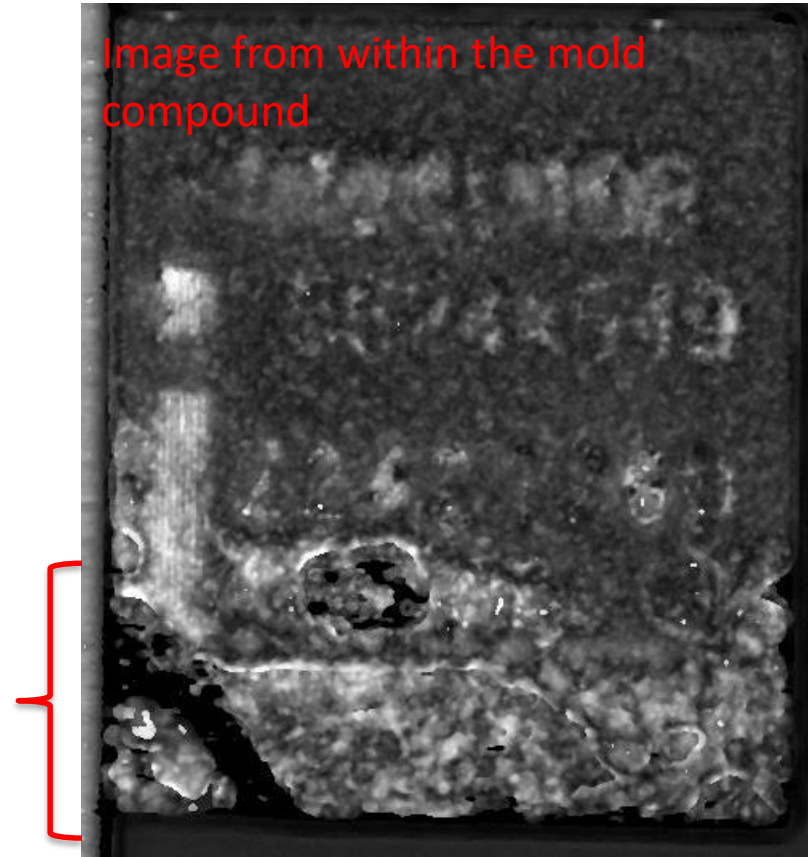
Image from within the mold compound

Acoustic imaging shows that there is a lot of sound attenuation/ scattering/ reflection from the mold compound in bottom 1/3 area of the package. This area exhibited voiding/cracks/ degradation in the mold material.

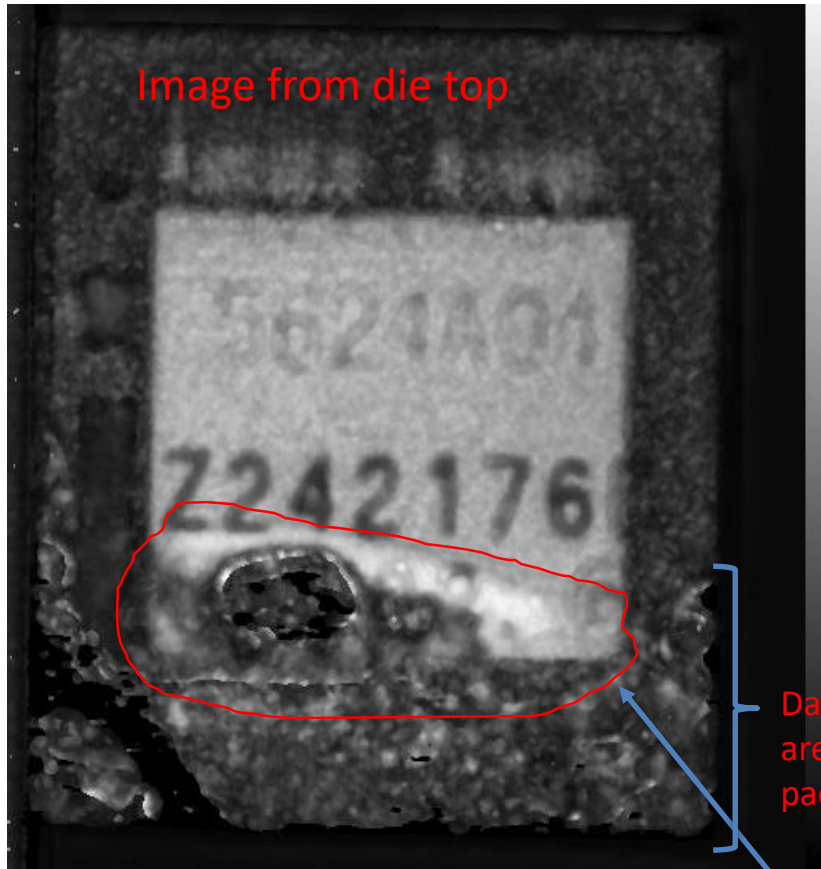
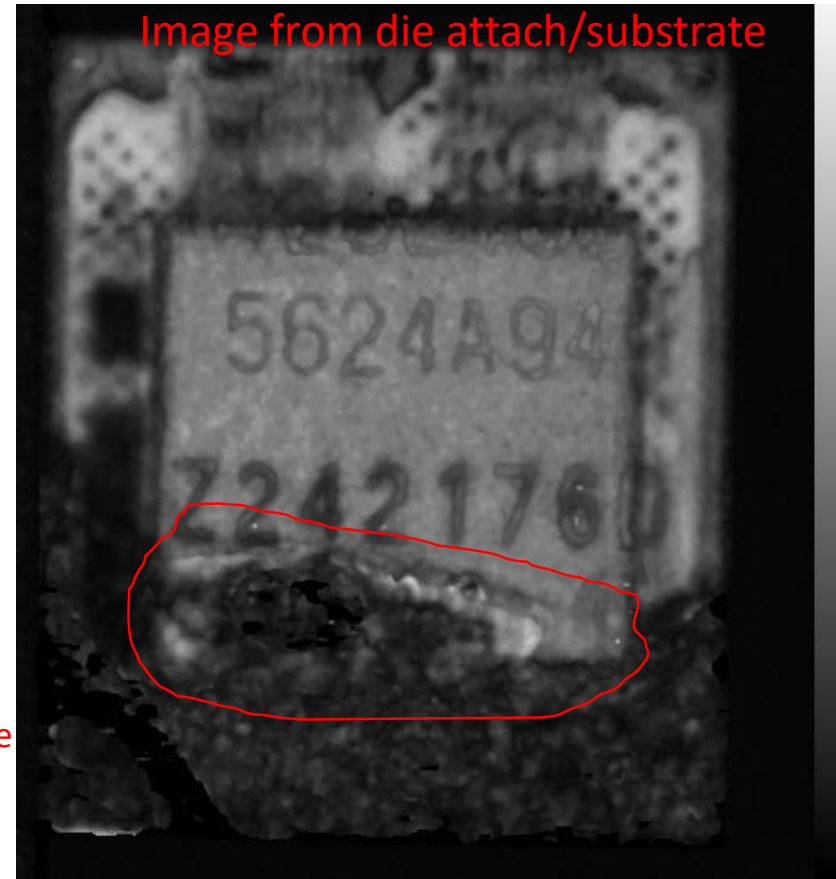
Acoustic images of the memory package

- Acoustic imaging confirms separation of the mold from the die (brightest areas due to high sound reflection)
- Because of the damaged mold in the bottom area of the package, sound is scattered/ reflected/attenuated and can not travel beyond the mold thickness.

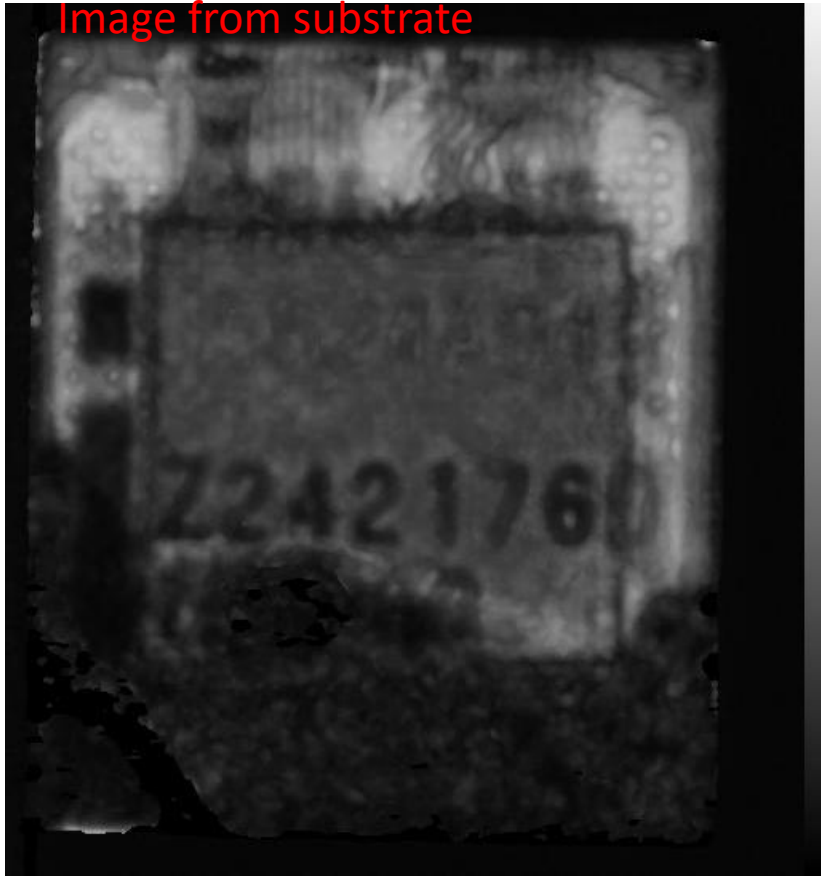
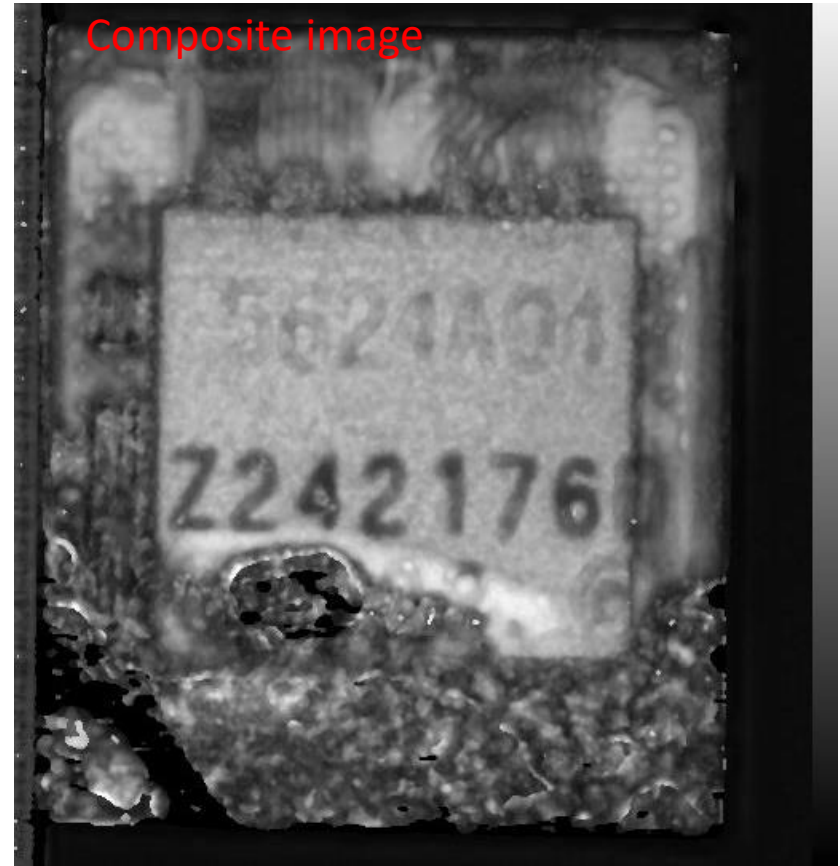
Acoustic images of the memory package

- Because of the damaged mold in the bottom area of the package, sound is severely attenuated and can not travel beyond the mold thickness.

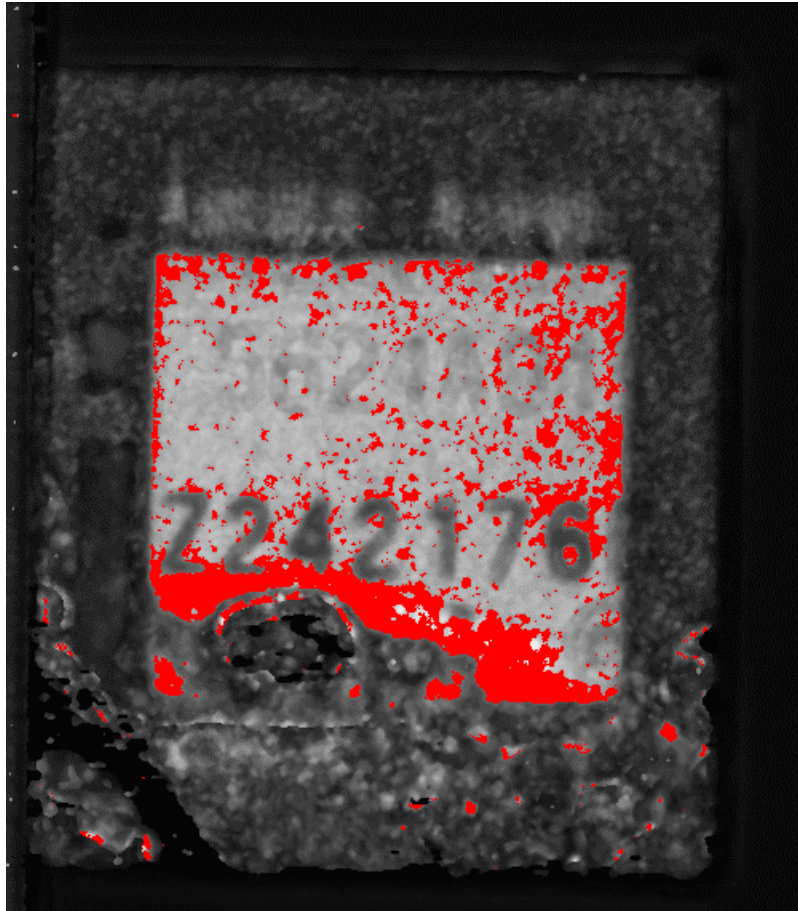
Red areas indicate possible delamination between the die and mold compound

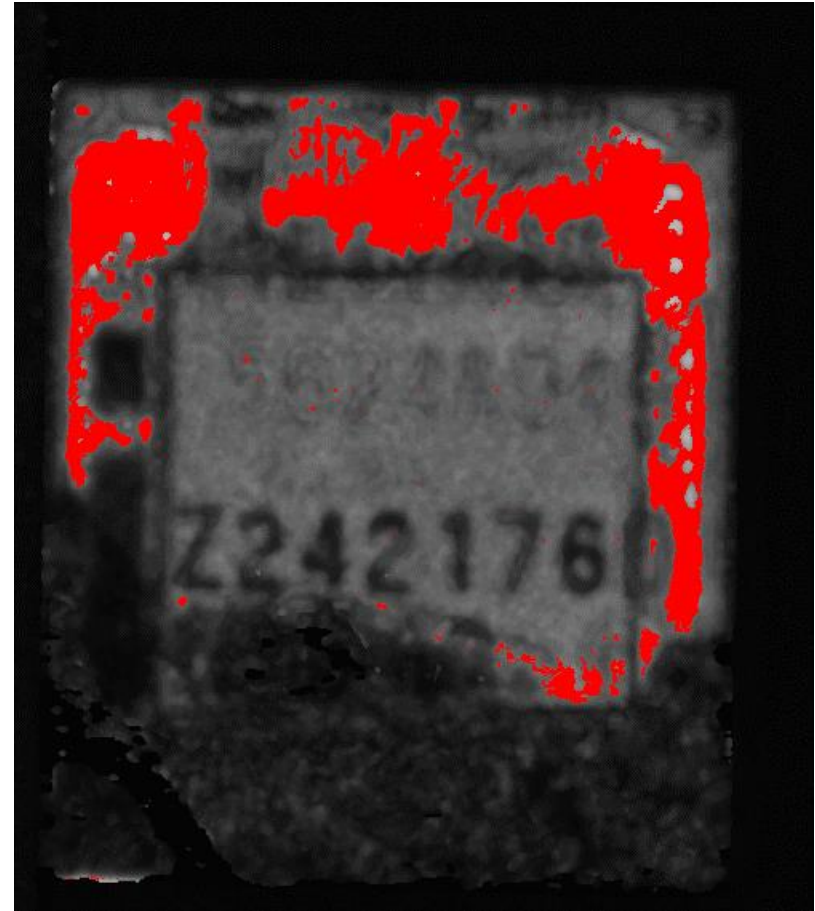
Red areas indicate possible delamination between the substrate and the mold compound

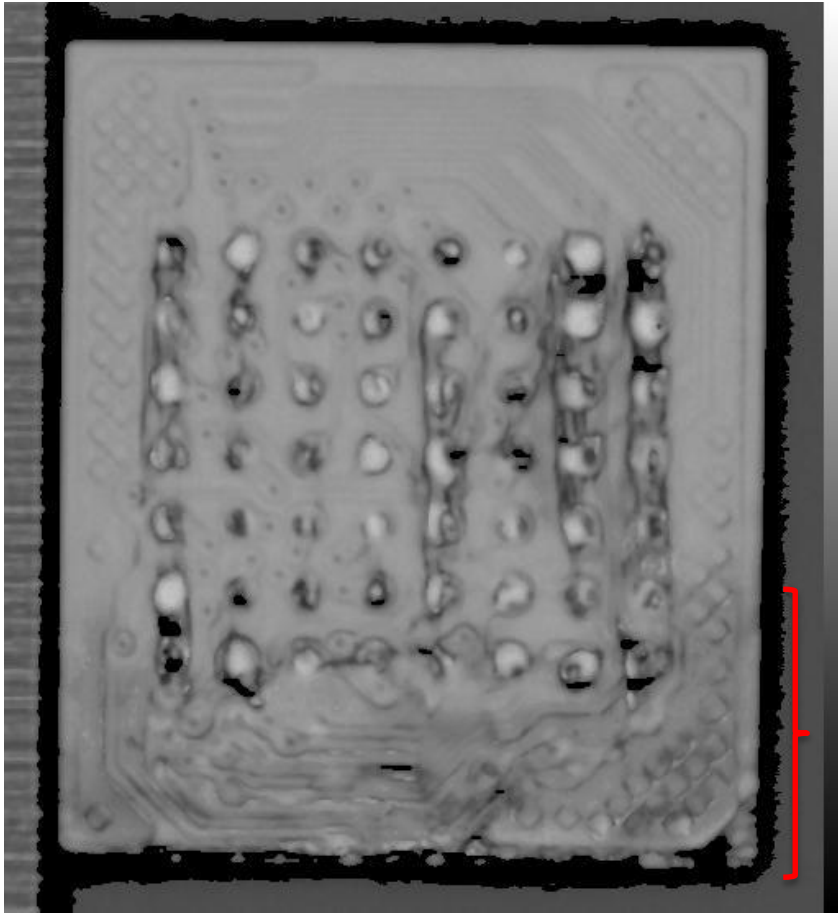
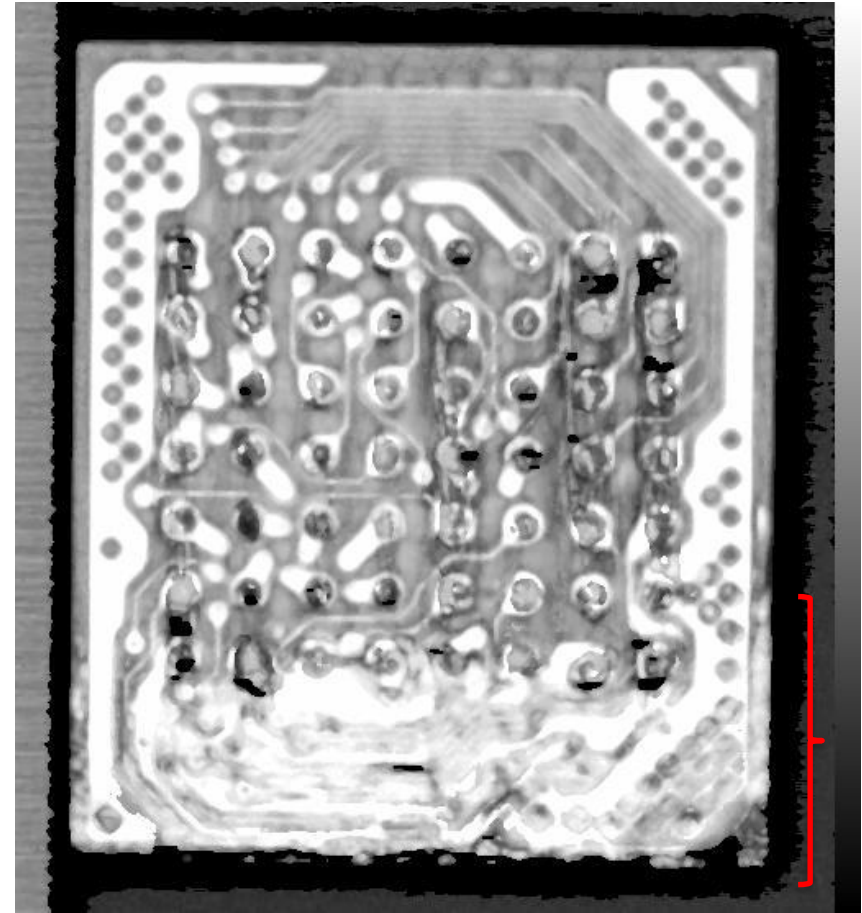
Acoustic images of the memory module from the backside

Acoustic imaging from the backside of the module shows internal damage within the substrate in the bottom area of the package

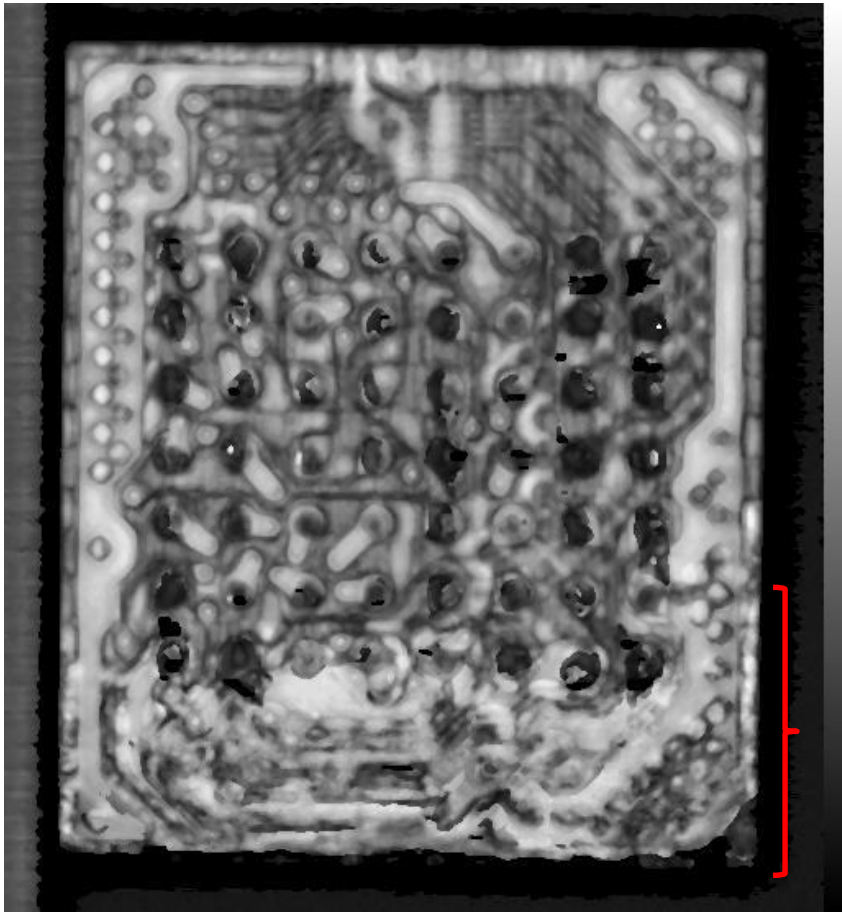
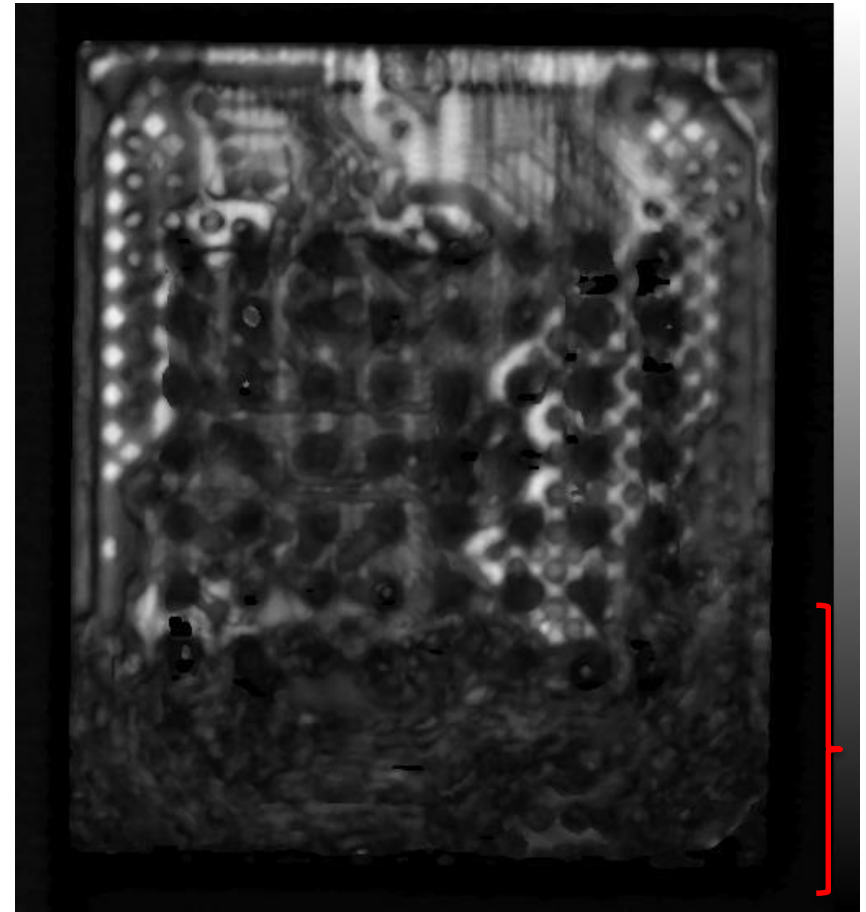
Acoustic images of the memory module from the backside

Acoustic imaging from the backside of the module shows internal damage within the substrate.
