NATIONAL TRANSPORTATION SAFETY BOARD

Group Chairman's Factual Report

STRUCTURES

CEN21FA198

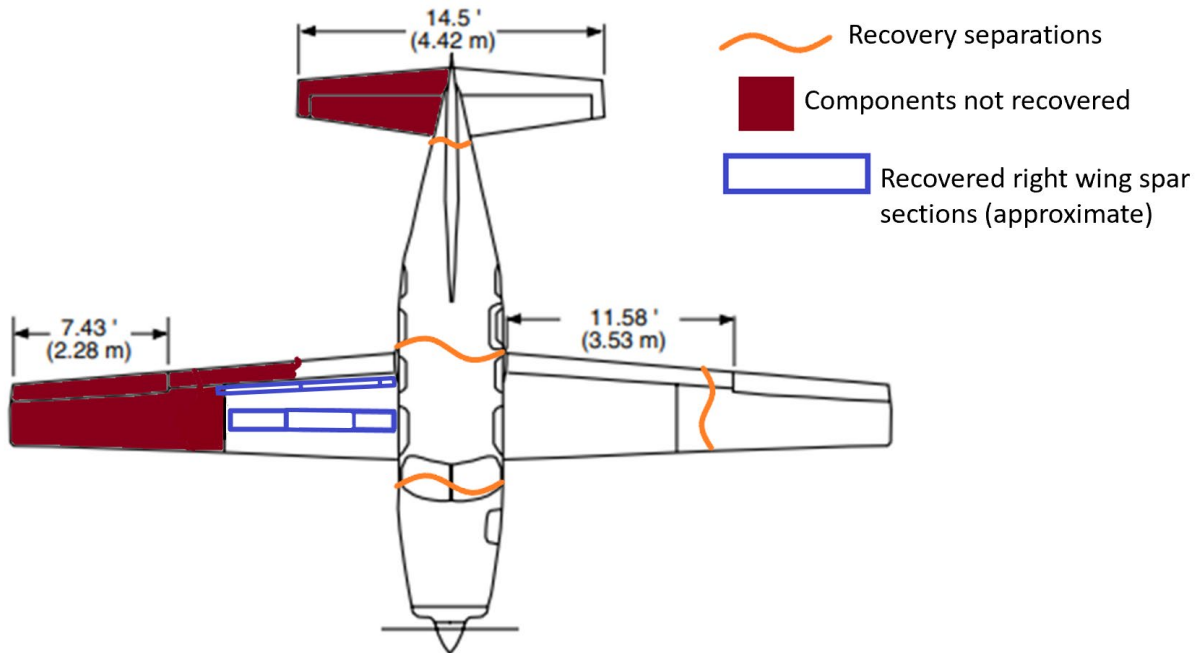
The airplane broke up in flight and the outboard right wing and the right horizontal stabilizer and elevator separated during the accident sequence. The separated items were not recovered (Figure 1). The remainder of the airplane came to rest in wooded tree covered terrain with significant damage. The group focused the examination on the left wing, right wing, and empennage.

Figure 1 - N461DK wreckage schematic

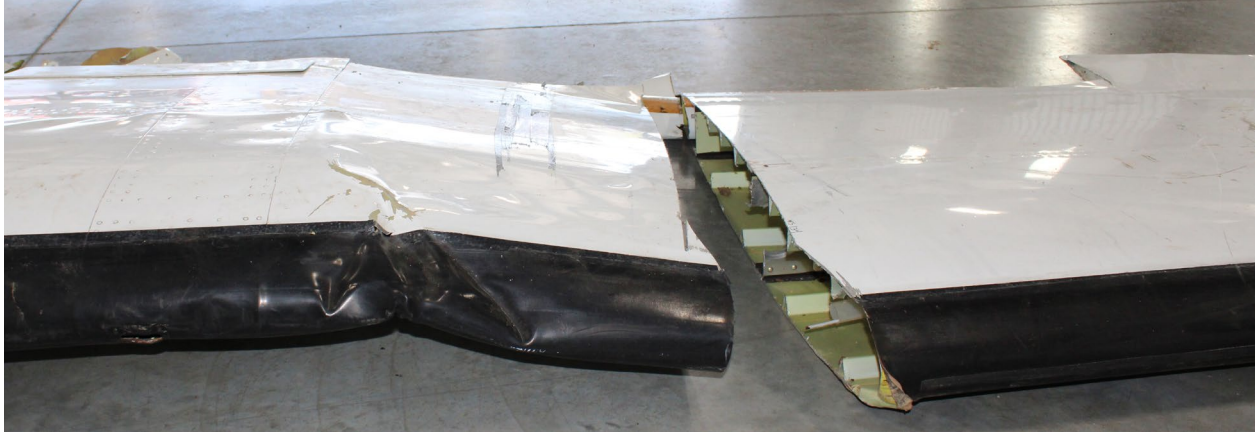
The left wing was mostly intact and remained attached to the fuselage on scene. The aileron was intact and attached and the flap was mostly intact and attached. The wing and flap were cut near wing station (WS) 134 to facilitate recovery. The outboard portion of the flap remained attached to the cut off section of wing. The inboard portion of the flap was separated into two pieces between WS 80 and WS 93 during recovery. A small portion of the left flap remained attached to the roller mechanism near WS 93. The left wingtip separated and was recovered at the main wreckage site. There was pronounced downward deformation of the wing evident near WS 118 with buckling damage to the leading edge and lower skin between WS 115 and WS 130 (Figure 2). The STC installed spoiler was intact, installed, and in the down position. The left aileron remained attached to the wing and was resting against a tree on scene. There was impact damage to the upper surface and the aileron was deflected downward on scene with over travel damage to the lower skin at both hinges noted during the examination. The forward spar upper cap rivets were popped through the upper skin between WS 204 and WS 240 and the WS 240 rib rivets were popped through the upper skin between the forward and aft spars. The airplane had an additional fuel filler opening and cap installed in the outboard fuel bay per STC SA00859AT to allow the carriage of 10 additional gallons of fuel in each wing.

Figure 2 - Left wing downward deformation near WS 118 and cut near WS 134

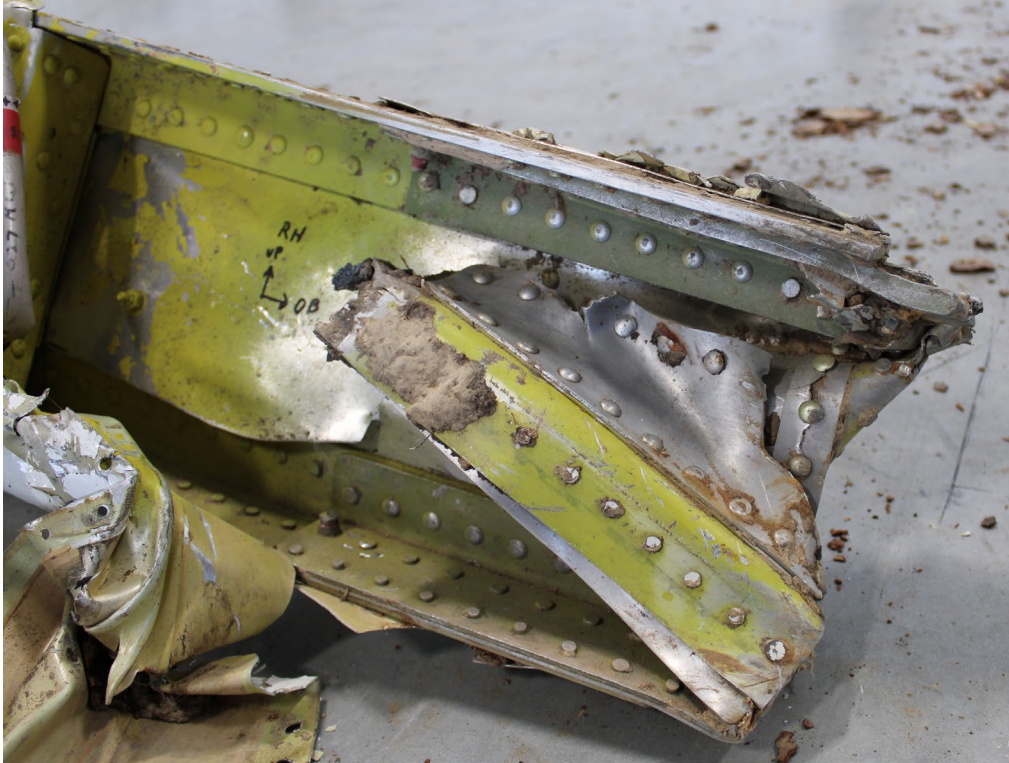
The airplane impacted the ground on the right side and the right wing was highly fragmented between the root at WS 29 and the splice at WS 107. Leading edge, forward spar, interspar, rear spar, and flap structure in this area was identified in the recovered wreckage with significant deformation and fracturing. There was tree debris and dirt embedded in the recovered inboard right wing wreckage. A section of the inboard portion of the right flap about 5 feet long was identified. The right main landing gear trunnion rib with attached upper trunnion assembly was identified. Portions of upper skin, lower skin, wing ribs, aft spar, and the right spoiler were identified. The outboard right wing separated near the splice joint at WS 107. The forward spar upper spar cap splice fitting fractured near WS 109 and exhibited slight upward deformation at the fracture location. The forward spar lower spar cap fractured near WS 116 at the outboard end of the splice fitting and the section between WS 107 and 116 was folded inboard upon itself (Figure 3).

Figure 3 - Right wing forward spar separation location (looking forward)

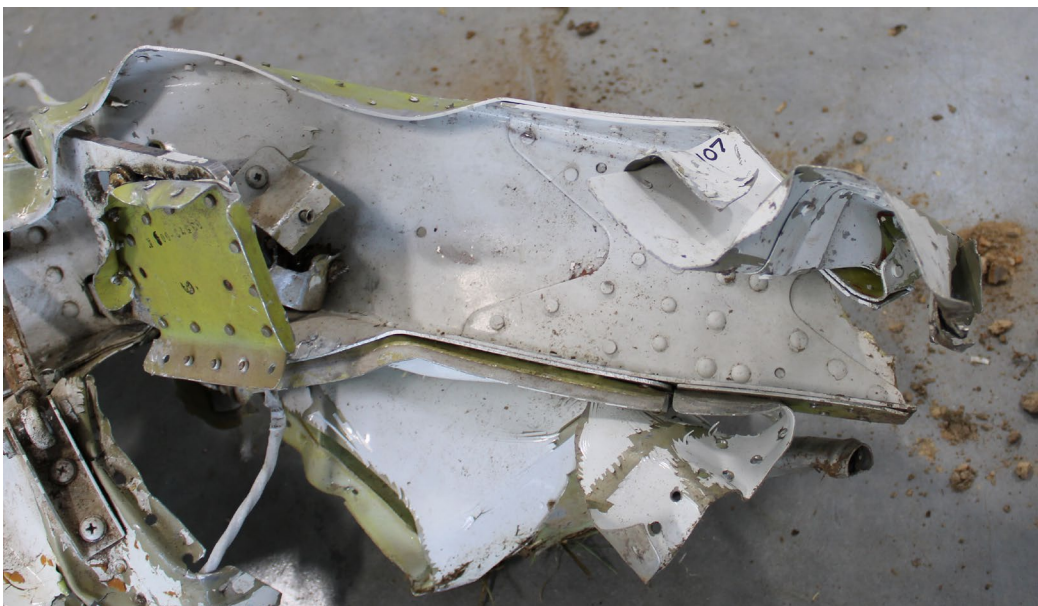
The right wing aft spar separated near WS 111 at the outboard end of a butterfly doubler installed on the aft face of the spar web (Figure 4). There was no discernable deformation of the lower spar cap and buckling deformation of the upper spar cap adjacent to the fracture location.

Figure 4 - Right wing aft spar separation location (looking forward)

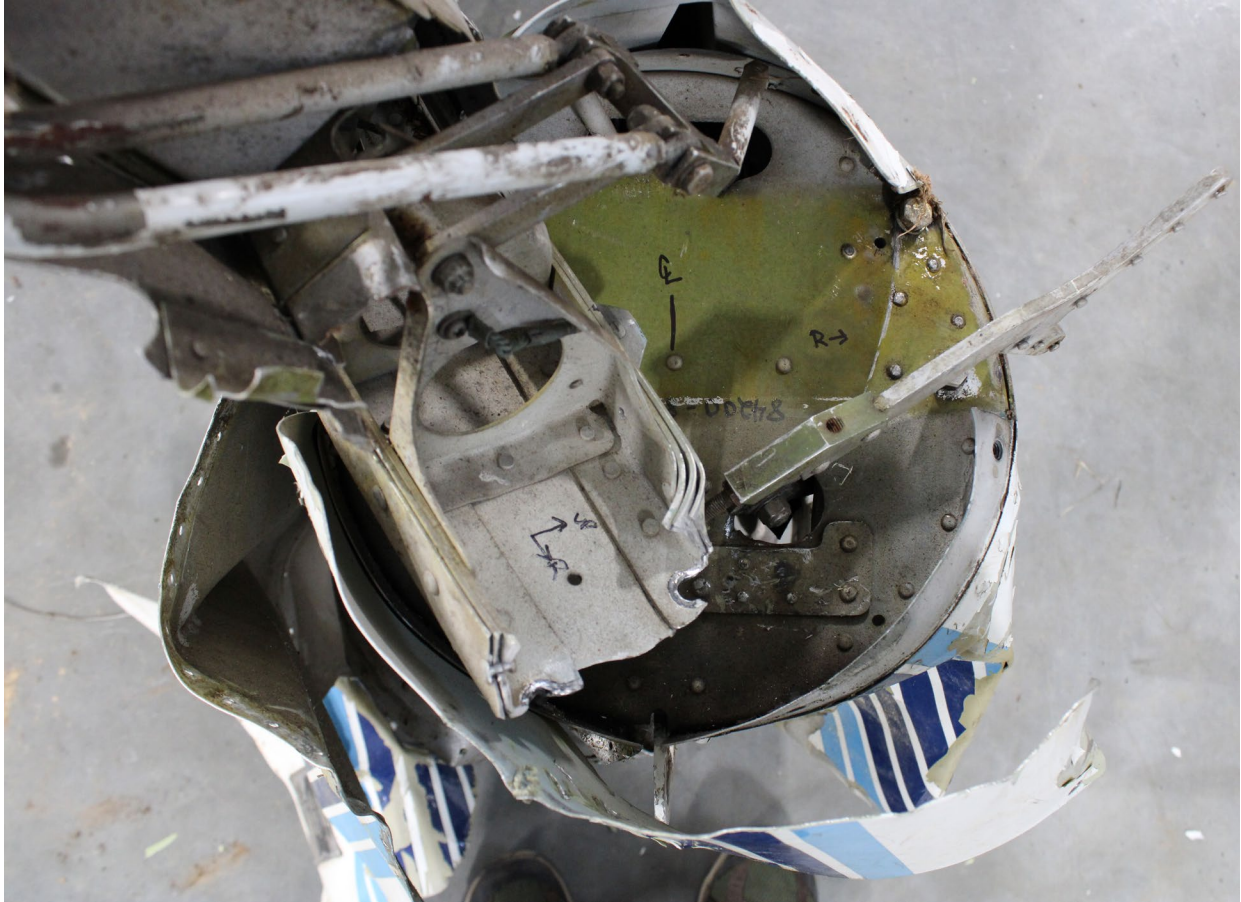
The right horizontal stabilizer and the right half of the elevator separated and were not recovered. The forward spar attach bolt was pulled through the empennage structure. The horizontal stabilizer aft spar was fractured about 4.5 inches right of the centerline through the attach point holes. The right upper and lower attach bolts were intact and installed in the empennage bulkhead. The right upper attach hole in the aft spar was pulled out in an upward direction and the right lower attach hole was pulled out up and to the right. The left lower attach bolt was intact and remained installed in the aft spar. The bolt was pulled out of the bulkhead to the left. The left upper attach bolt was intact and installed through the aft spar and bulkhead. The left side of the horizontal stabilizer was rotated up about 70° around the left upper attach bolt and jammed in place (Figure 5). There was an arced witness mark in the bulkhead paint from the right upper attach point down and left. At the aft spar fracture location, the horizontal stabilizer aft spar lower cap had little discernable deformation while the upper cap was buckled downward. The elevator bell crank was intact and connected to the push-pull tube. All of the rivets in the bellcrank were intact with little deformation and were pulled from the elevator. The two trim tab links were intact and attached to the trim tab and the bell crank. The trim tab rods forward of the bell crank were fractured. The left side of the trim tab remained attached to the left elevator and was fractured about 1 inch right of the centerline. About 3 feet of the trim tab hinge pin extended out from the right side of the trim tab that remained.

Figure 5 - Horizontal stabilizer attach point (looking forward)
