Repair of Memory Module from Incident CEN21FA198

S.R. Cain, A. Sharma, M. Alhendi, B. Chan

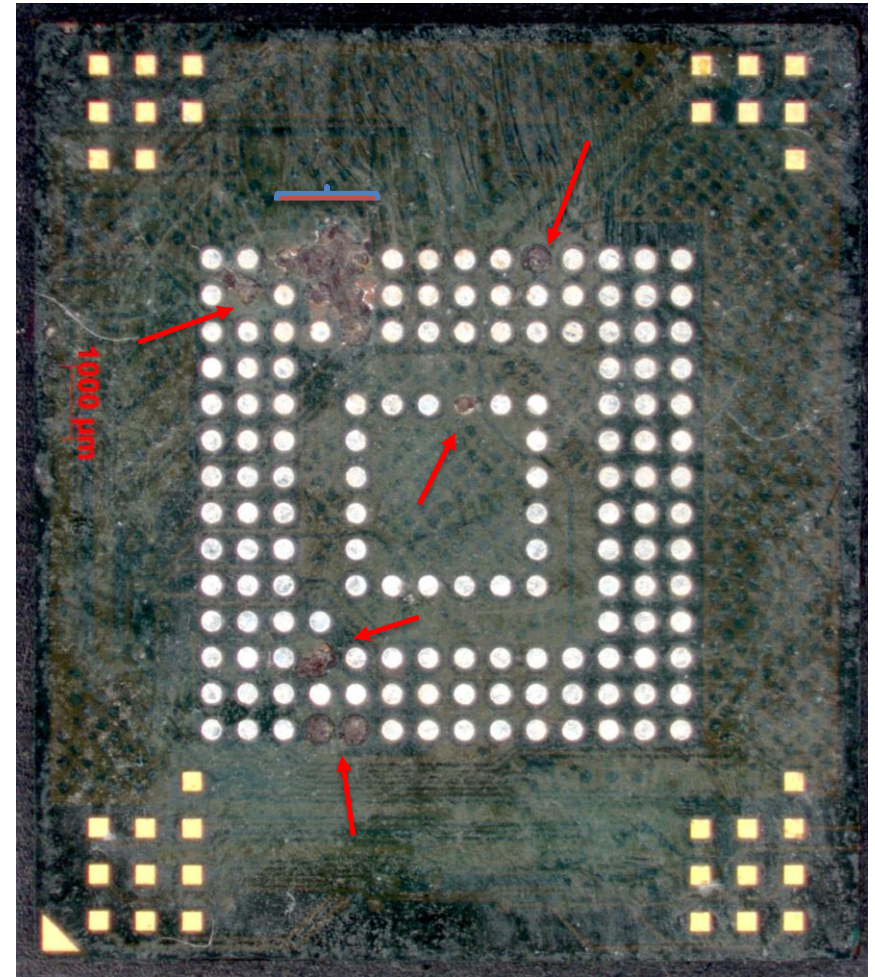
- **One module received for analysis**
 - Incident CEN21FA198
 - Module type: Flash Memory
 - Part: Samsung KLM8G2FE3B-B001
- **Disposition from nondestructive analyses**
 - Multiple instances of missing circuitry from the bottom layer of the package (red arrows)
 - Chip is intact
 - Repair may be attempted
- **Approach**
 - Devise reconnection scheme from similar modules (X-ray tomography or flat sectioning)
 - Remove dielectric from the bottom circuit layer
 - Print conductors to replace the missing circuitry

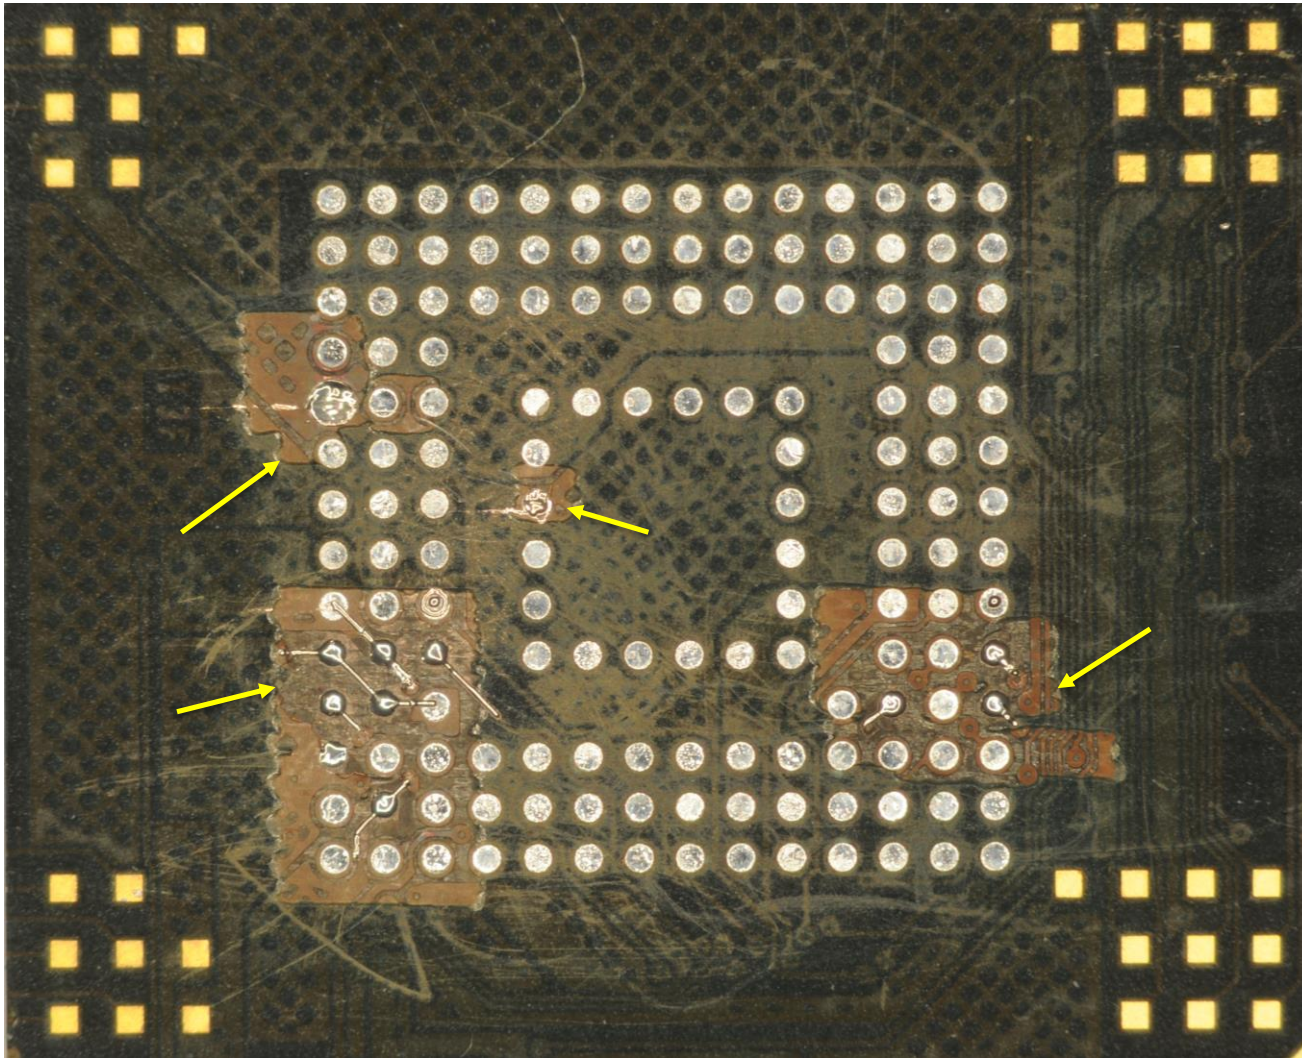
View of the Module After the First Repair Attempt

Yellow arrows show the areas where the repair was done

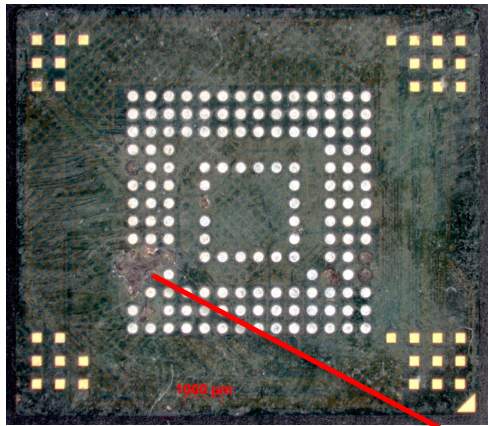
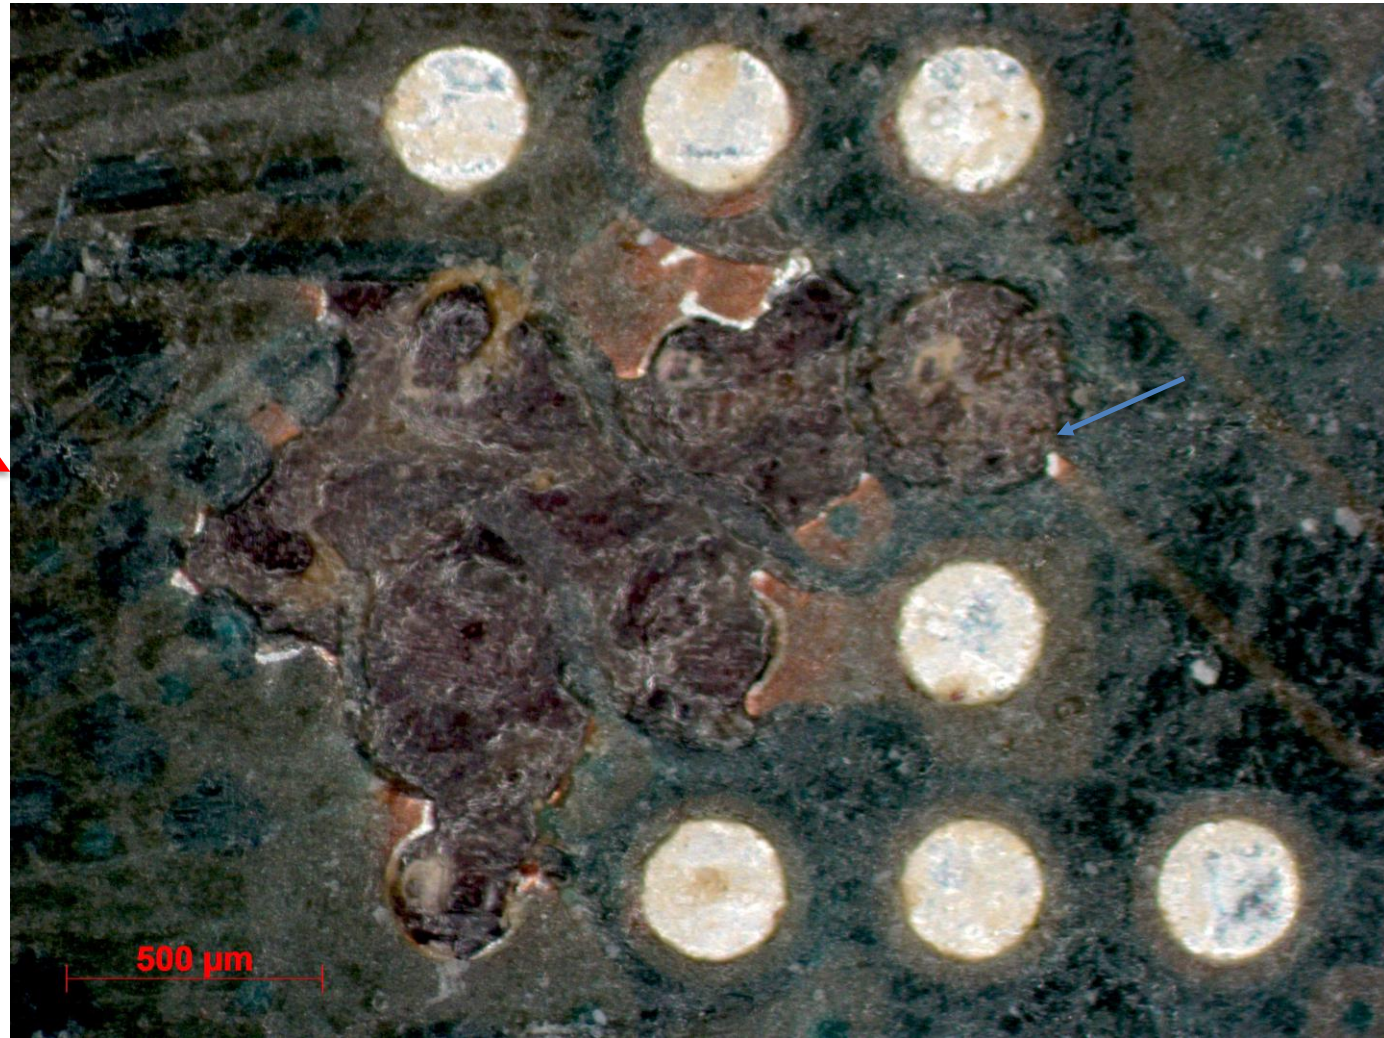
Optical Micrograph of the Damaged Area

FIRST DAMAGED AREA TO BE REPAIRED

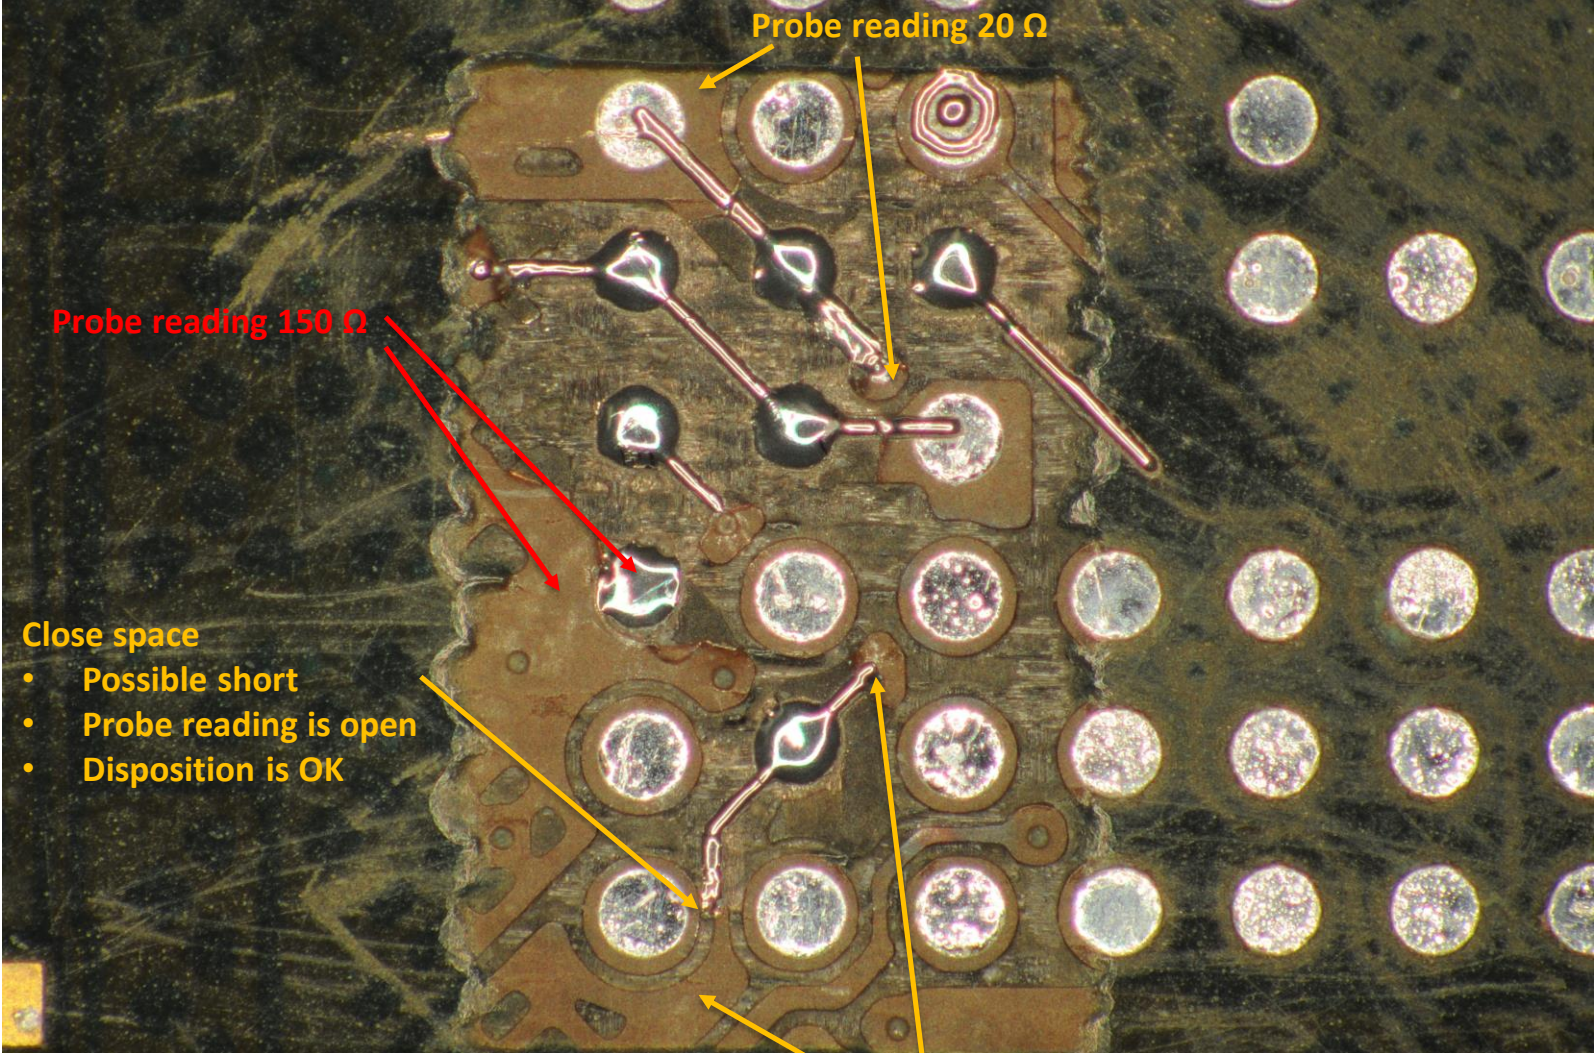
First Repair Attempt in This Area

Probe reading 150 Ω

Probe reading 20 Ω

- Close space
- Possible short
 - Probe reading is open
 - Disposition is OK

Probe reading, 66 Ω

Red arrows indicate additional repair needed

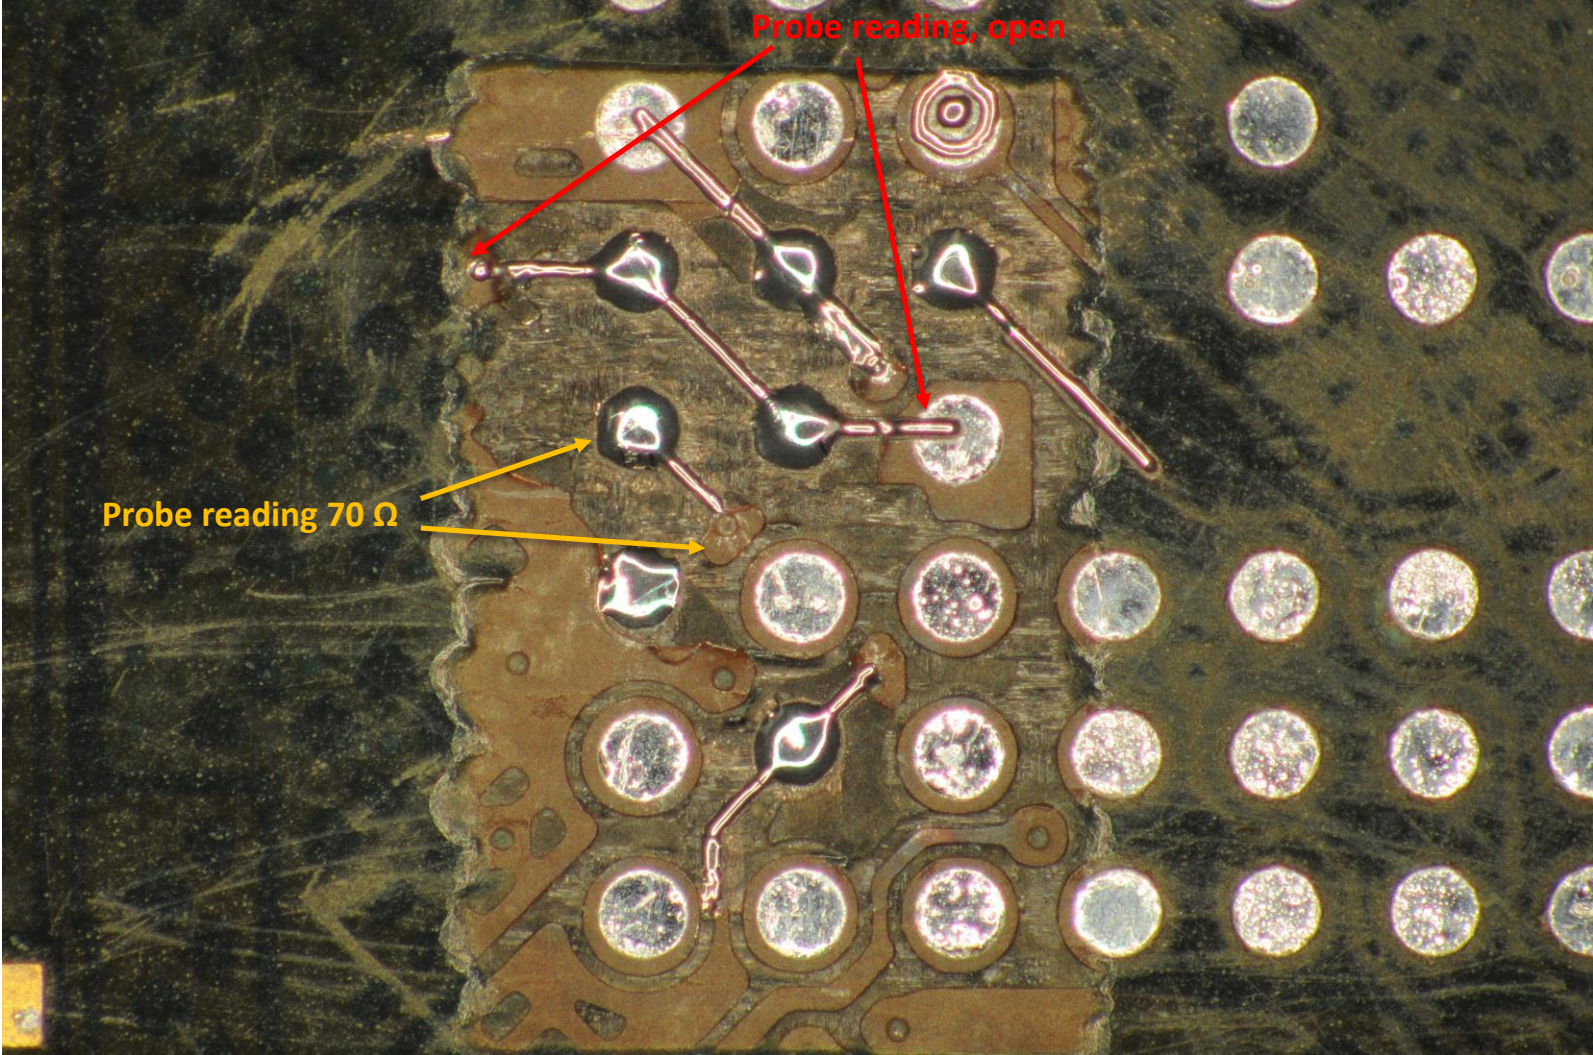
First Repair Attempt in This Area, cont'd.

Red arrows indicate additional repair needed

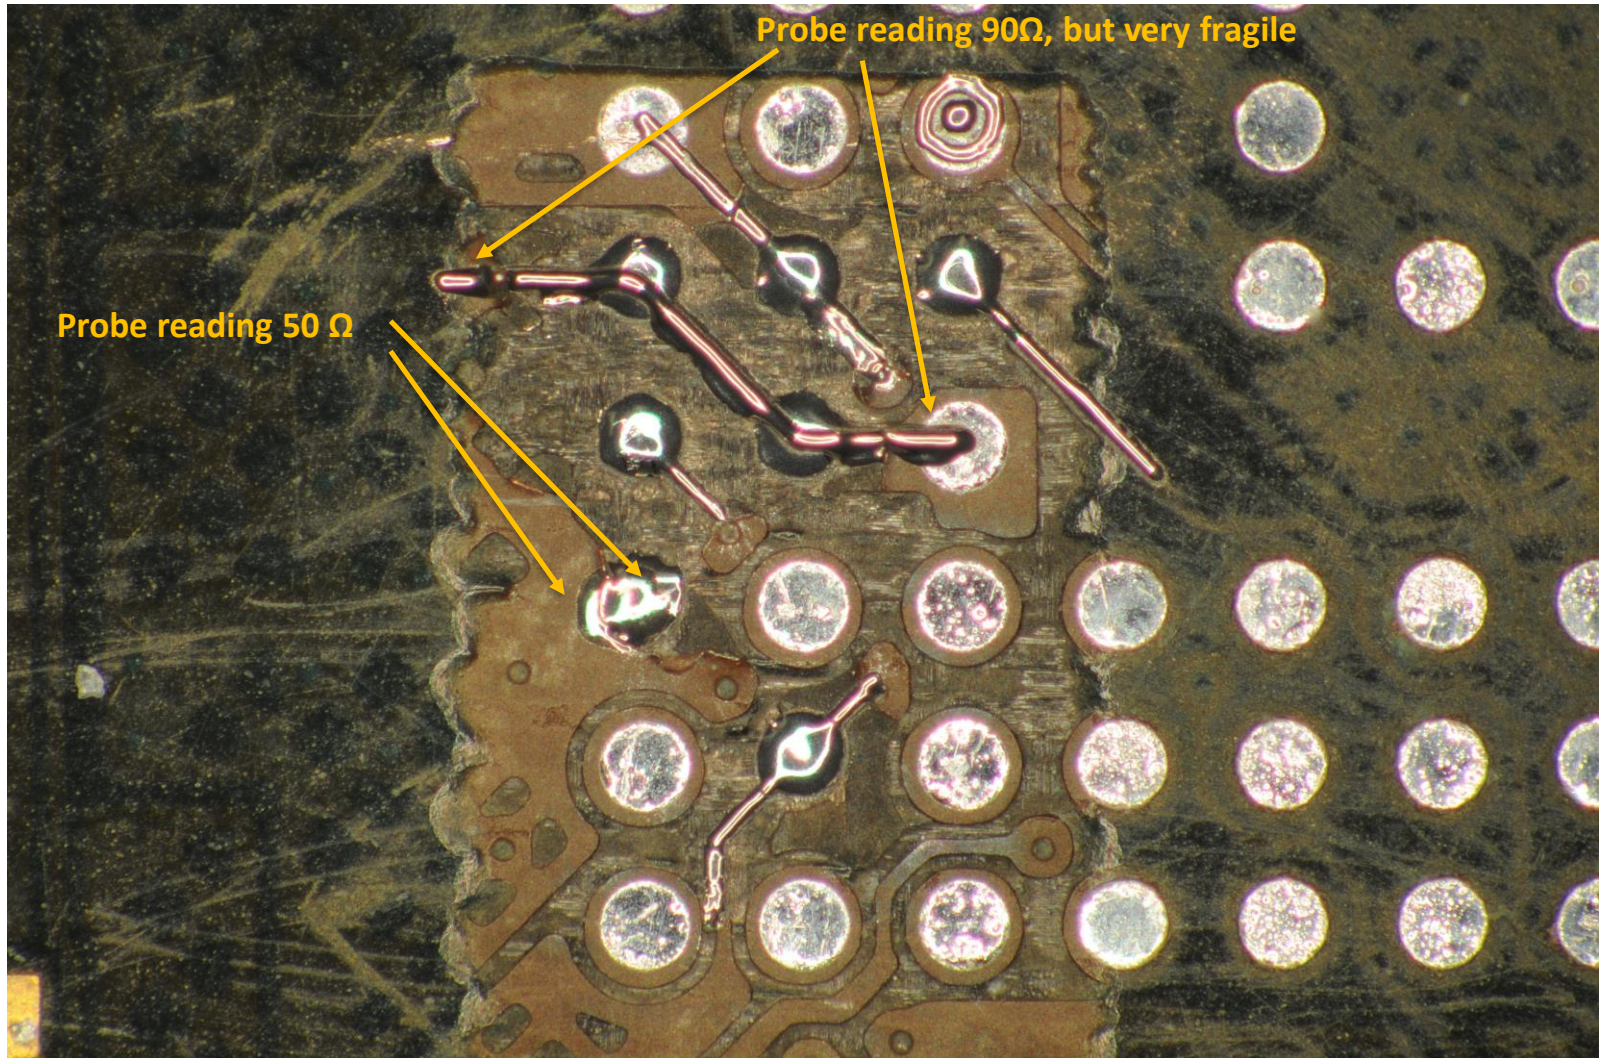
Second Repair Attempt in This Area

Note: one of the repairs is quite fragile, which may be problematic in the attempt to read data

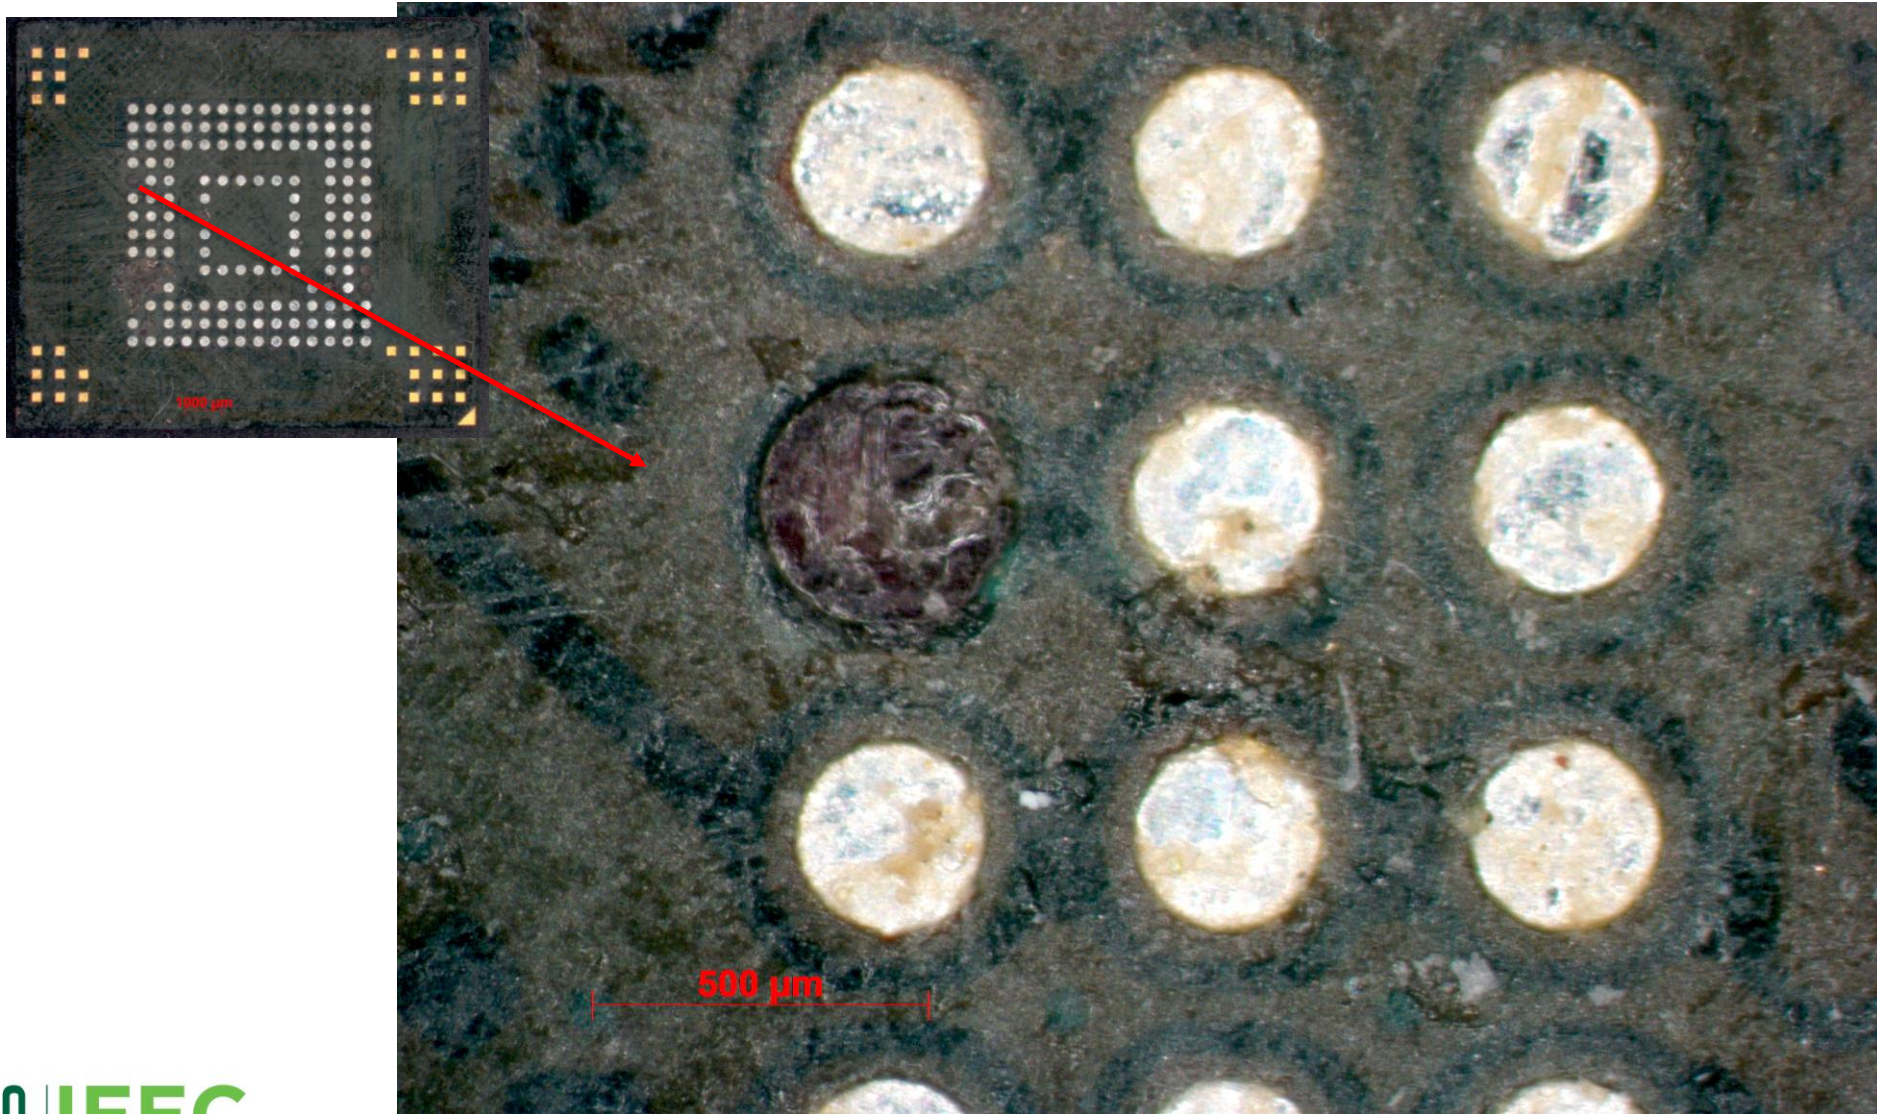
Optical Micrograph of the Damaged Area

SECOND DAMAGED AREA TO BE REPAIRED

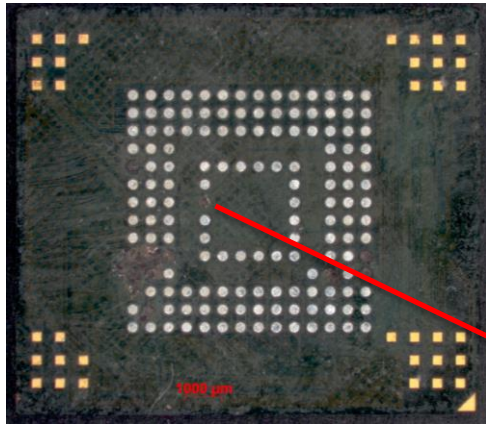
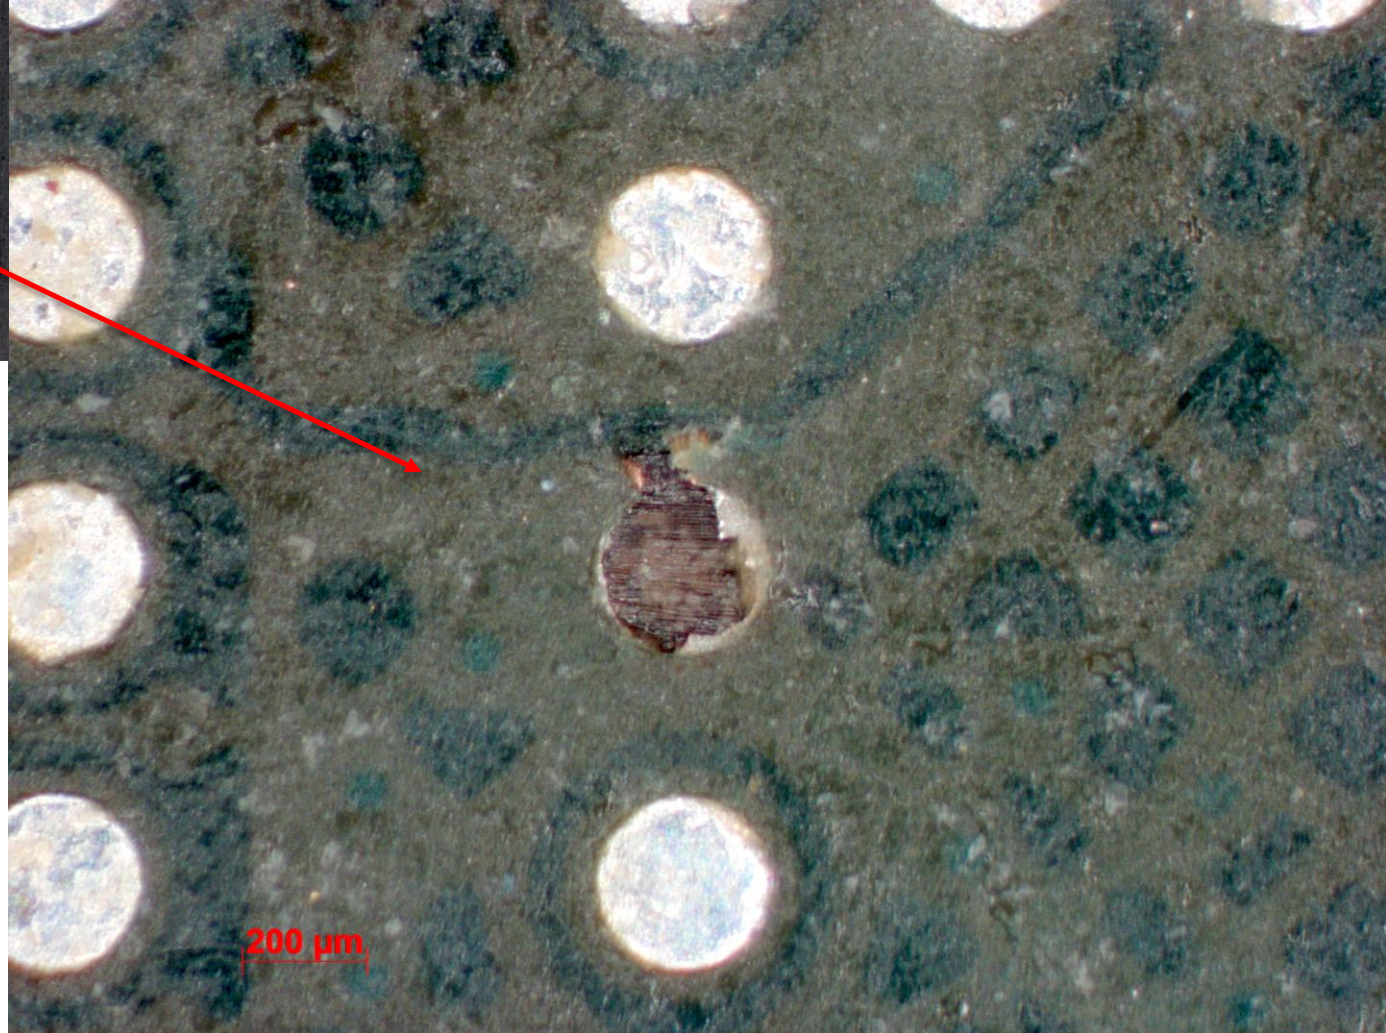
Optical Micrograph of the Damaged Area

THIRD DAMAGED AREA TO BE REPAIRED

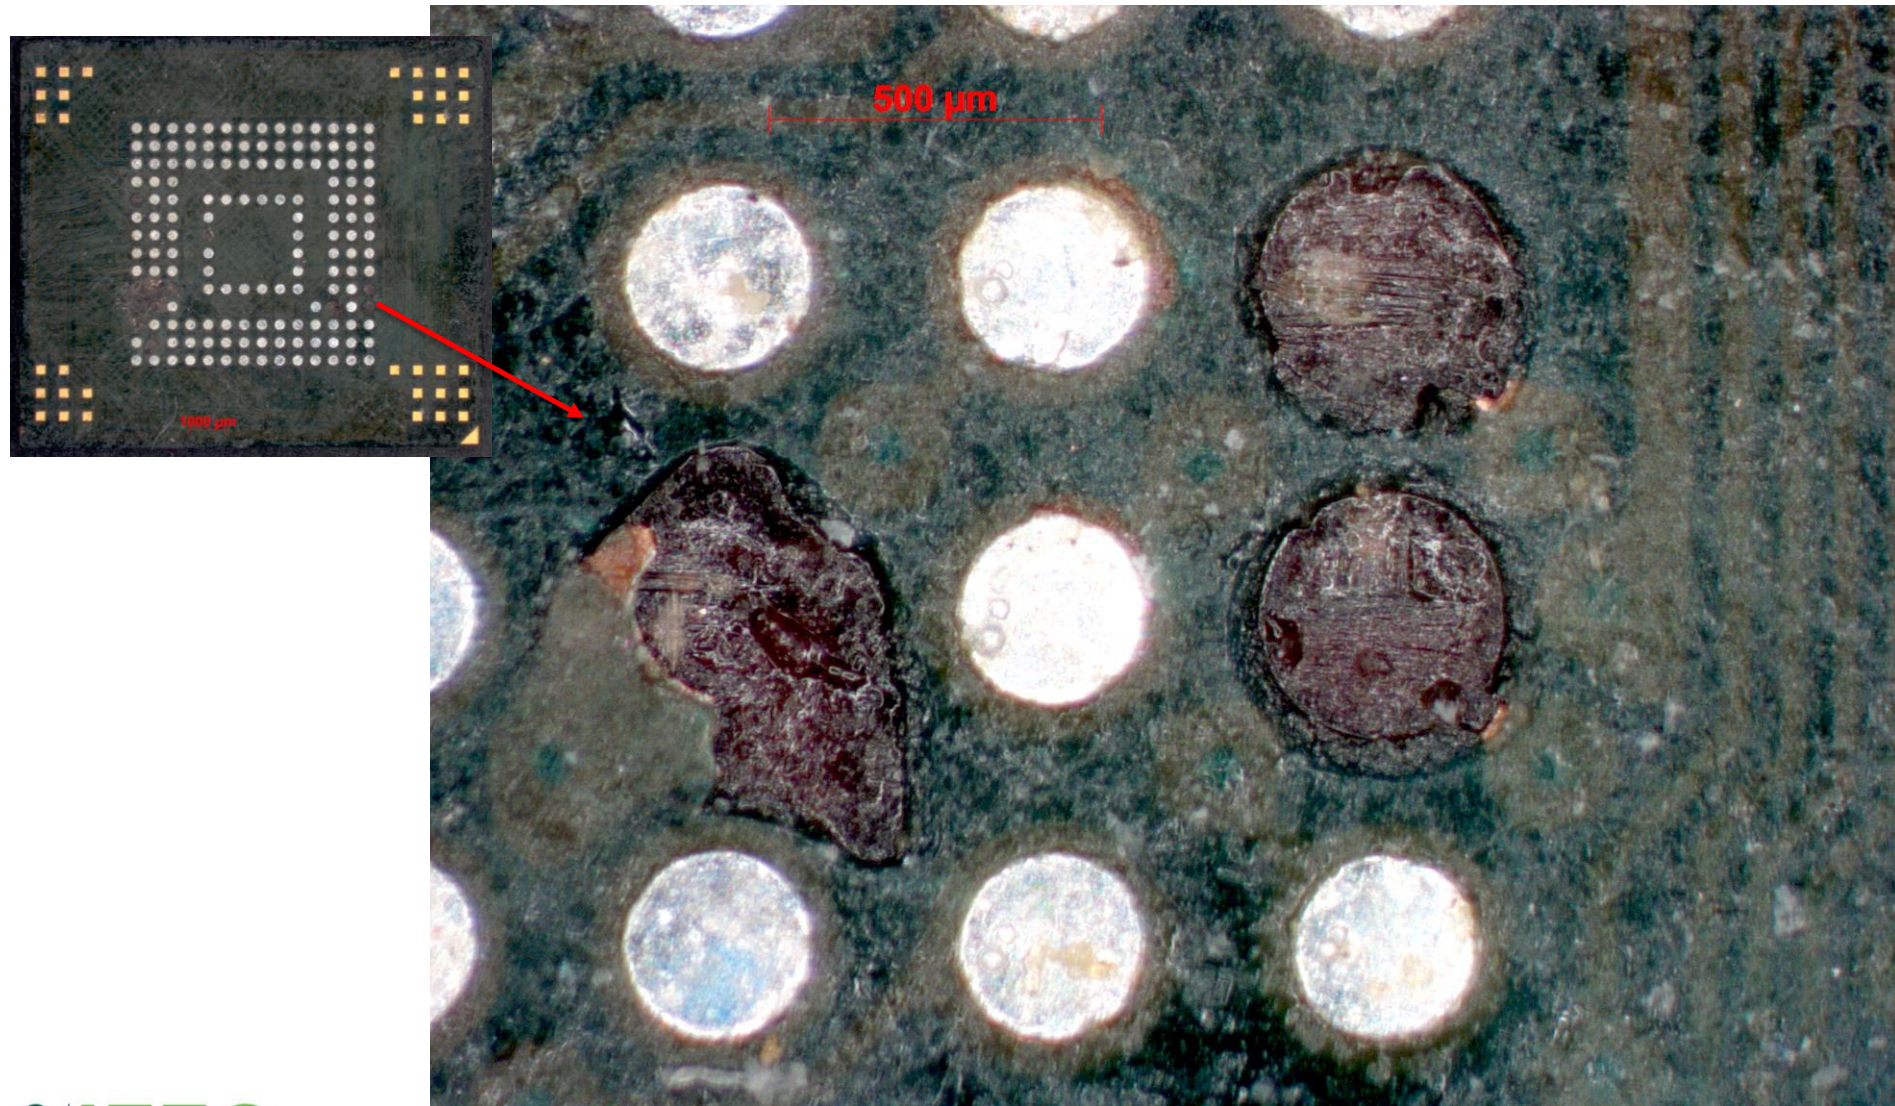
Optical Micrograph of the Damaged Area

FOURTH DAMAGED AREA TO BE REPAIRED

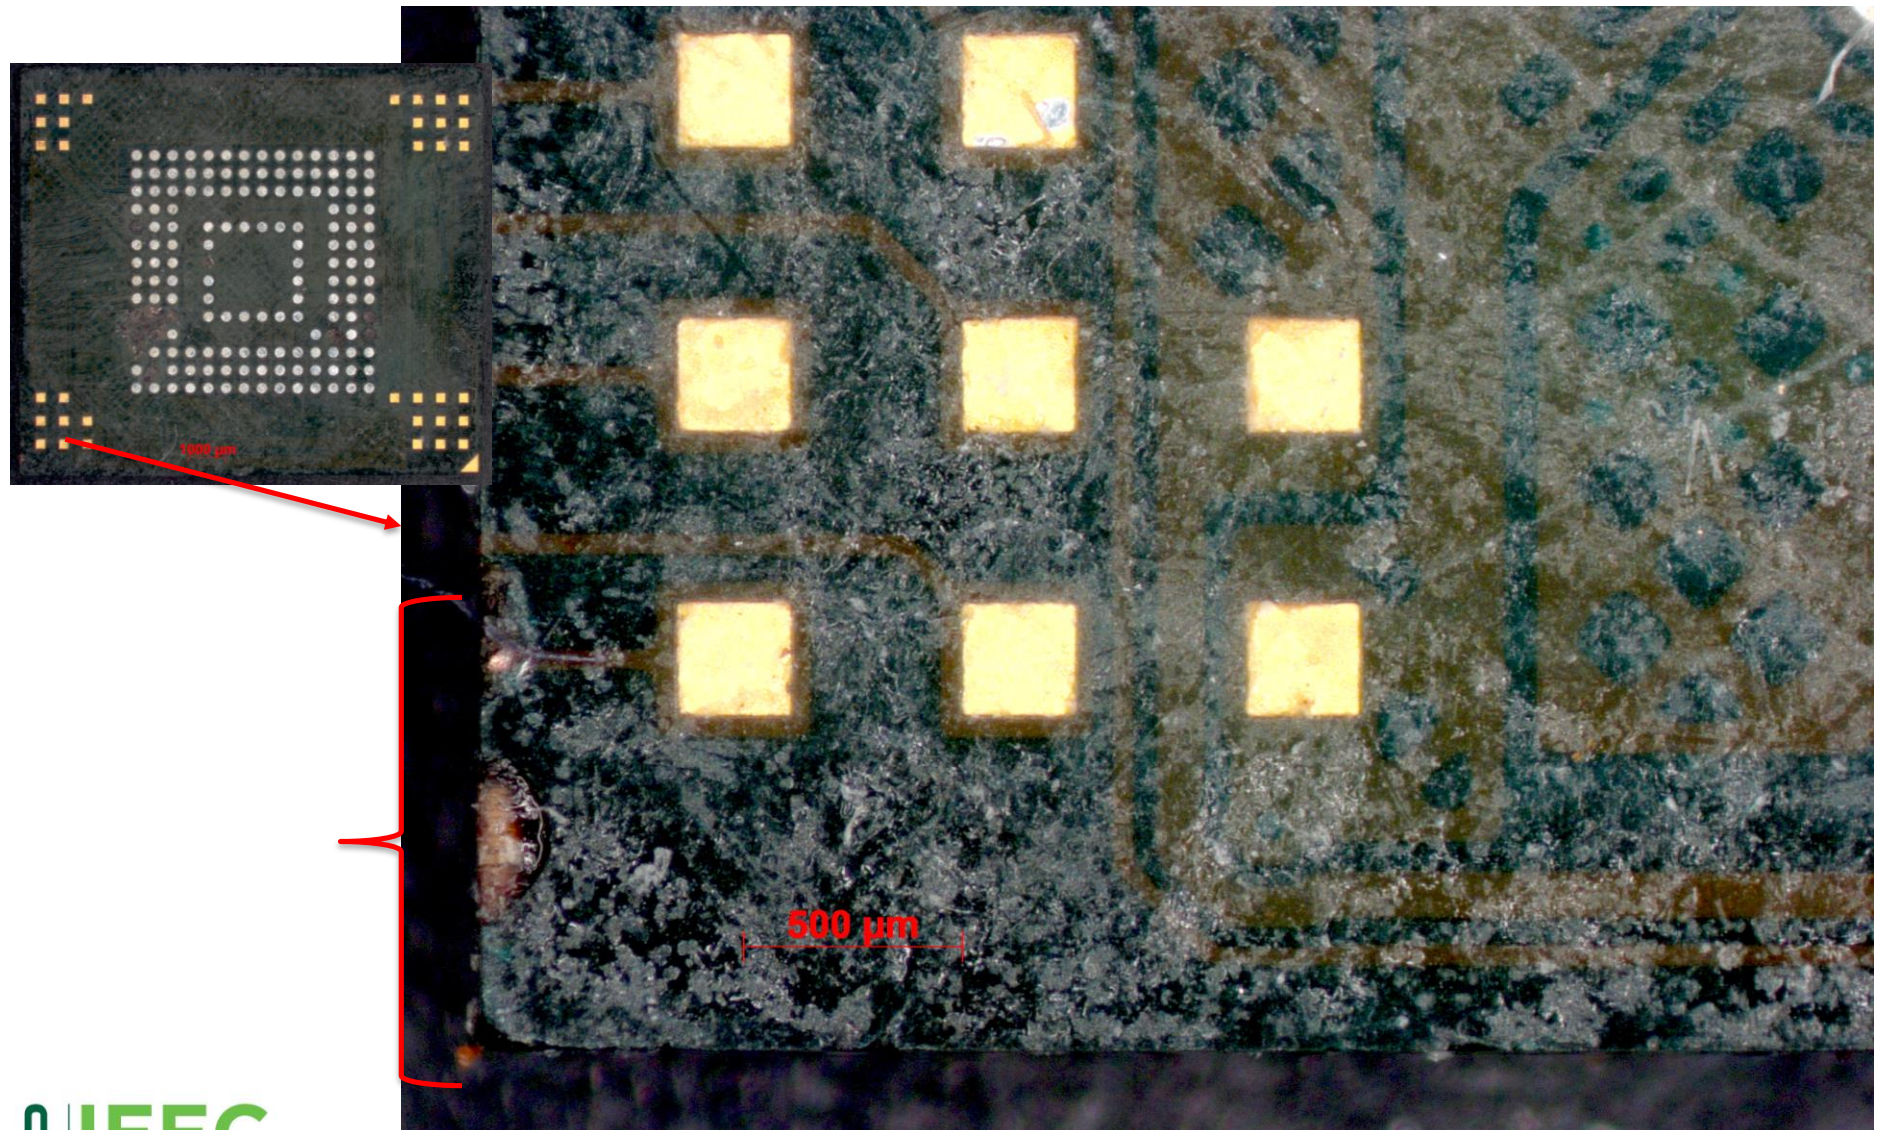
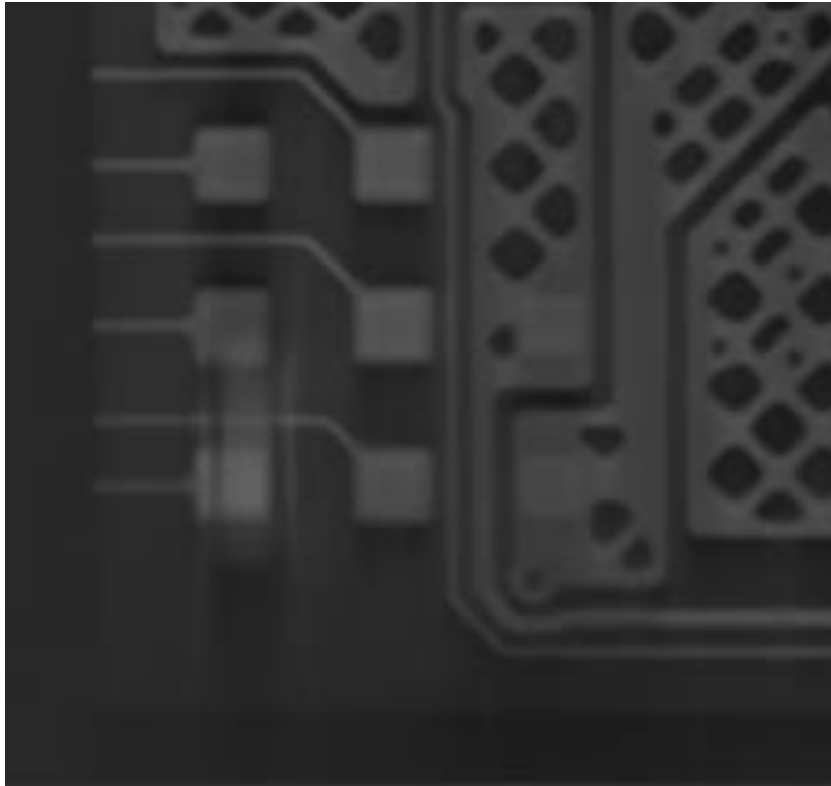
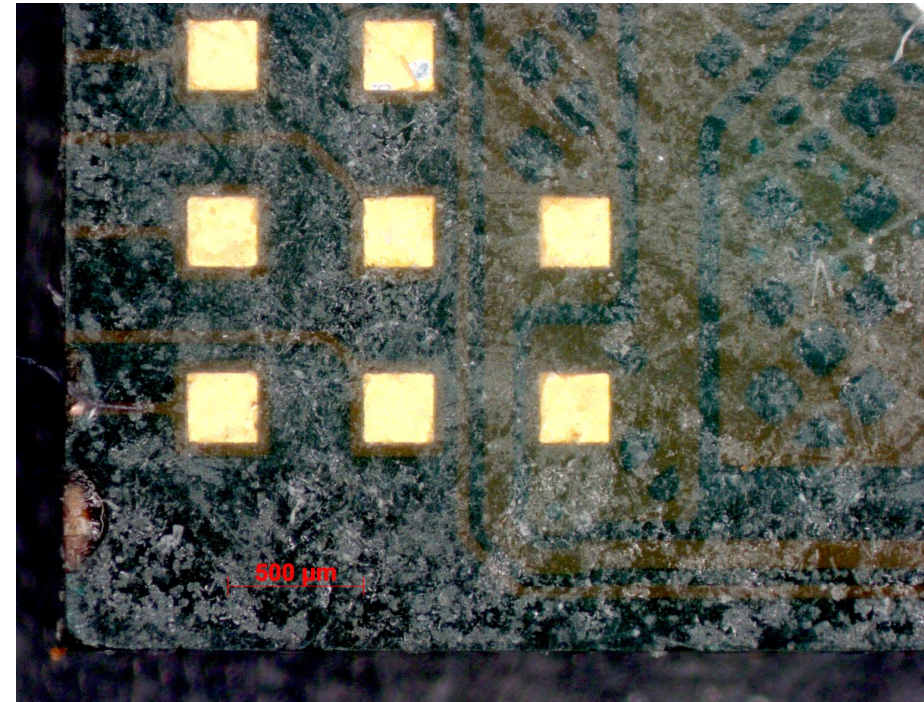
Optical Micrograph of the Damaged Area

Damage at the edge of the package in this region only affect lead that run to communing bars – these are not involved in the functionality, and no repair is needed
