Specialist's Report – Attachment 1
Records of Conversations and Witness Statements

OPERATIONAL FACTORS

CEN21FA199

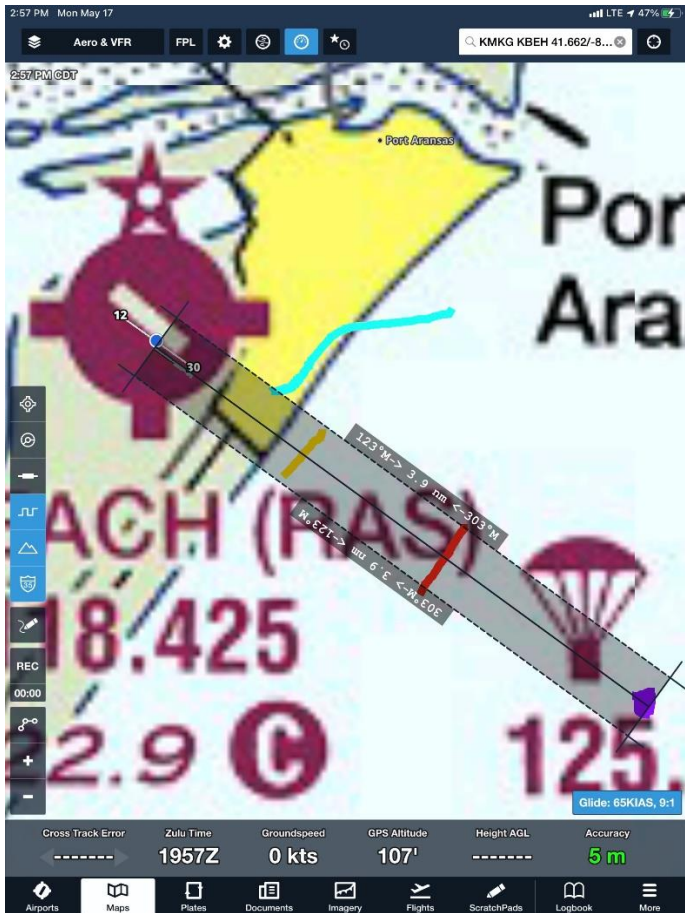
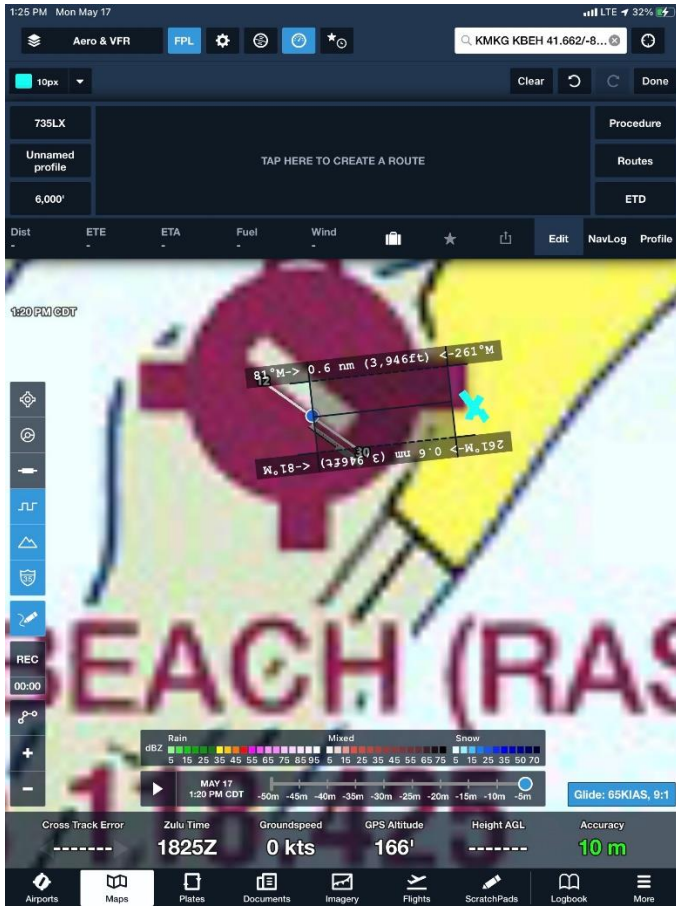
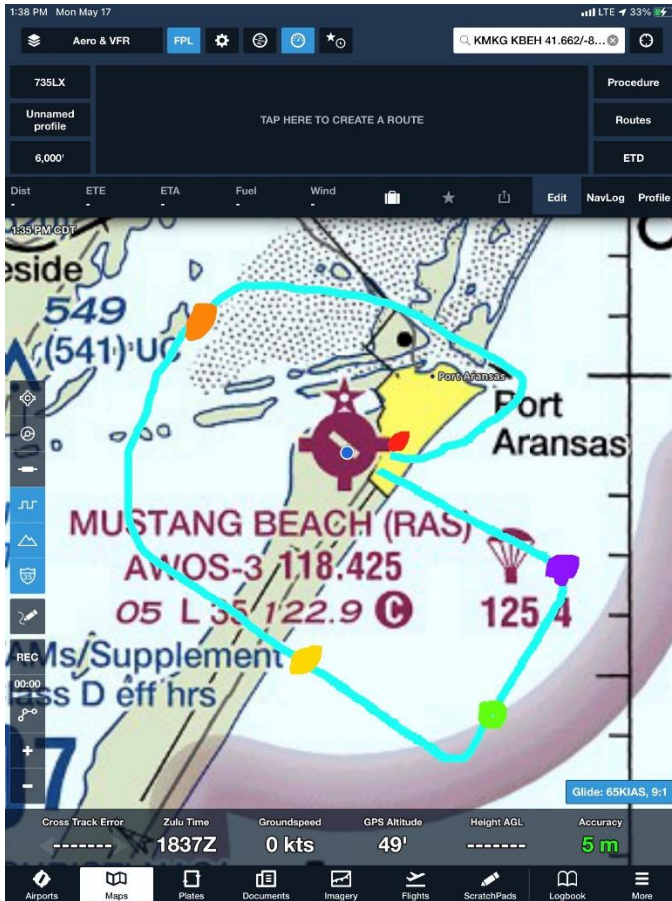
- - I also heard a Polatus call they were 11 miles out (I believe to the west)
 -
-
-
- Green Dot - Location of third radio call approximately 5000 AGL "Skydive 00F extended left base runway 30"
-

- -
 - I flew over the ocean further than normal because I wanted to be on a long final to and have visual on any
 - planes in the pattern
 -
-
-
- Purple Dot - Location of my call when I turned final approximately 4000 AGL "Skydive 00F 4 mile final runway 30"
-

- -
 - I heard other pilots in the pattern and around the airport but no radio calls from the Cirrus
 -
-
-
- Red Line - The Polatus made another position call and asked the location of the skydivers, "I said jumpers are on the ground and 00F is on a 2.5 mile final." I do not remember hearing any other calls at that point
-
-
-

- Yellow line - I called "00F on short final runway 30." Immediately after I released my mic the Cirrus called
- "short final 30." The Cirrus did not say if he saw me. I became very concerned, I thought he might be underneath me because my approach angle is steeper than most planes. I did not see the Cirrus after a few seconds of visual searching. I then saw the Cirrus

- on my ADSB receiver (blue line). He was flying directly towards the runway threshold at approximately a 45° angle and off my right side (the ADSB receiver showed the Cirrus at my same altitude I never had visual on him). Based on our locations we were going
