NATIONAL TRANSPORTATION SAFETY BOARD

Specialist Factual Report

OPERATIONAL FACTORS

CEN21FA199

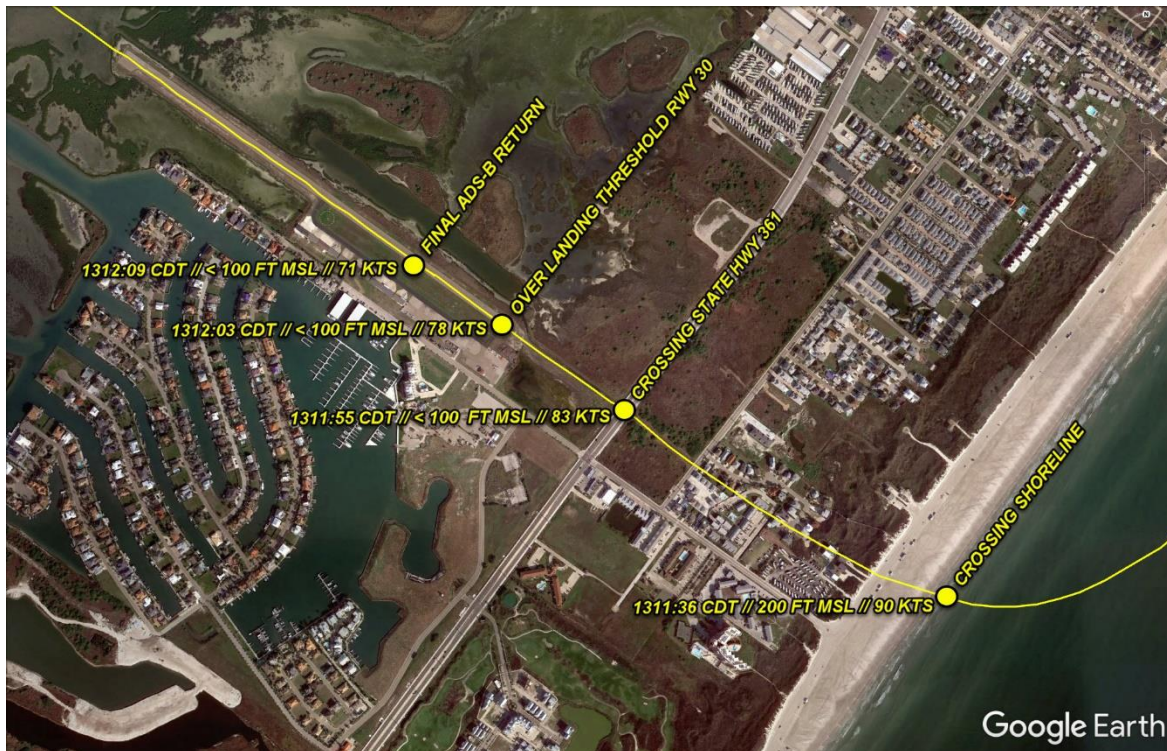
Witnesses stated that the flight appeared low on the approach to the runway 30, and almost touched down short of the runway. Witnesses told the NTSB that they observed the pilot’s left-side door was opened out about a foot prior to landing.¹⁰

Figure 4: Radar ground track of N587CD's accident flight approach to KRAS runway 30 on April 24, 2021.¹¹

Prior to touching down on runway 30, the pilot appeared to execute a go-around. At 1312 CDT (1812Z) witnesses observed the N587CD pitch up sharply, then rolled off to the left and impact the ground inverted in front of a row of hangers at KRAS. Witnesses also reported that the Cirrus Airframe Parachute System (CAPS) system deployed on impact.¹² The pilot was fatally injured, and the father and his son were severely injured.

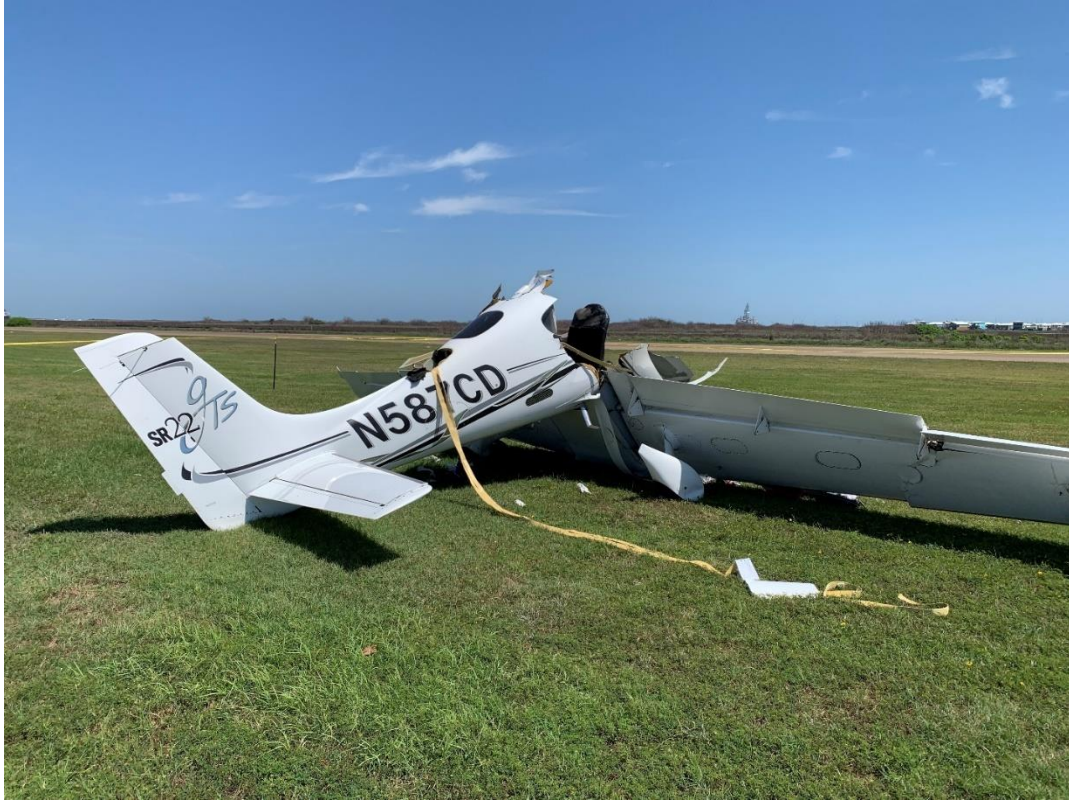
Examination of the N587CD wreckage occurred on April 25, 2021. Representatives from Cirrus Aircraft, the FAA, and the NTSB were present. According to the Cirrus Aircraft representative, the wing flap position of N587CD was consistent with the flaps being UP. Further, the flap actuator extension was measured at 4.5 inches, also consistent with the flaps being UP.

Photo 2: April 25, 2021 photo of N587CD right wing with flap position consistent with flaps UP (0%).³³

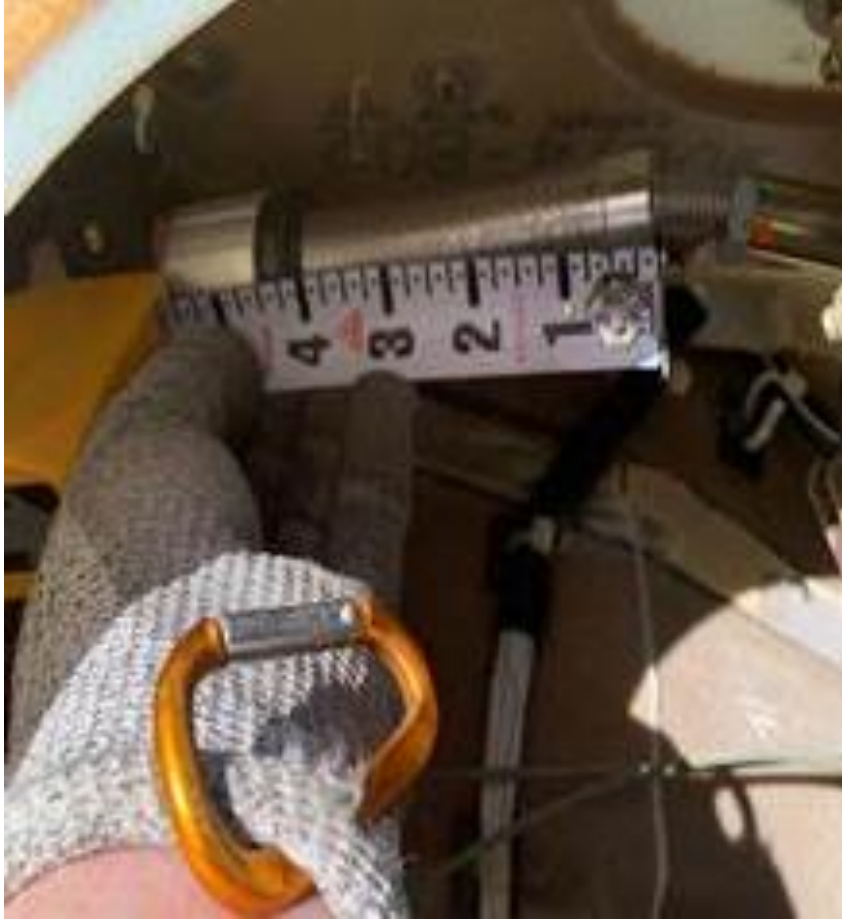
Photo 3: April 25, 2021 photo of N587CD flap actuator extended 4.5 inches, consistent with Flaps Up (0%).³⁴

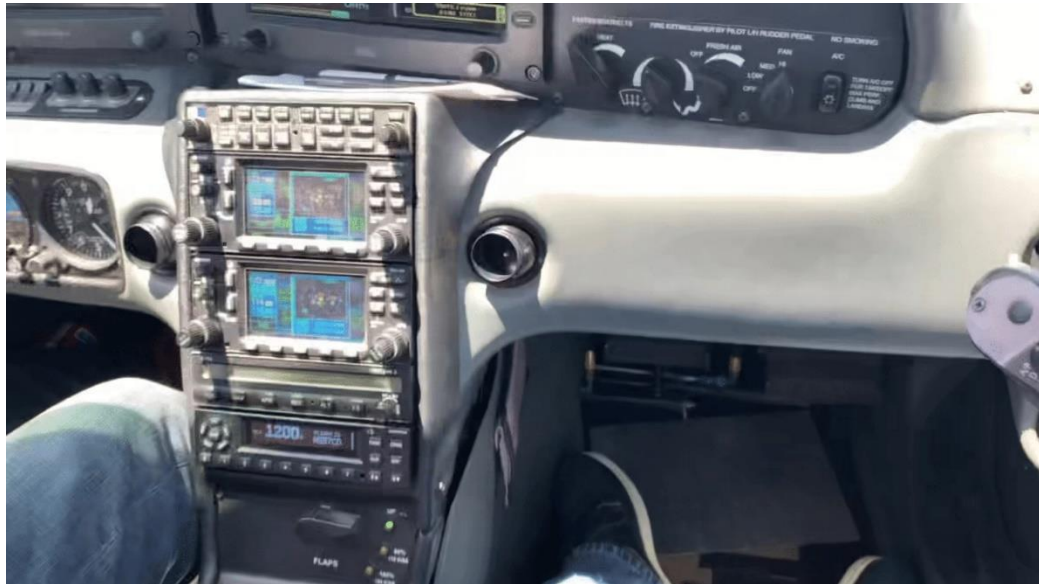
prior to impact, showed the flap selector switch consistent with the flaps up position, and the UP (0%) green light illuminated.

Photo 4: Screen shot of cockpit video taken about eight seconds prior to impact.

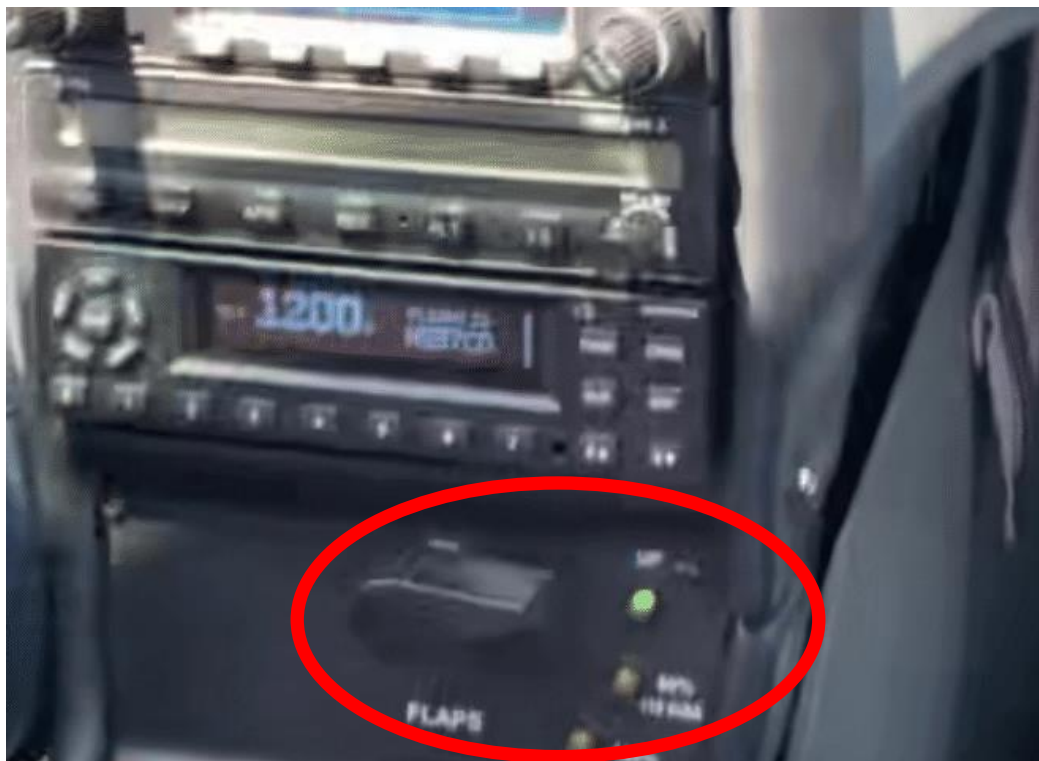
Photo 5: Enlargement of previous photo showing the flap selector switch consistent with the flaps up position, and the UP (0%) green light illuminated.
