**NATIONAL TRANSPORTATION SAFETY BOARD**  
Office of Aviation Safety

**STRUCTURES GROUP CHAIRMAN'S FACTUAL REPORT**

**CEN21FA215**

Location: Englewood, Colorado  
Date: May 12, 2021  
Time: 1023 Mountain Daylight Time (MDT)  
Operator A: Key Lime Air, Flight 970  
Aircraft A: Swearingen (Fairchild) SA226-TC, N280KL  
Operator B: Private  
Aircraft B: Cirrus Design SR22, N416DJ

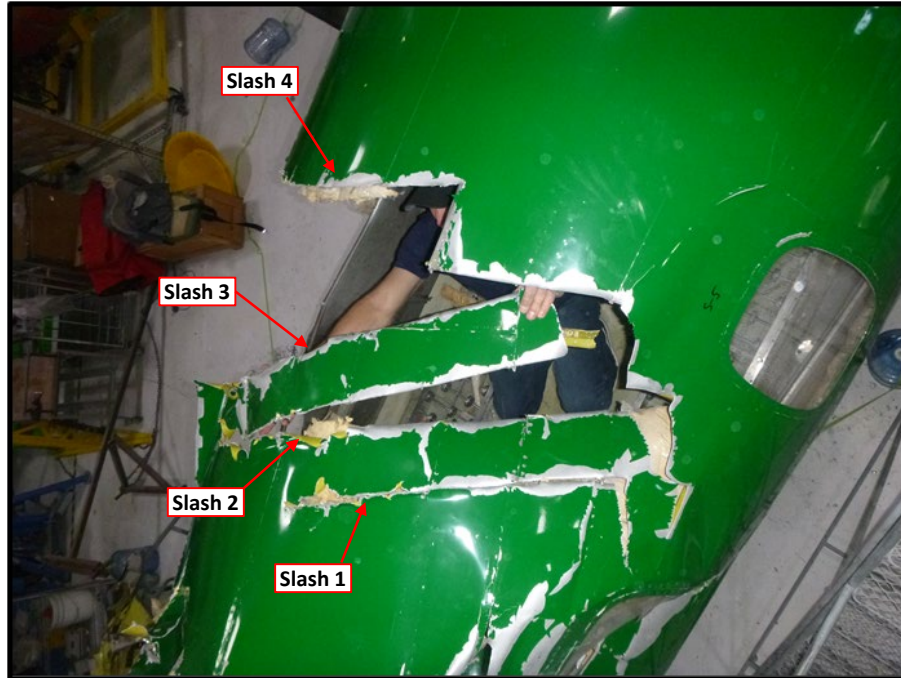
There were 4 distinct parallel slash marks or cuts in the upper fuselage structure, Figure 1. Each of the slashes had inward deformation of the structure on the right side and outward deformation of the structure on the left side. Slash 1 was about 26 inches long and extended from about FS 370 and S-5.5R to about FS 377 and S-1.5R. The slash was oriented about 74° right of the longitudinal axis. The right 12 inches had inward deformation and the left 14 inches had outward deformation. Slash 2 was about 41 inches long and extended from about FS 362 and S-5R to about FS 372 and S-3L. The slash was oriented about 77° right of the longitudinal axis. The right 24 inches had inward deformation and the left 17 inches had outward deformation. Slash 3 was about 37 inches long and extended from about FS 359 and S-4R to about FS 366 and S-4L. The slash was oriented about 73° right of the longitudinal axis. The right 25 inches had inward deformation and the left 12 inches had outward deformation. Slash 4 was about 27 inches long and extended from about FS 356 and S-2R to about FS 362 and S-4L. The slash was oriented about 72° right of the longitudinal axis. The right 15 inches had inward deformation and the left 12 inches had outward deformation. Matching cuts were identified in the cargo liner panels installed in this area.

Figure 1-SA226-TC parallel slash marks in upper fuselage.

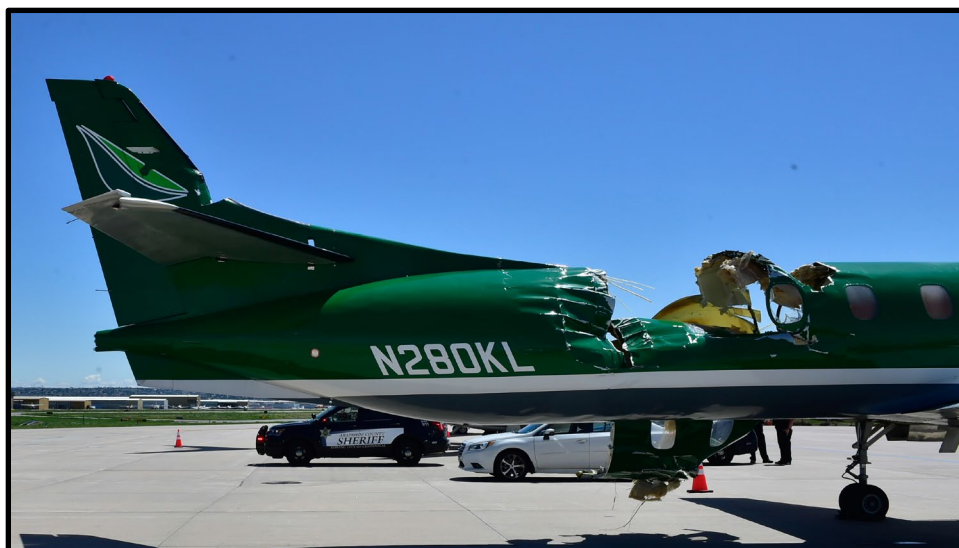
The right fuselage skin and stringers were fractured circumferentially about FS 392 from S-8R to S-4L at the forward end and about FS 449 from S-10R to S-2L at the aft end and longitudinally from S-4L near FS 392 to S-2L near FS 449 at the upper end, Figure 2. This section of skin structure was deformed inward (or left) above the floor at S-10R. There was an area of black rubber transfer marks and gouging of the skin between FS 390 and FS 399 and between S-5R and S-7R. There was another area of black rubber transfer marks, gouging and scratching between FS 442 and FS 452 and between S-6R and S-8.5R. The fuselage skin and stringers were crushed inward between about FS 449 and FS 473 and from S-3R to S-10R. There was mechanical damage and deformation along the skin fracture at FS 449 from S-3R to S-2L.

Figure 2-SA226-TC right fuselage damage.

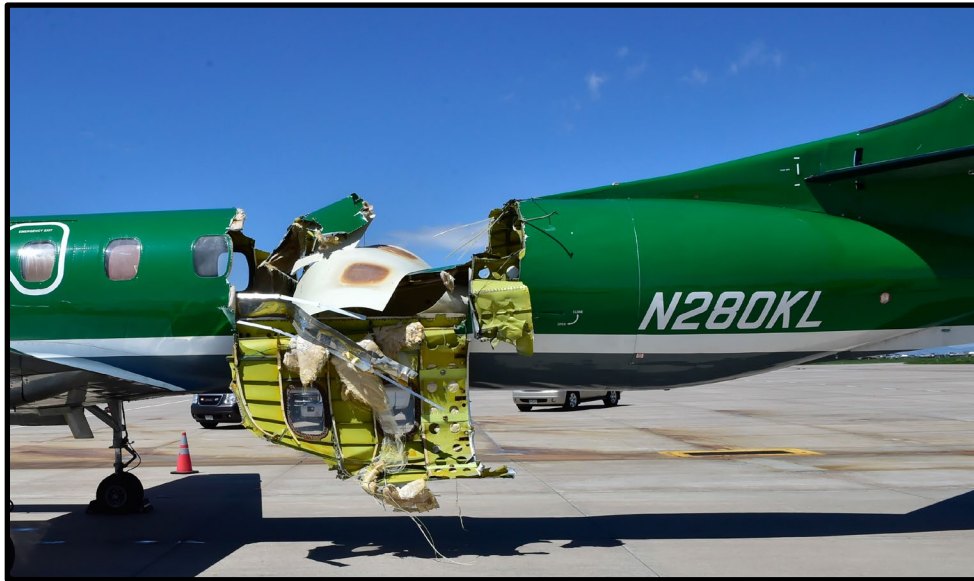
The left fuselage skin and stringers were fractured circumferentially about FS 362 from S-2L to S-10L at the forward end and about FS 438 from S-2L to S-10L at the aft end and longitudinally about S-2L at the upper end, Figure 3. This section of skin structure was deformed outward (or left) above the floor at S-10L. A section of the upper forward corner of the cargo door about 18 inches long by about 18 inches tall was separated from the cargo door and recovered in the debris field. There was a semi-circular impact impression along the cargo door hinge. A smaller piece of fuselage structure with the fuselage side of the cargo door hinge in this area was also separated and recovered in the debris field. A section of the cargo door skin from about FS 438 to FS 452 and above about 23 inches above the lower door sill was folded outward (or left). The lower fuselage skin was buckled between about FS 407 and FS 491 and between S-11R and S-11L.

Figure 3-SA226-TC left fuselage damage.

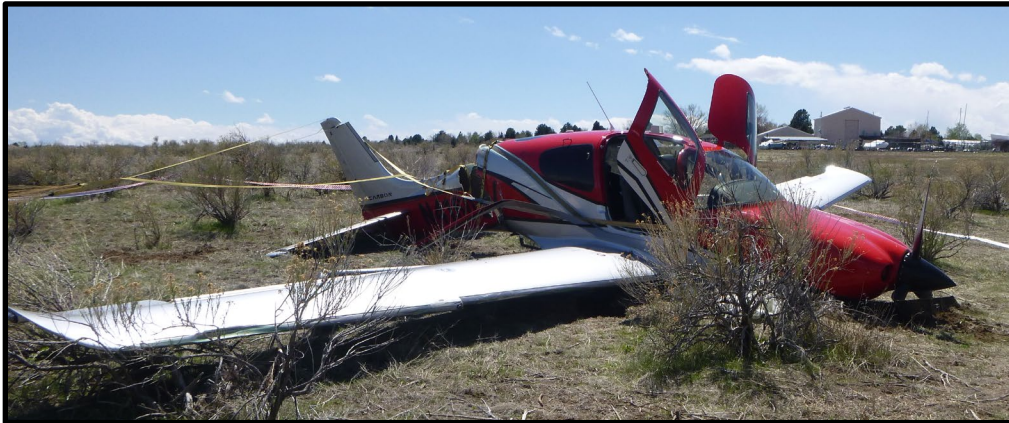
The SR22 airplane was mostly intact after the accident, Figure 4. The empennage was fractured from the fuselage at the aft end of the parachute housing aft of the cabin. The empennage remained attached to the fuselage by the control cables and wires. The wires were cut and the cables were disassembled at the turnbuckles for recovery. The lower 18 inches of the metallic rudder was crushed and deformed to the right and there were black rubber transfer marks on the left side. There was a black oily residue

on the lower end of the rudder and inside the lower rudder cap.

*Figure 4-SR22 airplane after accident.*

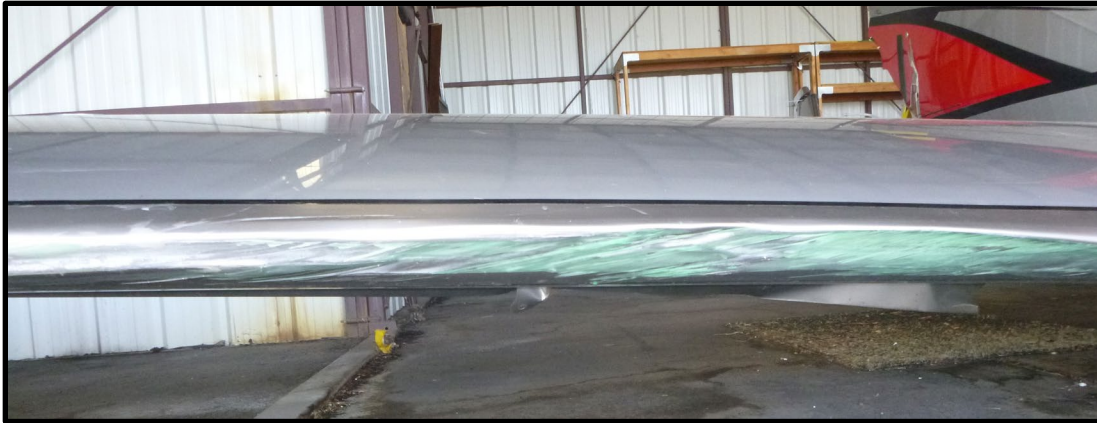
The right wing metallic leading edge had impact damage, aftward crushing, gouging, and significant green paint transfer from the outboard end to the outboard end of the stall wedge, Figure 5. The paint transfer and gouging were all in a spanwise direction. The housing for the stall warning vane was separated from the right wing leading edge and found in the debris field with green paint transfer. There was an area of black rubber transfer marks just aft of the leading edge near the  $\frac{3}{4}$  span location. The right wing lower skin had green paint transfer marks, abrasion, and gouging of the composite skin on the forward half over most of its length. There were two distinct directions association with the damage, one oriented spanwise and one oriented about  $20^\circ$  from spanwise. The right flap outboard hinge fitting was fractured.

*Figure 5-SR22 right wing leading edge.*
