National Transportation Safety Board

CEN21FA360

AUTOMATIC DEPENDENT SURVEILLANCE- BROADCAST (ADS-B) STUDY

Airplane Performance Study

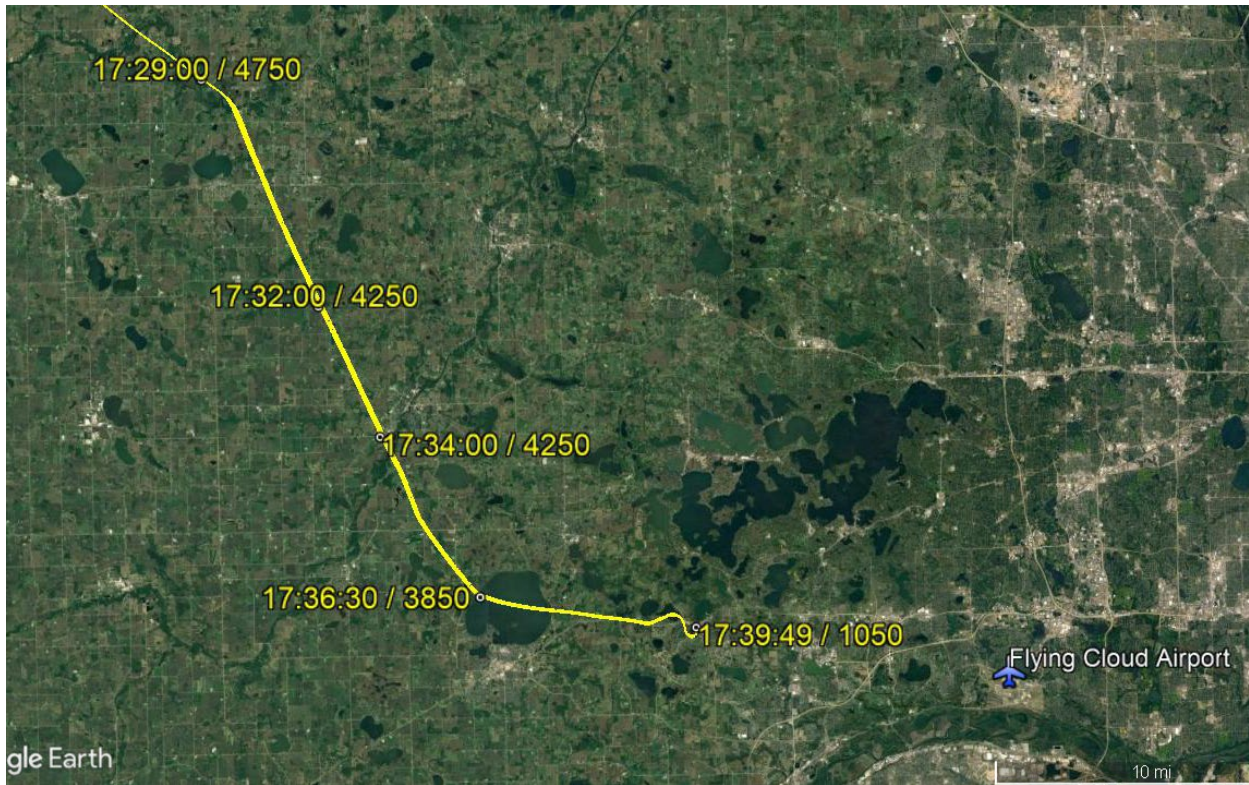
The airplane departed Chandler Field Airport (AXN), Alexandra, Minnesota, at 16:54 on an instrument flight rules (IFR) flight plan to Flying Cloud Airport, Minneapolis, Minnesota. The pilot was cleared by air traffic control to fly the instrument landing system (ILS) approach to Runway 10R at FCM. The airplane approached from the northwest (Figure 1), descending from 5,200 ft mean sea level (msl) and slowing from 160 kts of airspeed (Figure 2). Just after 17:36:30, the airplane aligned with the heading for runway 10 at Flying Cloud. At this point it was approximately 14 NM from the airport.

Figure 1. Accident flight in yellow with select times and altitudes (msl) annotated in yellow.

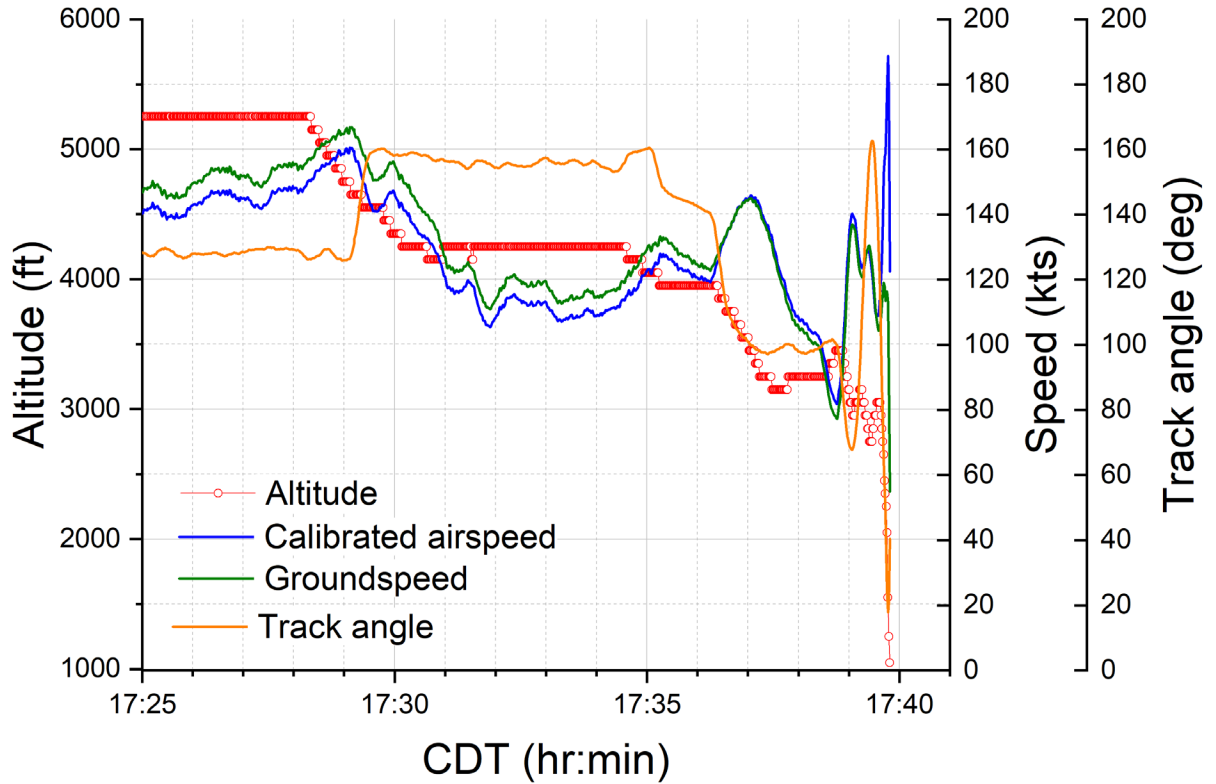
Figure 2. Recorded altitude (msl) and calculated airspeed, groundspeed, and track angle.

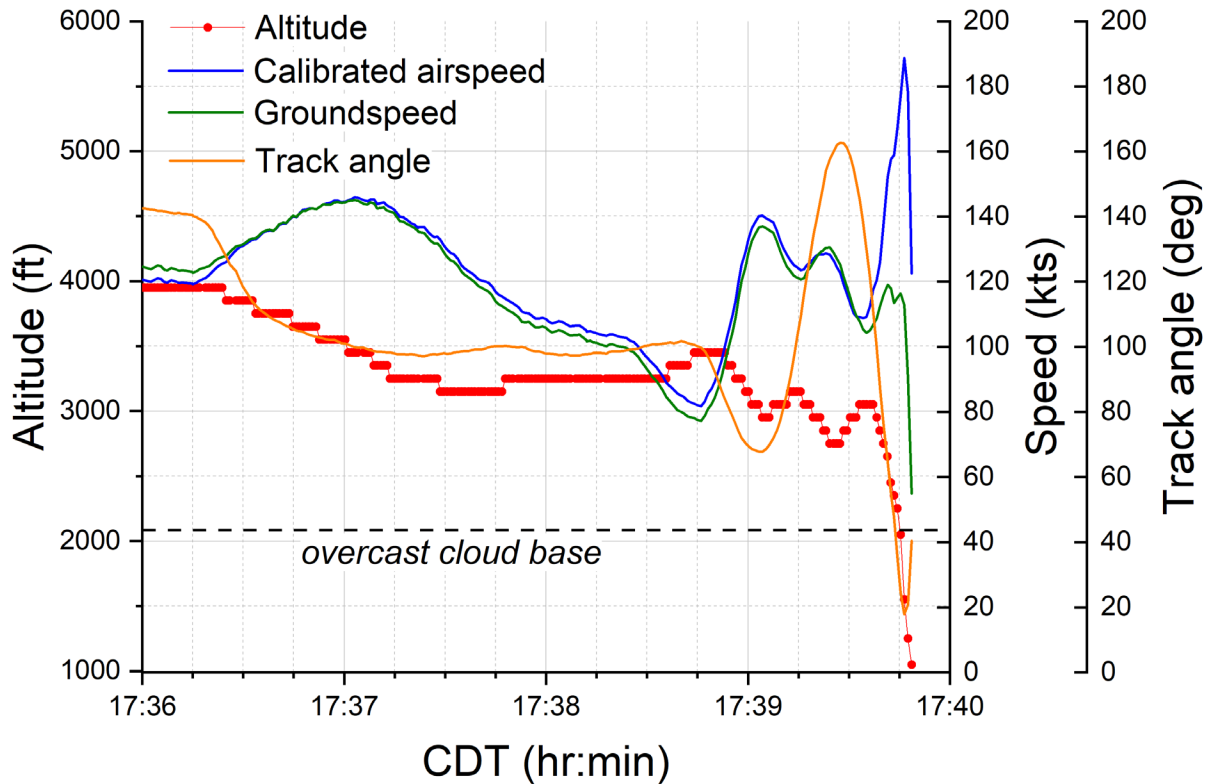
While on the runway heading, the airplane slowed to 80 kts and descended to about 3,200 ft (Figure 3). Then, at about 17:38:45, the airplane's airspeed increased to 140 kts and shortly after the track diverged to the left (Figure 4) and the airplane descended about 200 ft. The airplane turned right and then left again in a tightening series of turns while speed increased to over 180 kts and altitude fluctuated. After 15:38:38 the airplane descent increased to 6,000 fpm for the final 12 seconds of data. The airplane was above the reported overcast cloud base for all but the last few seconds of the flight path.

Figure 3. Recorded altitude (msl) and calculated airspeed and groundspeed for the end of flight.

The airplane's maximum maneuvering speed, V_A , (the speed at which full deflection of any flight control should not be attempted because of the risk of damage to the aircraft structure) is listed as between 111 kts (light) and 126 kts (heavy) calibrated airspeed [1]. Figure 3 and Figure 4 show that after 17:39 the airplane made increasingly tight turns at speeds above V_A . Also, in the Limitations section of the Pilot Operating Handbook, the manufacturer lists the maximum positive load factor with flaps up as 3.8 g [1].

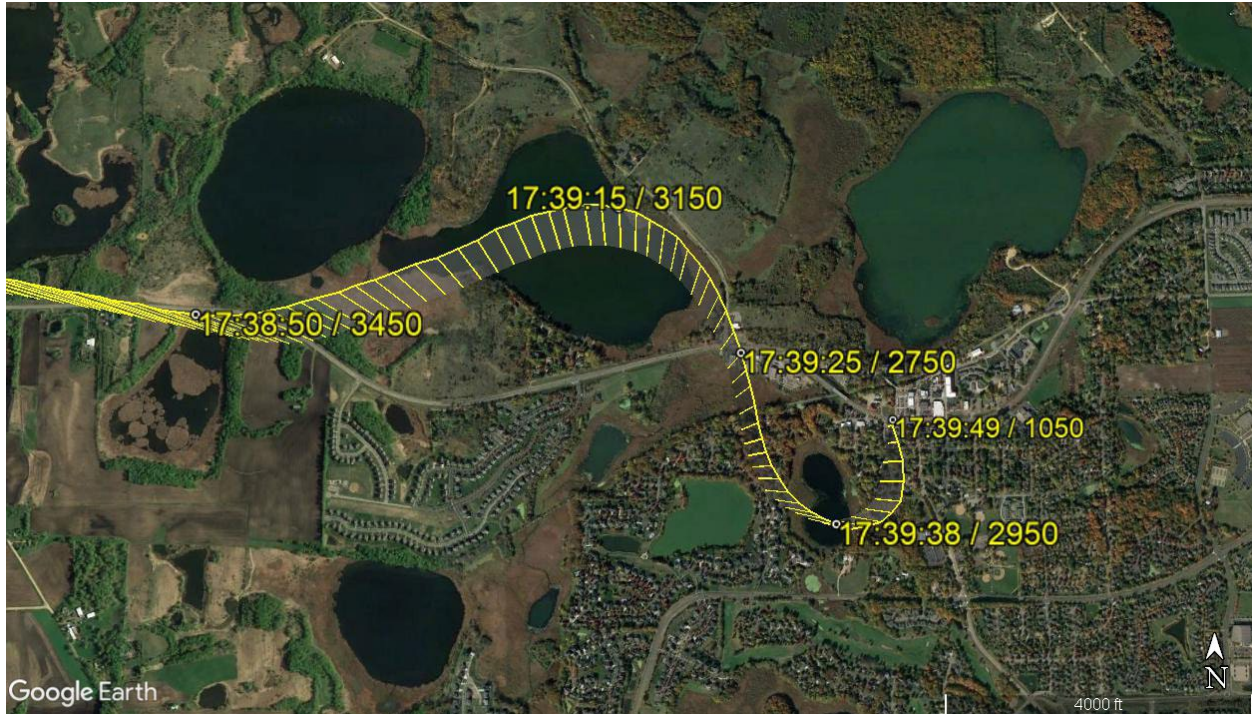
Figure 4. End of flight path in yellow with select times and altitudes (msl) annotated in yellow.

After 17:39:39 the flight path changed. The turn, which had been on a radius of about 1,100 ft since 17:39:31, tightened markedly and the airplane began to rapidly descend at more than 7,000 fpm. Airspeed and groundspeed began rapidly increasing. As stated in the Weather section, IMC prevailed and an overcast ceiling at 1,100 ft agl was reported at the airport. In the area of the accident, 1,100 ft agl would have been 2,100 ft msl, which the airplane passed below between 17:39:44 and 17:39:45. However, actual height of the overcast cloud ceiling in the area may have been higher or lower than what was reported 8 NM away.

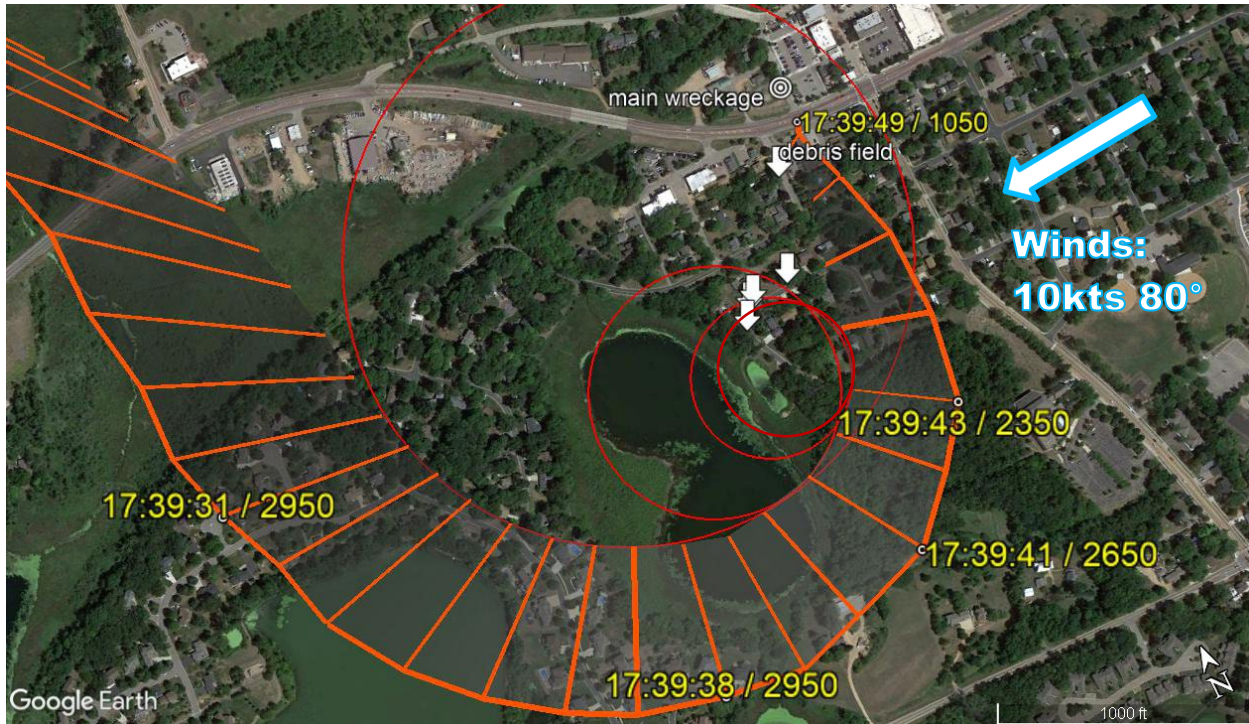
where φ is the bank angle and g the acceleration due to gravity. Table 1 shows the resultant calculations using the true airspeed at 17:39:38, 17:39:41, 17:39:43, and 17:39:44. Each point was on an increasingly smaller red circle (shown in Figure 5), reflecting the tightening radius of the final left turn. As the turn tightened and the speed increased, the resulting bank angle and load factor increased. By 17:39:43, the

estimated load factor of 4.8 g exceeded the manufacturer’s listed maximum positive load factor of the airplane. One second later, the increased speed and tighter turn resulted in a load factor over 8 gs.

Figure 5. Final turn with time and altitudes marked in yellow. The airplane broke up in flight and debris is marked with white arrows. The main fuselage wreckage is shown with a white circle. The red circles show the radius of the turn at four different points.

Table 1. Calculated bank angle and load factors for three turns highlighted in Figure 5.

Time	Radius, ft	True airspeed, kts	Bank angle, deg	N, load factor
17:39:38	1,100	127	52	1.6
17:39:41	850	160	69	2.8
17:39:43	510	168	78	4.8
17:39:44	400	195	83	8.5

The final left turn would have required larger and larger control surface deflections while at speeds greater than V_A . By 17:39:43 the airplane exceeded the manufacturer’s listed maximum positive load factor and forces continued to increase. The debris field and wind direction are consistent with a breakup near this portion of the flight path as the pieces would have continued forward but carried to the left of the flight path by the reported winds.
