CEN21LA176

ENGINE & FUEL SYSTEM EXAM

Location: Pearland, Texas
Date: April 3, 2021
N5240C; Beechcraft B35

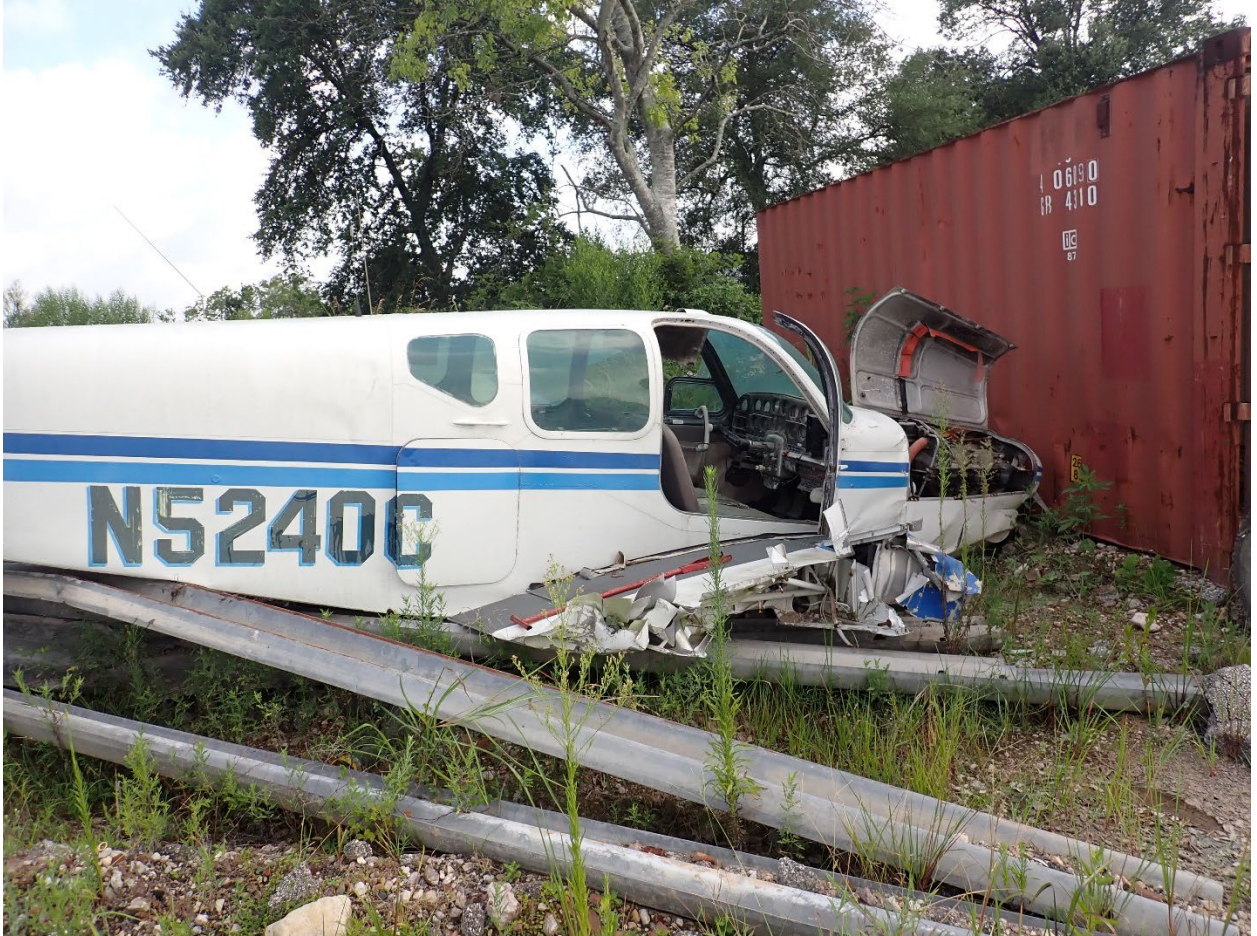
- The engine remained attached to the fuselage (Figure 1).
- The foam air filter element was clean and unremarkable.
- No blockages were noted in the exhaust or induction systems.

Figure 1: The airplane at the storage yard.

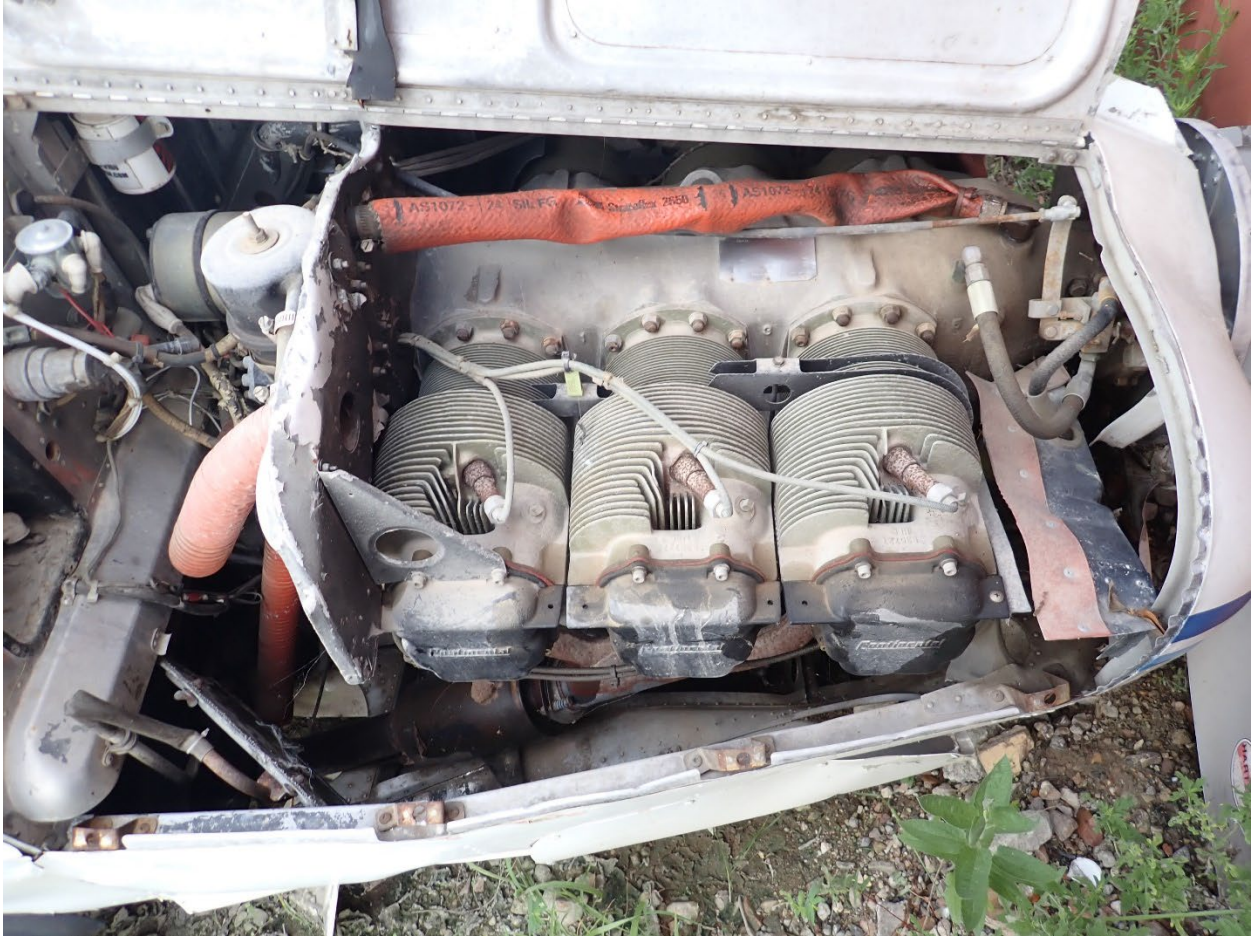
- A blue liquid consistent with aviation gasoline was observed at the fuel servo.
- Top spark plugs were removed and when compared to Champion AV-27 Check-a-Plug chart were consistent with “normal” condition. All plugs had surface corrosion on their exterior (Figure 2).

Figure 2: Engine condition as found. Note the corrosion on the exterior surface of the spark plugs.

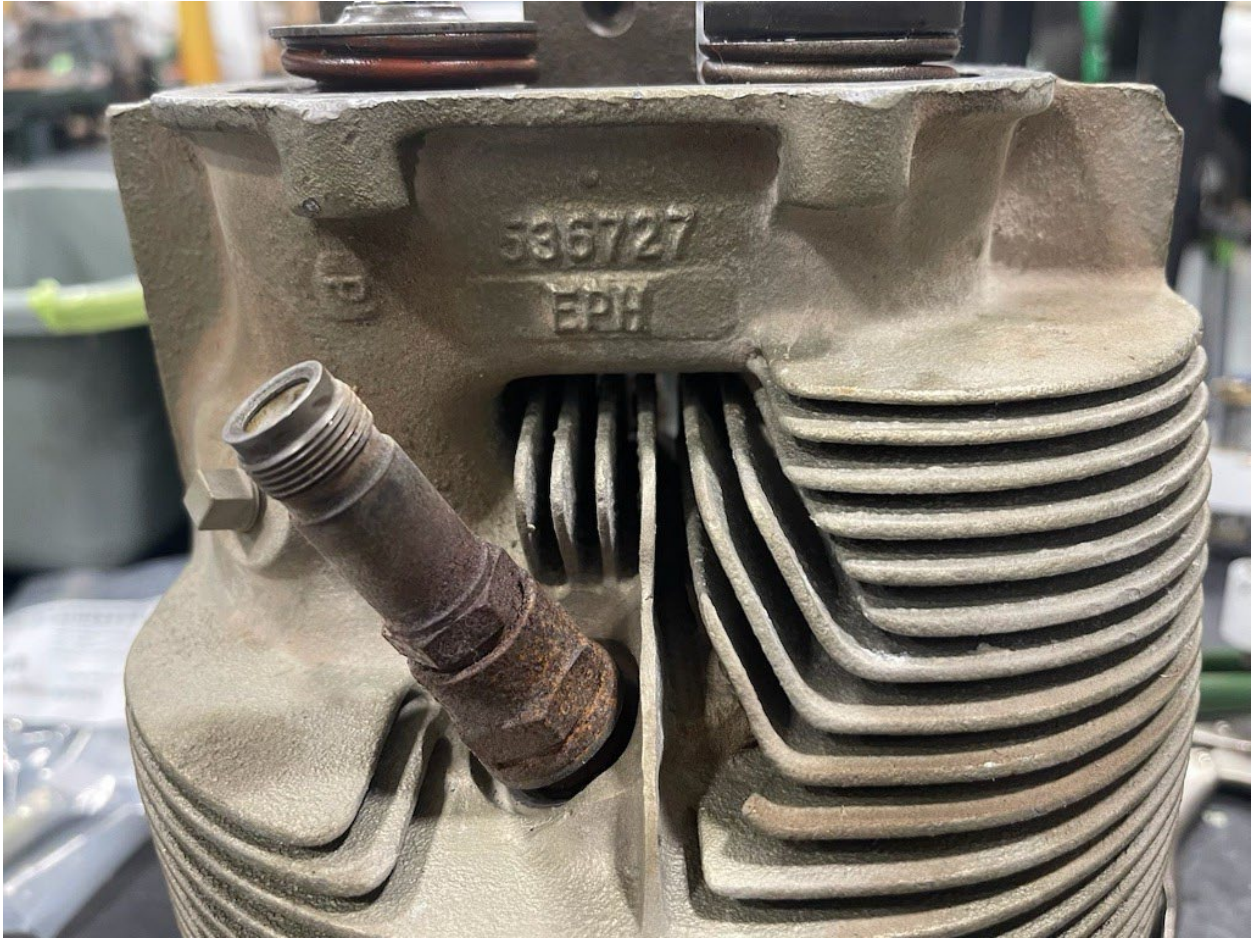
- Cylinder 1 exhibited little to no thumb compression when the engine was rotated through.
- Cylinder 1 cover was removed, intake and exhaust valves moved as expected when the engine was rotated through.

- Cylinder 1 pushrods were removed, no damage noted.
- Cylinder 1 was removed. Examination revealed corrosion and erosion of the cylinder head and a crack was observed between the cylinder bore and cylinder head (Figure 3 & 4).

Figure 3. EPH #1 cylinder.

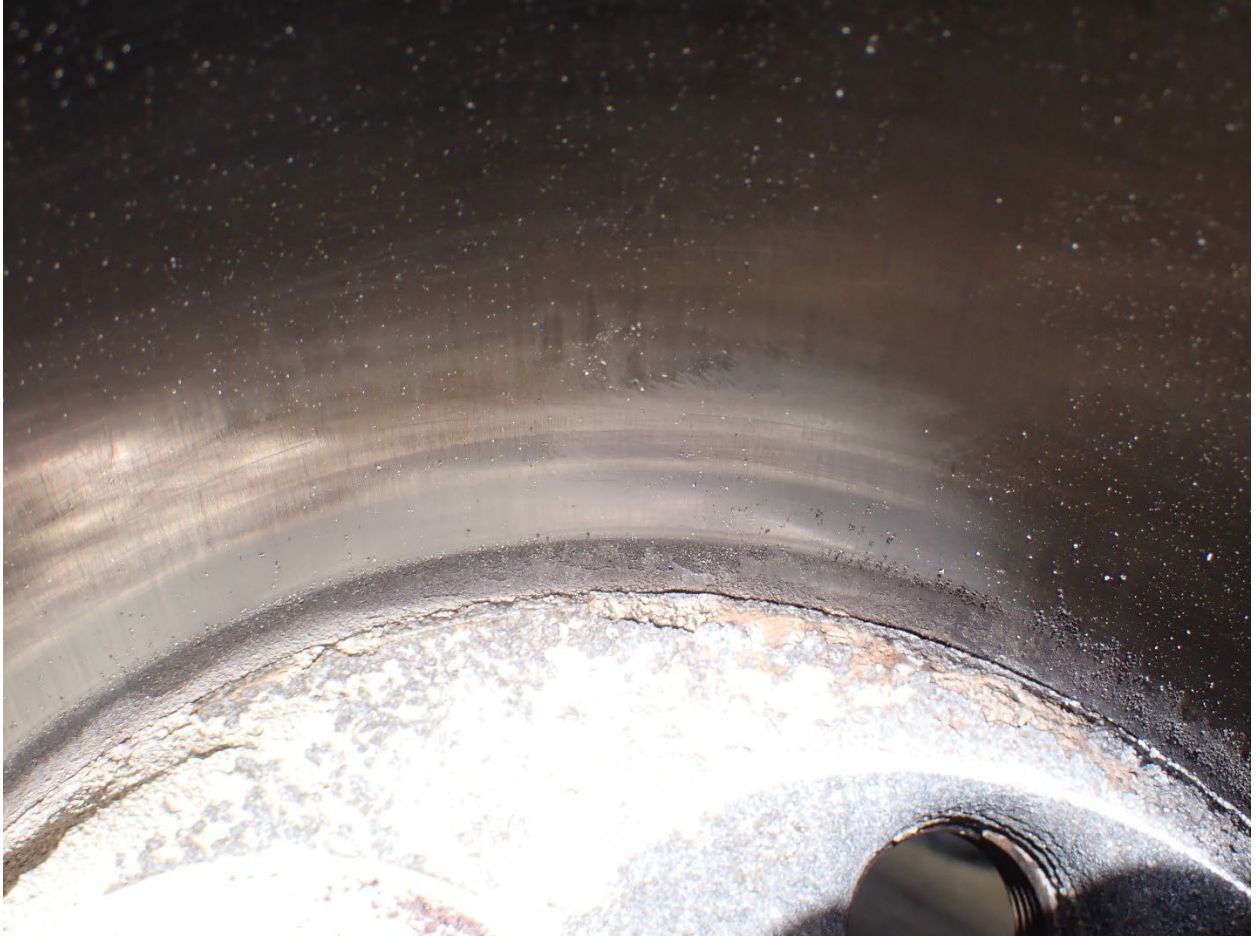
Figure 4: Corrosion of the #1 cylinder head and a crack between the cylinder head and bore.
