NATIONAL TRANSPORTATION SAFETY BOARD

Specialist's Factual Report

METEOROLOGY

CEN21LA471

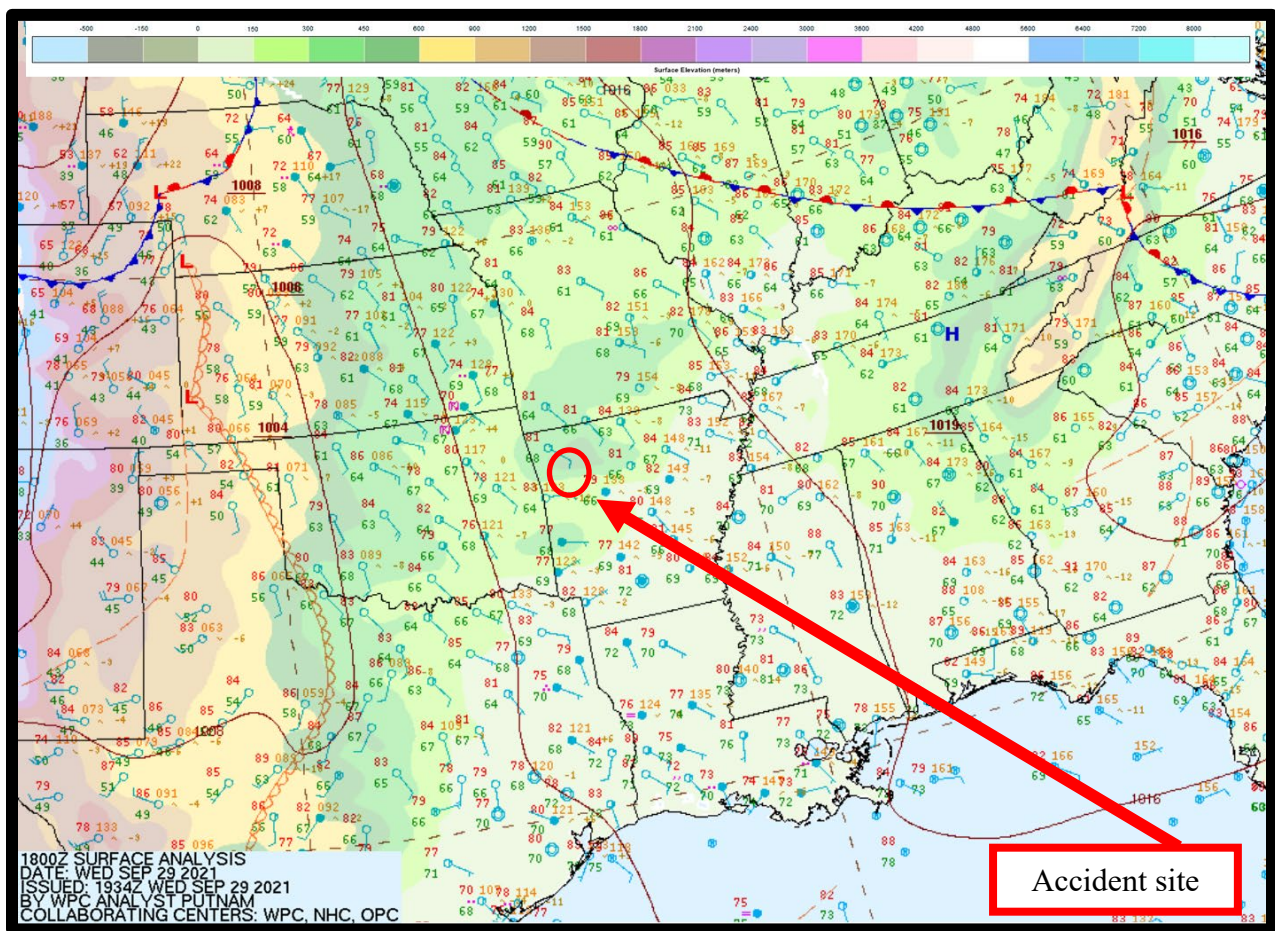
Figure 1 – NWS Surface Analysis Chart for 1300 CDT.

The NWS Surface Analysis Chart centered over the central United States for 1300 CDT is provided as figure 1 with the location of the accident site within the red circle. The chart depicted a frontal boundary from North Carolina northward into the Upper Midwest with another frontal boundary stretching from South Dakota southward into central Texas. Low-pressure systems with pressures of 1004-, 1008-, and 1008-hectopascals (hPa) were located along the frontal boundary from South Dakota southward into central Texas. The accident site was located south and east of the frontal systems on the warm side of the fronts in an area of southerly winds.

The station models around the accident site depicted air temperatures in the low 80's degrees Fahrenheit (°F), dew point temperatures in the mid to upper 60's °F with temperature-dew point spreads of 13°F or more, partly cloudy skies, and south to east winds at 10 knots.

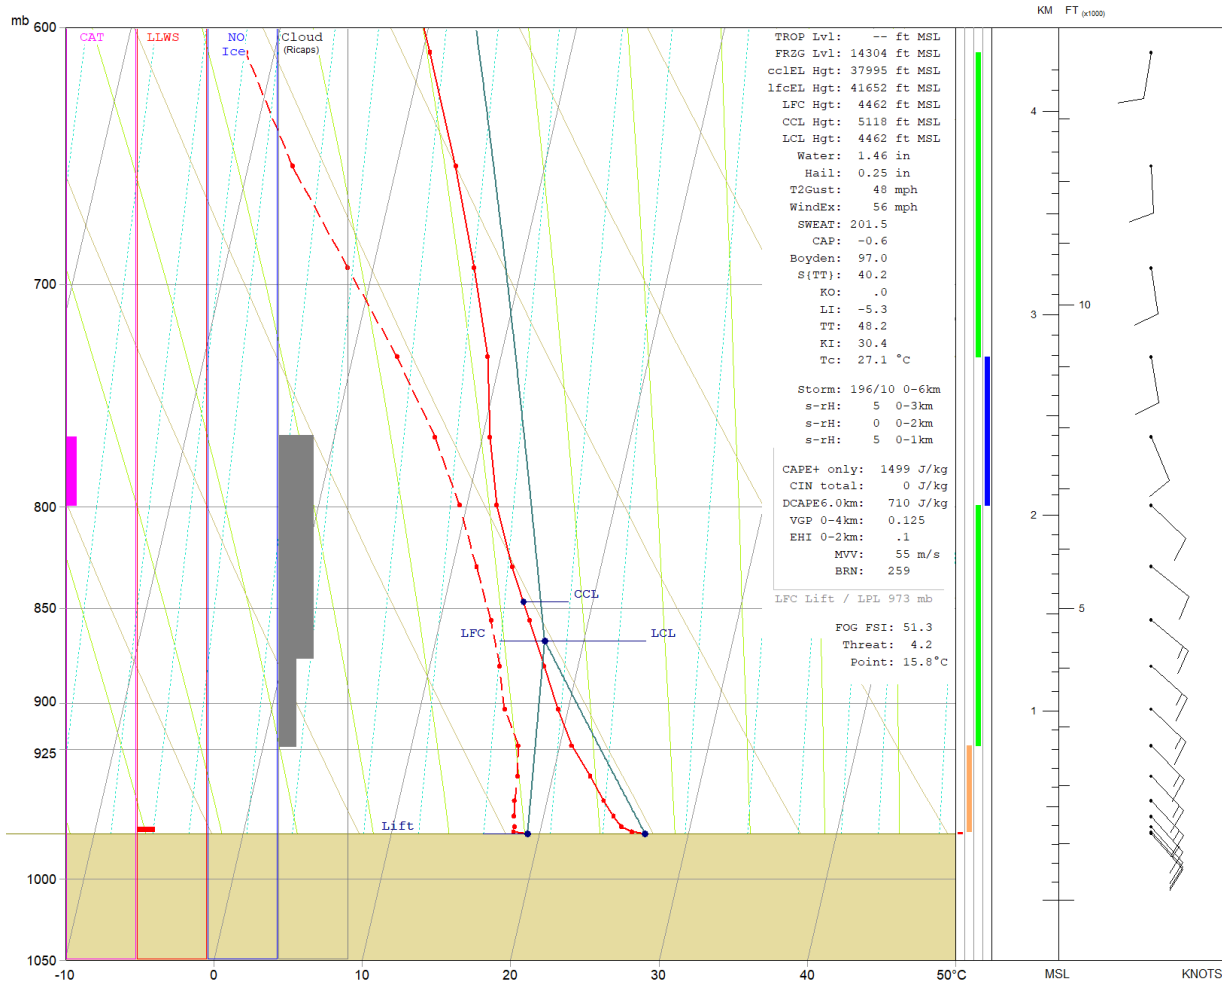
Figure 3 – 1400 CDT HRRR sounding.

A High-Resolution Rapid Refresh (HRRR)⁹ model sounding was created for the accident site for 1400 CDT which provided a surface elevation of 1,171 ft.¹⁰ The 1400 CDT HRRR sounding was plotted on a standard Skew-T Log P diagram¹¹ with the derived stability parameters included in figure 3 with data from the surface to 600-hPa (or approximately 14,000 ft above msl). These data were analyzed using the RAOB¹² software package. The sounding depicted the lifted condensation level (LCL)¹³ and the level of free convection (LFC)¹⁴ at 3,291 agl (4,462 ft msl), and the convective condensation level (CCL)¹⁵ at 5,118 ft msl. The freezing level was located at 14,304 ft. The precipitable water value was 1.46 inches.

The 1400 CDT HRRR sounding for the accident site indicated an unstable environment from the surface through 2,750 ft (~1,600 ft agl). Clouds were indicated by RAOB to be present from 3,000 ft through 8,000 ft. No icing potential was indicated by RAOB below 14,000 ft.

The 1400 CDT HRRR sounding wind profile indicated a near surface wind from 139° at 9 knots with the wind increasing to 15 knots by 2,000 ft (~800 ft agl) from the southeast. The wind remained southeasterly through 7,000 ft. RAOB indicated the possibility of light low-level wind shear (LLWS) between the surface and 400 ft agl. The potential for light clear-air turbulence was noted by RAOB around 7,000 ft.
