# National Transportation Safety Board

CEN22FA100

## **WRECKAGE EXAMINATION**

Location: Houma, LA  
Date: January 14, 2022  
Time: 1001 Central standard time (CST)  
1501 Universal coordinated time (UTC)  
Helicopter: Bell 407 / N167RL

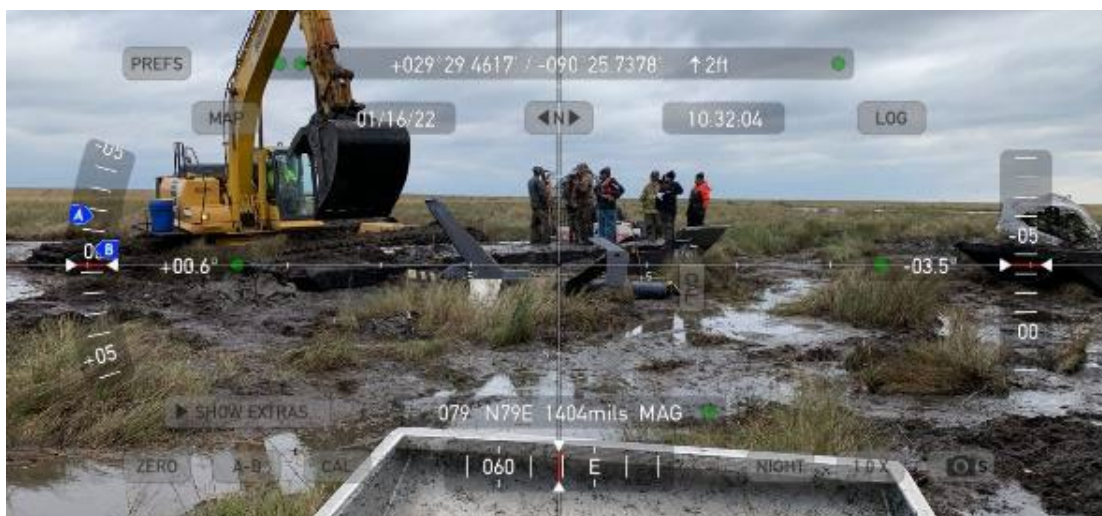
The wreckage was located 19 miles east of Houma, Louisiana, in a deltaic coastal marsh, and was completely submerged in marsh water and mud except for the tailboom and some sections of main rotor blade (Figure 1). The wreckage was removed using self-propelled swamp excavators and placed on floating barge platforms.

**Figure 1.** Helicopter impact area.

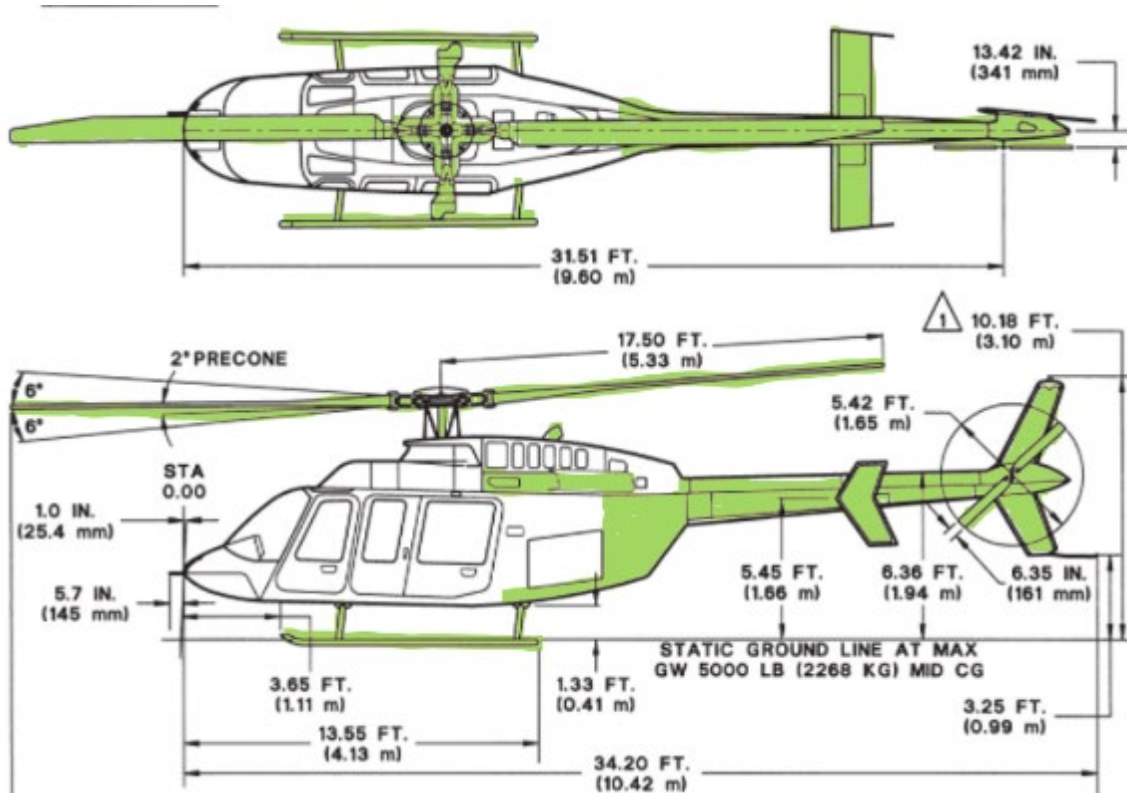
Figure 2. Green highlight represents airframe sections recovered and examined.

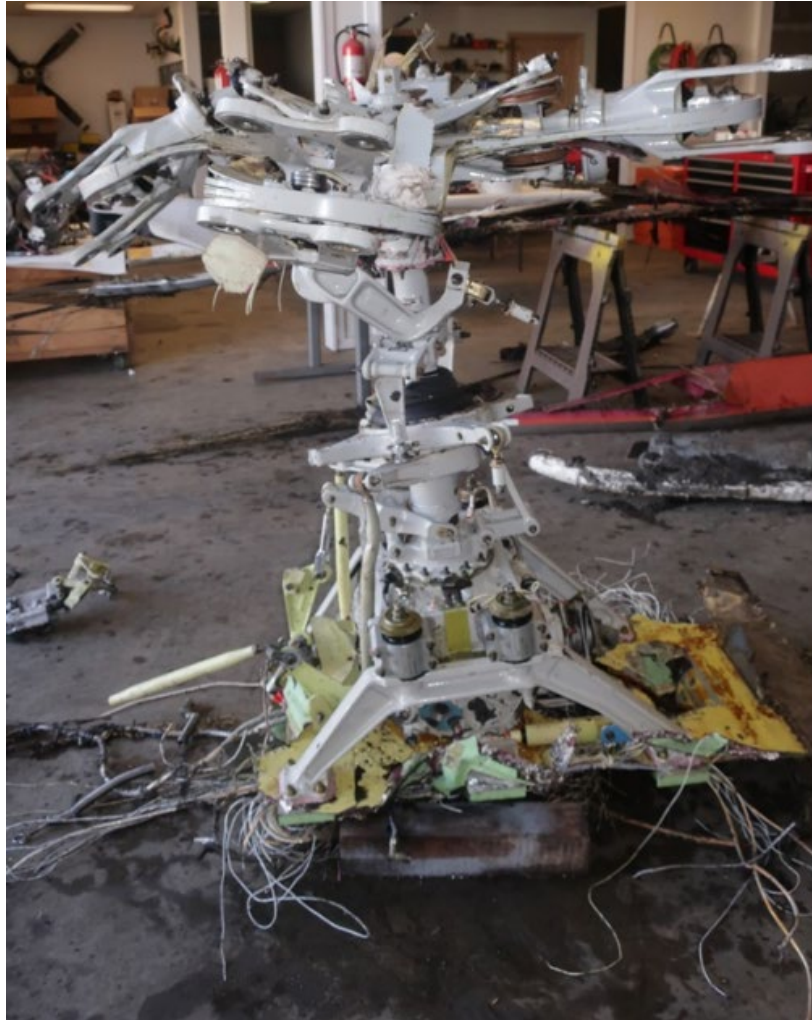
The main rotor driveshaft (KAFlex) was fractured near the transmission input adapter. Main rotor powertrain continuity was established by turning the yoke by hand and observing the rotation of the mast through the transmission to the power input quill. No binding or abnormal sounds observed during rotation. The transmission upper and lower chip detectors were checked, no chips observed. There was a trace amount of transmission oil present but compromised by marsh water. The transmission remained attached to the pylon assembly which remained attached to the roof structure of the helicopter (Figure 3). All four live mounts remained in place. The freewheeling assembly could not be rotated by hand due to a fractured case.

**Figure 3.** Transmission, transmission mount, mast, and main rotor head.

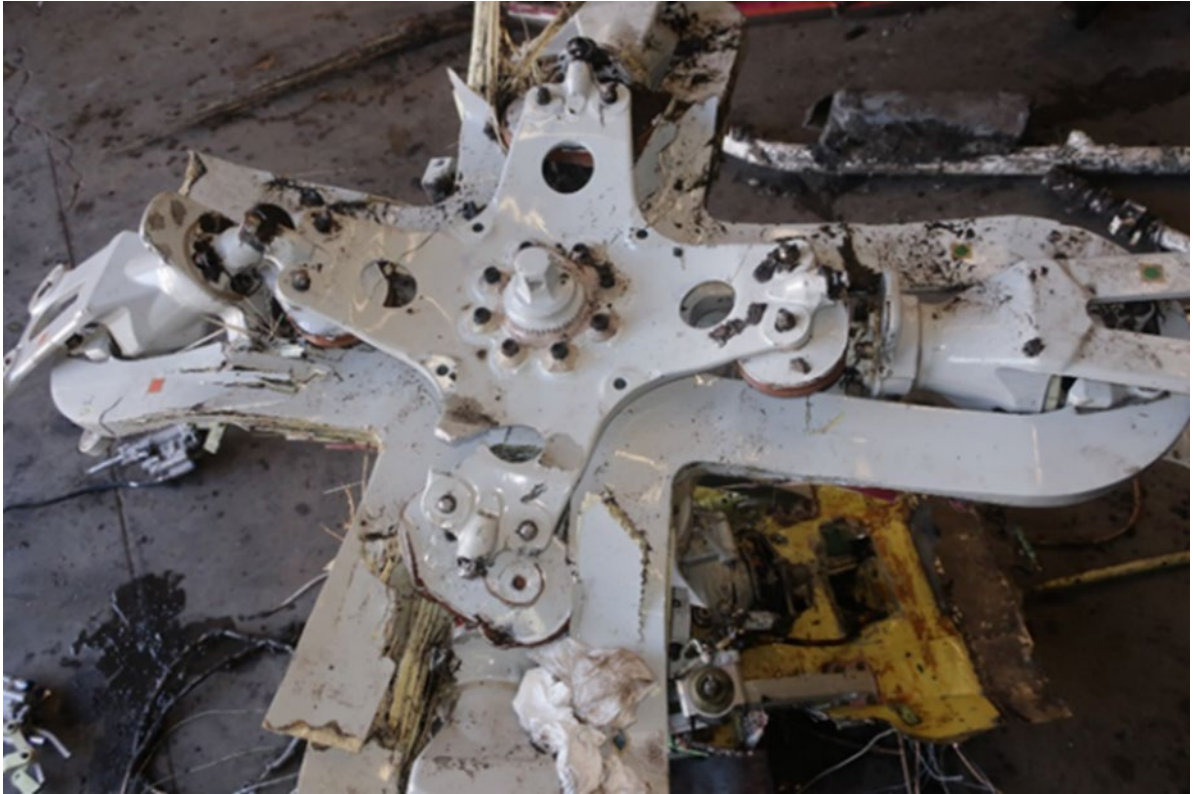
The main rotor cover and main rotor Frahm damper assembly had been removed prior to flight. The mast nut remained in place, and all arms of the hub upper plate were deformed upwards. All up-stop assemblies were present and severely damaged. The red down stop assembly was broken off; all three other down stop assemblies were damaged. All four yoke arms were intact and exhibited delamination of the composite structure (Figure 4). The inner elastomeric pivot bearings (feathering bearings) of the blue and orange blades had been pulled out, the red and green elastomeric bearings were in place. The blue arm of the hub lower plate was severely bent downwards, and the red arm slightly bent. Observations while on-scene showed all four blades remained attached to their blade grips. The blades were removed by the recovery personnel for transporting the wreckage.

**Figure 4.** Main rotor head.

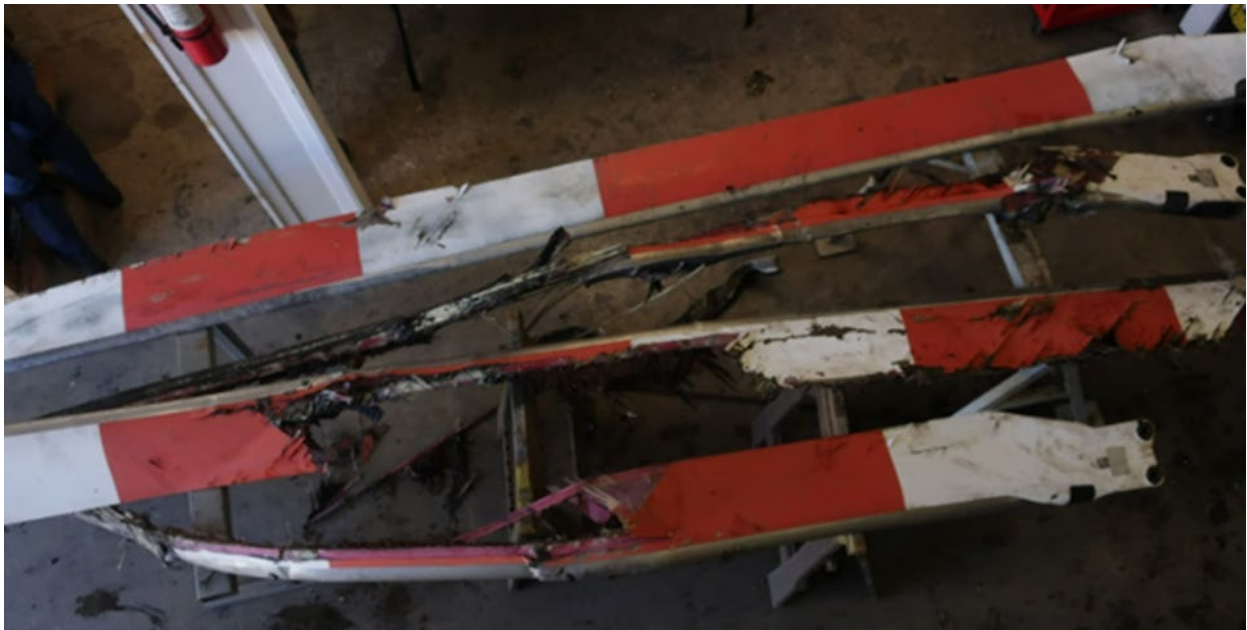
Portions of all four rotor blades were recovered (Figure 5).

The orange blade length measured 14 feet long. The afterbody portion was missing the outboard 5 feet 3 inches. The leading edge was buckled at the 5 foot point.

No data plate was found on the green blade. The part number and serial number were recorded from the maintenance records. The green blade length measured 15 feet 6 inches; the weight pocket was missing where the blade was fractured. The blade center afterbody was not present between 4 feet 4 inches out to 9 feet. There was a leading-edge fracture at 14 feet 5 inches.

The red blade length measured 15 feet 6 inches. There was a leading-edge fracture at the 6 foot location, and the blade afterbody was missing extending outboard from the 2 foot point.

The likely rotor blade impact sequence based on blade damage progression was: orange, red, green, and blue.

**Figure 5.** Main rotor blade layout.

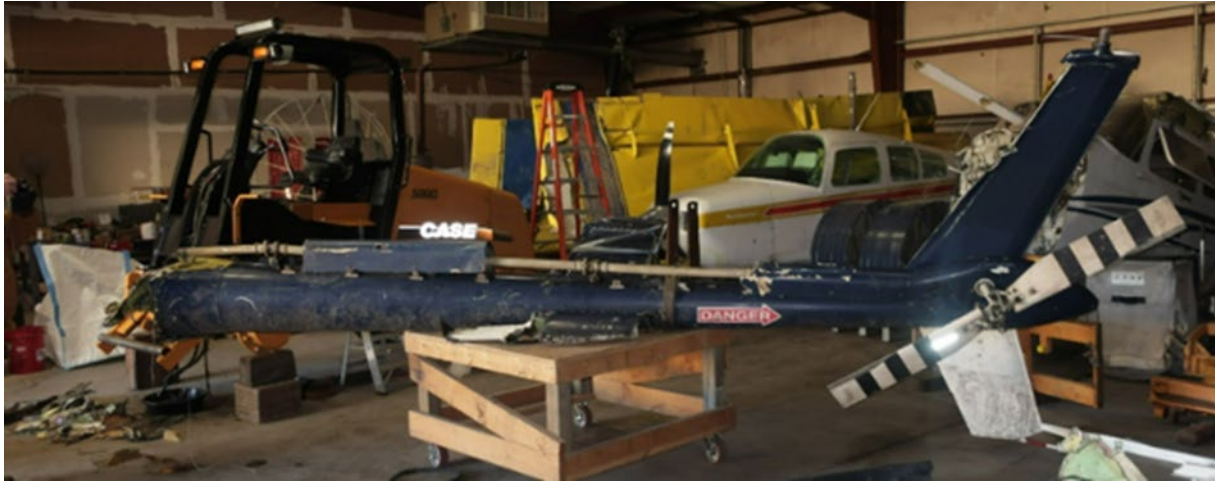
The forward short shaft (steel) remained attached to the freewheel unit. The steel shaft was fractured about 12 inches aft of the freewheel unit attach point. The oil cooler blower "Squirrel cage" was present but was unable to be rotated due to damage. The oil tank was present but severely damaged. The oil cooler was attached to the blower. The remaining section of the steel short shaft that attaches to the oil cooler blower was not present. The aft short shaft had separated from the oil cooler aft spline. The drive shaft had separated in torsion overload. Rotational scoring was observed on the No. 1 tail rotor drive shaft section, which remained on the tailboom. The tail rotor drive shaft sections 2 through 4 remained in place on the tailboom and attached to the tail rotor gearbox (TRGB) (Figure 6). The No. 1 Thomas coupling (or coupling disc pack) exhibited warping, numbers 2, 3, and 4 Thomas couplings and hanger bearing were undamaged. Rotational continuity was observed from the aft short shaft through the tail rotor gearbox to the tail rotor with no binding or abnormal sounds observed. The chip detector was checked, no chips observed. A trace amount of oil remained in the TRGB and was compromised by water.

**Figure 6.** Tailboom layout.

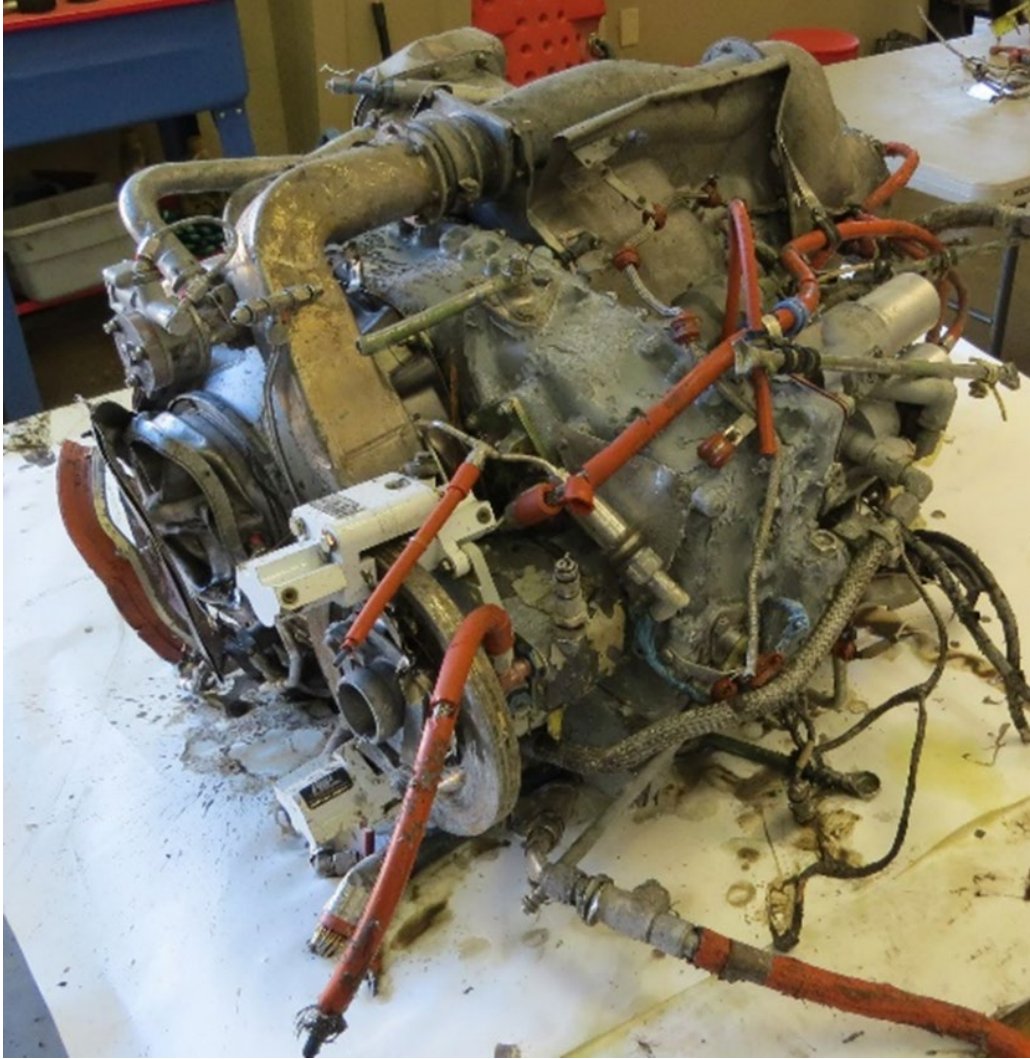
**Figure 7.** Engine on the examination table.

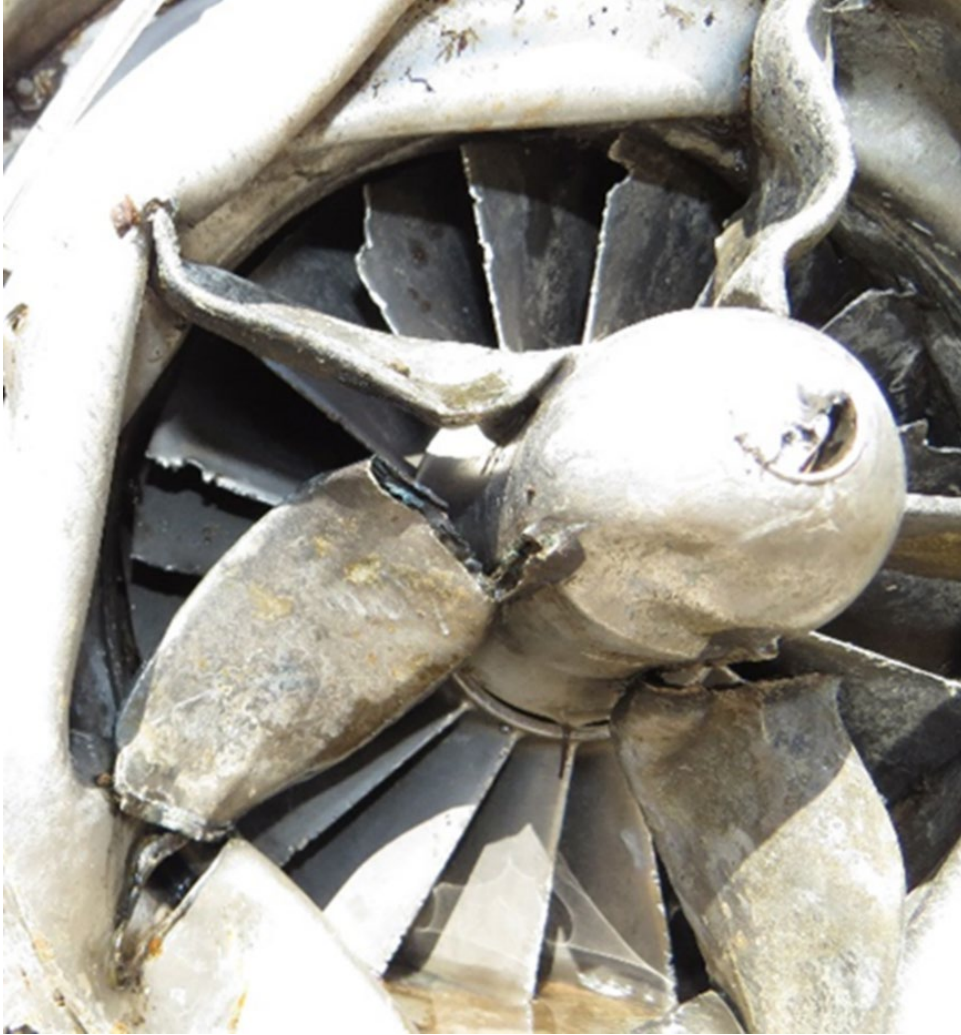
The engine was a Rolls-Royce 250-C47B turboshaft engine, SN CAE 847201. At the time of the accident, the engine had accumulated 15,401.5 hours' time since new (TSN). The inlet guide vanes were crushed (Figure 10). The compressor blades exhibited leading edge hard body damage and bending opposite the direction of rotation. Clean fuel was present throughout the engine fuel system up to the fuel spray nozzle. The oil filter was clean and not in bypass. The entire engine was packed full of mud, and minor hard body damage to the first stage turbine blades was evident. The KAFlex shaft was fractured in overload. The freewheel unit was seized and unable to be rotated by hand; damage to the case was observed. The magnetic chip detectors had water and mud but no ferrous debris. The auxiliary gearbox was punctured and full of water. The N1 and N2 turbines could not be rotated by hand. Marsh water had done extensive corrosion to the auxiliary gearbox case. The hydraulic mechanical unit (HMU) manual mode piston was extended, the power lever arm was fractured, and internal damage to the HMU observed consistent with impact. The engine control unit (ECU) memory board was retained to be sent to Triumph for data download.

**Figure 8.** Inlet section of the engine exhibiting crushed inlet guide vanes.
