National Transportation Safety Board

CEN22FA317

WRECKAGE EXAMINATION

Group Chair's Factual Report

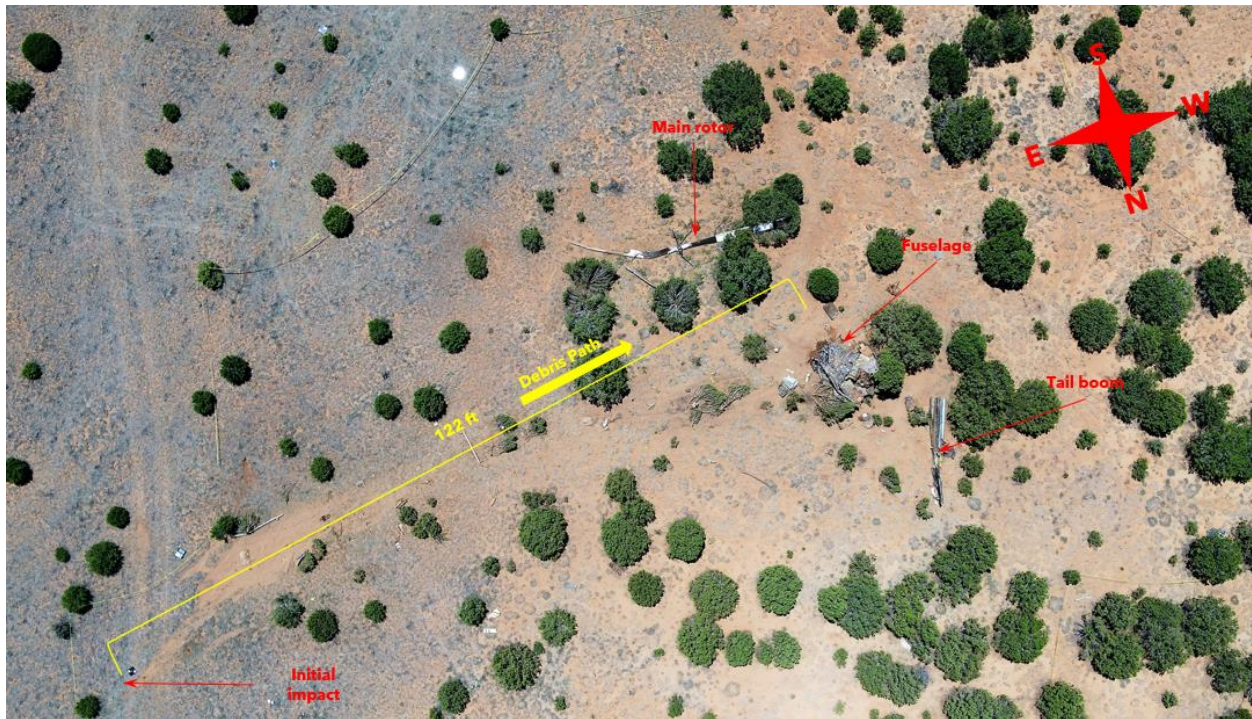
The wreckage was located in high southwestern desert terrain at an elevation of about 5,800 feet mean sea level (msl) near Chapelle, New Mexico and was populated with scrub juniper bushes. The initial ground impact area was easily identified by disturbed ground in the shape of helicopter tail and fuselage. The tail boom had separated from the main fuselage, both resting about 122 feet west of the initial impact area (Photo 2).

Figure 2. Overhead view of the accident site. (Photo source: Bernalillo County Sheriff Dept)

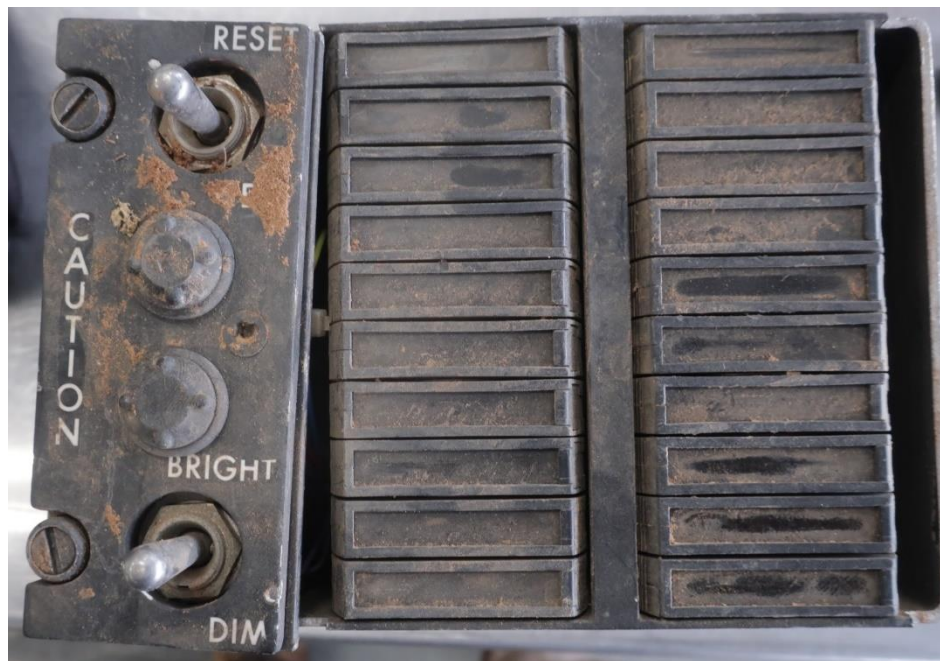
The caution/warning panel (Figure 3) and three (3) master caution lights from the accident aircraft were submitted to the Materials Laboratory for examination. The caution/warning panel consisted of twenty (20) individual annunciators containing two (2) bulbs each. The panel was intact and exhibited only minor impact damage. The left and right master caution lights each contained three (3) bulbs and the center master caution contained two (2) bulbs. No hot filament stretch was found in any of the bulbs for the annunciator panel (Attachment 1). The status of the lights ("on" or "off" at impact) is inconclusive. It is possible that the panel was not subjected to sufficient impact force needed to stretch the bulb filaments.

Figure 3. Caution/Warning Panel

The master caution lights were examined, and no hot filament stretch was found in any of the master caution lights. The status of the lights ("on" or "off" at impact) is inconclusive. It is possible that the panel was not subjected to sufficient impact force needed to stretch the bulb filaments.
