National Transportation Safety Board

CEN22LA336

ENGINE EXAMINATION

Location: Ray, Michigan
Date: July 22, 2022
Time: 1450 Local
1850 UTC
Airplane: Beech A36, N60ED

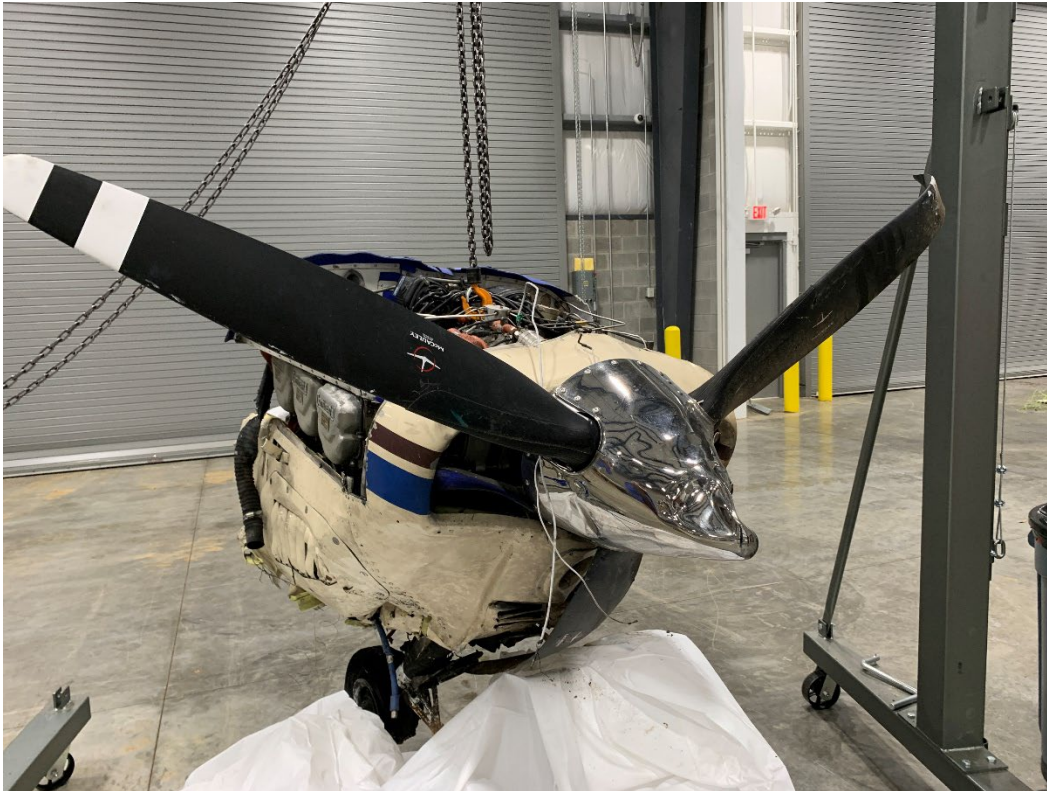
Figure 1 Engine (NTSB Photo)

To facilitate transportation, the engine control cables were cut at the firewall. The engine displayed signs of impact and fire damage. The oil and fuel lines remained attached and displayed thermal damage mainly to the rear of the lower left side of the engine. The fuel pump had been removed prior to transportation by the responding FAA inspector.

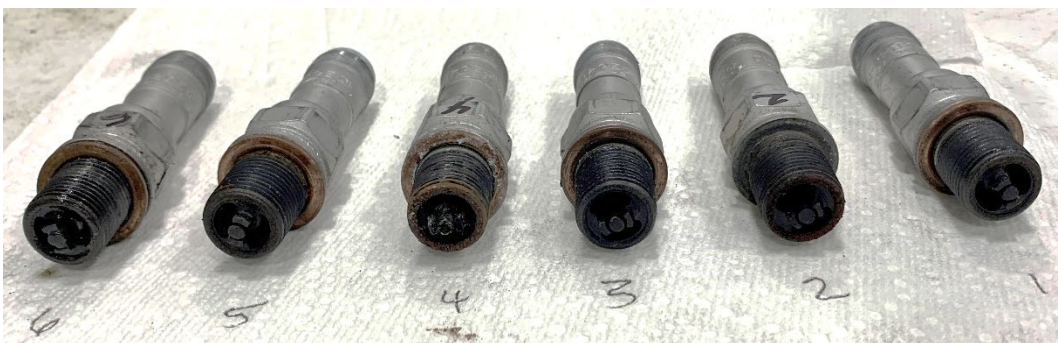
Figure 2 Spark Plugs (NTSB Photo)

The rocker box covers were removed, and no damage was noted to the rocker arms. The upper bank of spark plugs removed, and photo documented. All the spark plugs looked to be gapped properly.

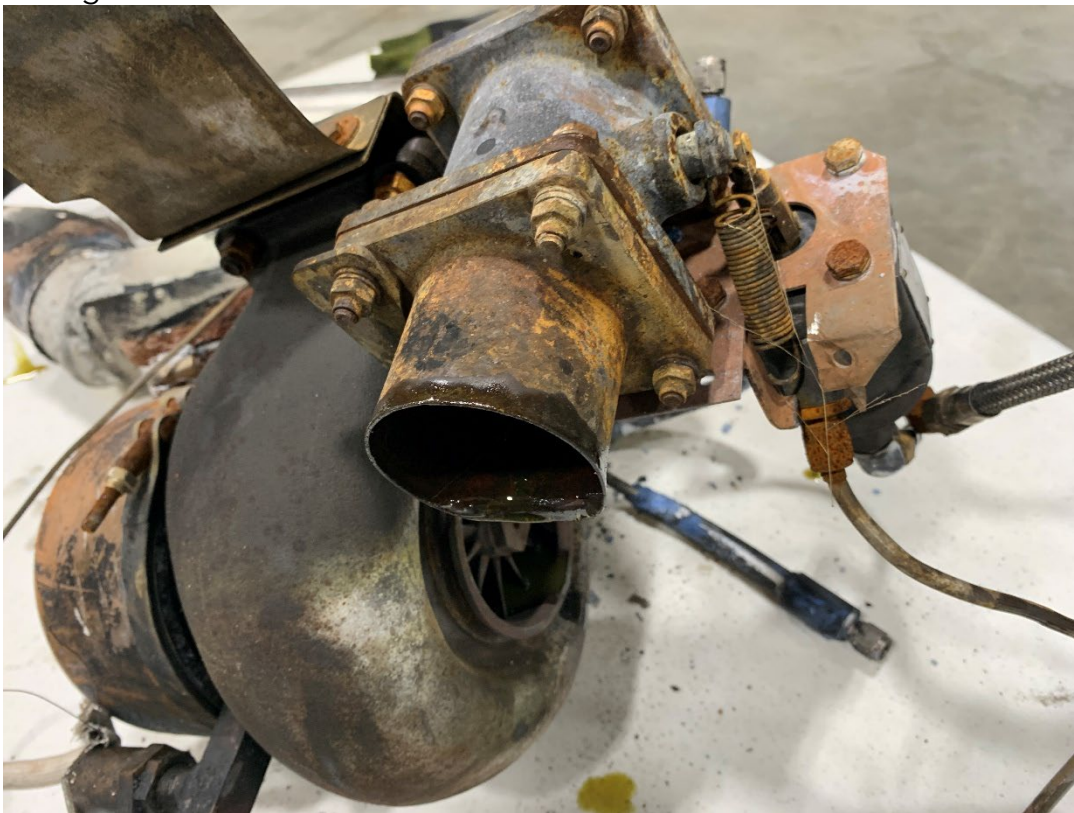
Figure 3 Turbocharger (NTSB Photo)

The turbocharger inlet hose was damaged by fire and partially consumed. The inlet hose fastener remained attached to the turbocharger inlet. The turbocharger control was fire damaged, but the metal hardware remained in place. The valve was in the open position. Examination of the turbocharger found that there was no damage to the impeller and compression side blades. The turbocharger displayed signatures of corrosion from storage. Rotation of the fan blades was obtained but with resistance. The waste gate was in the closed position. The turbocharger pressure

relief valve had fire damage to the inlet and exhaust hoses, but the metal hose fasteners remained in place with remnants of the hoses.

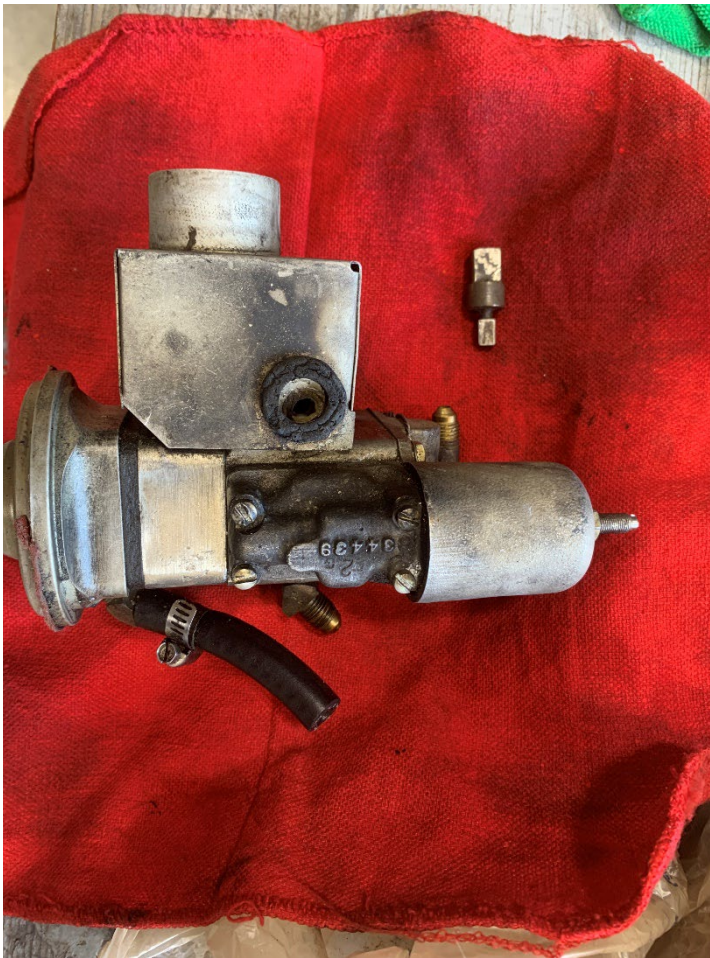
Figure 4 Fuel Pump (NTSB Photo)

The fuel pump was disassembled and no preimpact anomalies were discovered.

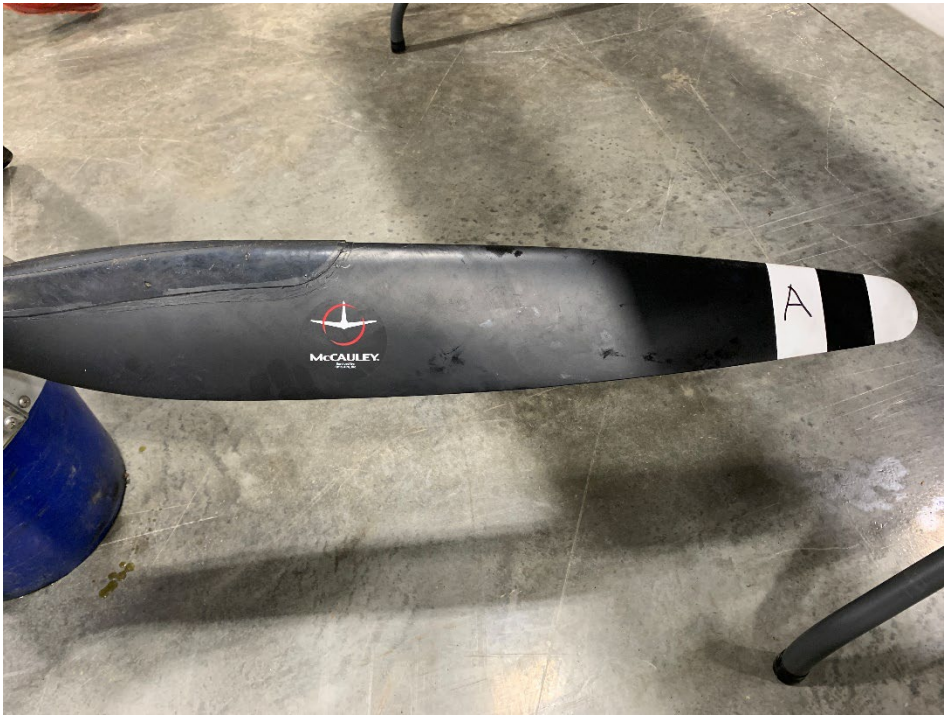
Figure 5 Blade "A" (NTSB Photo)

The propeller remained attached to the engine via the propeller flange. The blades were labeled A, B, and C for documentation purposes. Blade A did not display any damage and was unremarkable. The very tip of Blade B had some bending rearward and displayed thermal damage. Blade C displayed some impact and fire damage but was largely unremarkable.
