National Transportation Safety Board

CEN23FA125

N949SH - AIRFRAME AND ENGINE EXAMINATION REPORT

Location: Port O'Connor, Texas
Date: March 6, 2023
Time: 2157 Central Time
Helicopter: N494SH, Robinson R-44II

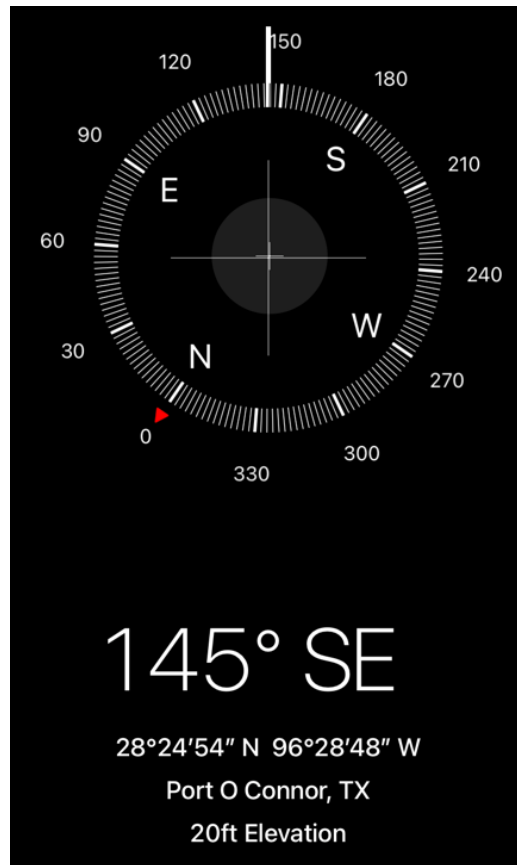
The helicopter impacted the initial impact point on a 138° heading. The initial impact point (a dirt crater) was about 10 ft long (north to south) by about 6 ft wide (east to west), and about 9 inches at its deepest point. There were two small divots, on each side, at the beginning of the crater. A small arc shaped divot was located

approximately 15 ft west of the crater and an 18 ft long divot was located approximately 10 ft south of the two small divots next to the large crater.

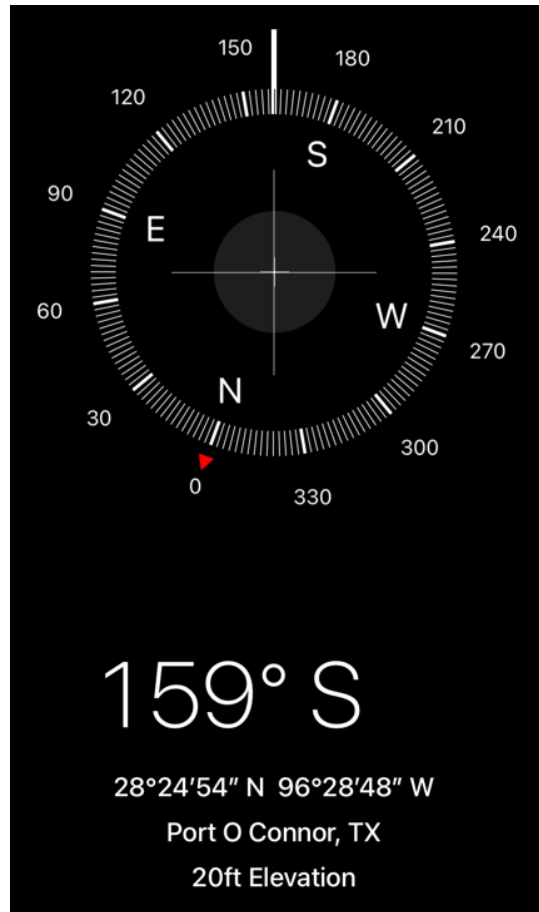
From the initial impact point to the final impact point, it was about 28 feet on a 145° heading.

For the final impact point, the helicopter came to rest on a 159° heading. The final impact point, an area of burned grass and dirt was about 10 ft long (north to south) by about 12 ft wide (east to west), with no visible depth like the initial impact point.

The debris field covered 200 ft north/south and 225 ft east/west.
