National Transportation Safety Board

CEN23LA035

WRECKAGE EXAMINATION

Group Chair's Factual Report

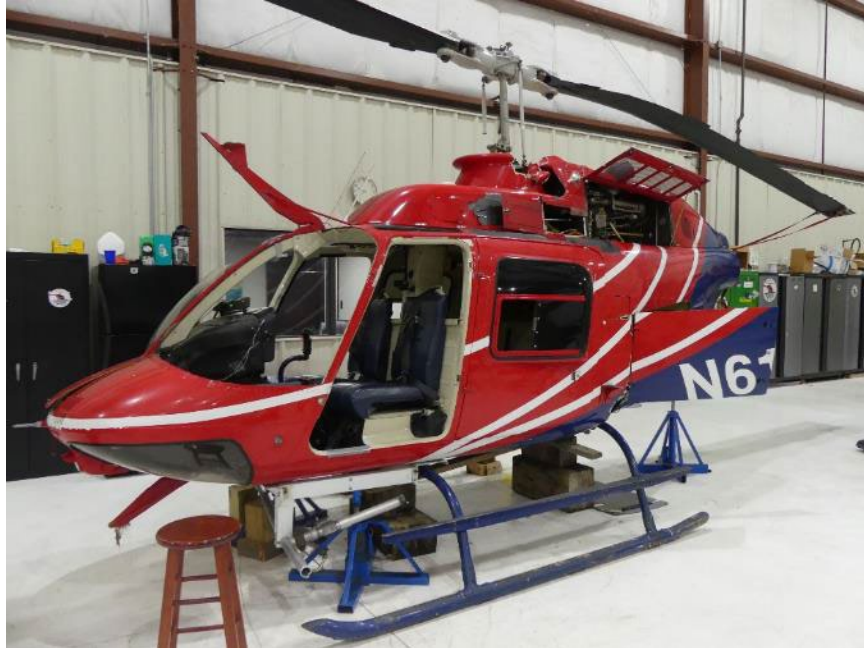
The wreckage examination of the helicopter was conducted at the Kash Helicopter Services facility in Mt Vernon, IL, on December 6, 2022 (Figure 1). The helicopter was manufactured by Bell Helicopter in 1977, as a model 206B III, serial number (SN) 2255 (Figure 1). It had accumulated 15,563.8 flight hours total time at the time of the accident

Figure 1. Helicopter situated for examination.

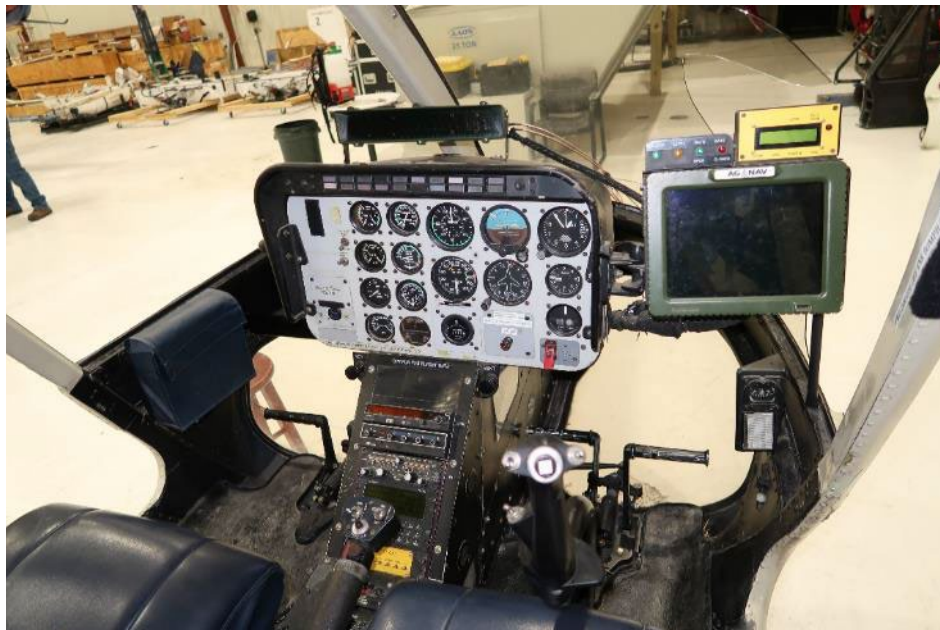
Figure 2. Cockpit

The cockpit structure was intact. The pilot and copilot seats had displacement deformation to the right of the cockpit. The right seat had the cyclic, collective, and pedals installed; the left seat had only the pedals installed. The instrument panel and center console remained in place with very little observable damage (Figure 2). Battery power was applied to the helicopter and the GEN FAIL, BAGGAGE DOOR, ROTOR LOW RPM, ENG OUT, and TRANS OIL PRESS lights illuminated. The Hobbs meter read 4,452.4-hours.

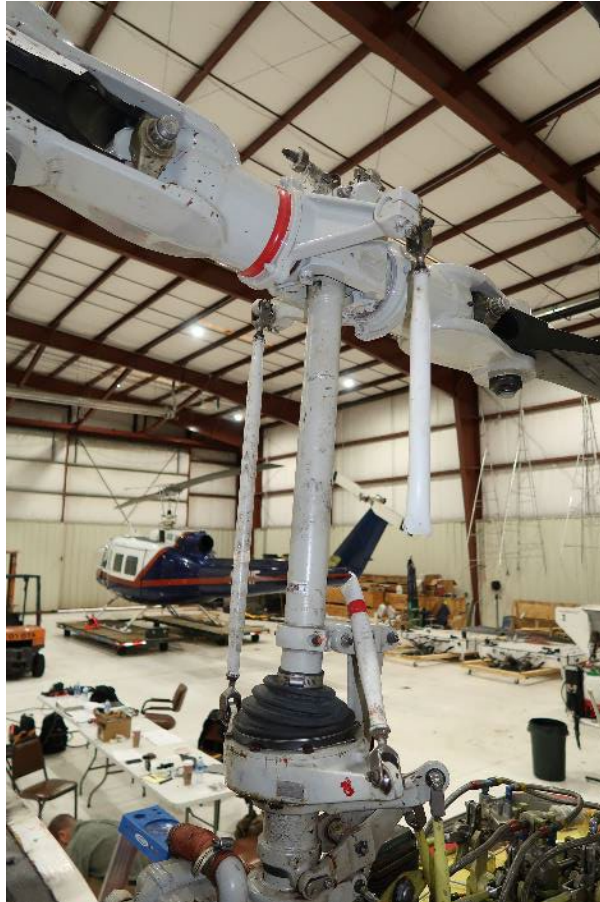
change link had separated mid span and the white pitch link remained connected at both ends (Figure 3). The antitorque pedals were moved and the rear fuselage bell crank moved in concert. The rear fuselage bell crank extending connecting rod had separated at the rod end connection. Tail rotor control continuity aft of the rear fuselage section was established thru multiple breaks of the control rod to the tail rotor gear box.

Figure 3. Main rotor head showing the fractured red pitch change link.

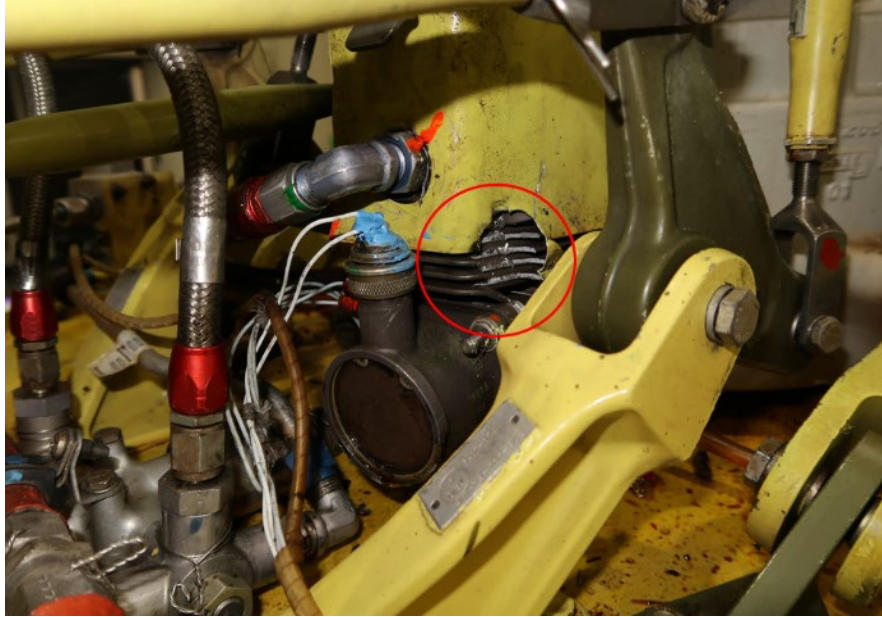
The flight control servos were attached to the mounting fixture. All servo hydraulic lines were connected. Each servo had a plastic bag zip tied to the end to collect leaking hydraulic oil. The hydraulic reservoir had a 2 centimeter diameter impact mark on its lower left side that aligned with a flight control bracket and nut (Figure 4). The reservoir and sight glass had residual oil and hydraulic oil was observed on the deck beneath the reservoir and pump.

Figure 4. Hydraulic reservoir damage shown in the red circle.

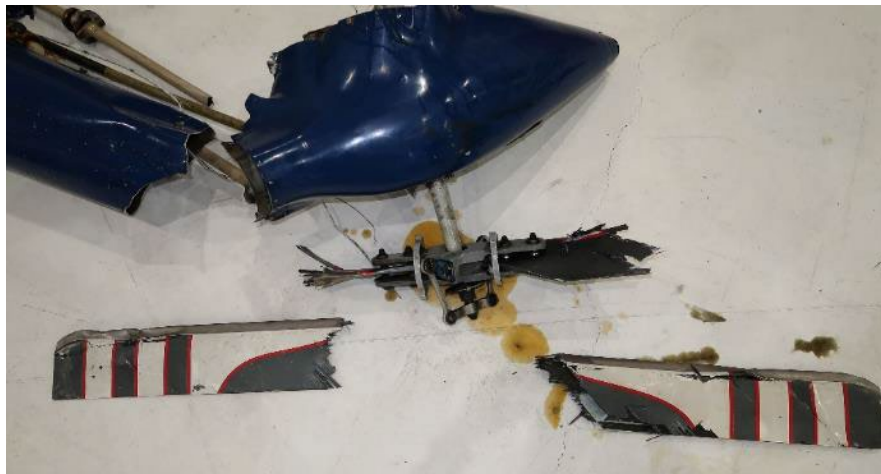
The tail rotor head remained attached to the tail rotor gear box (Figure 5), and pitch change on both blade roots was demonstrated through manual manipulation of the tail rotor control rod bell crank. Both tail rotor blades had fractured a few inches outboard of their blade roots.

Figure 5. Tail rotor assembly.

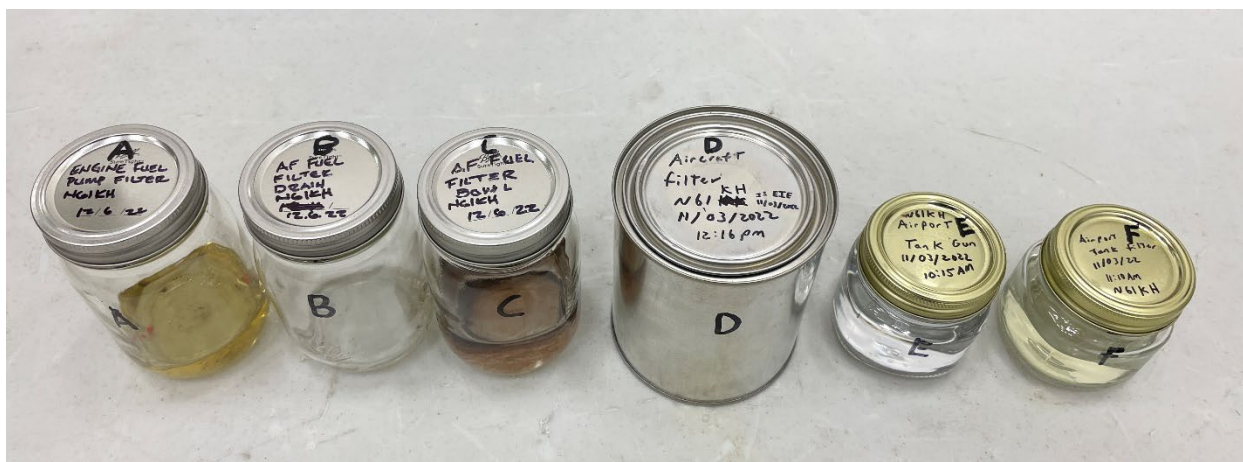
- A. Engine fuel pump filter. Straw colored fuel. A couple of flakes of red torque stripe fell in to the bowl while it was being removed.
- B. Airframe fuel filter drain. Fuel was clear with some black particles settled out.
- C. Airframe fuel filter bowl. There was brown sediment in the filter bowl.
- D. Aircraft fuel filter (taken the day after the accident).
- E. Fuel from fuel farm tank nozzle at Greenville, IL, (taken the after the accident).
- F. Fuel from fuel farm tank filter at Greenville, IL, (taken the day after the accident).

Figure 6. Photo of the fuel samples that were retained with the engine. (Source: Rolls-Royce)

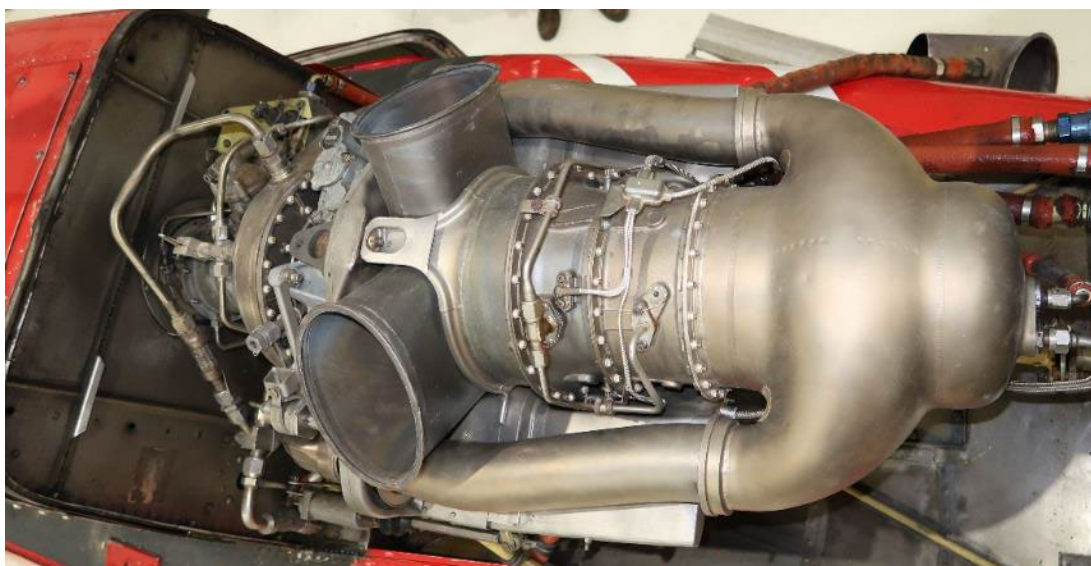
The accident engine was a Rolls-Royce model 250-C20B, SN CAE822827F, with a 420 shaft horsepower rating (Figure 6). The engine had accumulated a total time (TT) of 33,298.6-hours, and 482.10-hours time since overhaul (TSO).

Figure 7. Engine as installed in the helicopter.
