# National Transportation Safety Board

CEN23MA034

## **UAS AERIAL IMAGERY FACTUAL REPORT**

Location: Dallas, Texas  
Date: November 12, 2022  
Time: 1322 central standard time  
1922 UTC  
Airplane 1: Boeing B-17G, Flying Fortress, N7227C  
Airplane 2: Bell P-63F Kingcobra, N6763

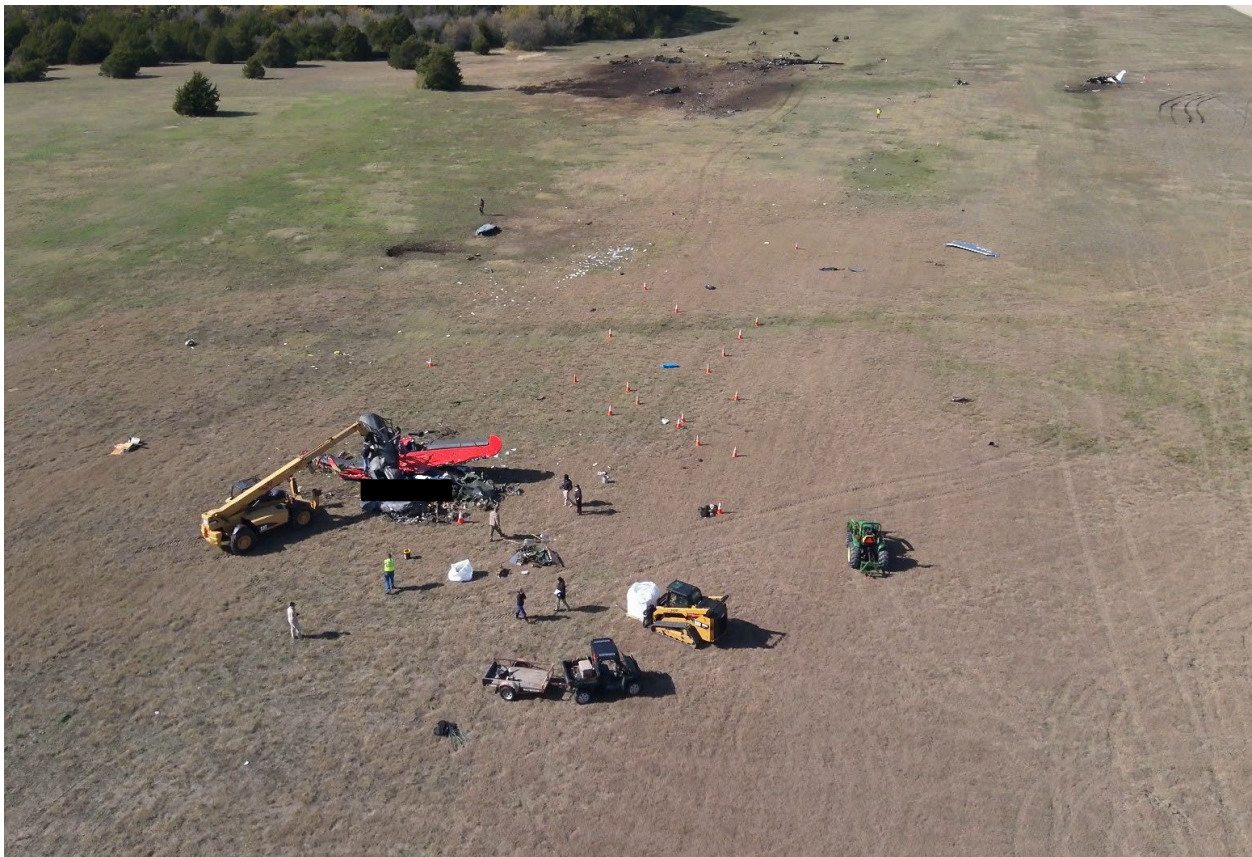
Figure 1. Aerial view of accident site with the B-17G tail in the left foreground. A small portion of the tail has been covered with a black box due to the sensitive contents in the image (Source: NTSB).

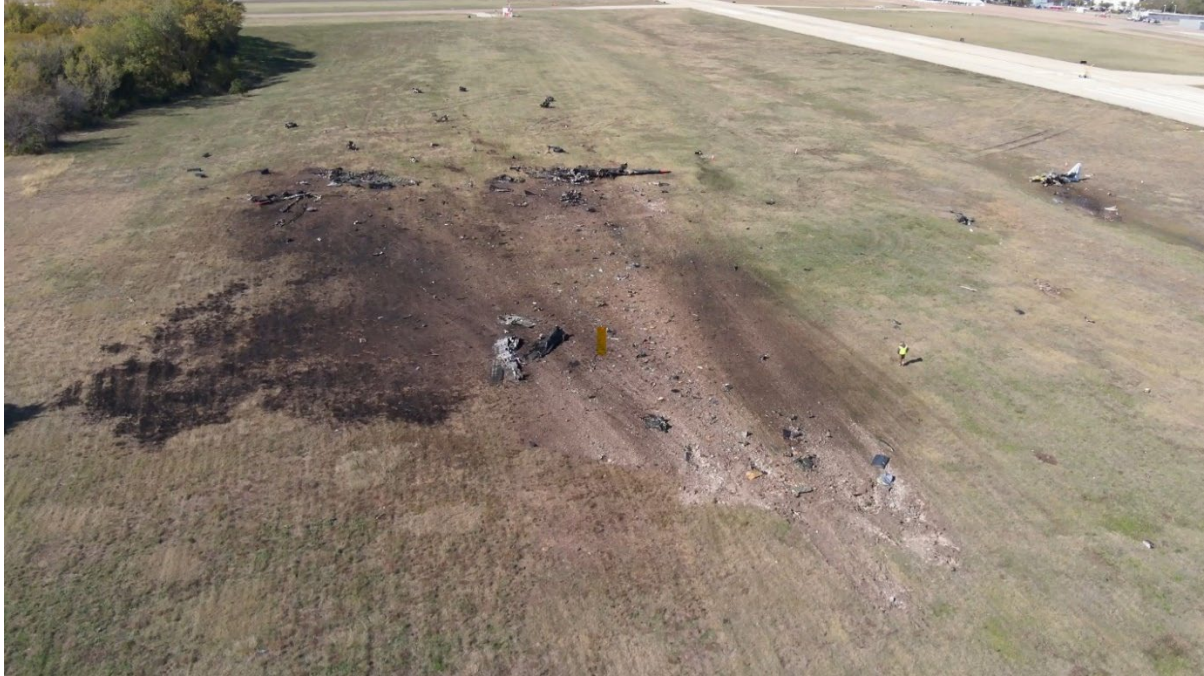
Figure 2. Aerial view of B17-G initial impact area and debris field facing northwest (Source: NTSB).

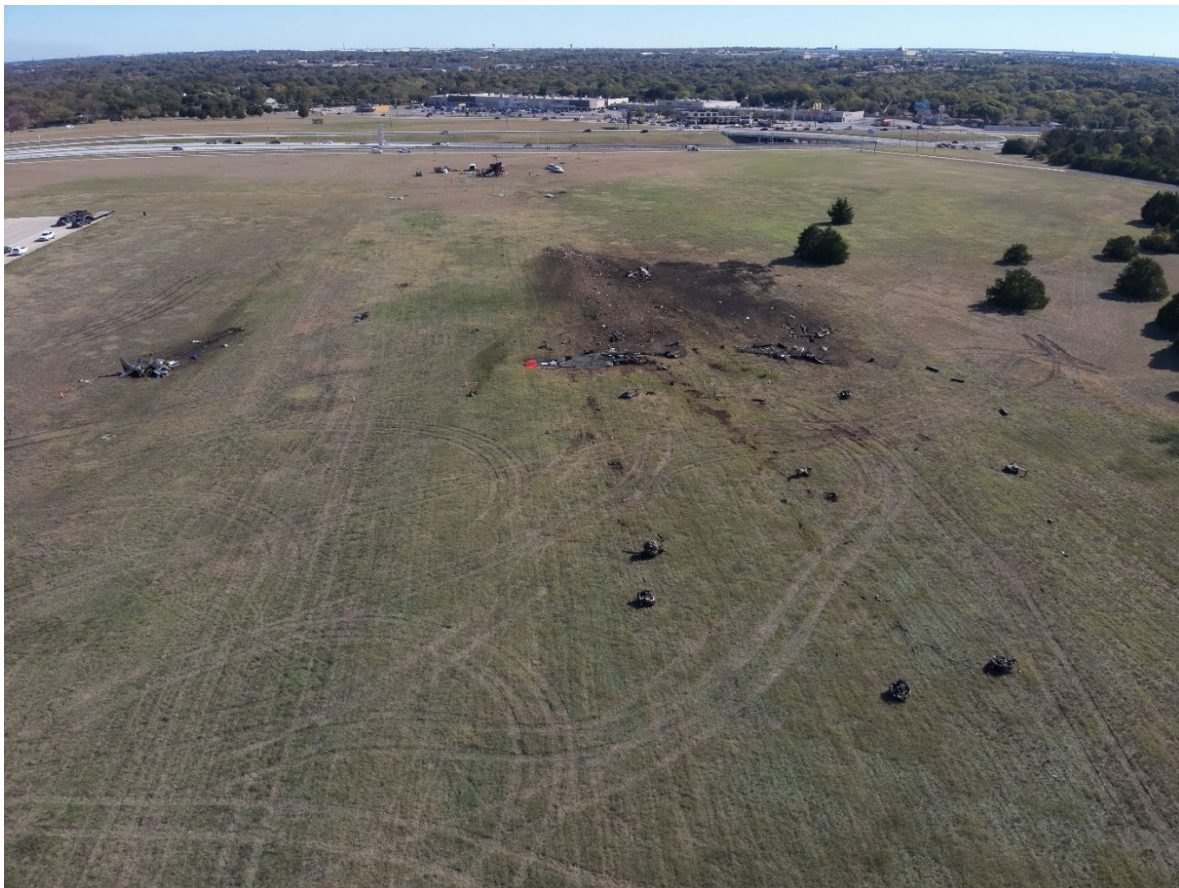
Figure 3. Aerial view of accident site facing southeast (Source: NTSB).

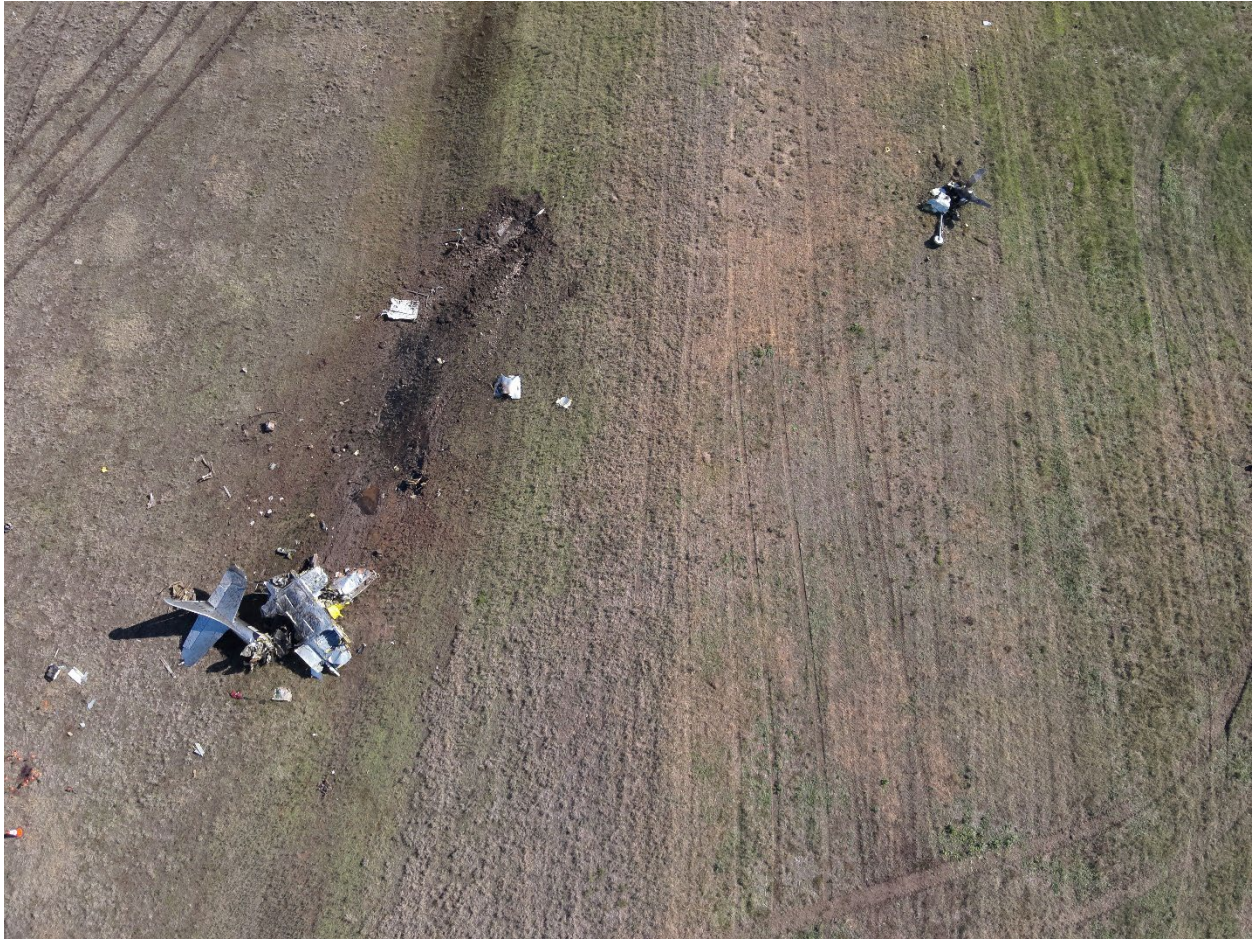
Figure 4. Aerial view of P-63F main wreckage (Source: NTSB).

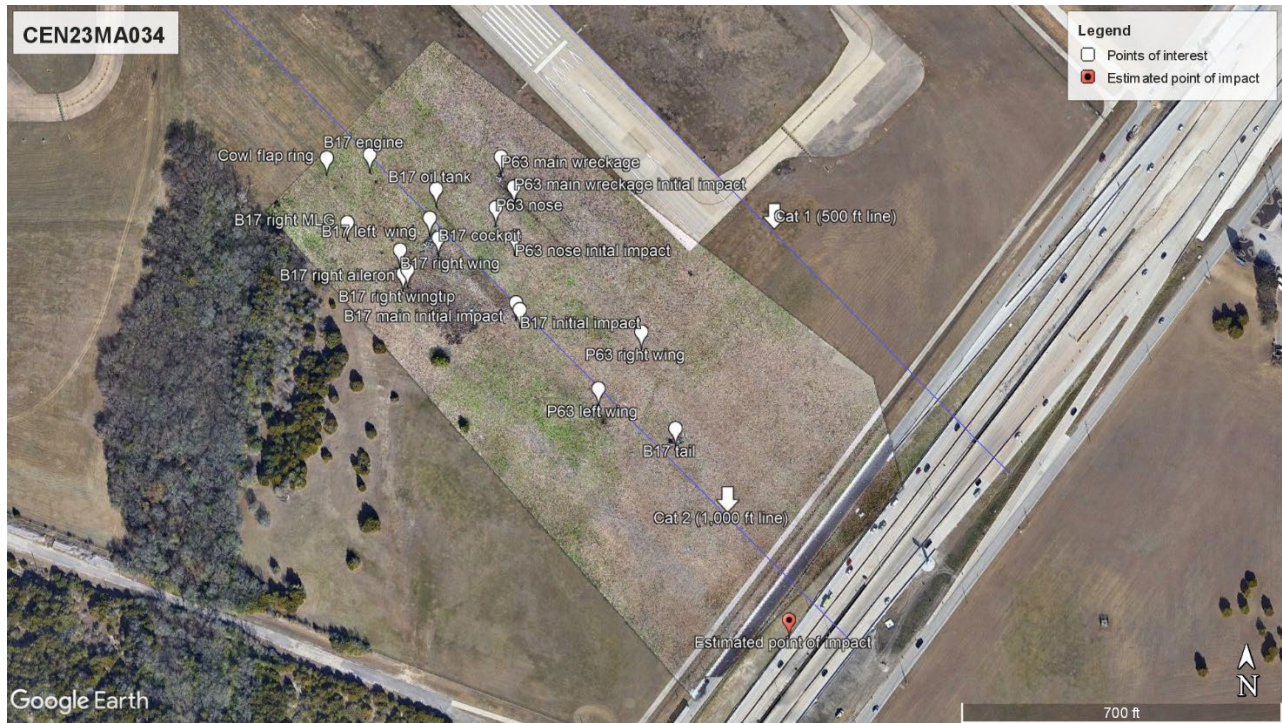
Figure 5. Overall view of the accident site with points of interest (Google Earth Overlay)

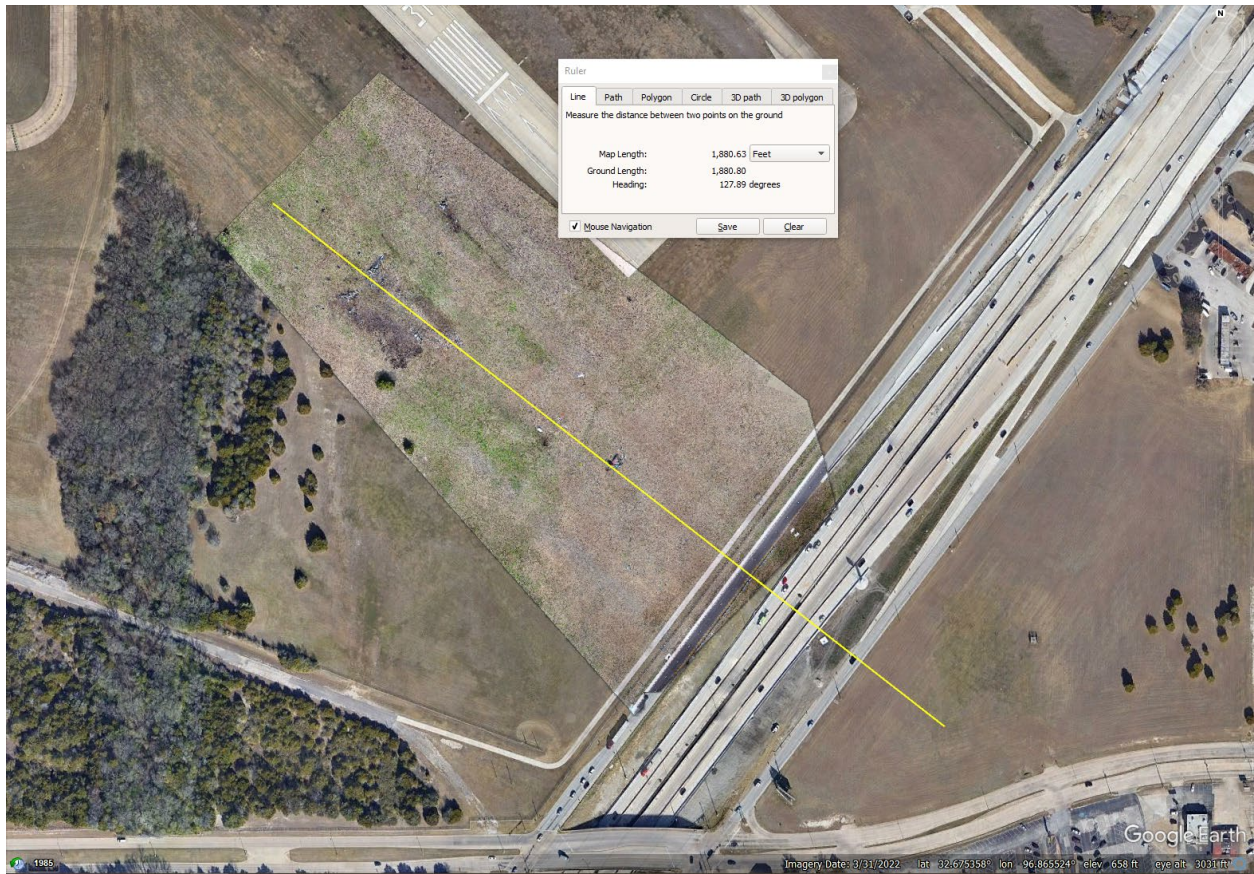
Figure 6. The full accident debris field was about 1,880 ft long northwest-southeast by about 410 ft wide northeast-southwest (Google Earth Overlay).

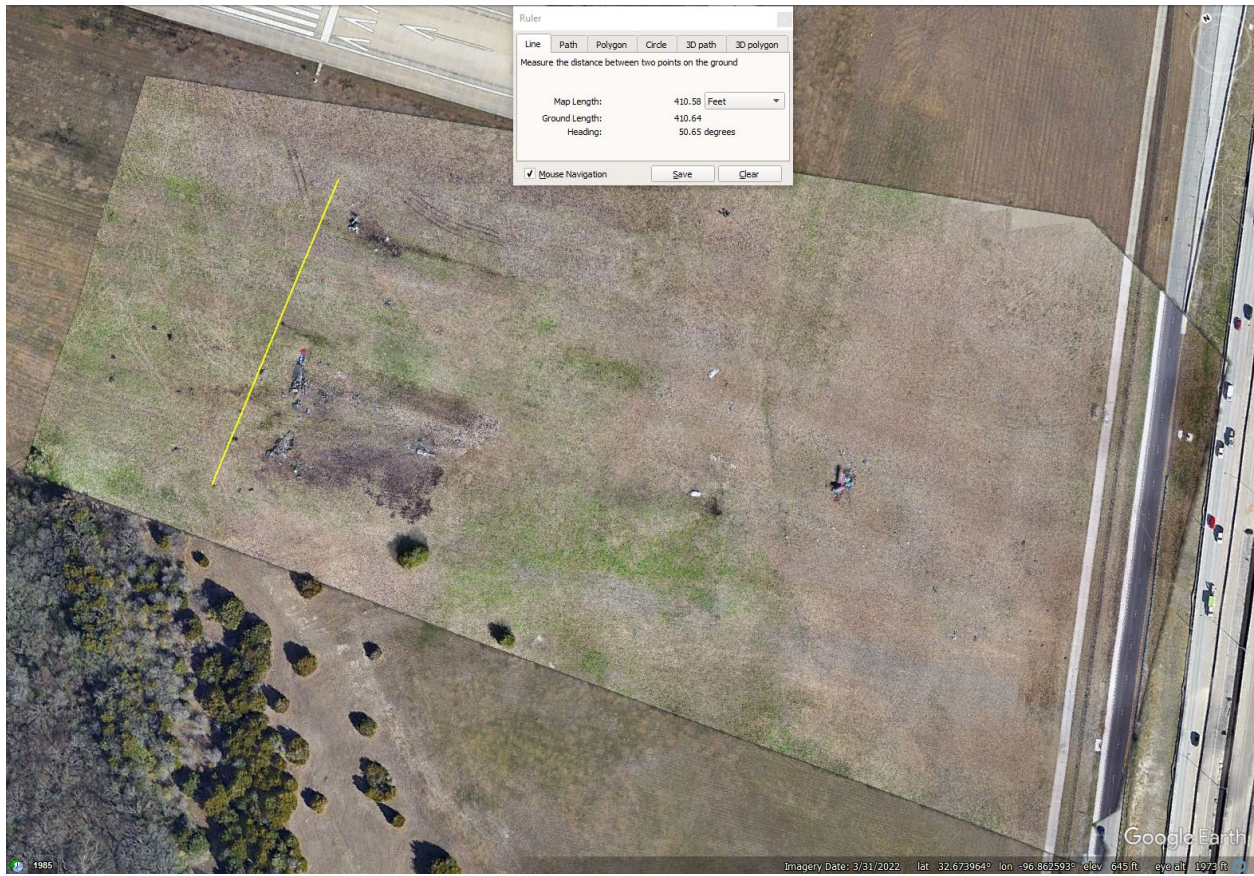
Figure 7. The full debris field was about 1,880 ft long northwest-southeast by about 410 ft wide northeast-southwest (Google Earth Overlay).

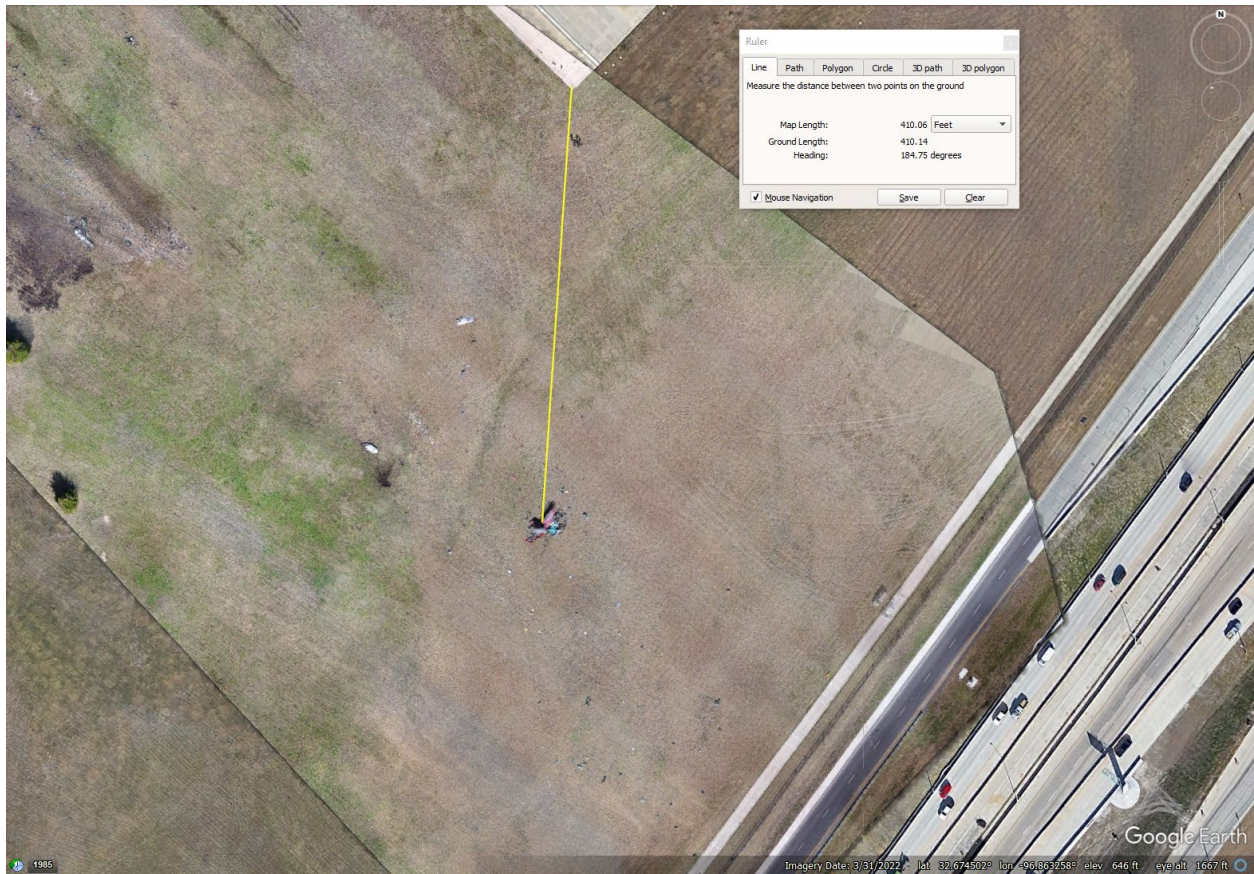
Figure 8. The southernmost debris area contained the aft fuselage and empennage of the B-17G that was lying upside down. It was located about 410 ft south of the corner of runway 31 (Google Earth Overlay).

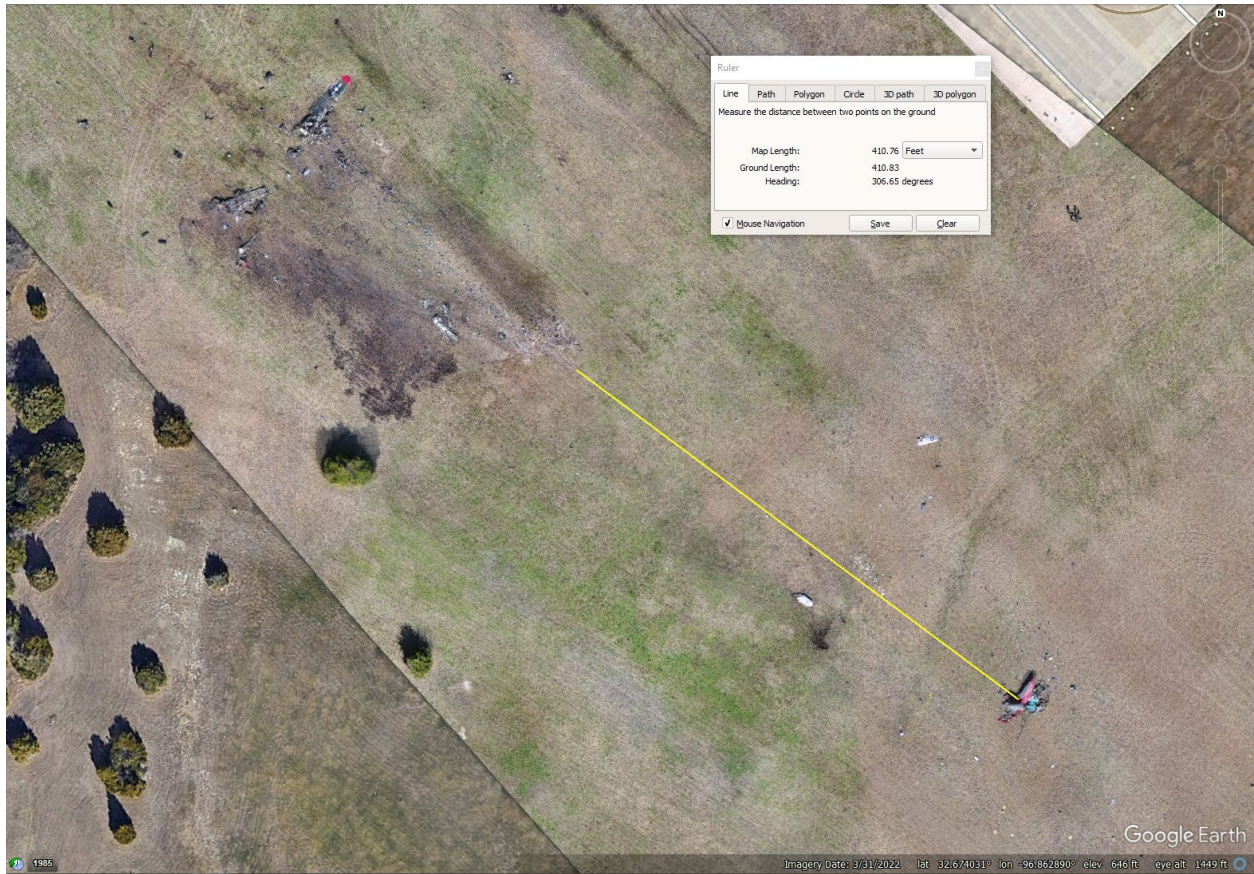
Figure 9. The B-17G initial impact point was located about 410 ft northwest of the tail (Google Earth Overlay).

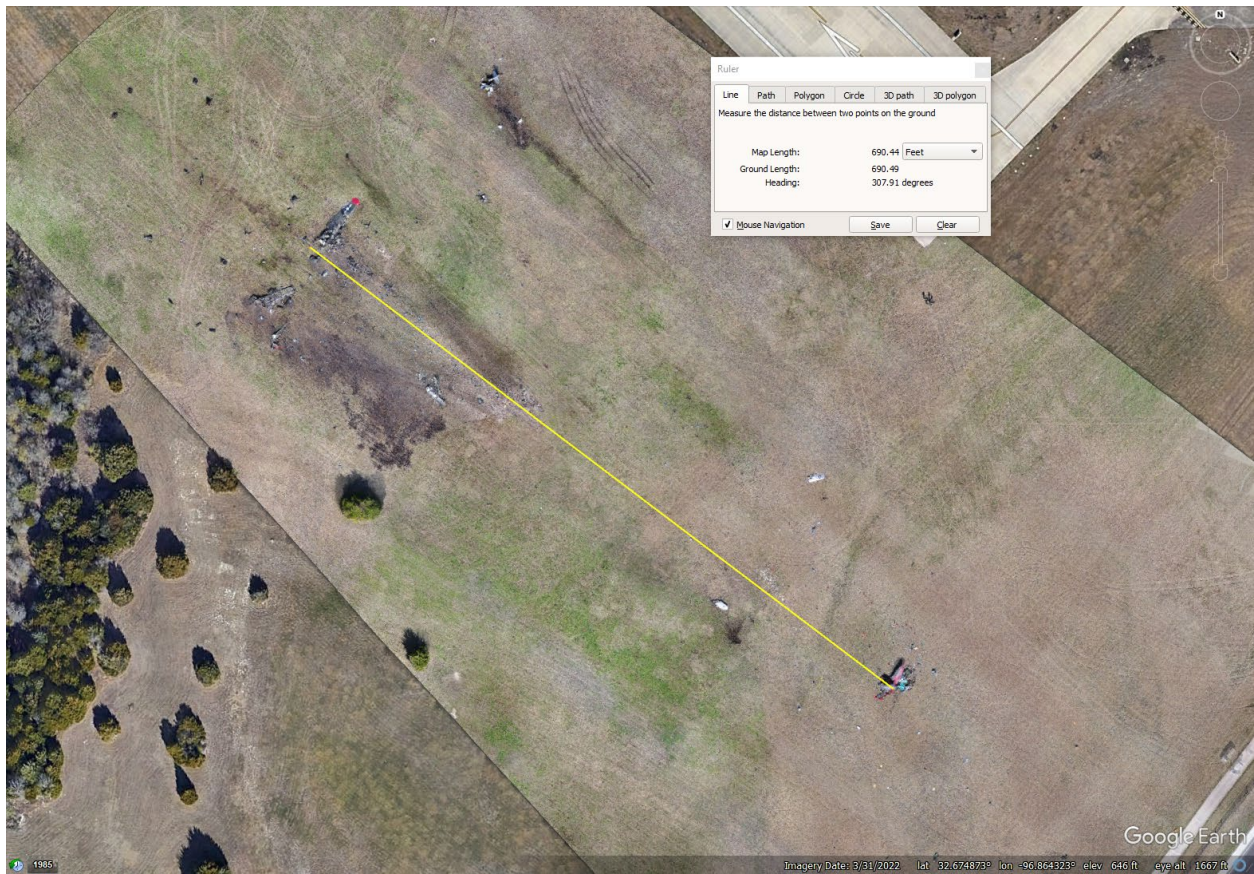
Figure 10. The B-17G central debris area was located about 690 ft northwest of the B-17G tail (Google Earth Overlay).

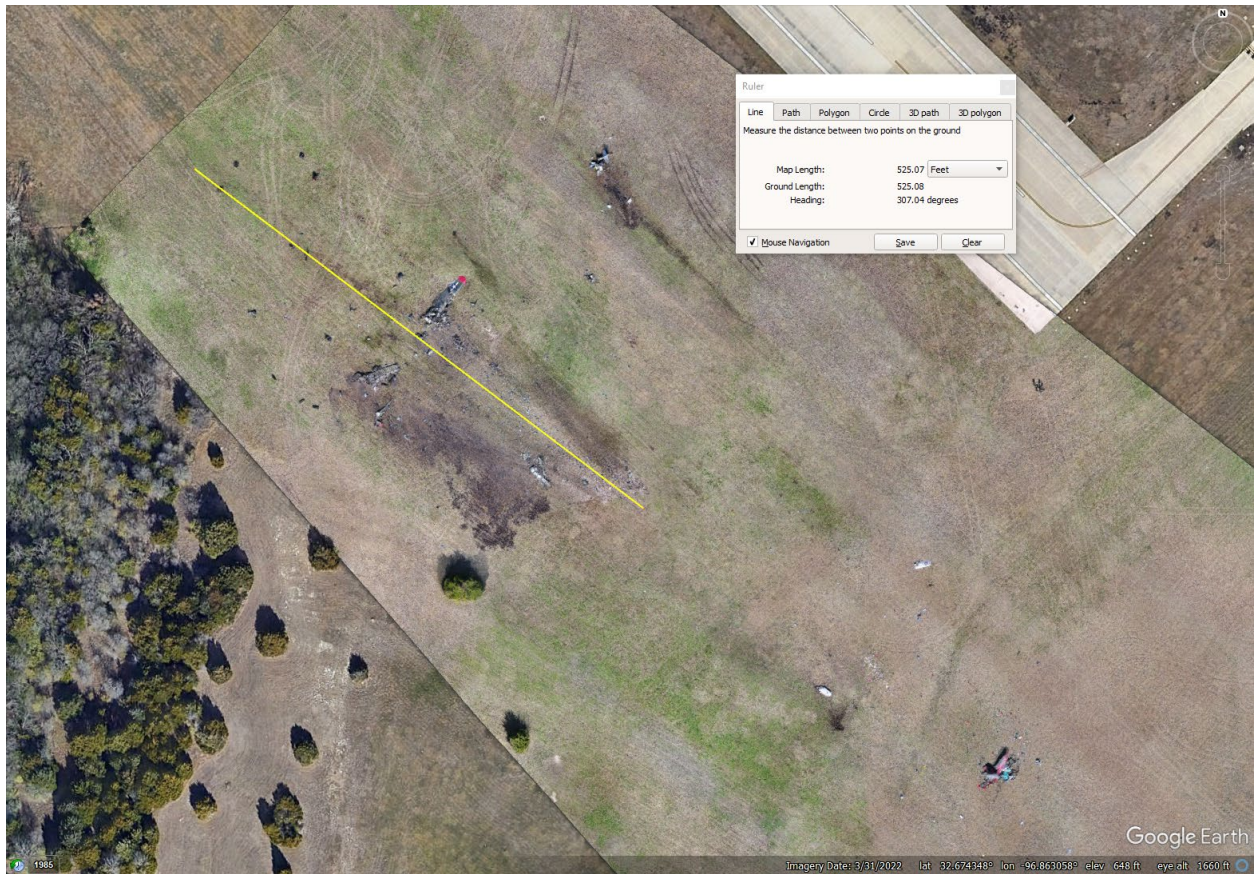
Figure 11. The main B-17G debris field measured about 525 ft long by about 225 ft wide (Google Earth Overlay).

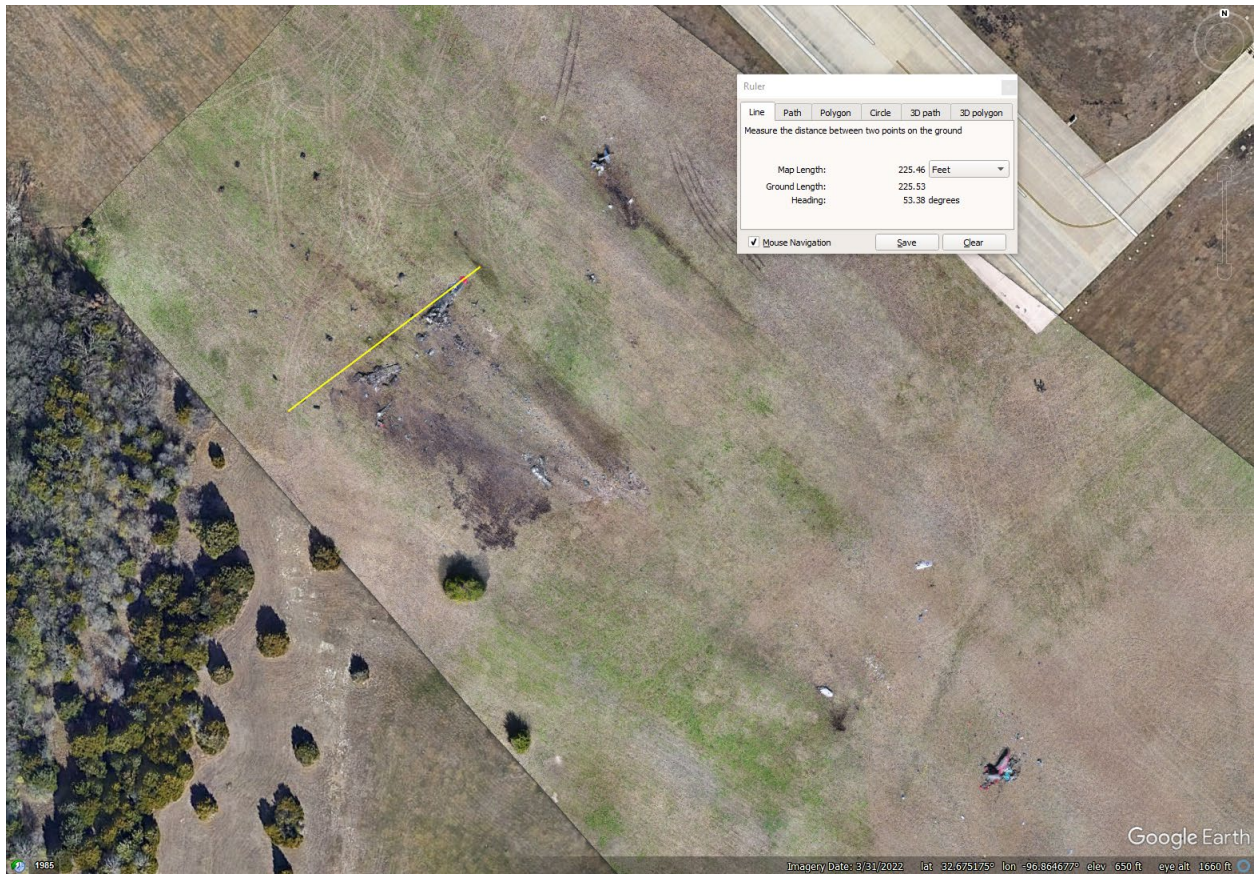
Figure 12. The main B-17G debris field measured about 525 ft long by about 225 ft wide (Google Earth Overlay).

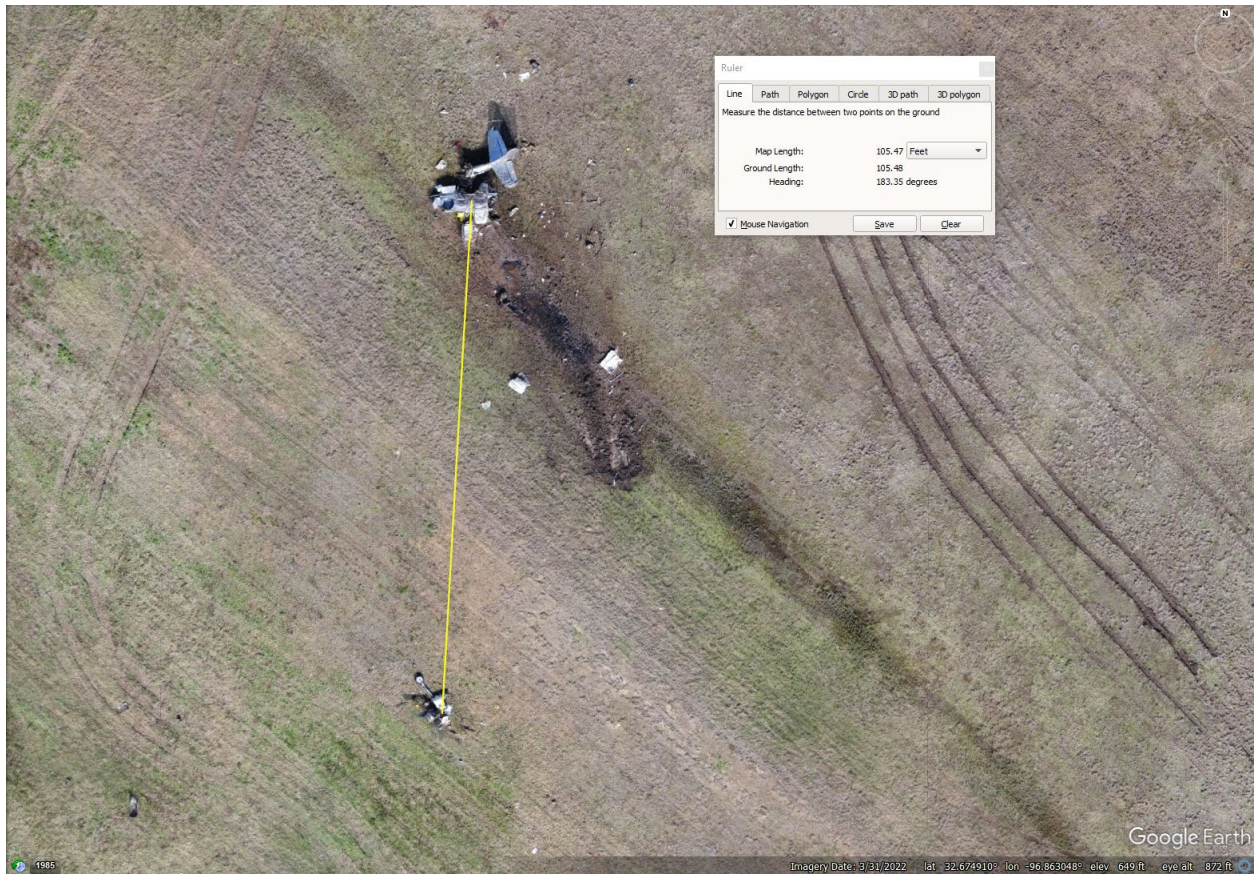
Figure 13. The P-63F propeller, gearbox, and nose landing gear separated from the forward fuselage during the collision and were found about 105 ft south of the P-63F fuselage.

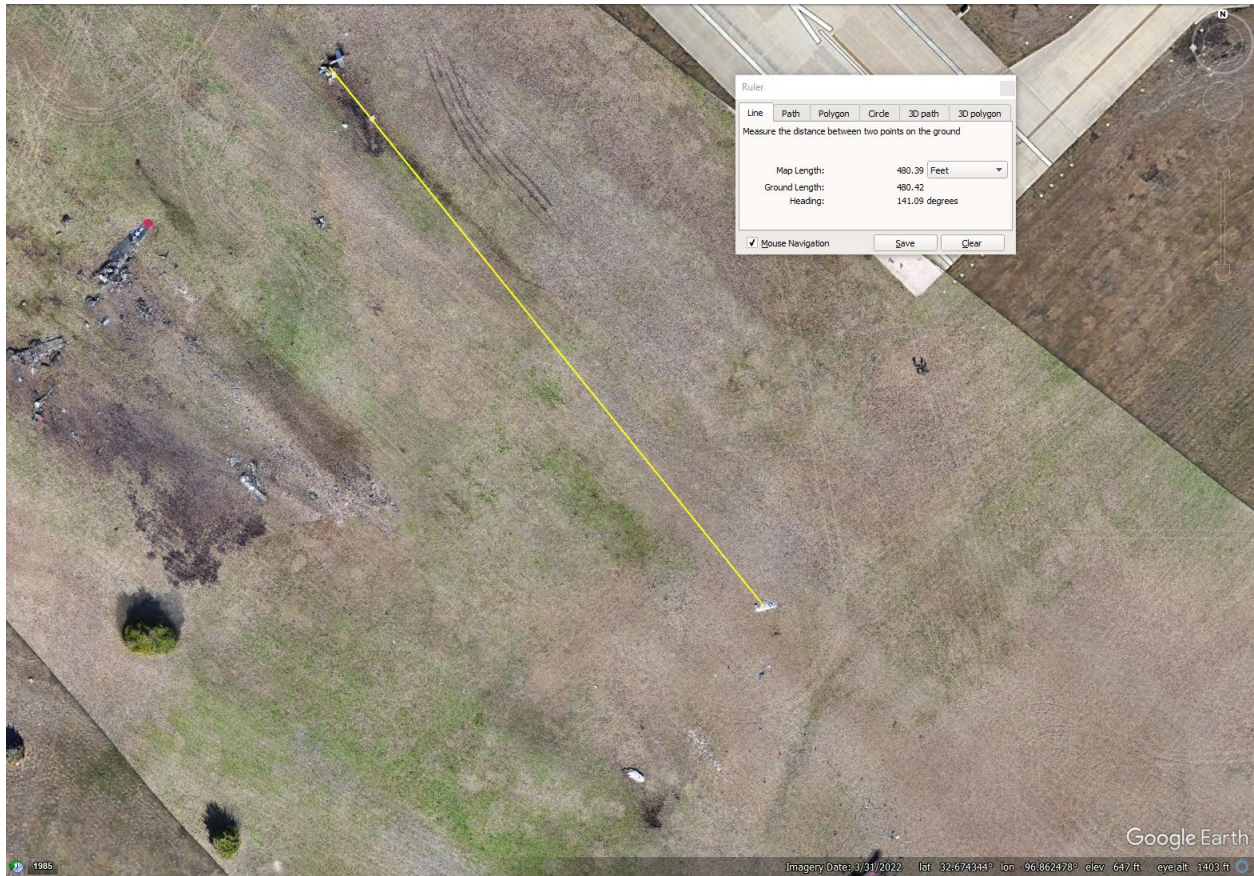
Figure 14. The P-63F left and right wings separated from the fuselage during the collision and were located in the debris field. The right wing was lying on its upper surface and was located about 480 ft southeast of the P-63F fuselage (Google Earth Overlay).

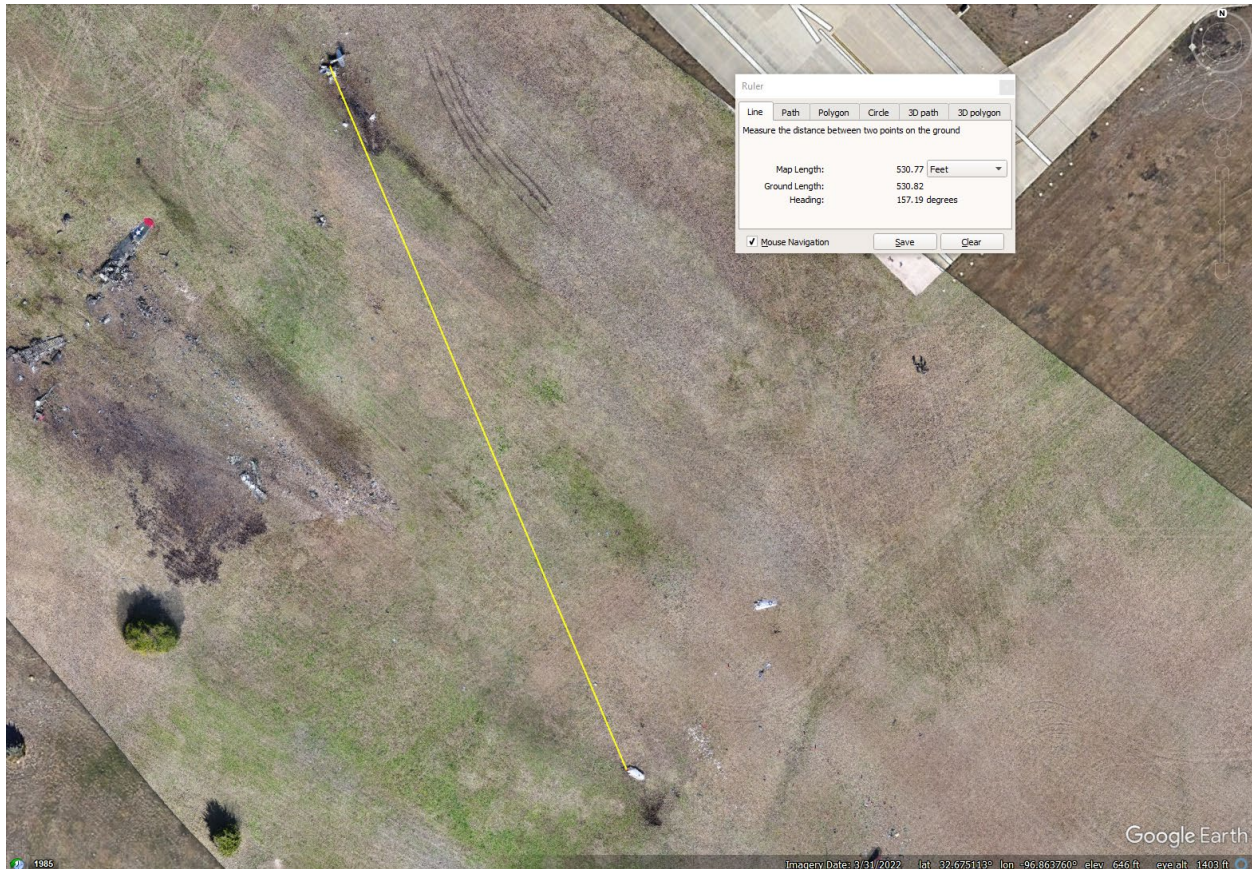
Figure 15. The P-63F left and right wings separated from the fuselage during the collision and were located in the debris field. The left wing was lying on its lower surface and was located about 530 ft southeast of the P-63F fuselage (Google Earth Overlay).

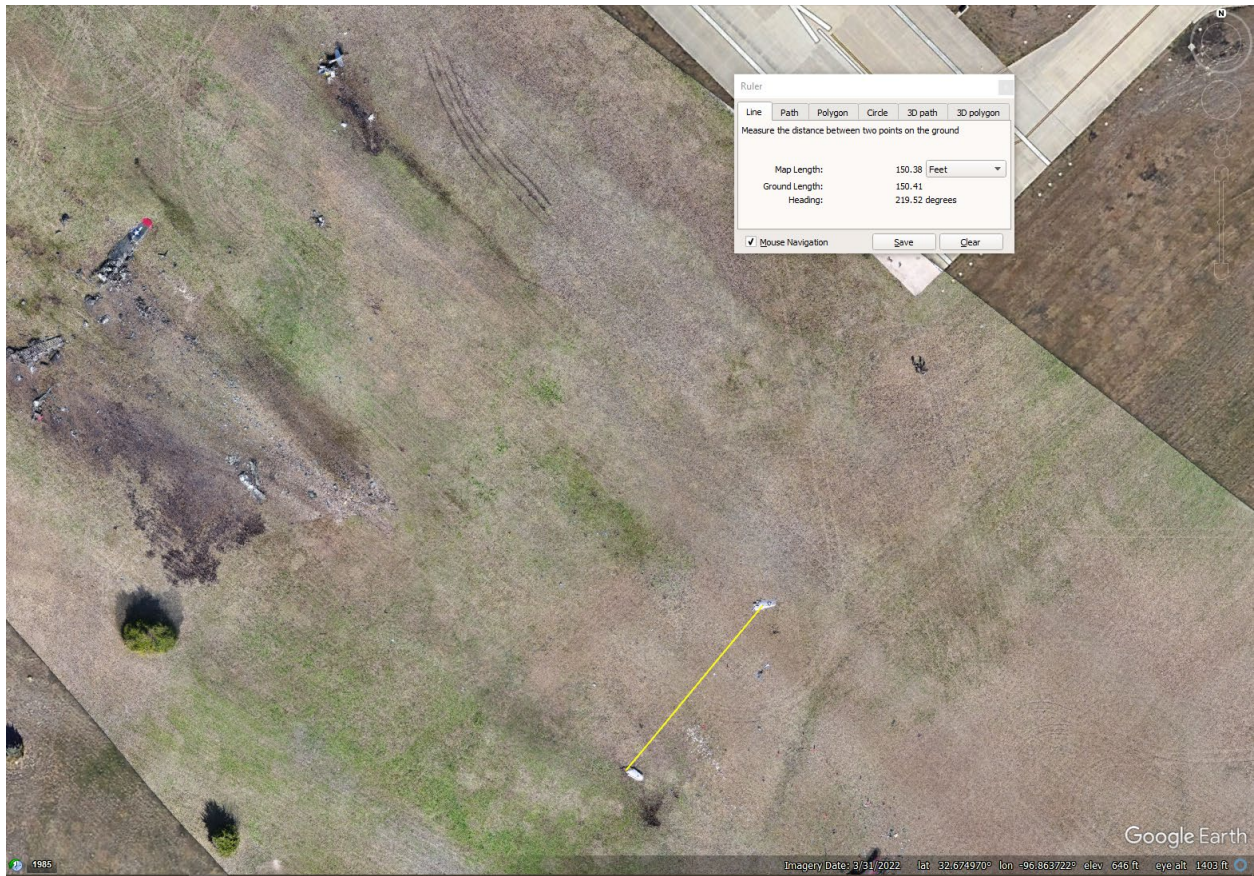
Figure 16. The P-63F left and right wings were separated by about 150 ft (Google Earth Overlay).

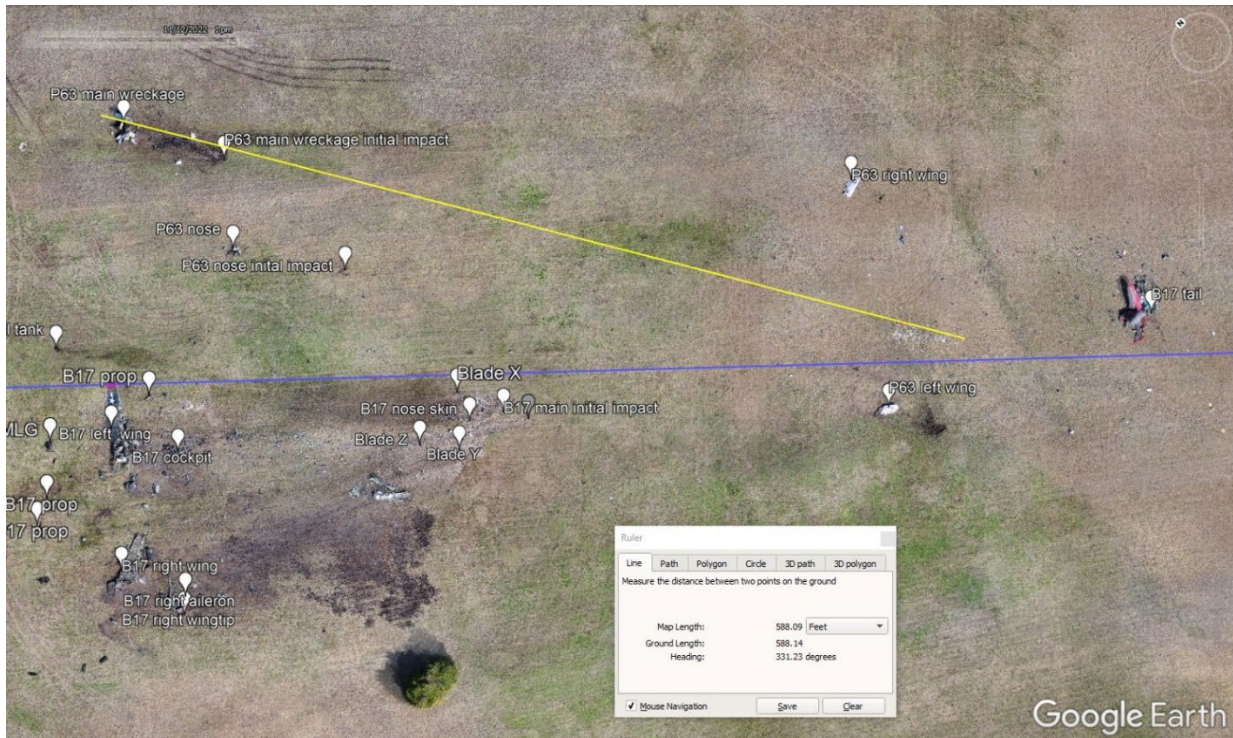
Figure 17. P-63F general debris path from the wings to the main wreckage ~600 ft (Google Earth Overlay).

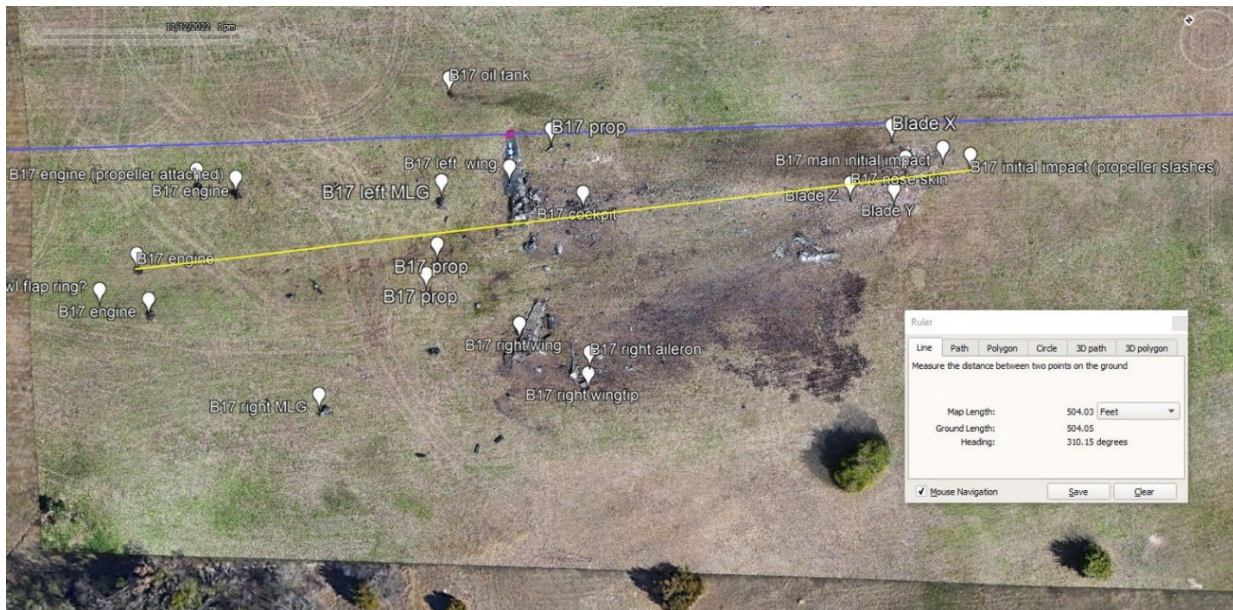
Figure 18. B-17G initial impact to the engines ~500 ft (Google Earth Overlay).
