# F/V SCANDIES ROSE

## Search and Survey Report

February 25, 2020

# Global Diving & Salvage Scandies Rose Location and Imaging Survey

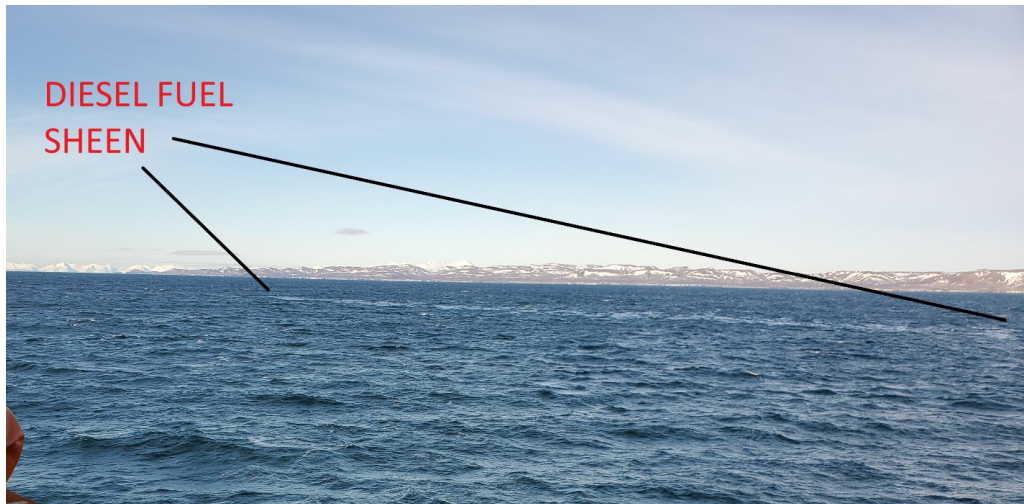
Upon arrival in the vicinity of the SCANDIES ROSE the crew observed the sheen of diesel fuel rising to the surface and extending with the current approximately ¼ mile. This discharge was observed throughout the time spent on the location. At one point during the ROV survey fuel bubbles were observed at the front of the house but no point of origin could be determined due to debris and entanglement hazards.

Figure 6: Diesel fuel on the surface

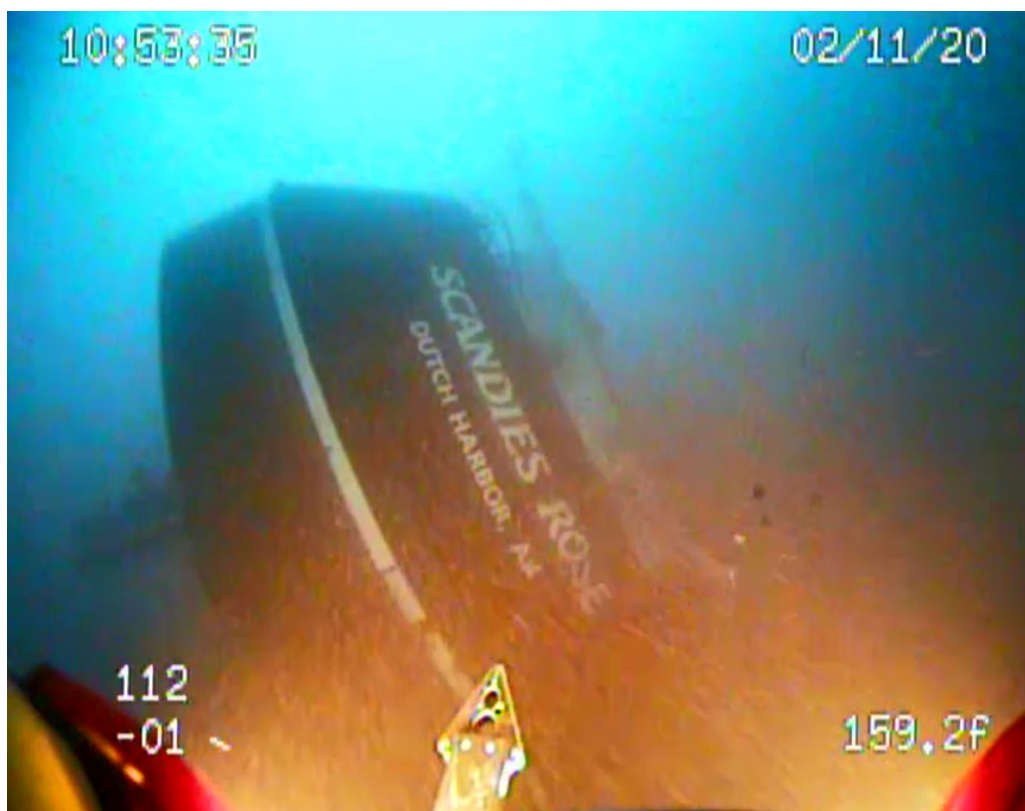
Figure 7: First image of SCANDIES ROSE

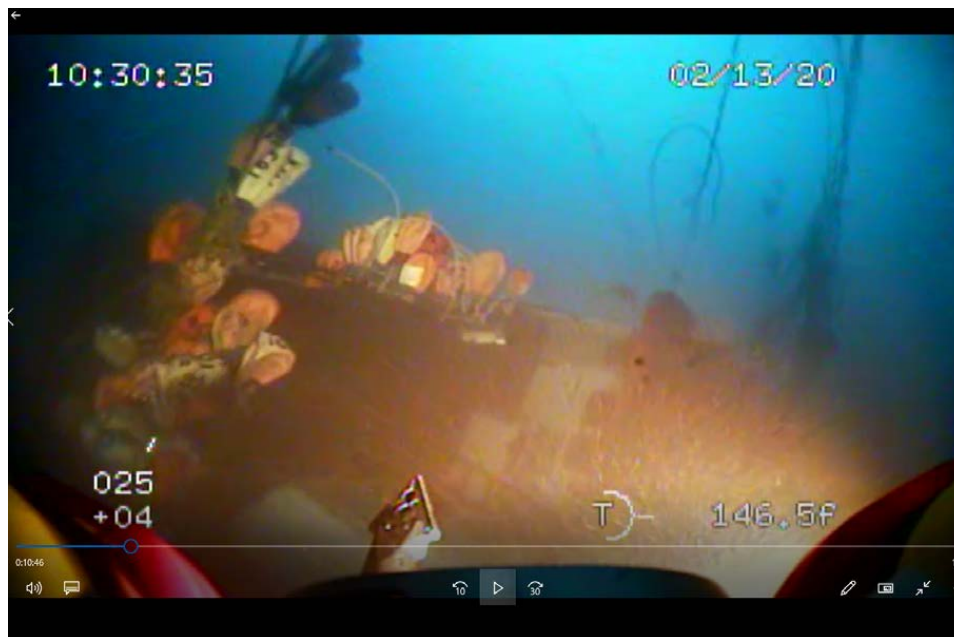
Figure 8: Crab pots, a tethered life ring and random lines extend upward from SCANDIES ROSE to within 40' of the surface

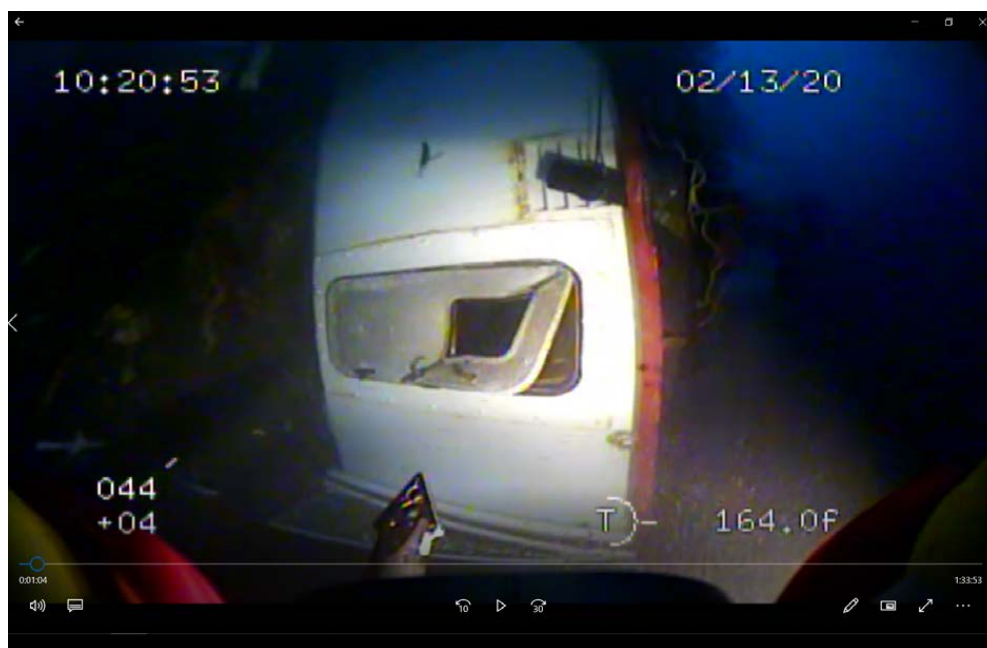
Figure 9: A man door located at the starboard stern of the accommodation suffered damage.

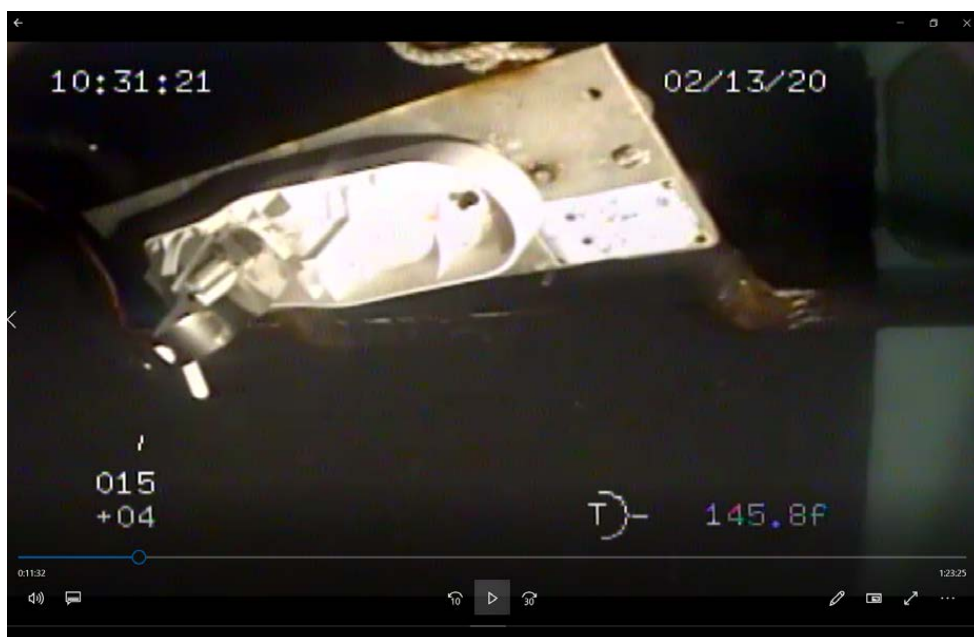
Figure 10: The EPIRB bracket was located on the port rail aft of the wheel house door.

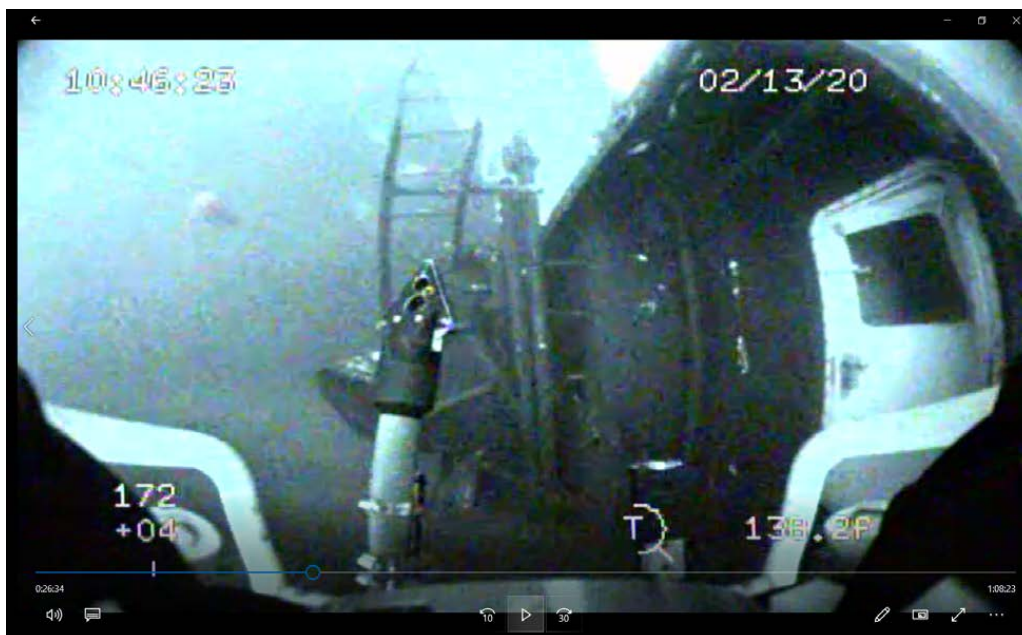
Figure 11: Port side forward main deck door is damaged

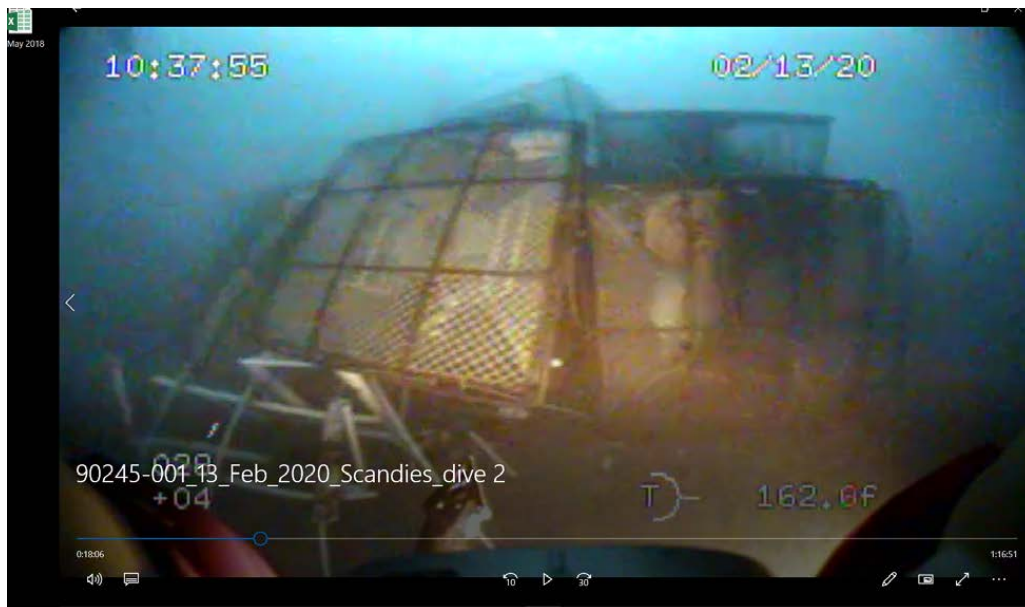
Figure 12: Dislodged crab pots are piled on the sea floor

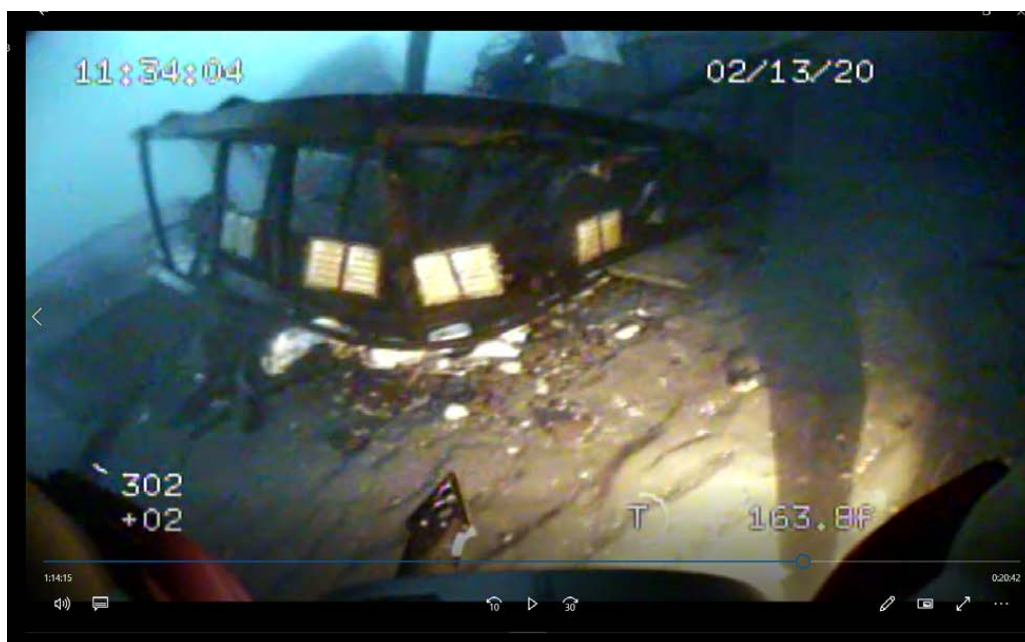
Figure 13: Foremast lies on the seafloor

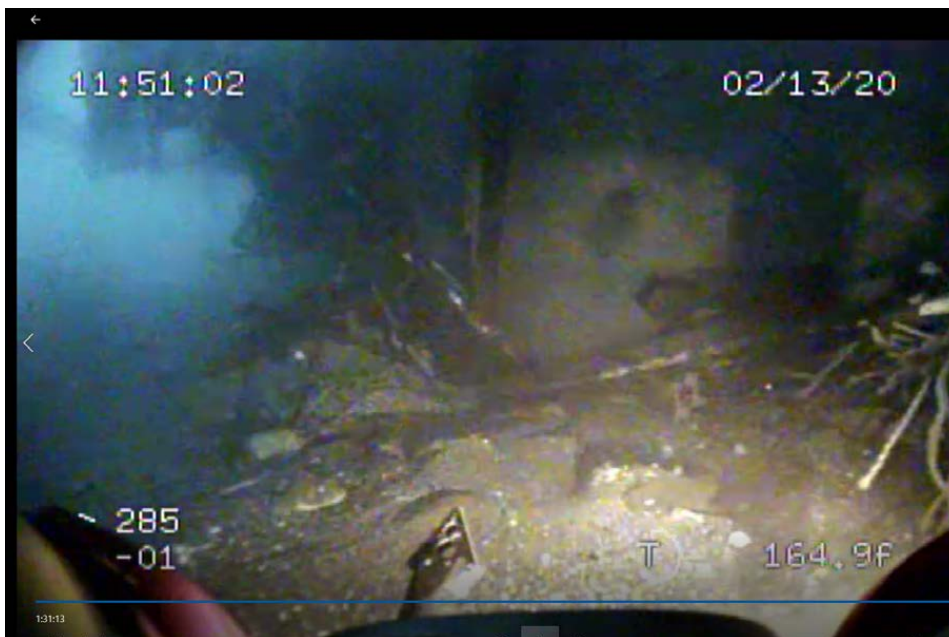
Figure 14: Starboard side shell impacting the seafloor and crushed debris precluded inspection of the starboard area of concern.

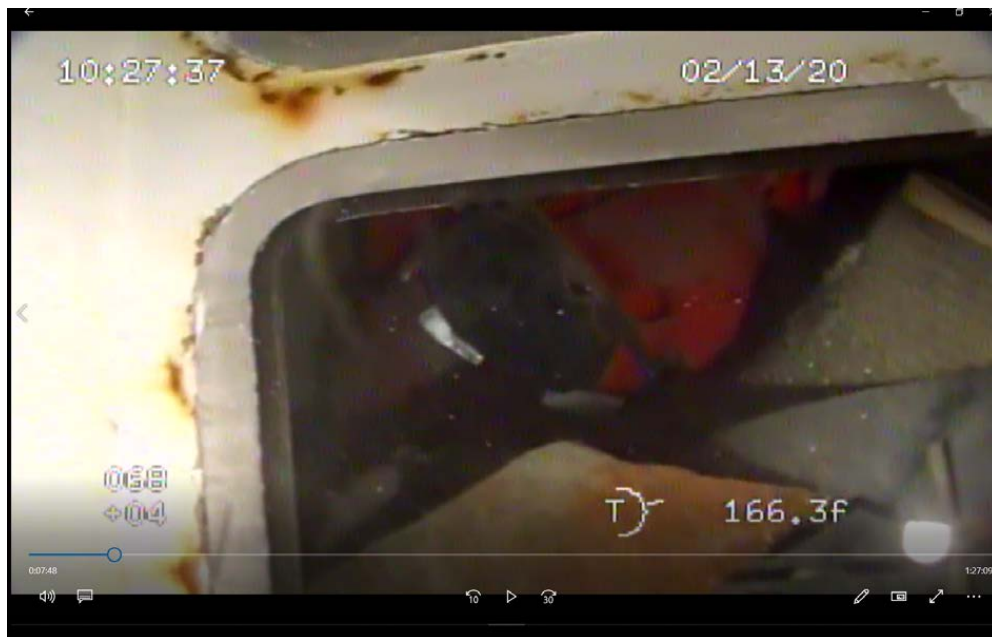
During the survey Global identified two orange survival suits inside the vessel. The suits appear to contain the remains of individuals.

Figure 15: Victim 1

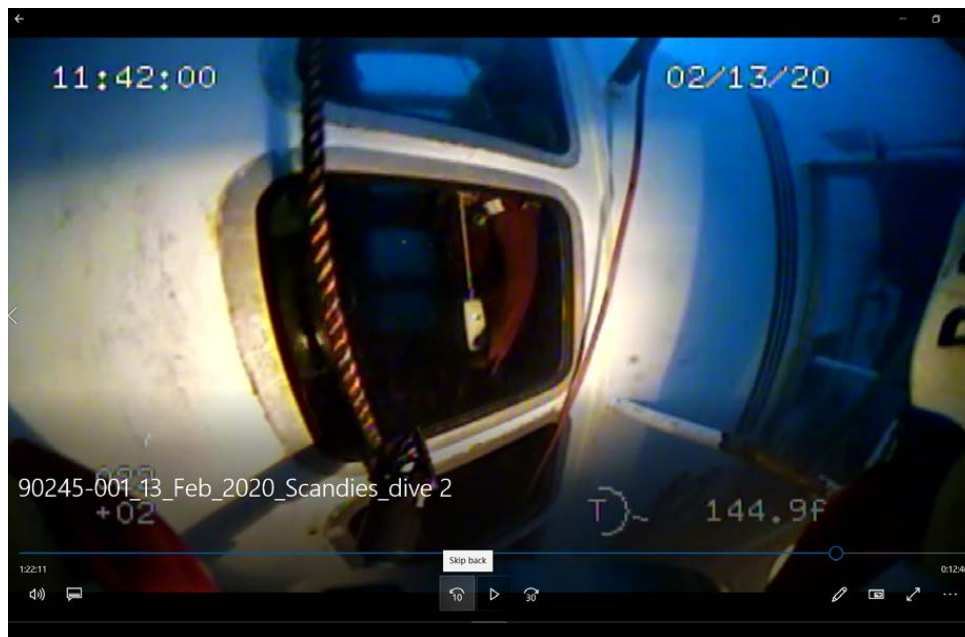
Figure 16: Victim 2

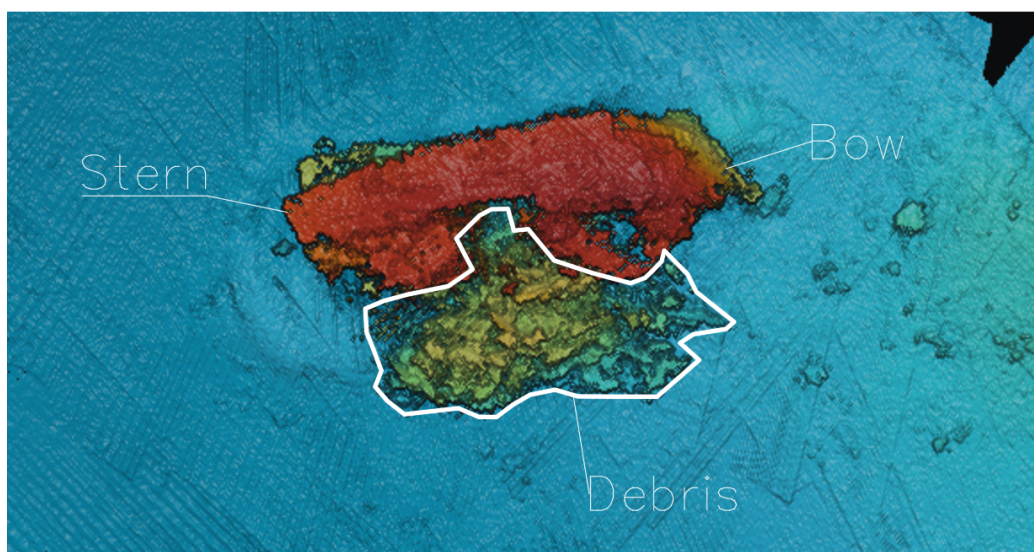
Figure 9 2D gridded surface of Scandies Rose

The multibeam bathymetric surface for the Scandies Rose ranges from -141ft to -167ft NAVD88 (Figure 9). What can be gathered from the multibeam data is the Scandies Rose is lying on its starboard side in an east-west direction with the bow pointing east. Off the deck side of the vessel is a debris field roughly 94ft x 42ft with height off the seafloor of ~20ft. East of the vessel shows various sized objects that could potentially be other debris that fell off the vessel during the sinking (Figure 10).
