Title of Investigation: MV Spirit of Norfolk - Fire Investigation (Assist: USCG & NTSB)	Investigation Number: 768026-22-0024	Report Number: 2
--	---	---------------------

Fire Scene Examination: Origin and Cause Investigation of a fire that damaged the Spirit of Norfolk, a cruising vessel based in Norfolk, Virginia.

**Statement of Certified Fire Investigator**

**Type of Exam:** ORIGIN and CAUSE REPORT

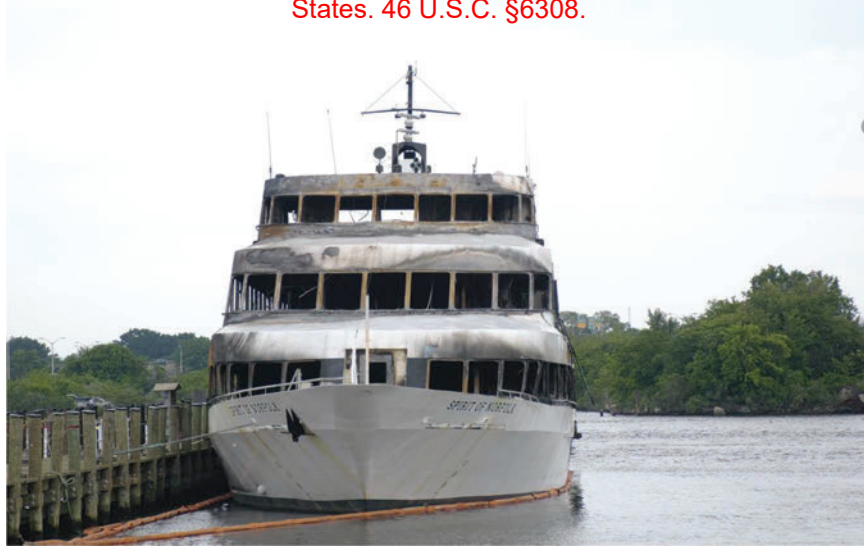
#### *Bow/Front Side*

24. The freeboard<sup>4</sup> on the Bow of the ship was intact. The paint was undamaged by fire and/or smoke and the words “SPIRIT OF NORFOLK” were clearly visible from the exterior of the vessel. Significant damage was observed from the main/first deck to the top of the vessel. The windows had failed during the fire and fire had vented from these windows to the exterior, causing both heat and smoke damage to the front of the vessel. The top deck of the front side was the most damaged with most of the paint burned away and heat damaged to the exterior shell. The damage observed is from fire spread within the interior and not from the fire originating on the exterior of the bow.

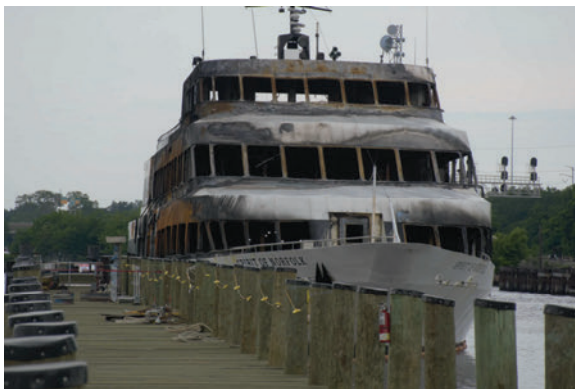
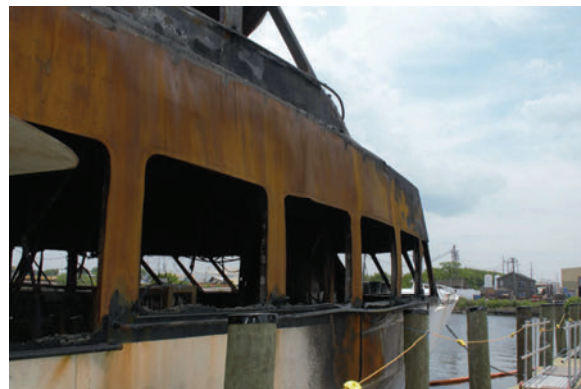
Starboard/Right Side

25. There was extensive heat damage on the starboard side of the vessel. All of the windows on this side failed during the event, venting fire to the exterior. The paint had burned away leaving an orange-like color consistent with oxidation of the metal shell of the vessel. This orange-like color is present through most of the center of the vessel and is observed from the main deck to the top deck. Closer to the rear on the starboard side, there were no windows, but vents were present. There was evidence of intense heat and black smoke venting from these vents. The damage observed on the Starboard side is consistent with fire on the interior, venting to the exterior.

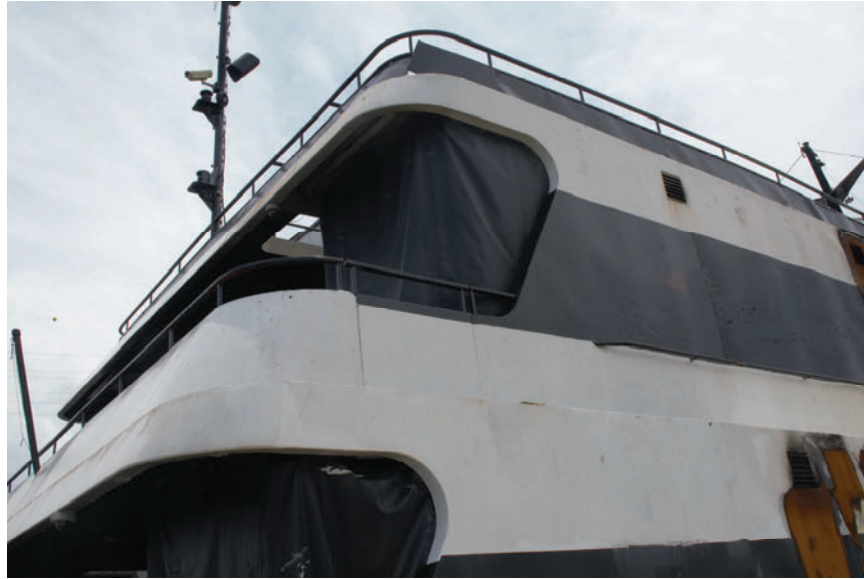
Stern/Rear Side

26. The exterior of the Stern of the vessel was largely intact. Items that would have been consumed in a fire were undamaged. The paint remained in place. This fire did not originate on the exterior of the Stern.

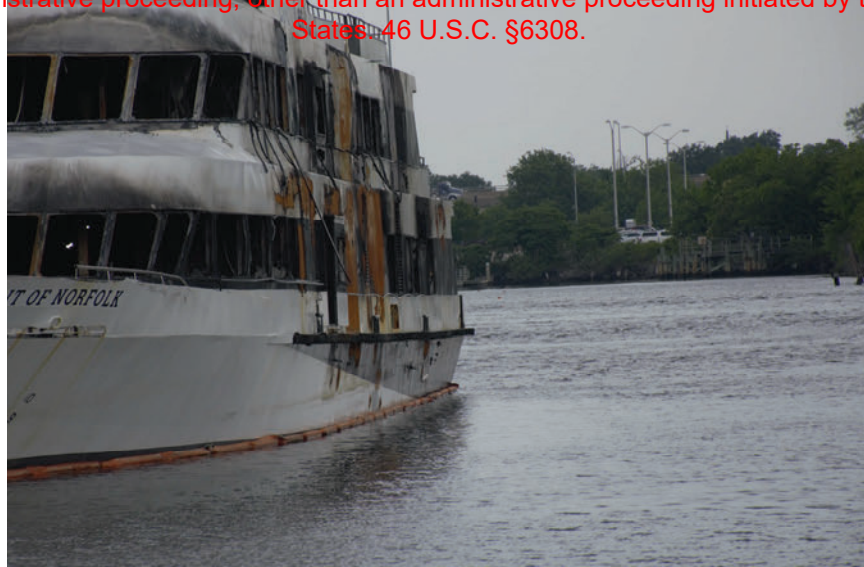
Port/Left Side

27. The damage to the port side was most prominent from the main deck to the top deck near the exit doors. These doors were utilized by the crew and passengers to exit onto other vessels during the rescue. The windows on this side also failed causing heat damage to the areas above the windows. The damage observed was consistent with a fire on the interior venting to the exterior.

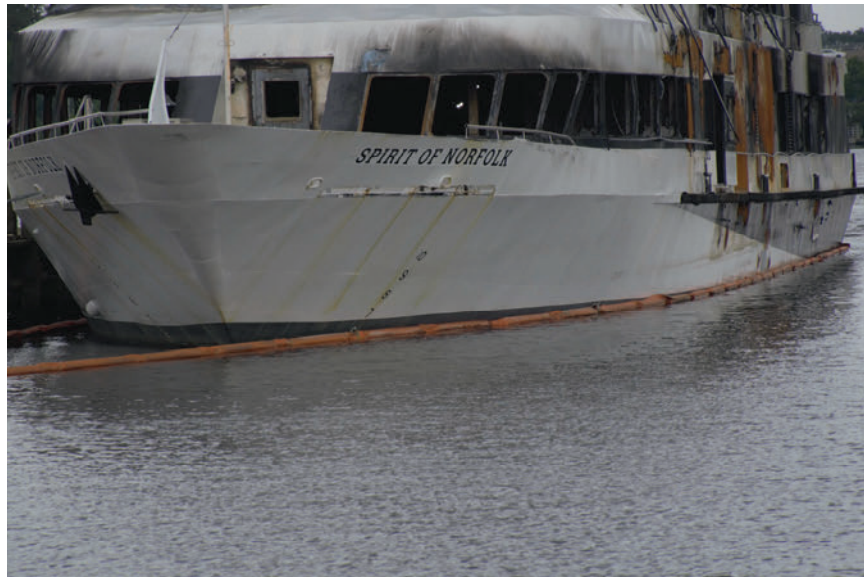
*Below the Freeboard to the Waterline*

28. There was minimal damage below the Freeboard. The paint was mostly intact below the Freeboard with only minor heat damage observed in some areas.

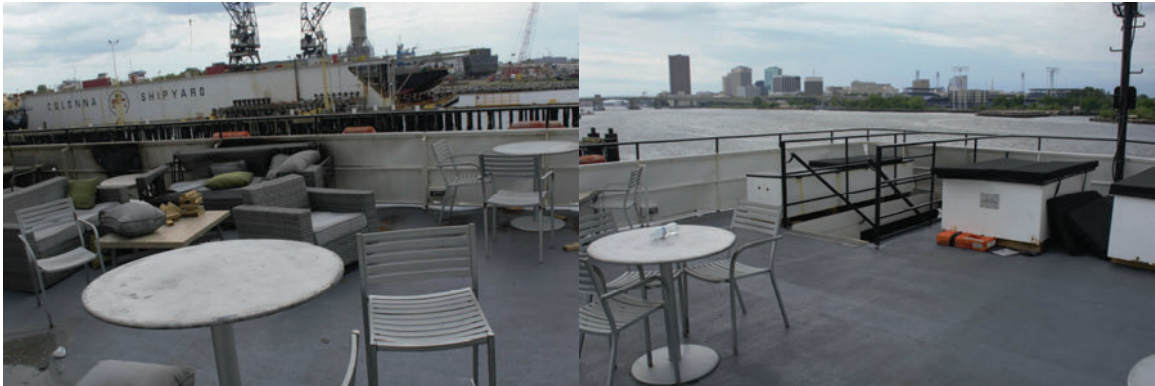
**Rear of Third Deck**

- a. Rear - The rear of this deck contained an open-air seating area, metal boxes containing flotation devices, and a staircase to the second deck below. This area was largely undamaged. The heat from other areas of this deck dissipated due to the open air. Where damage was observed, it was minor to some of the wicker style furniture on the deck close to the middle section of the deck or to the sides of the vessel where heat was rising from below.

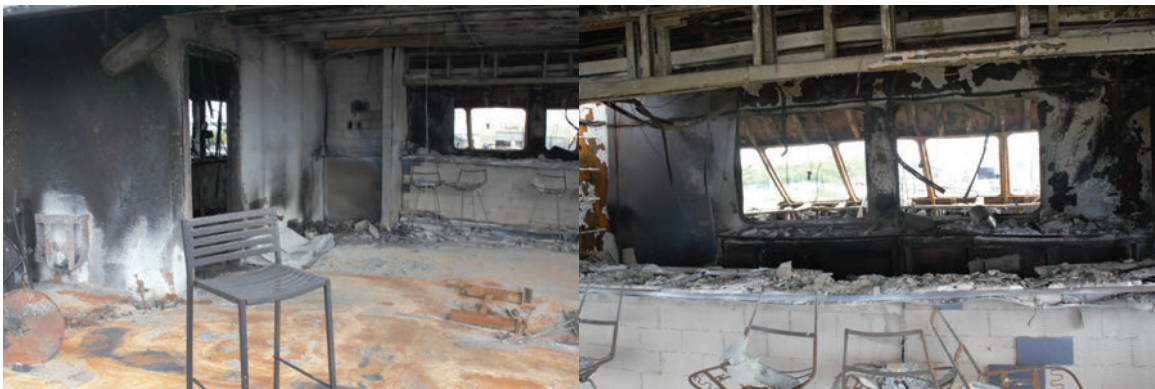
**Third Deck Damage**

- b. Center – The center was a bar area, that was covered by a metal roof. This area was connected to a staircase on the Port side and a hallway that led to the wheelhouse on the Starboard side. This area was significantly damaged. All consumable products in this area were burned. What remained were the metal components from the chairs and tables and the portions of the bar equipment behind the bar. The fire in this area was from fire spread from below that reached this area via the Port side staircase.

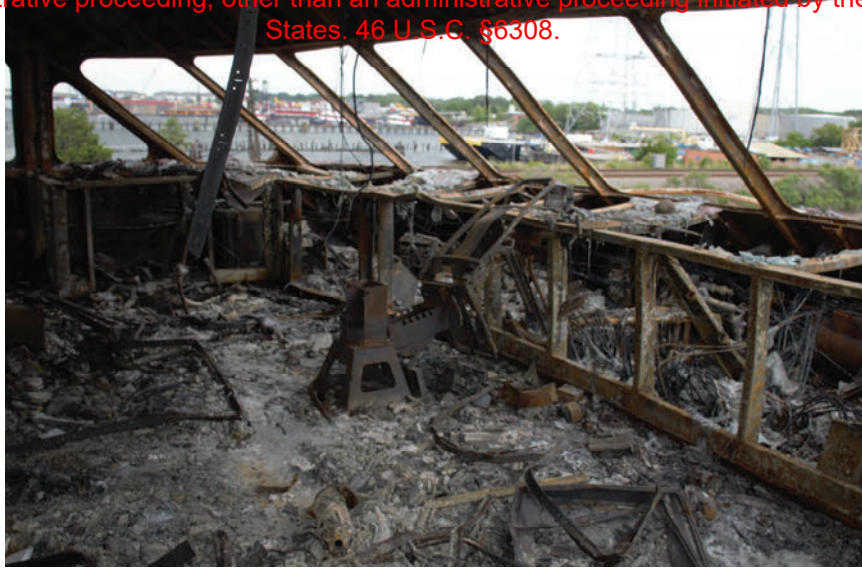
### Wheelhouse Damage

- c. Front – The front contained the wheelhouse that connected to a staircase on the Port side and to the bar on the starboard side through doors. The wheelhouse had been destroyed by fire, with fire burning for a significant period of time in this area. All that remained were metal components to the wheelhouse. The equipment utilized to monitor the systems of the vessel were extremely damaged. Retrieval of data from any of these systems was not possible. The windows to the wheelhouse failed during the event releasing heat and smoke to the exterior.

31. The damage on this third deck is consistent with fire spread from below via the Port side staircase and from heat exposure from fire on decks below. This event did not originate on the top/third deck.

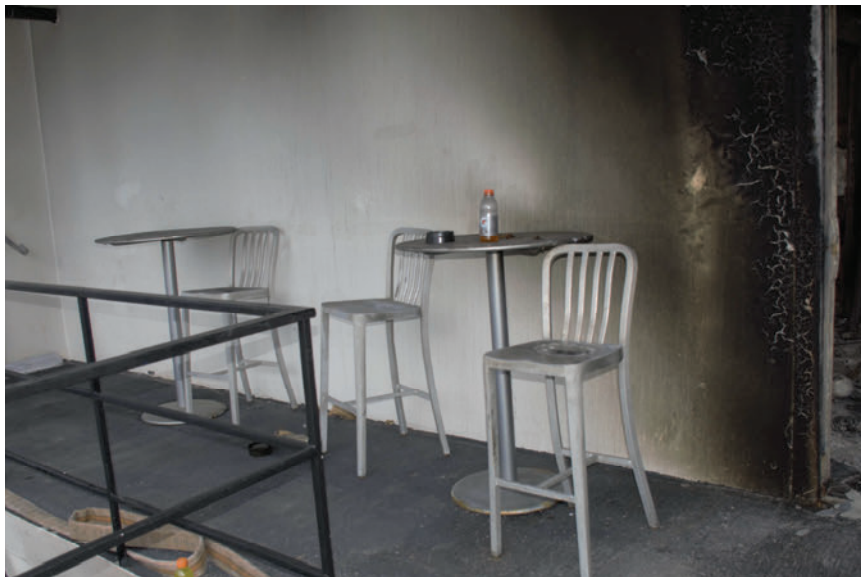
**Second Deck Rear Seating Area**

- a. Rear Exterior – This was a small open-air area with two small tables with seating and some storage. Staircases to and from the top and first deck were also present in this area. This area was largely undamaged by fire. The area adjacent to the door to the interior was damaged by internal heat. The door to the interior was largely damaged on the interior side with little to no damage on the exterior side. The damage observed is consistent with this door being closed during most of the fire event limiting damage to this area.

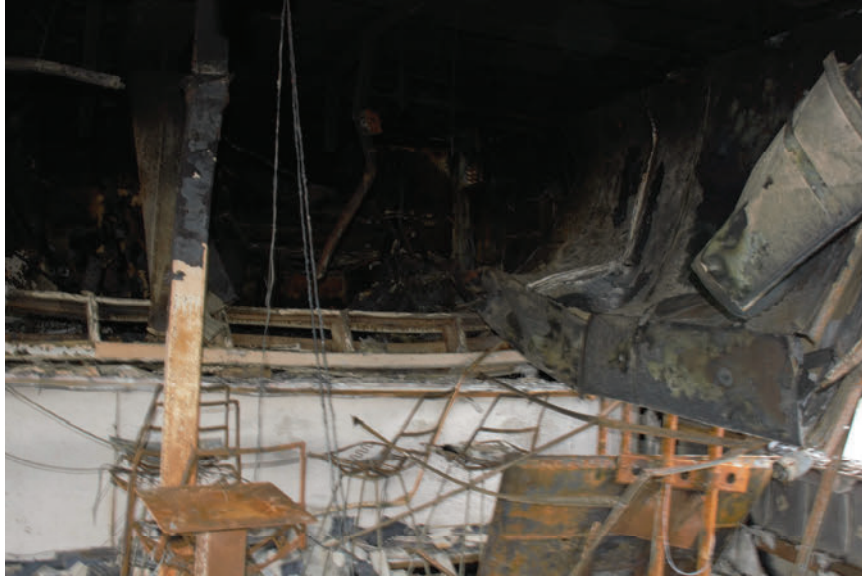
**Second Deck Bar Area Damage**

- b. Rear Interior – The rear deck entered into a hallway with a bathroom on each side. There was a large amount of smoke on the walls of the starboard side bathroom. The port side bathroom was damaged in a similar fashion with some collapse in and around the door limiting access to it. A small service area and bar were adjacent to these bathrooms. These areas sustained significant fire damage and collapse from the ceiling.

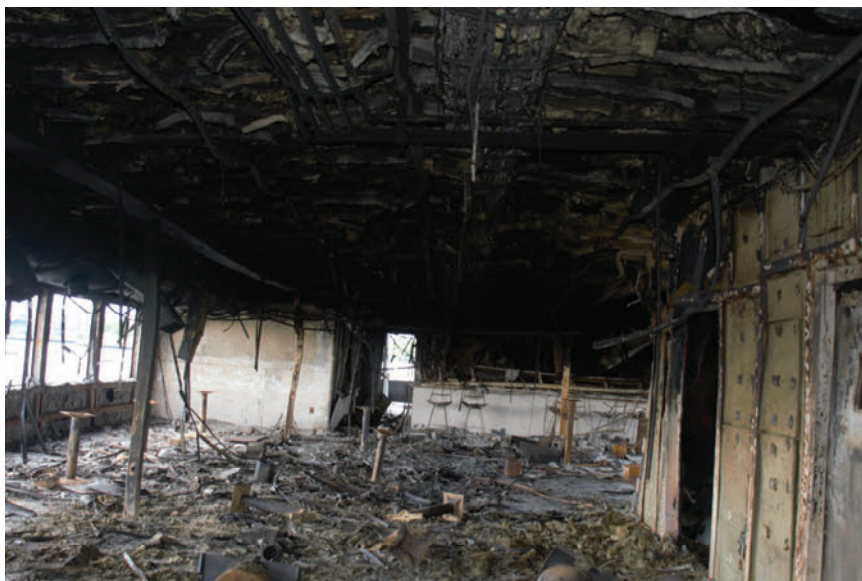
**Second Deck Interior Damage**

- c. Main Section and Front – This was a large, mostly open area with seating. The Port side contained a service area with an elevator and doors to the staircase, a supply room and an exit point utilized by passengers to exit the vessel during the event. The main room sustained significant fire damage consistent with fire burning for a long period of time.

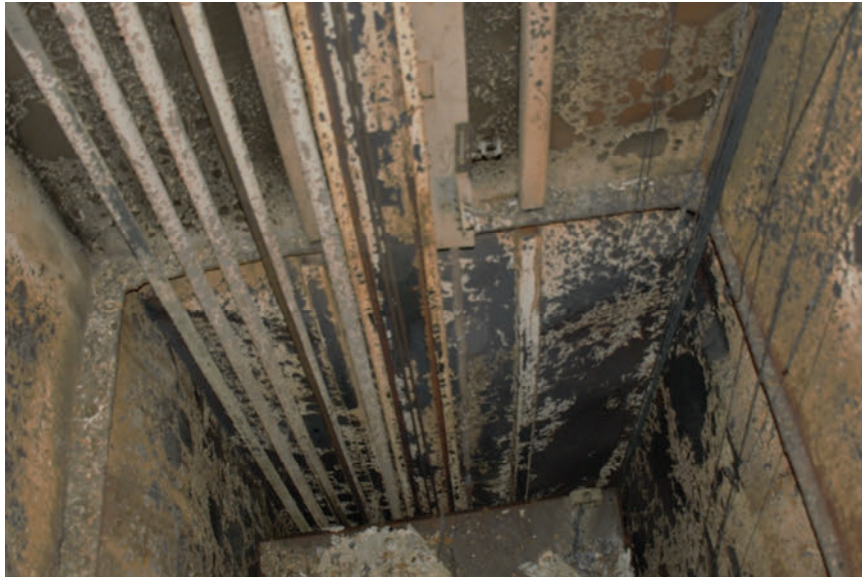
**Inside of the Elevator Shaft**

- d. Investigators photographed the elevator shaft that serviced this deck, the deck below and down into the galley. The damage in this elevator shaft is consistent with fire spread from below. The elevator shaft sustained significant heat damage during the event and contributed to the fire spreading to this deck of the vessel.

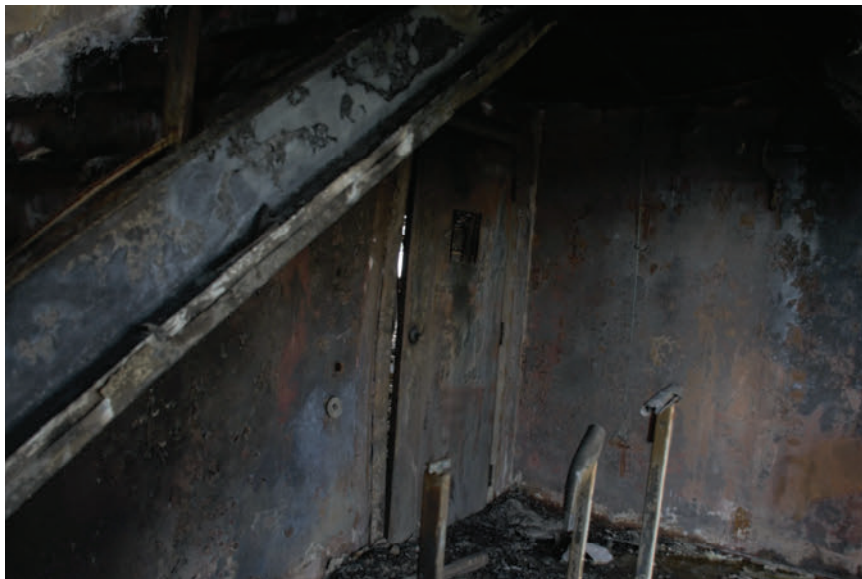
**Port Side Stairs**

- e. The staircase on the Port side of this level was significantly damaged by fire spread. The handrails had largely been consumed by fire and the walls sustained a high level of heat damage. The patterns present in this area are consistent with a fire spreading from the lower floors, into this deck, and continuing to the top deck.

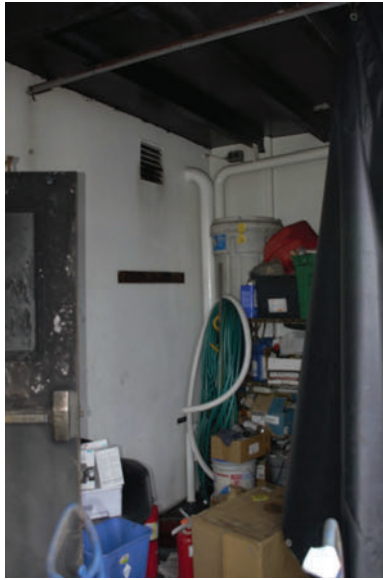
**Storage Area Undamaged on the Rear of Main Deck**

- a. Rear Exterior – This area was undamaged by fire. The double doors that enter into the interior were likely closed during the event, protecting this area. The equipment and material stored in this area were undamaged.

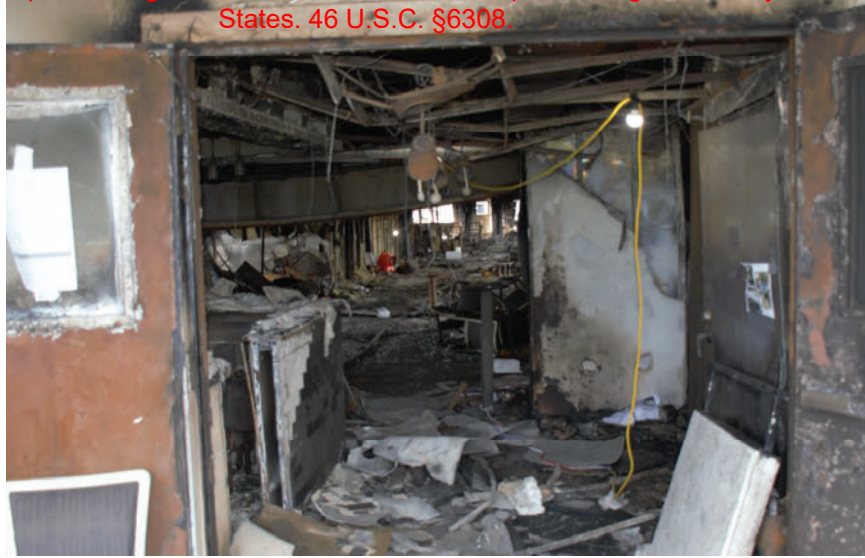
**Rear Interior Damage**

- b. Rear Interior – This area sustained fire damage but not as much as areas closer to the front. There were areas of collapse and burn patterns present, but much of the consumable items, such as chairs, tables, and portions of the walls, remained only partially damaged.

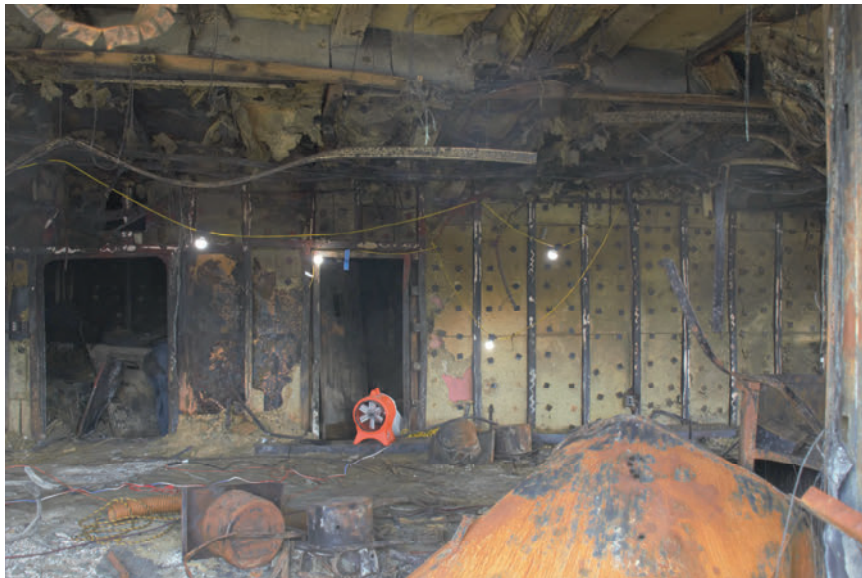
**Main/First Deck Cabin Damage**

- c. Main Area – This area was significantly damaged by heat and fire. The doorways on the Port side leading to the elevator shaft and staircase to the galley were damaged by fire spread from below. The area between these doorways was the most damaged portion of the deck. From this area, the patterns observed showed fire movement to the Port side stairs and to the decks above. The windows in this area failed releasing heat to the exterior and contributed to the damage to the decks above.

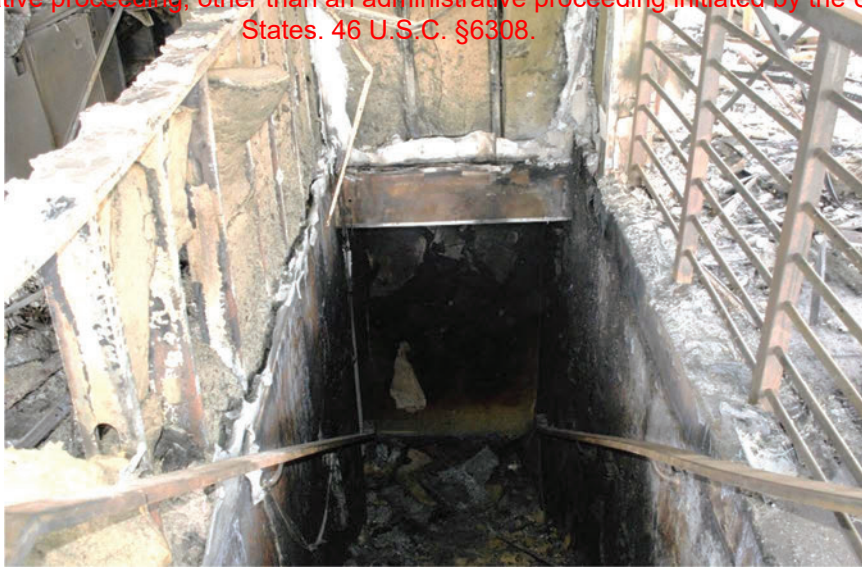
**Stairs to the Below Deck Bathroom**

- d. The staircase closer to the bow of the vessel was less damaged by fire but a large amount of smoke was present coming from the area of the below deck bathrooms and supply areas.

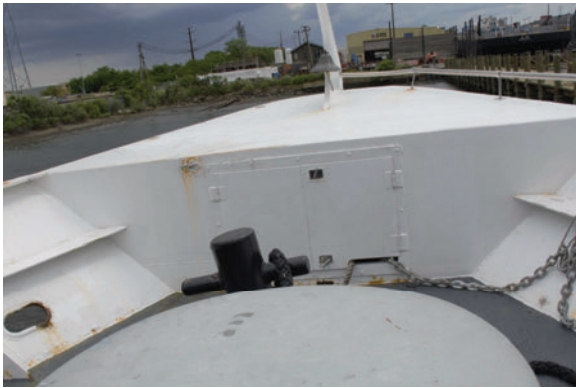
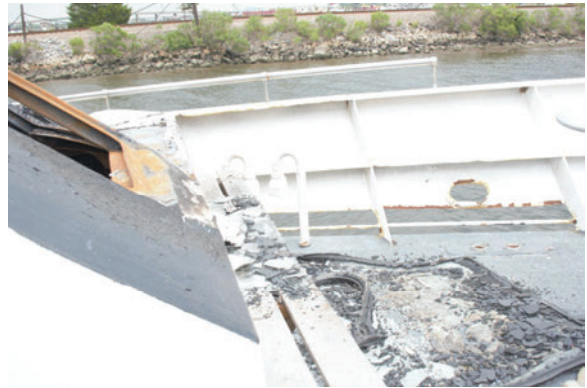
**Bow and Damage from Failing Window**

- e. Bow Exterior – The Bow was largely undamaged during the event. What damage did exist was from the windows failing on the front of the vessel and emitting heat to the exterior from those windows.

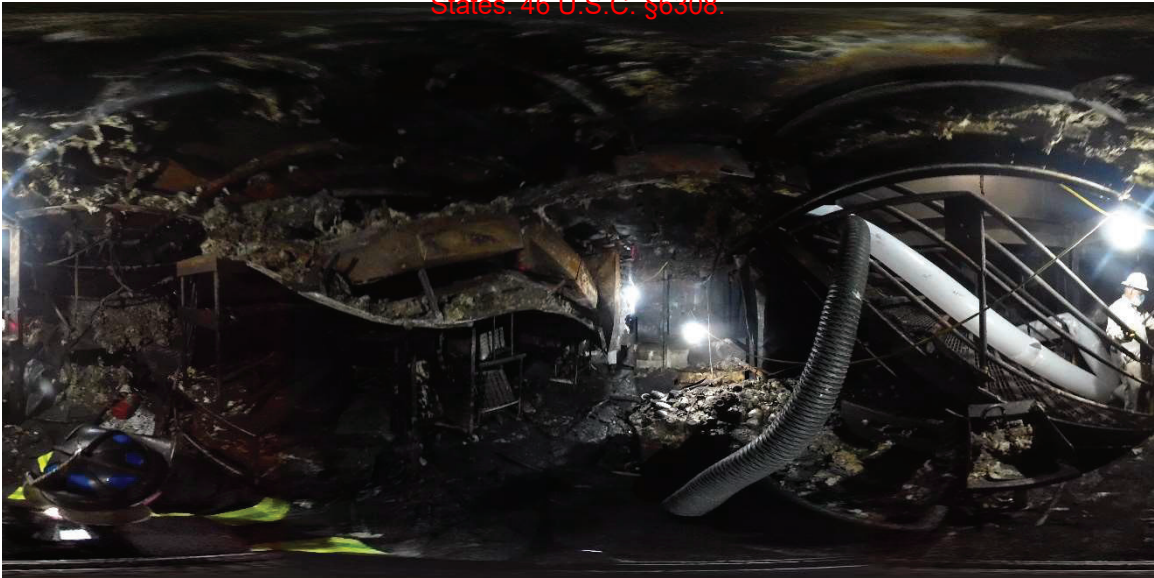
**360° of the Galley Area**

- 36. Front - This area contained bathrooms and storage area. There was a significant amount of smoke and water damage in this area below deck. There was no fire damage observed. This area was separate from the galley and engine rooms and access by a separate staircase from the main deck. This event did not originate in this area below deck.
- 37. Galley – The galley is in the center below deck and is accessed from the center staircase on the main deck and a service elevator that runs from the galley to the second deck. This area had a strong odor of diesel fuel present. The fire damage appeared to be mostly at the chest level and higher in the galley area, as the below deck flooded during the suppression operation. The diesel fuel, floating in the water burned, and spread the fire to the decks above.

38. Cooking equipment and other items stored in the galley were all over the floor once the water was pumped from the area. Photography was extremely difficult due to the darkness and hazardous conditions in the area. The damage in the galley is consistent with statements of the firefighters who were in the area when the engine room door opened releasing water and fire into the galley. This event did not originate in the galley area.

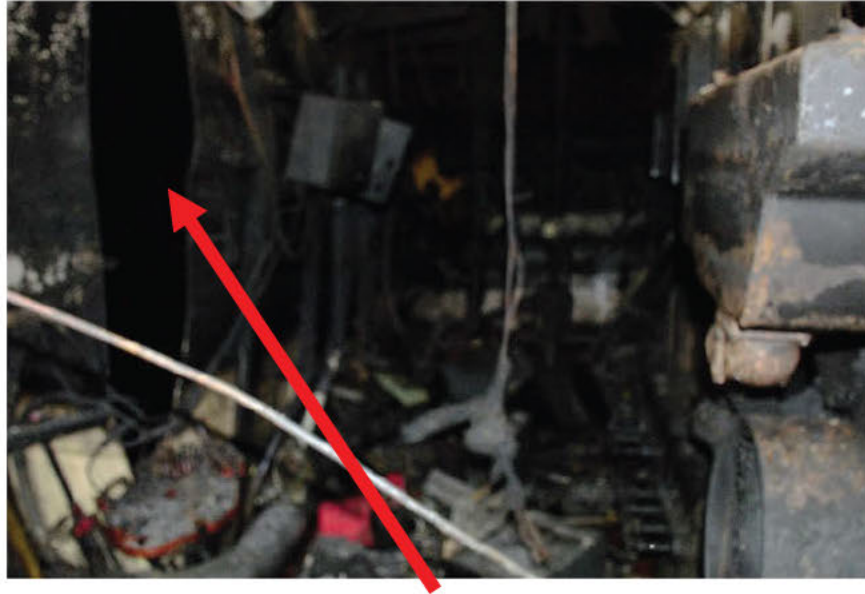
**Opening in Starboard Tank**

40. The engine room was extensively damaged. The damage was more pronounced high in the room as water build up protected the lower portion of the engine room during the suppression operation. In the early stages of this event, the fire burned and quickly filled the engine room with smoke. Due to limited ventilation to from the intake and outtake ventilation on the Starboard and Port sides of the vessel, the oxygen level was limited, but significant enough to allow the fire to continue to burn and to build up heat in this room. At some point during the event, enough heat was produced to cause the starboard side fuel tank to split open, releasing diesel fuel through the engine room.

41. Diesel fuel is lighter than water and will separate from and float on top of the water. The patterns observed in the engine room point toward a water level at approximately waist high when the tank split, as the area below the waist in the room was less damaged, including the paint on portions of the generators and other equipment present in the room. The water protected the lower portions of the room from the burning diesel fuel.

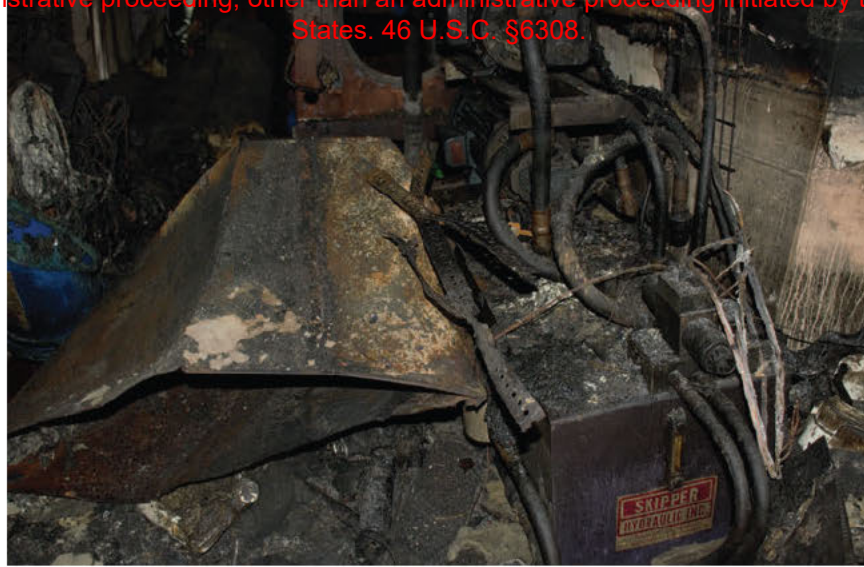
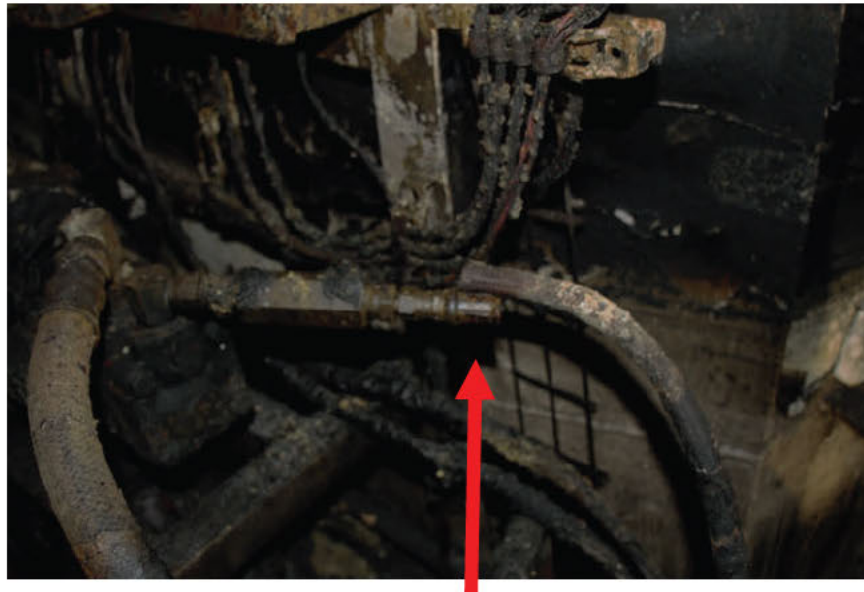
**Hydraulics Damage**

43. There was some mechanical damage to the hydraulics on the Port side of the engine room. Portions of this system are currently undergoing testing by the NTSB. It is the belief of the fire investigators this damage was likely caused later in the event, possibly when the water rushed from the engine room into the galley area when the door was breached.

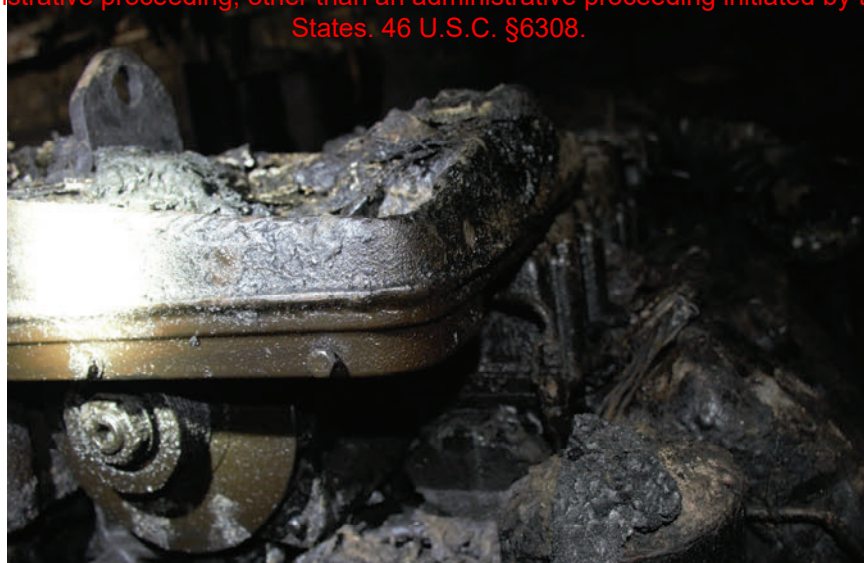
**Damage to the Top of the Port Side Engine**

44. Investigators examined the Starboard side engine and it appeared to be in working order and mostly undamaged by this fire event. It is likely this engine failed later in the event when water flooded the engine room. The Starboard engine did not cause this event.
45. The most damaged portion of the room was on and around the Port side engine. The top of this engine was significantly damaged, with some mass loss and melting to some metal components. The shelves adjacent to this engine and the items on these shelves were also significantly damaged and acted as an early fuel during this event. This Port side engine was the origination point of this fire event.

46. This engine had recently undergone a rebuild and witnesses spoke of continued issues with the engine after the rebuild. A leak in the area of the turbocharger of the Port side engine had been observed by the engine mechanic. This required the turbocharger to be replaced. The part had been ordered but the repair was still pending the day of this event. A turbocharger can generate temperatures in excess of 1800° Fahrenheit. This temperature is capable of igniting combustible items stored in the area of the Port side engine.

56. Based upon the fire scene examination and a review of witness statements, photographs, video, and documents provided by other investigators, it is the opinion of the fire investigators this event originated in, on, or about the Port side engine of the vessel. Fire spread from this engine to adjacent shelving where combustible material was present.
