Subject: FW: WPR19LA006 - Cape Girardeau, MO Weather

Weather conditions for WPR19LA009 – Cape Girardeau, MO on October 9, 2018

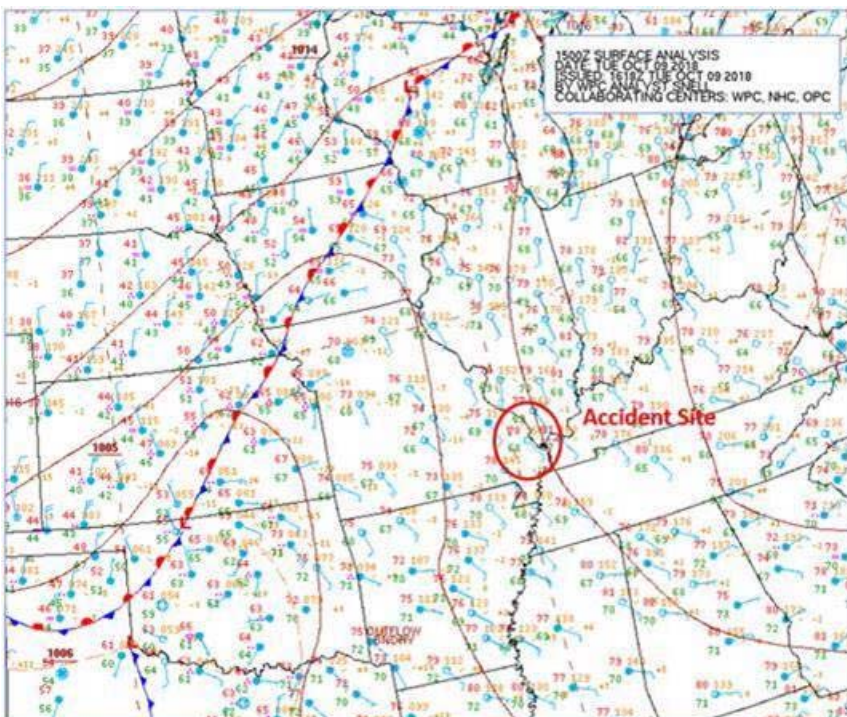
Synoptic conditions – the central section of the NWS Surface Analysis Chart for 100 CDT (1500Z) is included below with the accident site locate within the red circle with the station model of Cape Girardeau, MO. The chart depicted a low pressure system at 1014-hectopascals (hPa) over Wisconsin, with a stationary front extending southwest from the low across Wisconsin, Iowa, extreme northwest Missouri, Kansas, into Oklahoma, where another low pressure system at 1005-hPa was located. A large area of area of moderate to heavy rain was depicted along and behind the frontal areas, with thunderstorm activity over northern Texas into Oklahoma. A high pressure system at 1029-hPa was located off the New Jersey coast with a ridge of high pressure extending west-southwest into Ohio and Tennessee Valley's. The accident site was located in the warm air sector ahead of the frontal system in a region of increasing pressure gradient with south-southeast winds of 10 to 15 knots, and partly cloudy sky conditions. The station model for Cape Girardeau indicated wind from the south-southeast at 10 knots, clear skies, temperature of 78° Fahrenheit (F), dew point 68° F, with pressure tendency falling over the period.

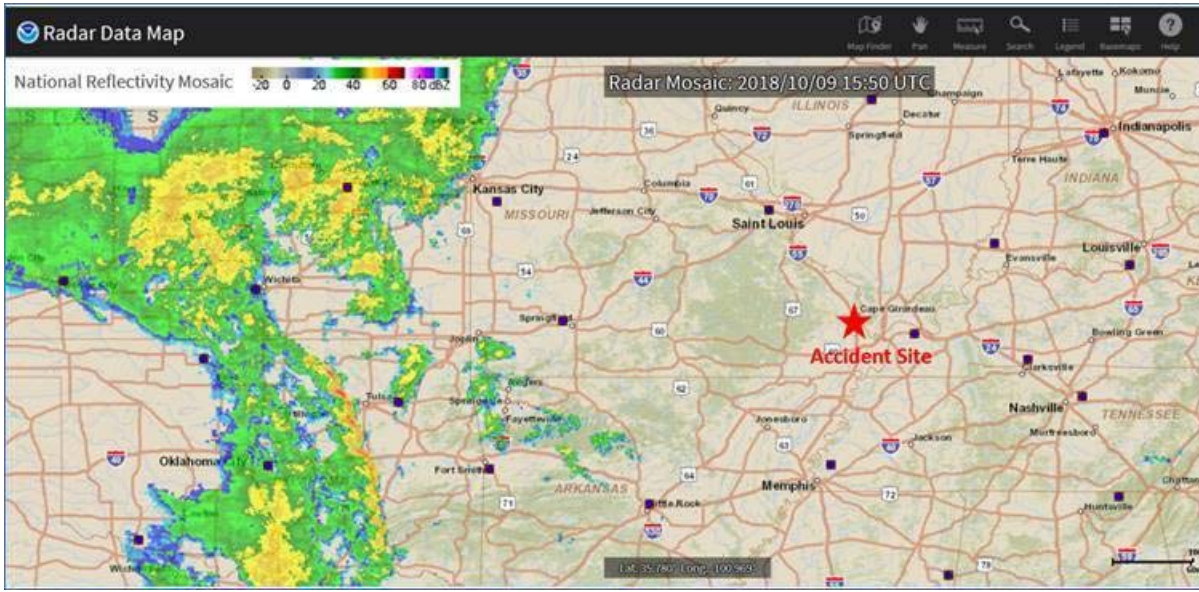
A review of the NWS National Composite Radar Mosaic for 1050 CDT (1550Z) is included with the approximate accident site marked by a red star. No weather echoes were identified in the immediate vicinity of the accident site, thus no

convective wind gusts, outflow boundaries, or microbursts contributed to the accident. Significant echoes were identified over Kansas and Oklahoma far to the west of the accident site.

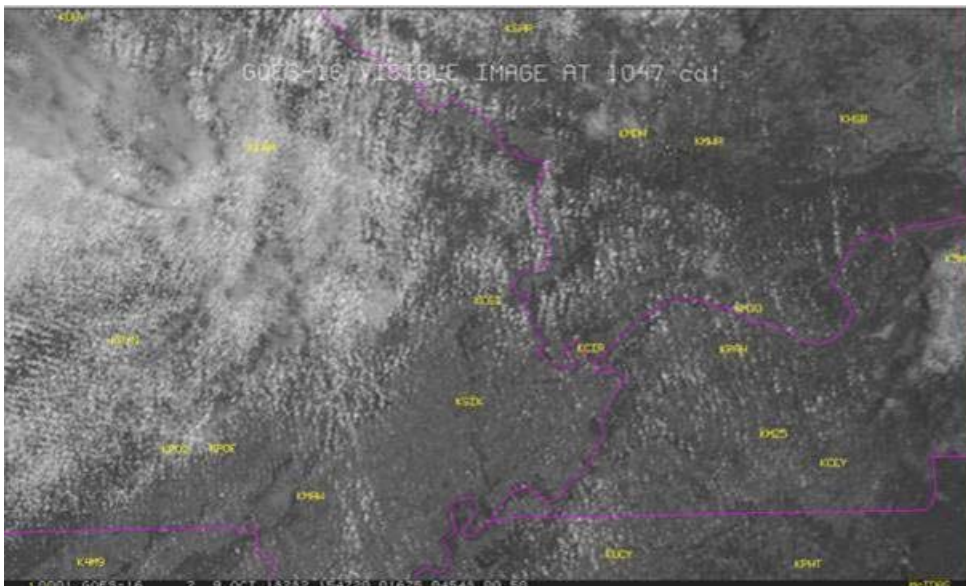
Satellite Imagery – the GOES-16 visible image at 2X magnification is included below and depicted scattered fair weather cumulus over the area.
