Continental Motors

ENGINE EXAMINATION REPORT LEFT

ENGINE MODEL	IO520C (15B)
ENGINE SERIAL NUMBER	287461-R
AIRCRAFT MAKE & MODEL	Beechcraft D55 Baron
AIRCRAFT SERIAL NUMBER	TE-616
AIRCRAFT REGISTRATION	N533Q
FILE NUMBER	18-366

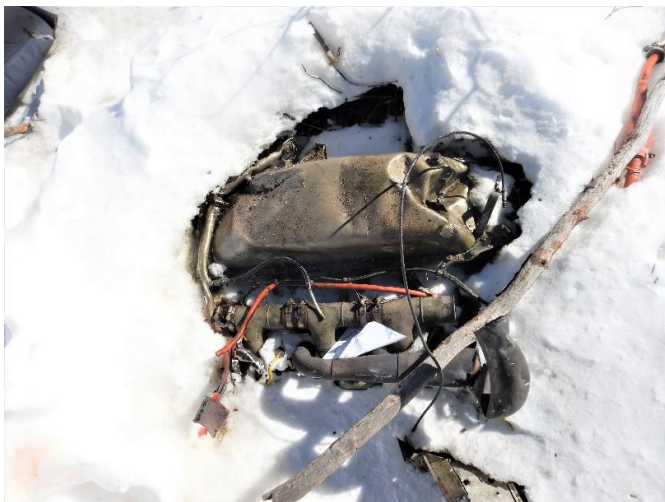
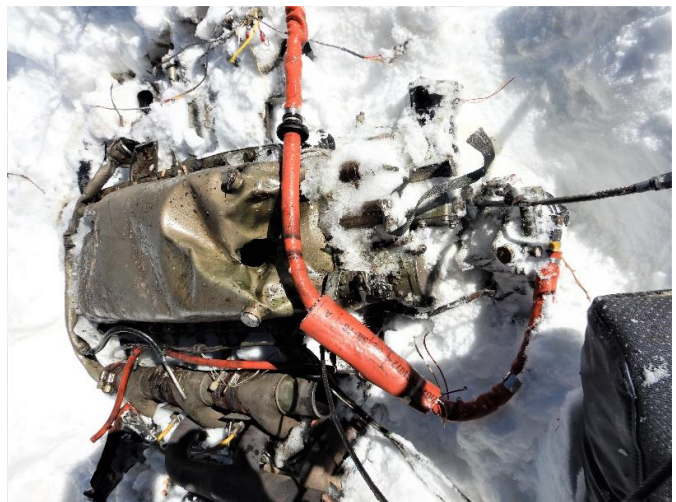
EXTERNAL ENGINE CONDITION

The engine separated from its nacelle and was found forward of the main wreckage in the snow. The engine was inverted, and the engine oil sump exhibited impact damage. The rear portion of the oil sump was crushed upward, and a hole was present. The shape of the puncture was consistent with an undetermined object pushing inward from the outside surface of the sump. The right and left oil drain plugs were present and remained secured with safety wire.

The fuel component-throttle body-mixture control remained attached but exhibited impact damage. The throttle and mixture control arms were intact and properly secured. The throttle control cable and mixture control cable were both attached but were separated at approximate mid-length.

Cylinders 1, 3, and 5 remained attached and exhibited damage to cooling fins and rocker box covers. Cylinders 2, 4, and 6 remained attached but all three rocker covers were impact damaged or missing.

The engine was manually rolled over, right side-up. The left forward crankcase half exhibited heavy impact damage. The right upper crankcase was intact and exhibited an engine data plate identifying the engine as a Continental Motors model IO-520C, serial # 287461-R. The fuel manifold remained attached and the assembly screws were secured. No lead seal was attached.

The left and right magnetos separated and were not recovered. The impact damaged ignition leads exhibited cuts and individual leads were broken with missing ends.

The forward mounted engine driven alternator separated and was not recovered. The instrument air pump separated at its mount and was not recovered. Only the mounting ring and plastic shear-drive coupling remained attached. The plastic drive gear was intact.

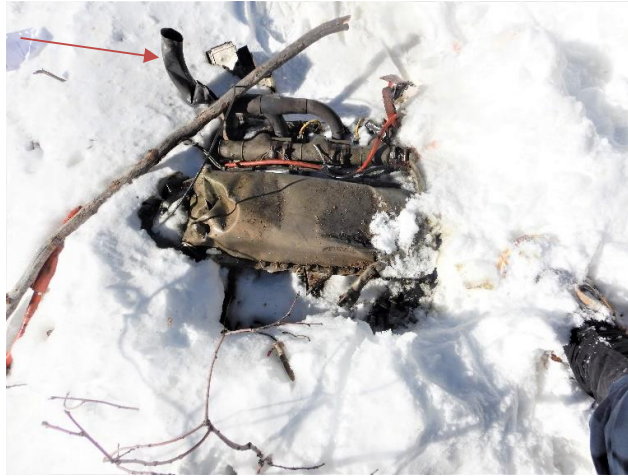
EXHAUST SYSTEM

Condition: The left side exhaust components were impact damaged and separated from the engine due to impact forces. The right exhaust collector and risers remained attached to cylinder ports but was impact damaged.

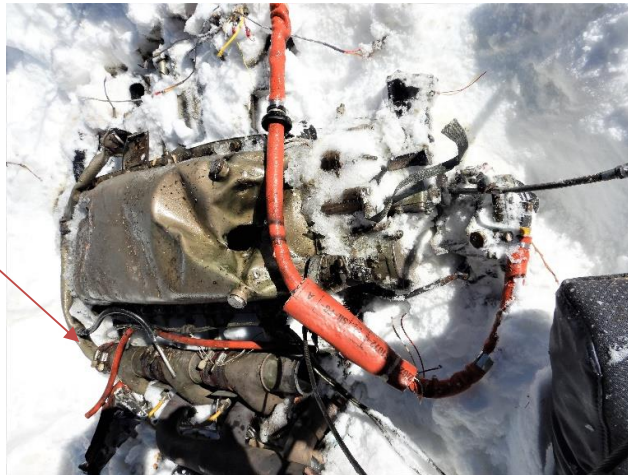
INDUCTION SYSTEM

Condition: The left induction intake tube elbows and hoses separated, and the forward balance tube assembly was crushed.

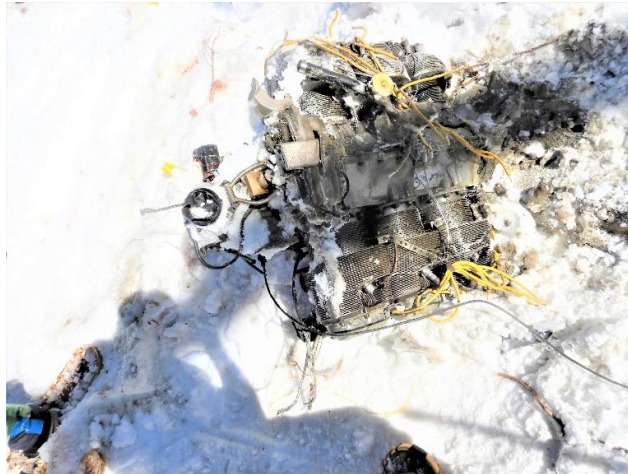
IGNITION SYSTEM

LEFT MAGNETO	Manufacturer: Undetermined	P/N: Undetermined	S/N: Undetermined
Condition:	Separated from engine and not recovered.		
RIGHT MAGNETO	Manufacturer: Undetermined	P/N: Undetermined	S/N: Undetermined
Condition:	Separated from engine and not recovered.		
IGNITION HARNESS	Manufacturer: TCM	P/N: Undetermined	S/N: Undetermined
Condition:	Individual ignition leads were cut and pinched due to impact forces.

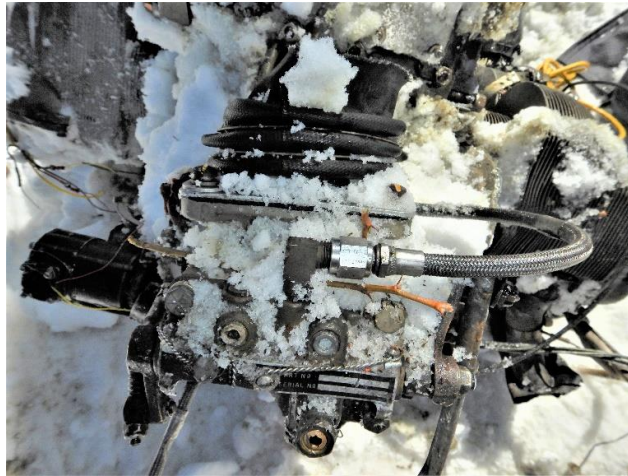
**THROTTLE
BODY
METERING UNIT**

Condition: The fuel component-throttle body-mixture control remained attached but exhibited impact damage. The throttle and mixture control arms were intact and properly secured. The throttle control cable and mixture control cable were both attached but were separated at approximate mid-length.

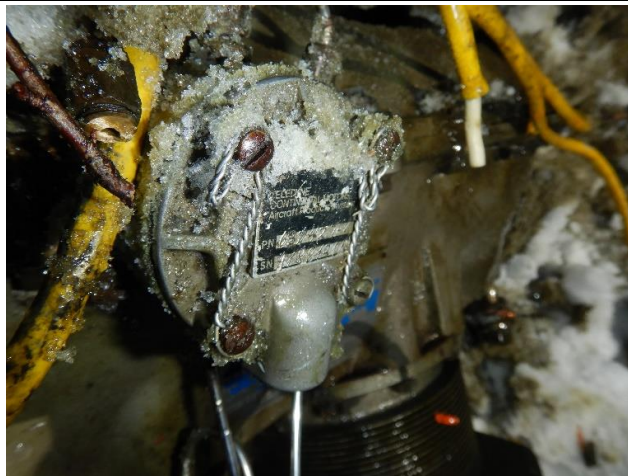
**FUEL MANIFOLD
VALVE**

Condition: The manifold valve was intact and attached at its mount. The assembly screws were properly secured.

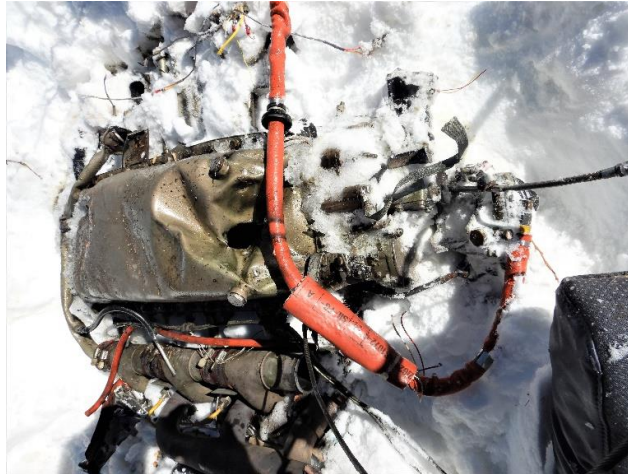
OIL SUMP

Condition: The rear portion of the oil sump was crushed upward, and a hole was present.

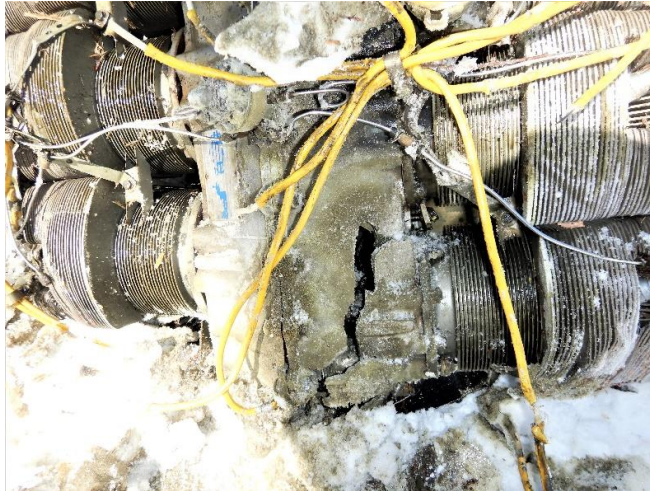
CRANKCASE

The left forward crankcase half was impact damaged.

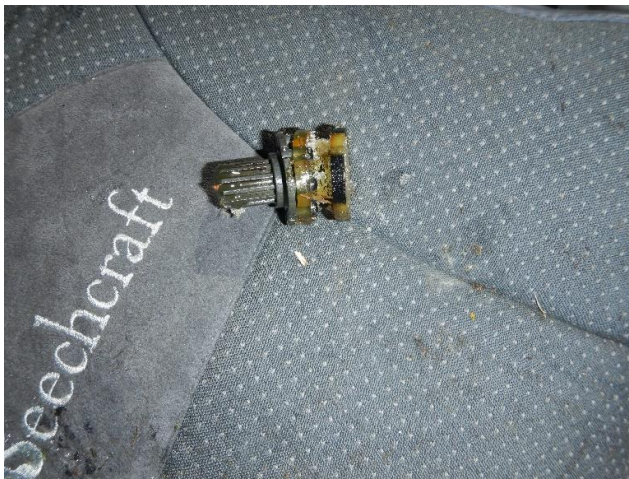
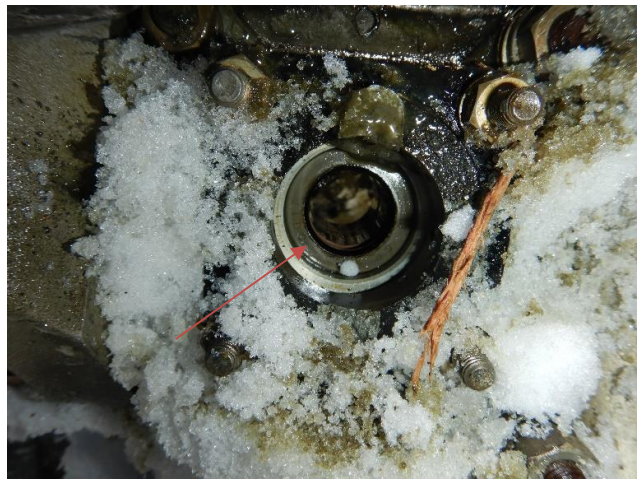
ACCESSORIES

STARTER	Manufacturer: Undetermined	P/N: Undetermined	S/N: Undetermined
Condition:	The starter separated and was not located in the wreckage.		
STARTER ADAPTER	P/N: Undetermined		
Condition:	The starter adapter remained attached but was impact damaged.		
ALTERNATOR	Manufacturer: Undetermined	P/N: Undetermined	S/N: Undetermined
Condition:	The forward mounted alternator separated and was not recovered.		
VACUUM PUMP	Manufacturer:	P/N:	S/N:
Condition:	The vacuum pump separated and was not recovered. An intact vacuum pump drive spline was found still engaged in the accessory gear.

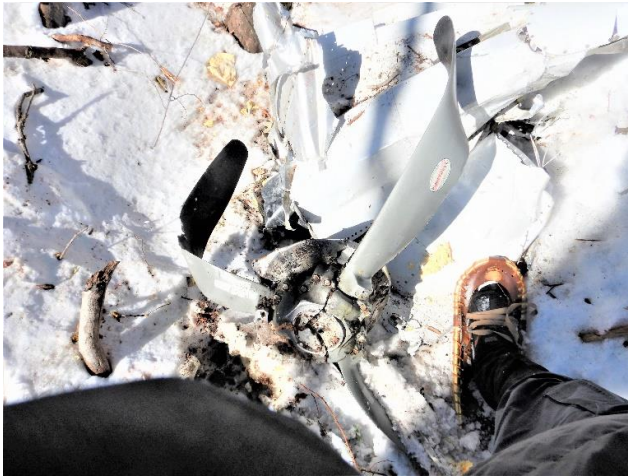
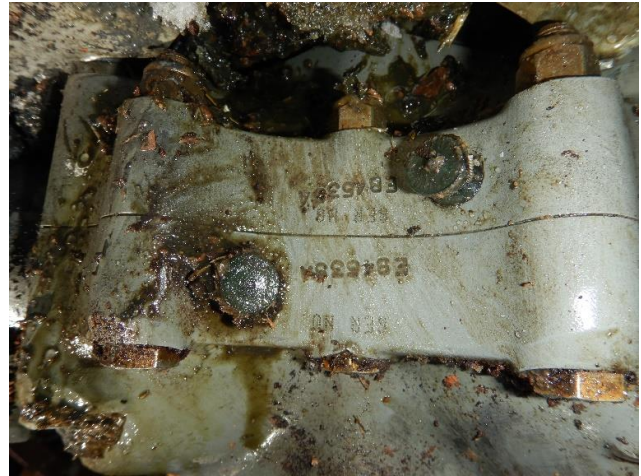
PROPELLER	Manufacturer: Hartzell	P/N: See note below	S/N: See note below
Condition:	Both propellers exhibited impact damage with rotational scoring on the cambered surfaces and torsional bending of the propeller blades. Damaged trees in the area of initial impact with propeller cuts exhibited 45-degree cuts.

A-Hartzell three blade full feathering propeller model: PHC-C3YF-2UF, hub serial number EB4535A

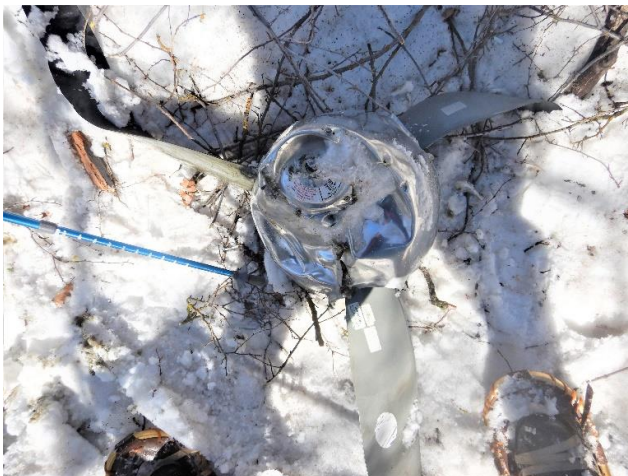
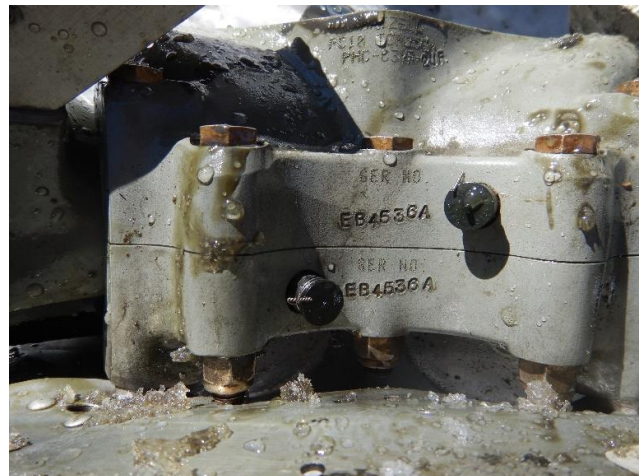
B- Hartzell three blade full feathering propeller model: PHC-C3YF-2UF, hub serial number EB4536A
