# ENGINE EXAMINATION REPORT

## RIGHT

<b>ENGINE MODEL</b>	IO520C (15B)
<b>ENGINE SERIAL NUMBER</b>	240456-R
<b>AIRCRAFT MAKE &amp; MODEL</b>	Beechcraft D55 Baron
<b>AIRCRAFT SERIAL NUMBER</b>	TE-616
<b>AIRCRAFT REGISTRATION</b>	N533Q
<b>FILE NUMBER</b>	18-366

EXAMINATION		ACCIDENT DATA	
<b>DATE</b>	2-23-2009	<b>NTSB ACCIDENT #</b>	WPR19FA086
<b>FACILITY</b>	Accident site	<b>NTSB INVESTIGATOR</b>	Jack Vanover
<b>ADDRESS</b>	Cummings Mountain Tehachapi, CA	<b>FAA INVESTIGATOR</b>	NA
		<b>ACCIDENT DATE</b>	2-21-2019
		<b>ACCIDENT LOCATION</b>	Cummings Mountain, Tehachapi, CA

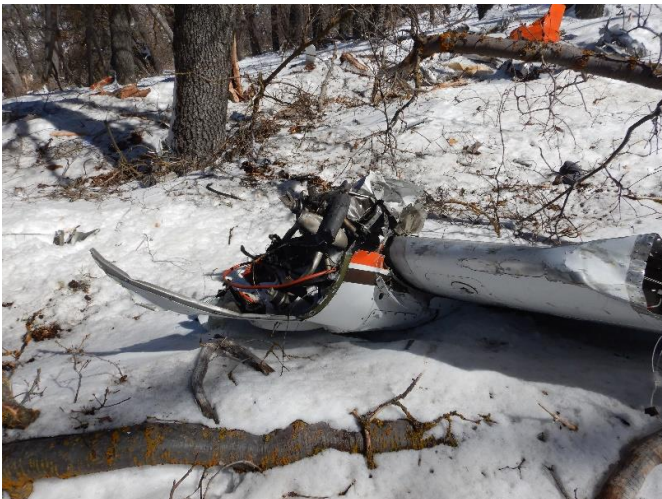
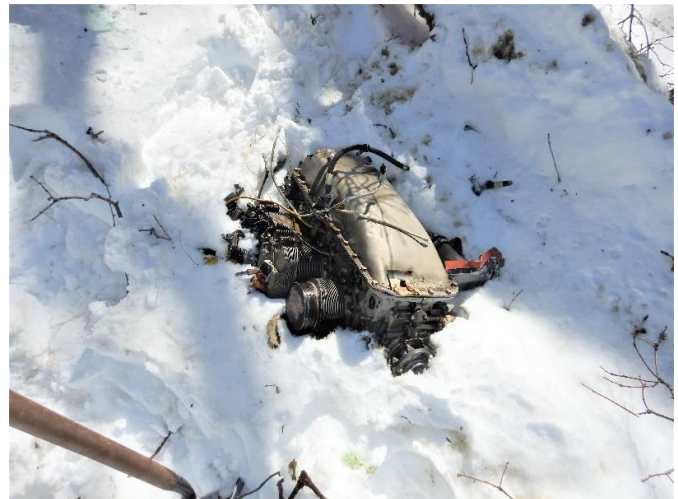
The engine separated from the airframe during the impact sequence and was discovered in an inverted position partially covered in snow. The engine mounts were broken, and the engine exhibited heavy impact damage. Cylinder heads received impact damage and exhaust and induction components separated.

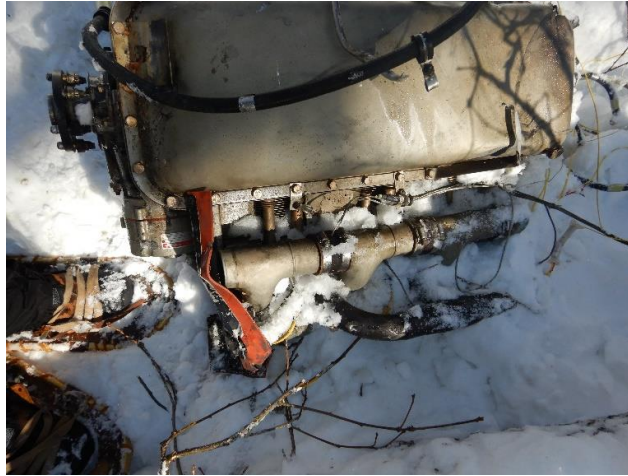
**EXHAUST SYSTEM**

**Condition:** The exhaust collector and risers for cylinders 1, 3, and 5 remained attached but received impact damage. The exhaust collector and riser for cylinders 2, 4, and 6 separated.

**Condition:** The induction elbows and tubes remained attached to the cylinder attach points on cylinders 1, 3, and 5. See photo above. The induction elbows separated from the cylinder attach points on cylinders 2, 4, and 6. The balance tube assembly was impact damaged.

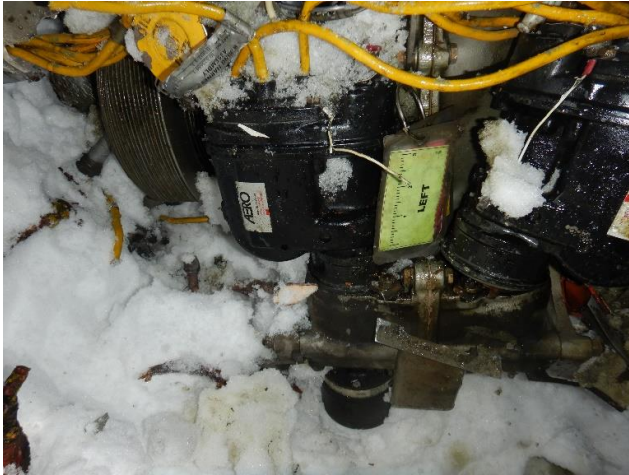
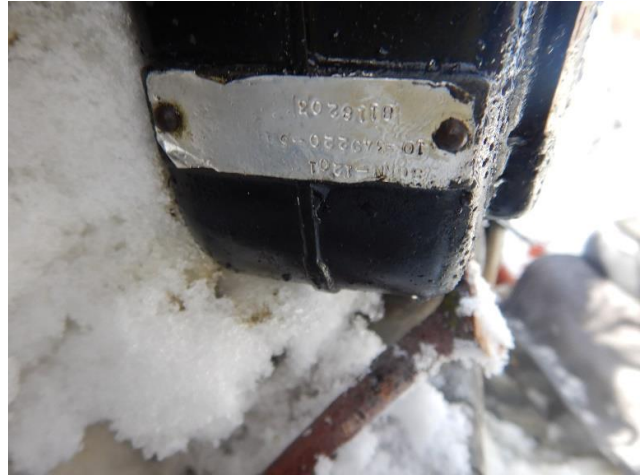
**LEFT  
MAGNETO**

**Condition:** The left magneto remained attached and intact.

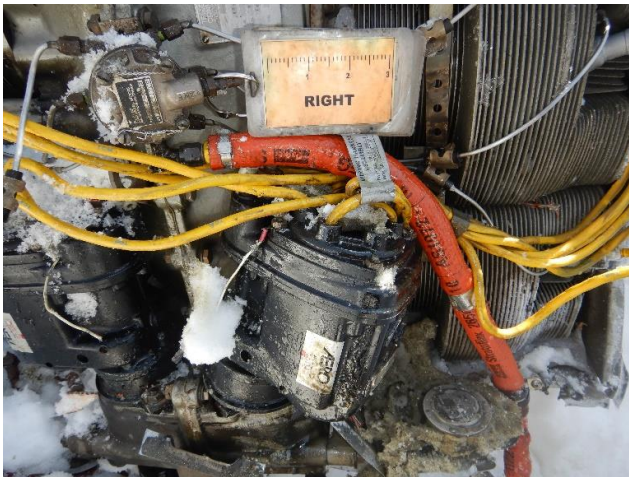
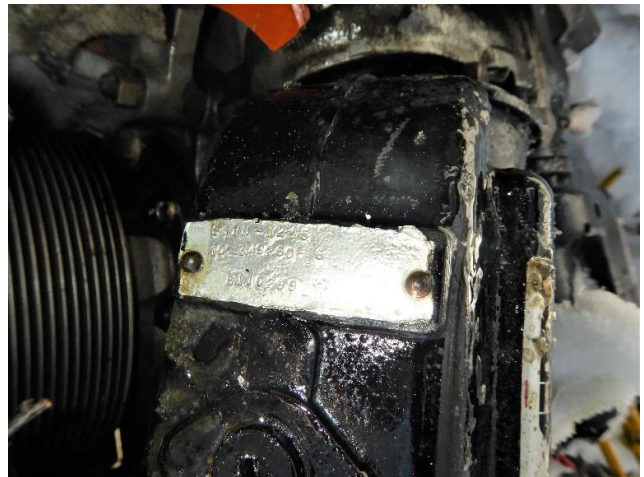
**RIGHT  
MAGNETO**

**Condition:** The magneto was intact, but the mounting ring was impact damaged.

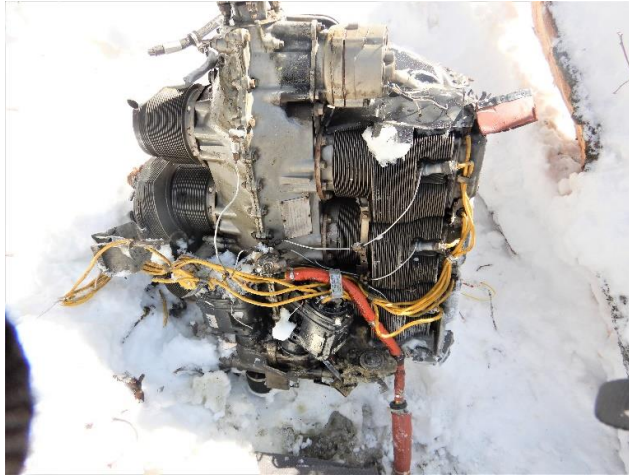
**IGNITION  
HARNESS**

Individual ignition leads were cut and pinched due to impact forces.

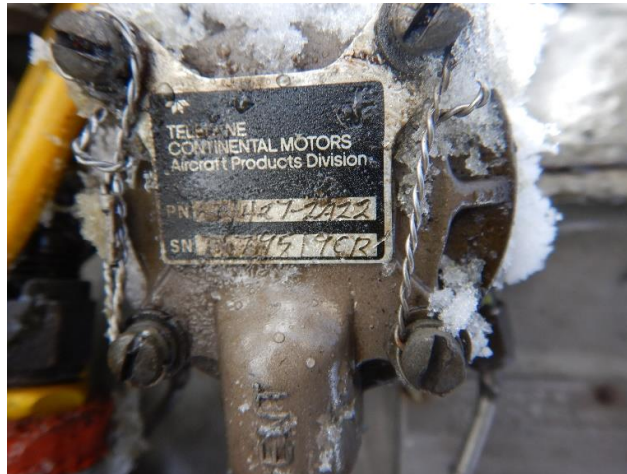
<b>FUEL PUMP</b>	Manufacturer: Undetermined	P/N: Undetermined	S/N: Undetermined
Condition:	The engine driven fuel pump separated was not recovered		
<b>THROTTLE BODY METERING UNIT</b>	Manufacturer: Undetermined	P/N: Undetermined	S/N: Undetermined
Condition:	The throttle body separated and was not recovered.		
<b>FUEL MANIFOLD VALVE</b>	Manufacturer: TCM	P/N: 631427-2A22	S/N: 7179519CR
Condition:	The fuel manifold was intact, and all assembly screws were present and secured properly.

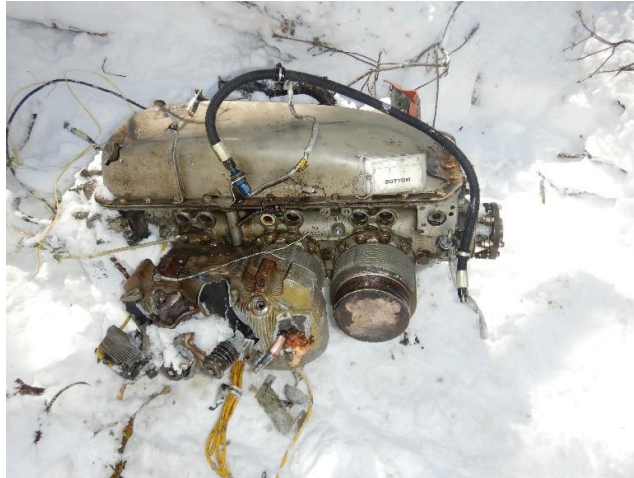
**OIL SUMP**

**Condition:** The oil sump was impact damaged

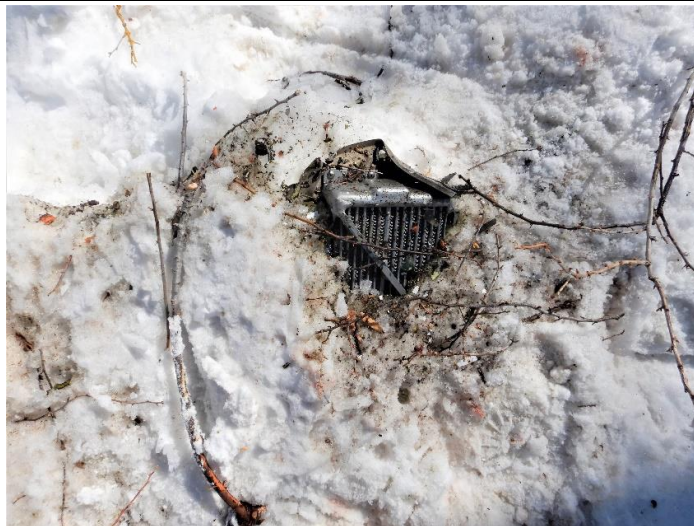
**OIL COOLER**

**Condition:** The oil cooler separated and was discovered in the wreckage path. Orientation could not be verified.

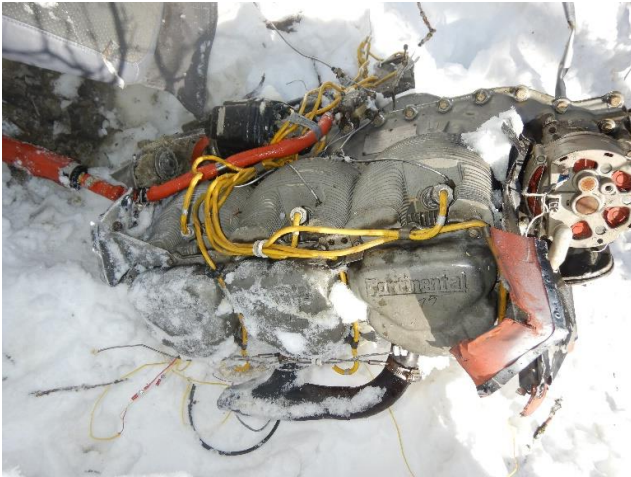
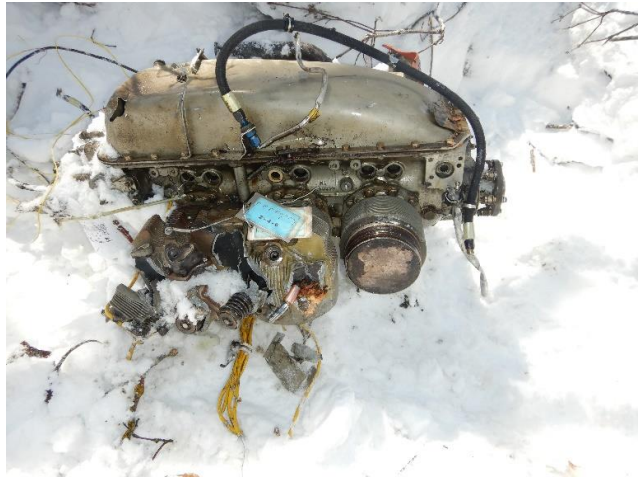
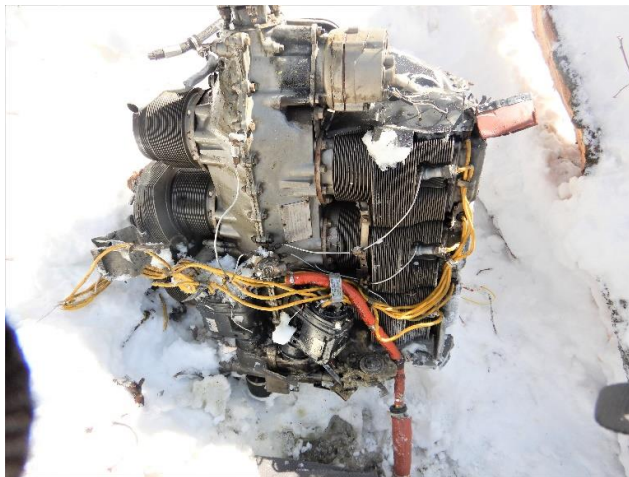
## CYLINDERS

Condition: All six cylinders remained attached to the crankcase mounting bases. Cylinders 1, 3 and 5 were intact. All sparkplugs and ignition leads remained in place. Cylinders 2, 4, and 6 received heavy impact damage and #2-cylinder head separated. Rocker covers on cylinders 4 and 6 separated and rocker arms, valve springs and valve stems were damaged.

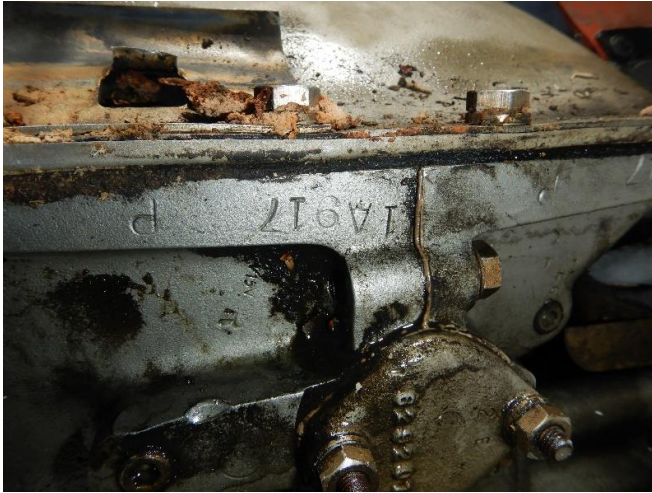
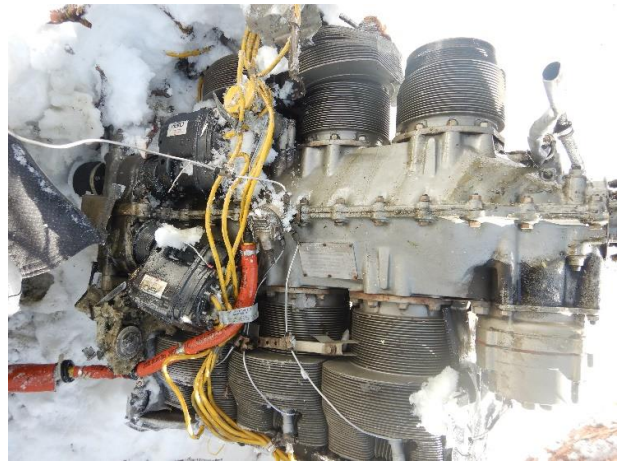
**CRANKCASE ASSEMBLY**

<b>CRANKCASE</b>	Casting Number:	1-3-5: Undetermined	2-4-6: Undetermined	S/N:1A917P
Condition:	The crankcase was intact.

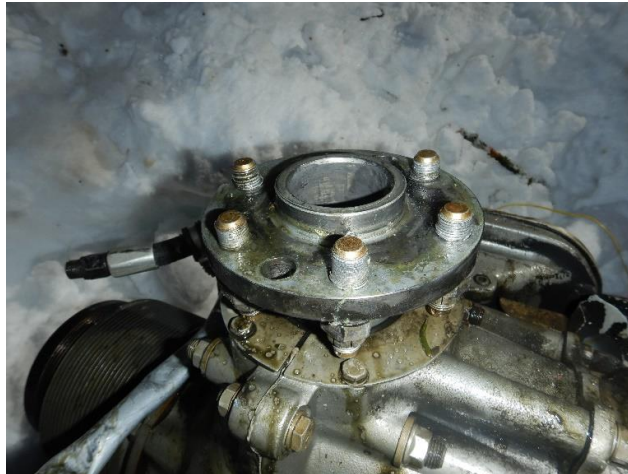
**CRANKSHAFT**

The crankshaft propeller flange was intact with propeller hub studs in place. The crankshaft was manually rotated through a partial rotation.

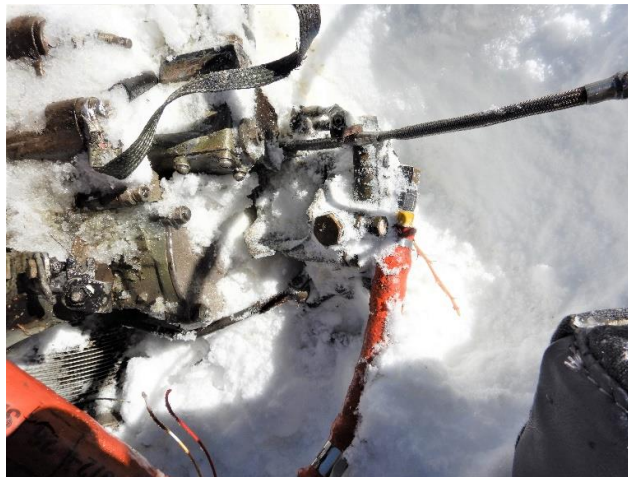
<b>STARTER</b>	Manufacturer: Undetermined	P/N: Undetermined	S/N: Undetermined
Condition:	The starter motor separated and was not found in the deep snow.		
<b>STARTER ADAPTER</b>	P/N: Undetermined		
Condition:	The starter adapter remained attached, but the starter motor mount separated.

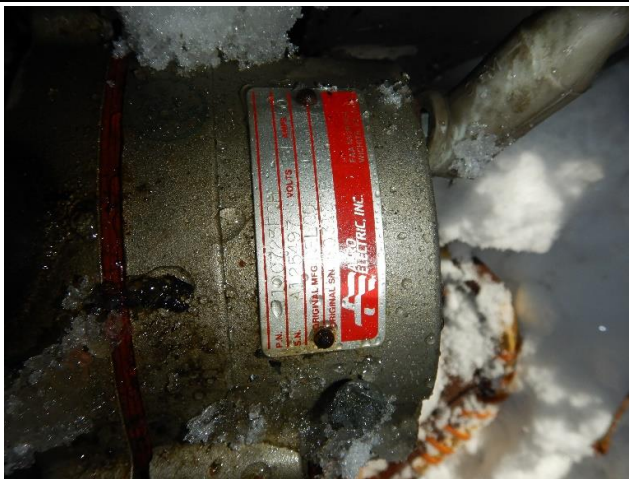
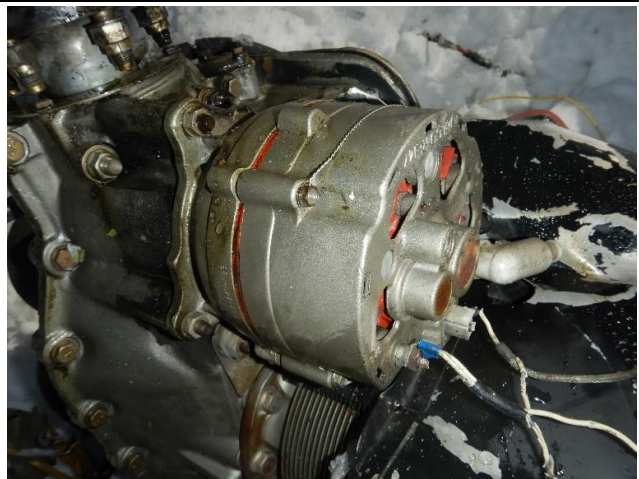
<b>ALTERNATOR</b>	Manufacturer: Aero Electric	P/N: 1100723ECH	S/N: A125497 6031339
Condition:	The front mounted alternator remained attached and intact.

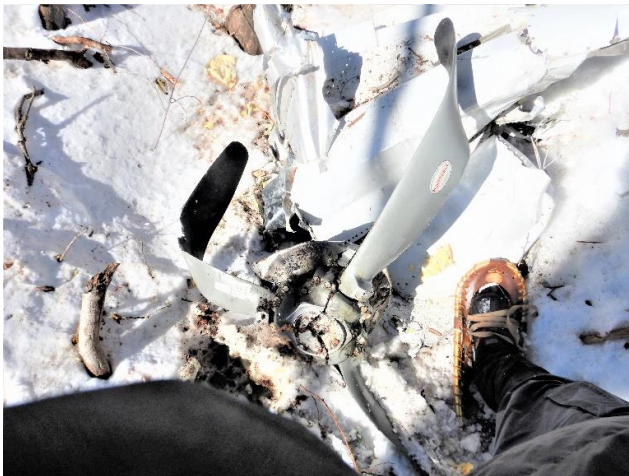
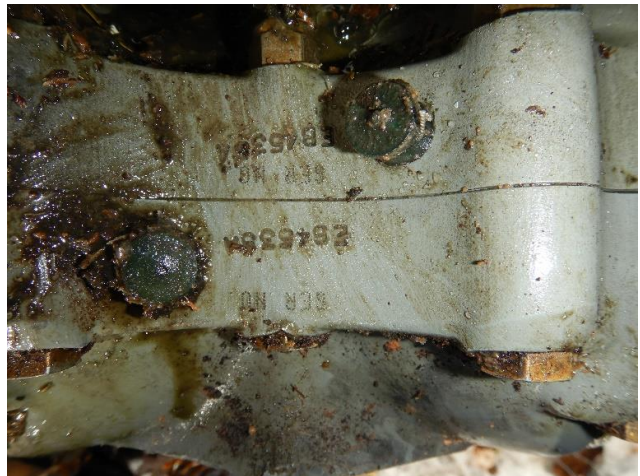
**A-Hartzell three blade full feathering propeller model: PHC-C3YF-2UF, hub serial number EB4535A**

Both propellers exhibited impact damage with rotational scoring on the cambered surfaces and torsional bending of the propeller blades. Damaged trees in the area of initial impact exhibited propeller cuts at 45-degree angles.
