ENGINE EXAMINATION REPORT

N257AR

ENGINE MODEL	Titan IOX-370-CLD1T4
ENGINE SERIAL NUMBER	E9E010
AIRCRAFT MAKE & MODEL	Commuter Craft - Innovator
AIRCRAFT SERIAL NUMBER	002 (Prototype)
AIRCRAFT REGISTRATION	N257AR
FILE NUMBER	18-372

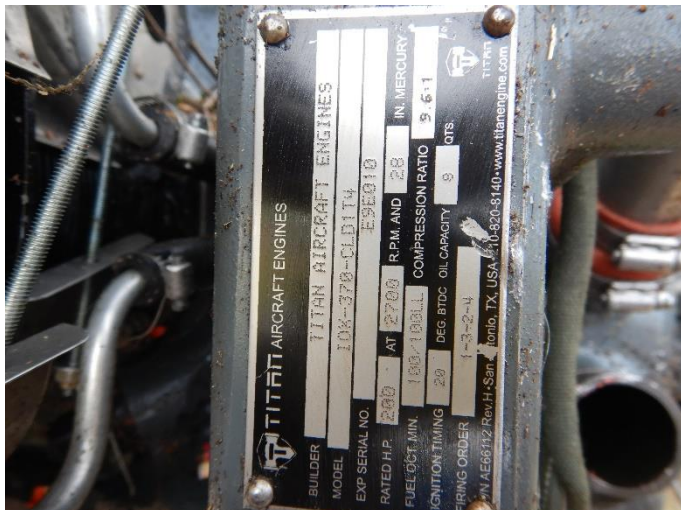
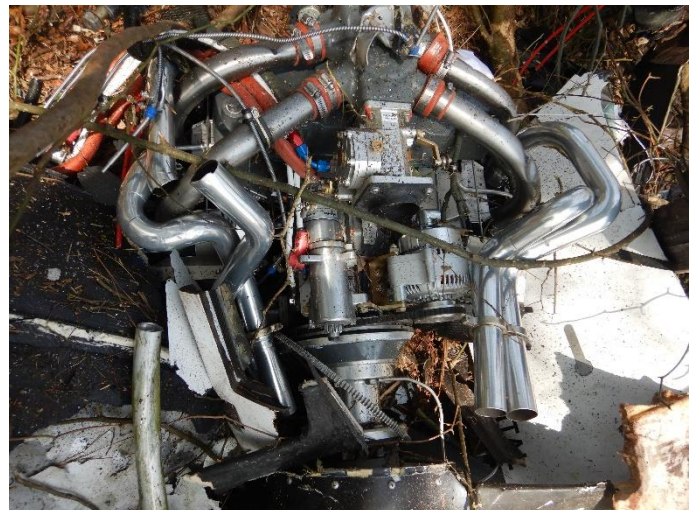
The engine mount tubes failed due to impact forces and the engine separated from the fuselage. The engine driven fuel pump separated but was recovered from the wreckage. The electronic "e-mags" received impact damage and the ignition harnesses separated. The right E-mag electronic ignition module was impact damaged.

Cylinder # 1 received impact damage with wood fibers imbedded in the cooling fins. The # 1 and # 4 exhaust tubes were impact damaged and the # 3 induction tube separated. The starter ring gear separated from the pulley. The oil filter adapter separated but was recovered from the wreckage path. The oil filter remained intact and attached to the broken adapter with proper safety wire still attached. The outer oil pump cover was impact damaged and separated from the pump. The oil cooler separated.

The two-blade constant-speed propeller hub remained attached to the engine crankshaft flange. Both composite propeller blades separated approximately 10-12 inches outboard of the propeller root consistent with engine power at impact.

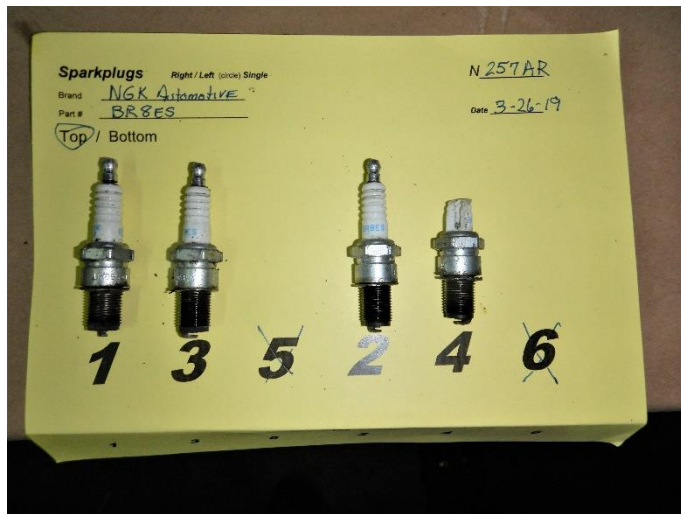
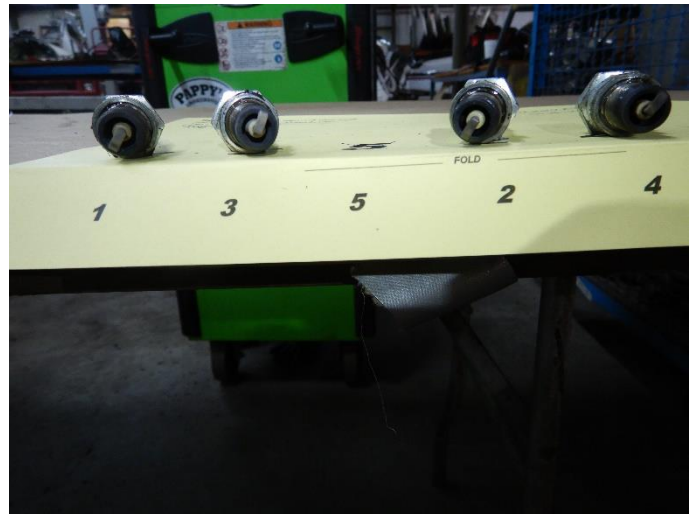
The top sparkplugs were removed and inspected. All four top sparkplugs (automotive type) exhibited normal combustion signatures and wear patterns. Number 4 top sparkplug was impact damaged. Cylinders 2 and 4 produced thumb compression when the engine was manually rotated. Cylinders 1 and 3 did not produce thumb compression. The cylinders were inspected using a lighted electronic borescope. All piston domes and valves faces exhibited normal combustion signatures. Cylinder # 1 exhaust valve was not fully closing. Cylinder # 1 rocker cover and cylinder head exhibited impact damage.

Cylinder # 1 rocker cover was removed. The intake and exhaust rocker arms, pushrods and valve springs were intact and moved correctly when the engine was manually rotated. However, the exhaust valve stem did not move fully in the valve guide which kept the exhaust valve from fully closing. Each cylinder rocker cover exhibited impact damage.

The right E-mag position was marked with a yellow paint pen then the E-mag was removed. The accessory gears moved correctly when the engine was manually rotated. The E-mag was then reinstalled.
