NATIONAL TRANSPORTATION SAFETY BOARD

CANOPY EXAMINATION

ERA19FA265

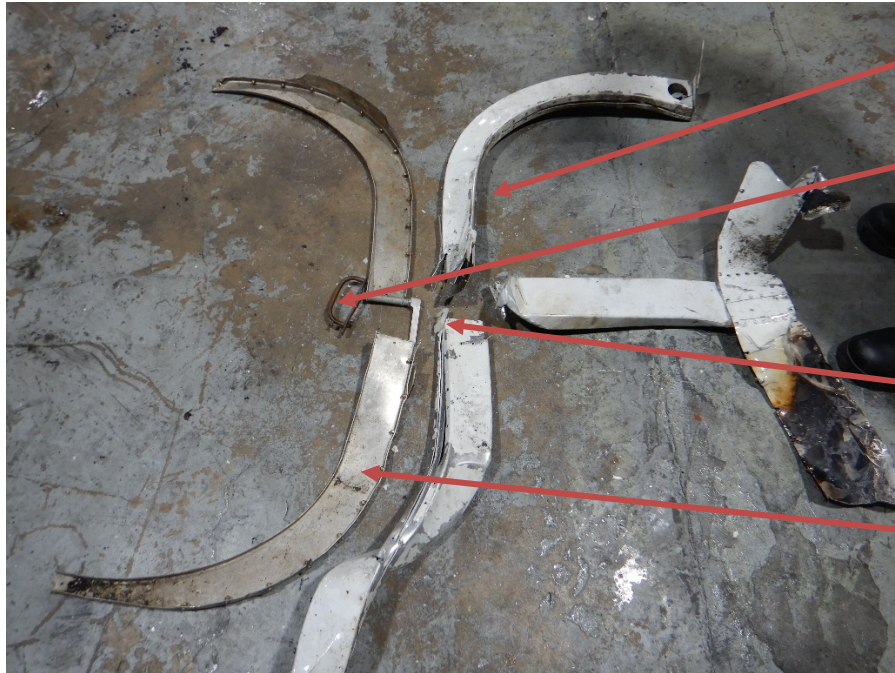
Examination of the metal canopy roll bar frames and latching mechanism revealed that the fixed portion of the canopy bow was separated at the midspan attachment point. The left side of the roll bar was impact twisted 180° while the right side of the roll bar displayed little deformation in shape. The latch block remained affixed to the left side of the roll bar. The canopy bow that connected to the fixed portion of the canopy at the latching mechanism was fractured at the handle but displayed no twisting. The latch handle was intact and slightly bent in the portion of the handle opposite where it latched over the latch block.

Canopy roll bar

Canopy latch handle (new)

Latch block (original design)

Canopy bow that connects to roll bar when latched.

Photo 1: Canopy roll bar and canopy bow

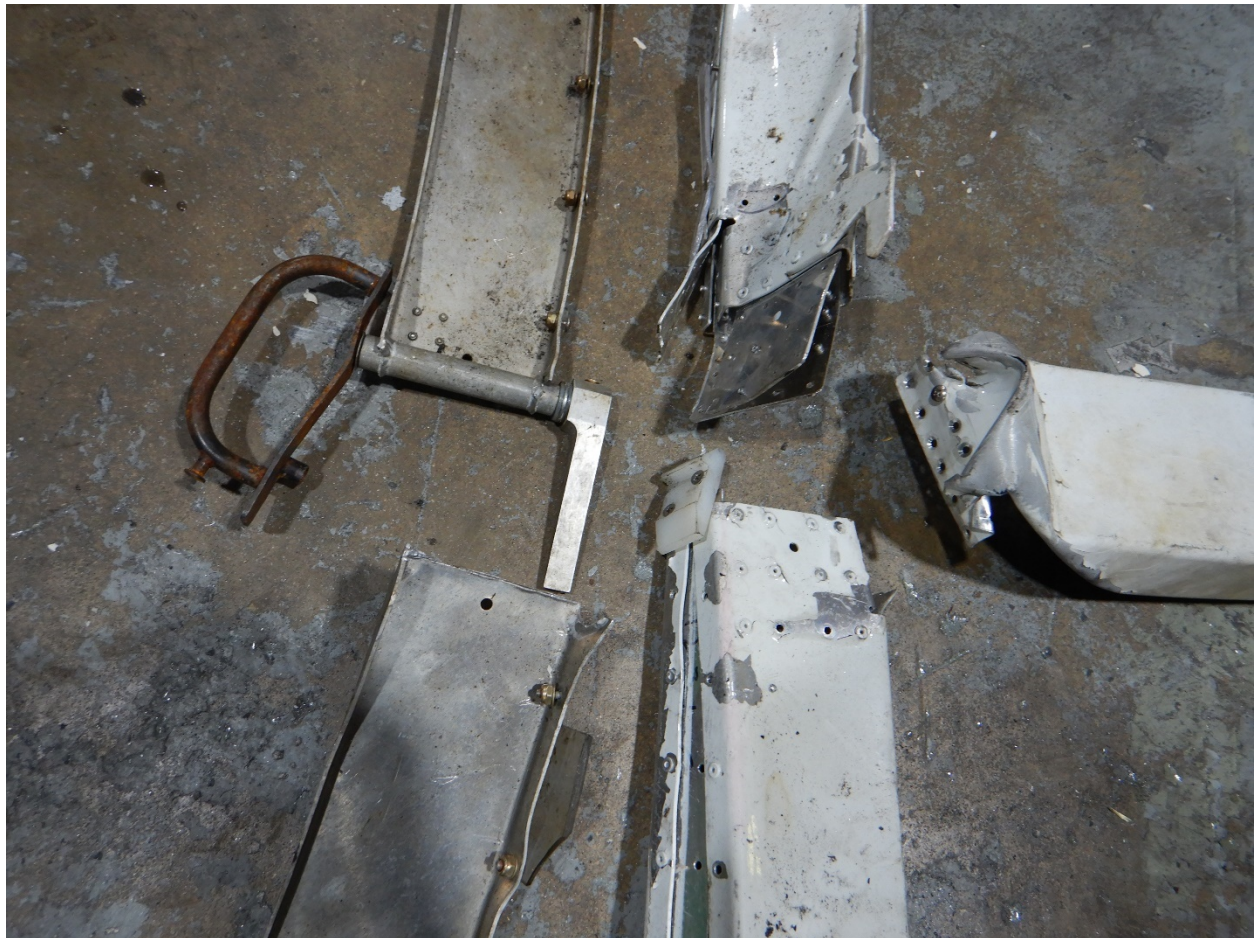
Photo 2: Close-up of Latching Area

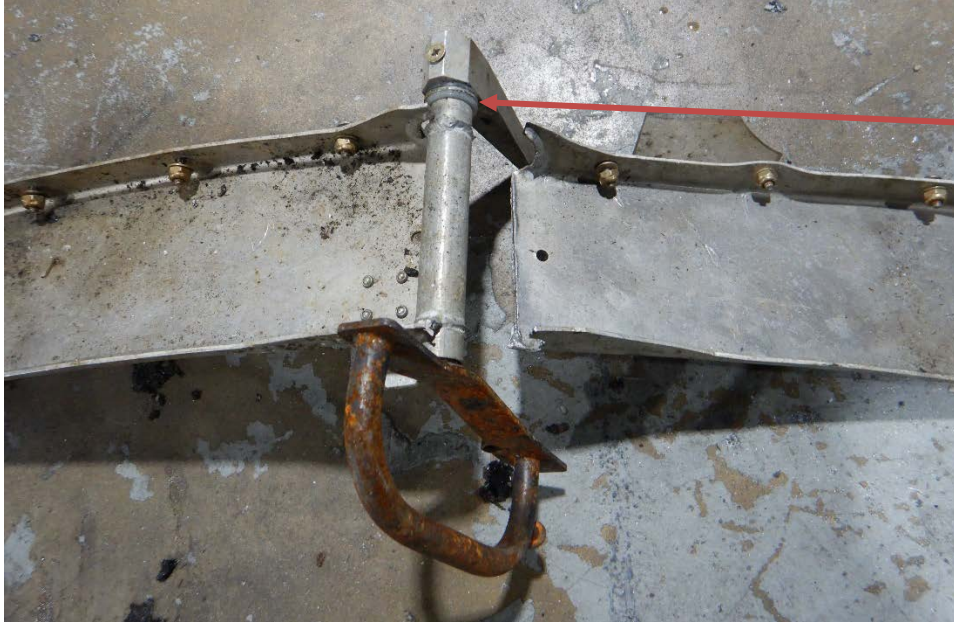
The latching mechanism was compared to drawings sent by Van Aircraft of both the original latch and canopy handle and the replacement kit that had recently been purchased by the pilot. Close examination revealed that only the canopy handle from the new kit was installed on the accident airplane. Additional washers were installed with this handle that were not part of the kit. The wreckage has the new handle with the older latching system. Per the schematics, the handle tube that protrudes through canopy is ¼ inch longer in the replacement handle than in the original handle tube. Little deformity observed in the area of the latch mechanism.

Extra washers

Photo 3: Latch handle

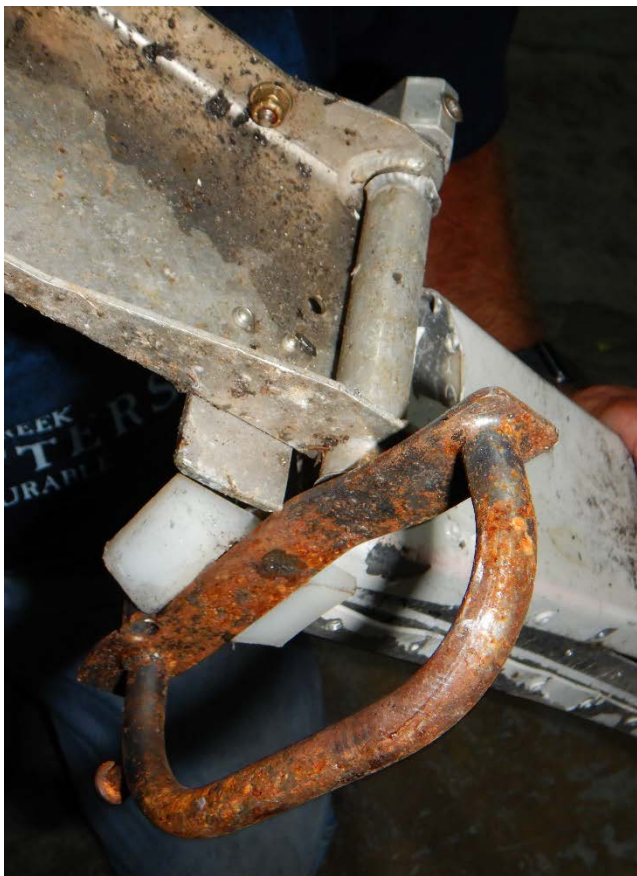
Photo 4: CloseUp View of Latching Mechanism

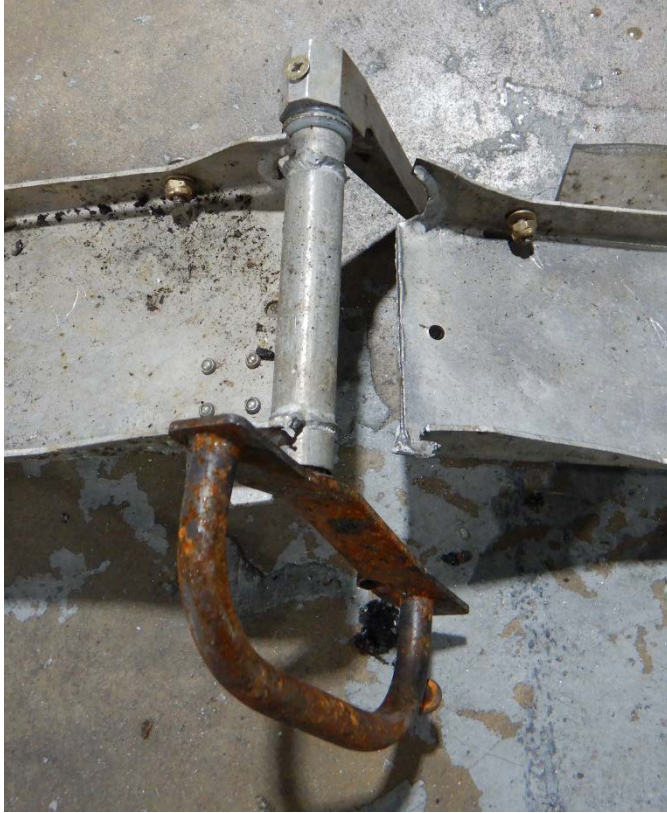
Photo 5: CloseUp Showing Additional Washers
