# Carburetor Ice Probability Chart CEN23LA226

Airplane: Temco GC-1B

Accident Date: June 3, 2023

Accident Location: Bristow, Oklahoma

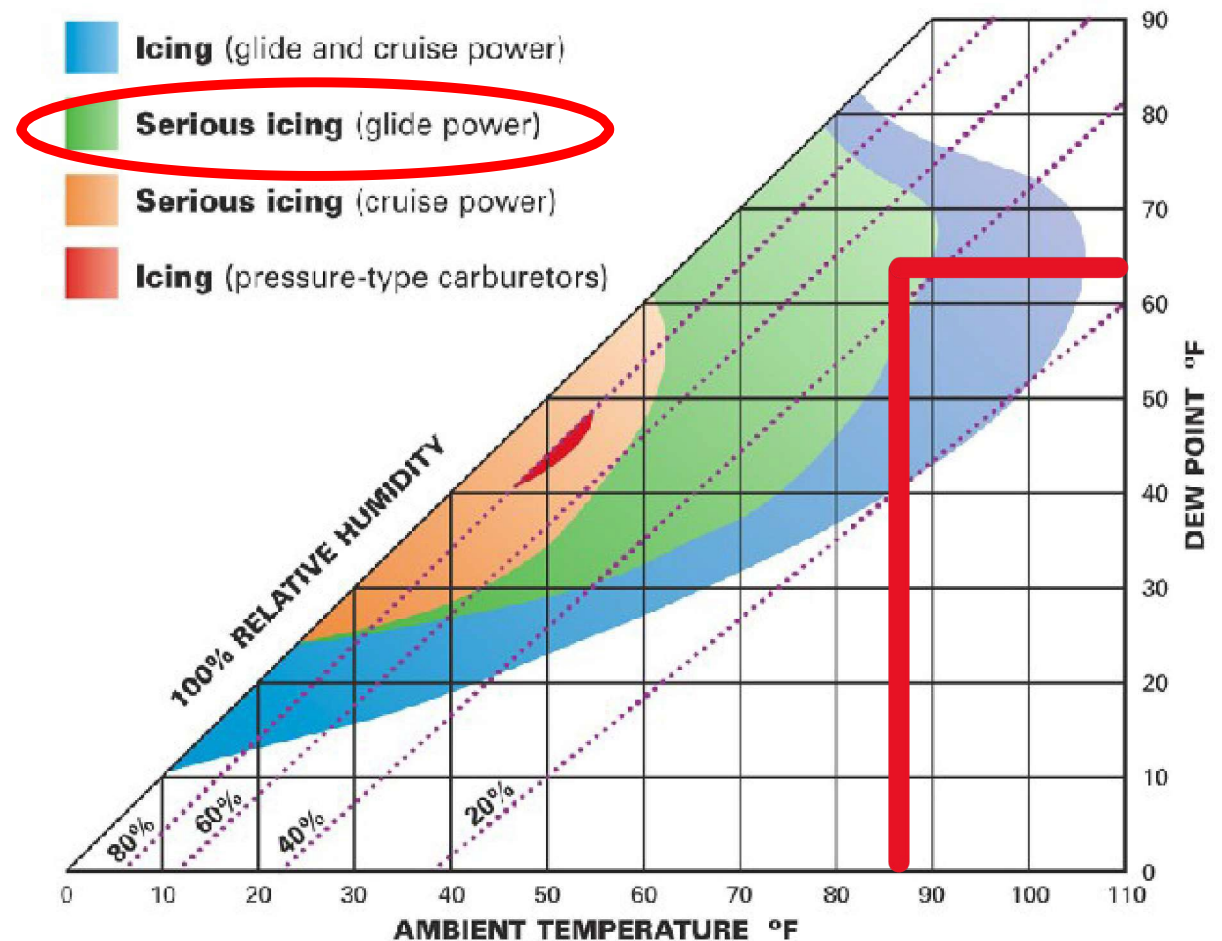
According to the chart, the airplane was operating in conditions conducive to serious carburetor icing at glide power and near the borderline of conditions conducive to icing at glide and cruise power

Temperature  
26 Degrees C = 87.8 Degrees F

Dew Point  
17 Degrees C = 62.6 Degrees F
