# Carburetor Icing Probability Graph – CEN20LA055

Airplane: Aero Commander 100, N5573M

Accident Date: 01/04/2020

Accident Location: Mullin, Texas

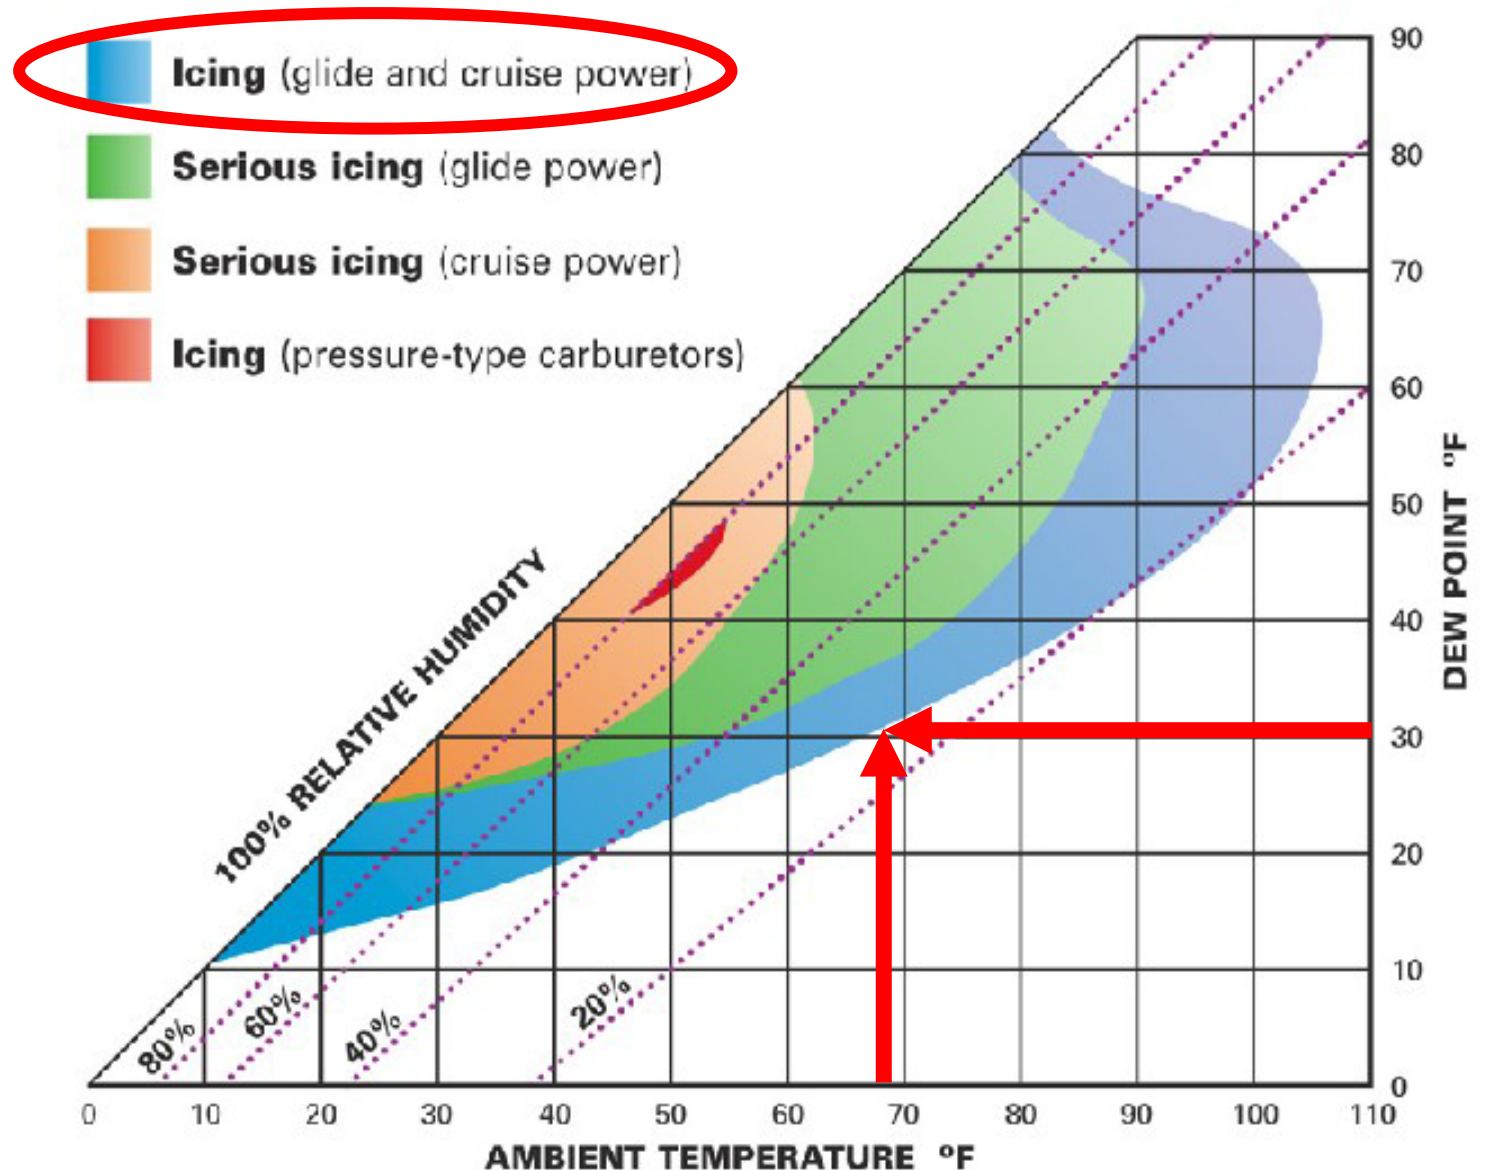
Weather: KMKN 042201Z [1601 CST] AUTO 26003KT  
10SM CLR 20/M01 A3028 RMK AO2

Temperature, 20° C = 68° F

Dew Point, -1° C = 30.2° F
