# **PRELIMINARY REPORT**

### **Union Pacific Railroad Contractor Employee Fatality**

**Castroville, Texas**  
**September 22, 2021**  
**RRD21LR016**

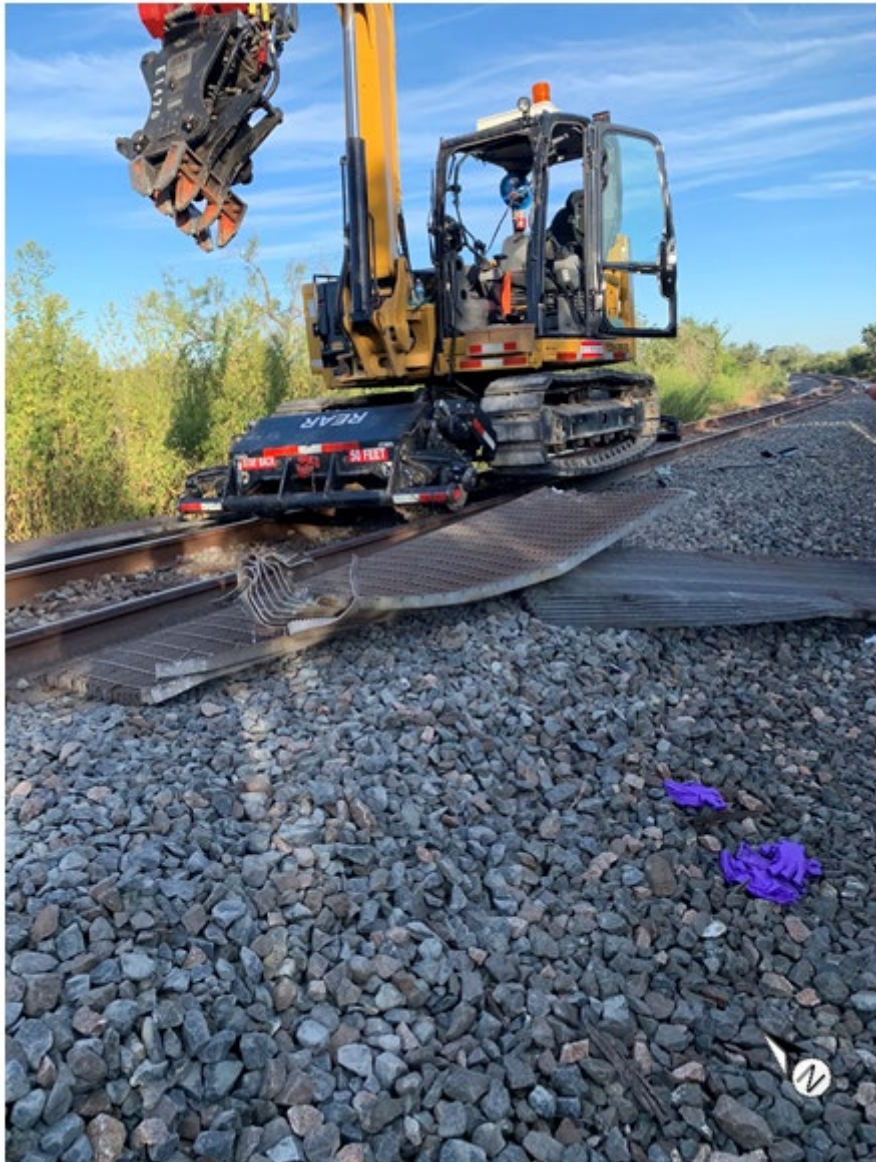
**Figure.** Photo of the roadway maintenance machine equipped with a boom.

Preliminary information indicates the employee was operating the roadway maintenance machine westward, with 3 spans of steel grating measuring approximately 20 feet long by 3 feet wide, and weighing about 2,200 pounds. The foreman in charge of the work gang made several attempts to contact the employee by radio. After about 5 minutes with no response, the foreman walked to the location where the employee was operating. The employee was found unresponsive still seated in the equipment. The foreman immediately called 911, and emergency personal arrived on-scene at about 3:00 p.m.
