EVERETT SHIP REPAIR			
  COLUMBIA-SENTINEL ENGINEERS, INC. NAVAL ARCHITECTS & MARINE ENGINEERS SEATTLE, WASHINGTON			
WSF CATHLAMET ABOVE DK DAMAGE			
DRAWN LNZ	APPROVED	APPROVED BY LETTER DATED: OWNER:	A.B.S.:
CHECKED	DATE 19 AUG 22		U.S.C.G.:
DWG NO. 2265-100-01		SHEET 1 OF 10	SCALE: NONE
		REV	D

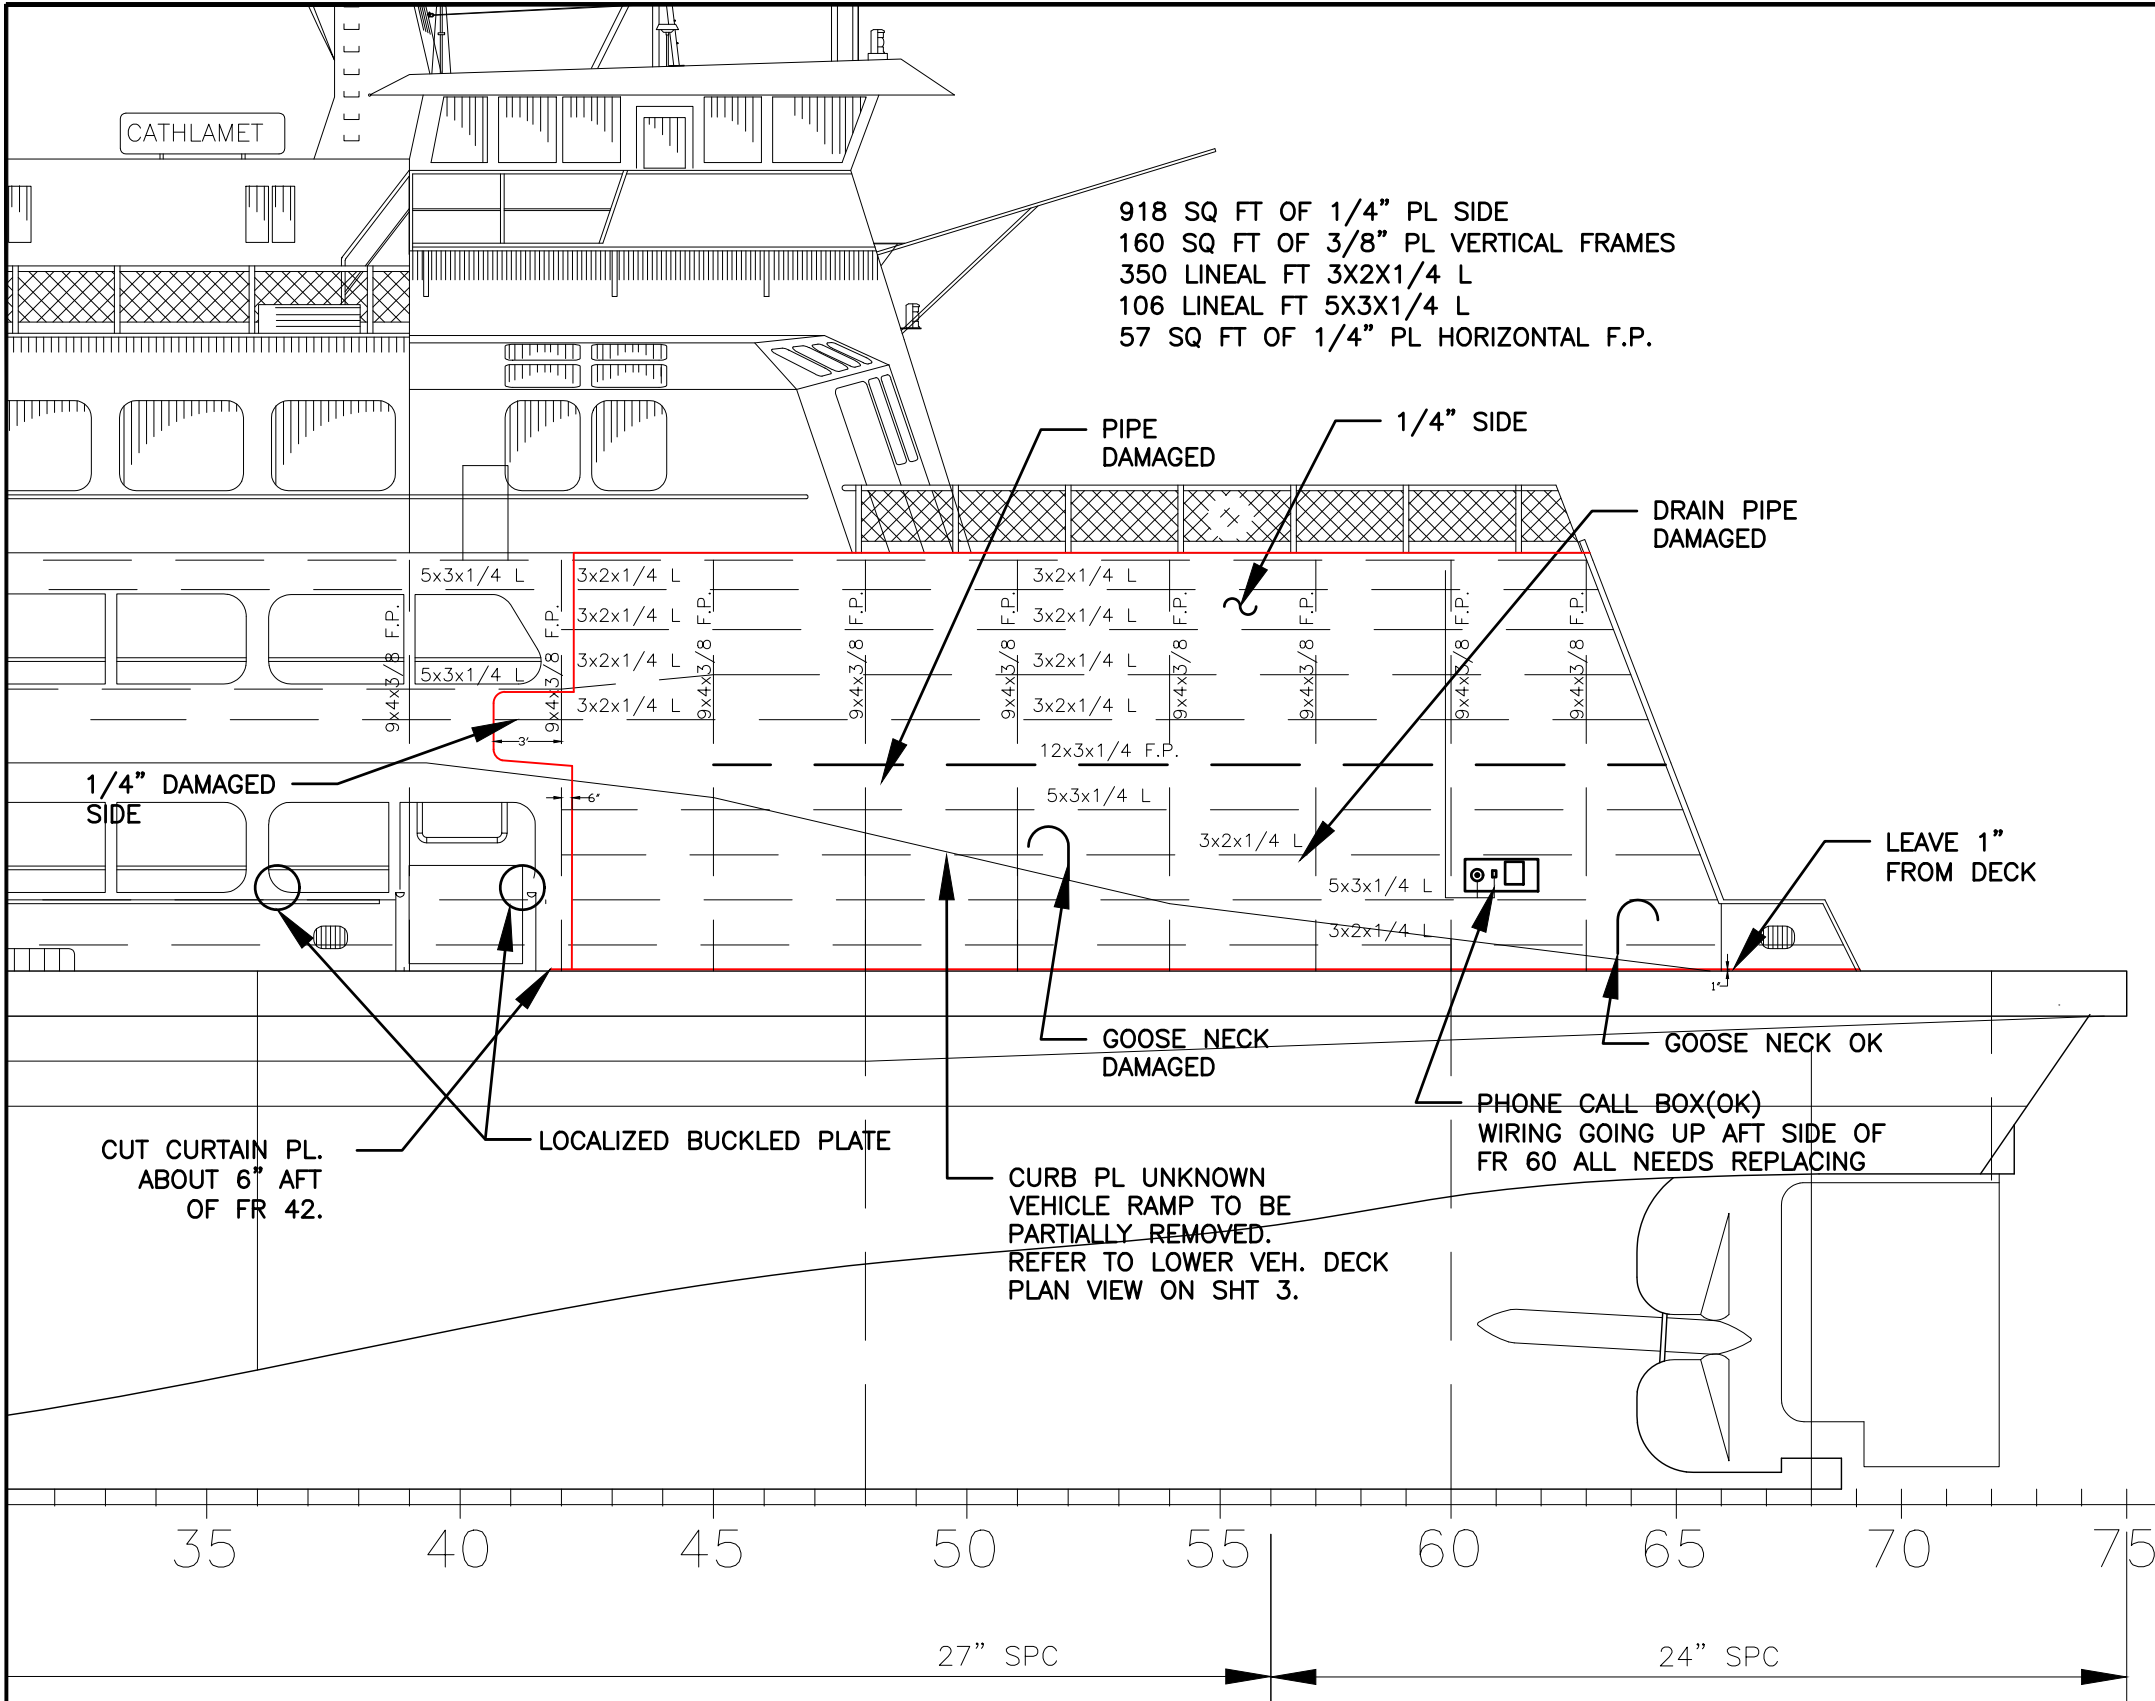
PROFILE

1/4" DAMAGED SIDE

LOCALIZED BUCKLED PLATE

918 SQ FT OF 1/4" PL SIDE
 160 SQ FT OF 3/8" PL VERTICAL FRAMES
 350 LINEAL FT 3X2X1/4 L
 106 LINEAL FT 5X3X1/4 L
 57 SQ FT OF 1/4" PL HORIZONTAL F.P.

CUT CURTAIN PL. ABOUT 6" AFT OF FR 42.

CURB PL UNKNOWN VEHICLE RAMP TO BE PARTIALLY REMOVED. REFER TO LOWER VEH. DECK PLAN VIEW ON SHT 3.
