Alaska Marine Field Service

CAUSE STATEMENT SUBMISSION NTSB INVESTIGATION OF THE QUALIFIER 105 FIRE

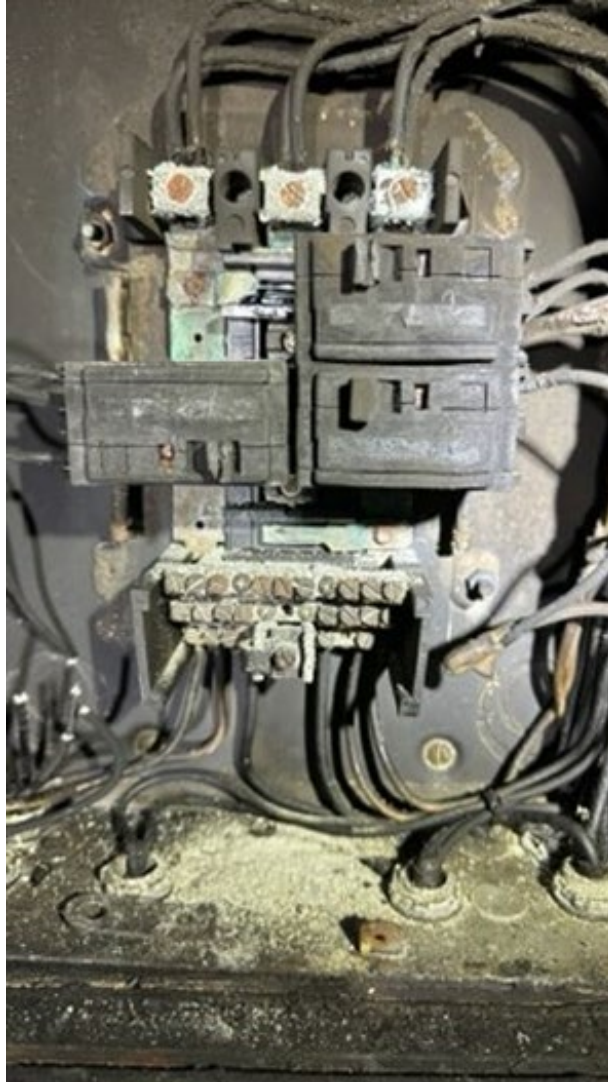
4. After the fire AMFS examined the circuit breaker boxes, especially the box near the stairwell on the port side of Stateroom J and found them heavily corroded. This was another indication of electrolysis; the corrosion on electrical system components can be part of the source of stray current creating potential electrical system failures.

Photograph 1. Circuit breaker box at bottom of rear quarters stairs, port side. Circuit breaker/s and wires associated with the two failed outlets along some other wires were removed by owner's insurance company representatives.

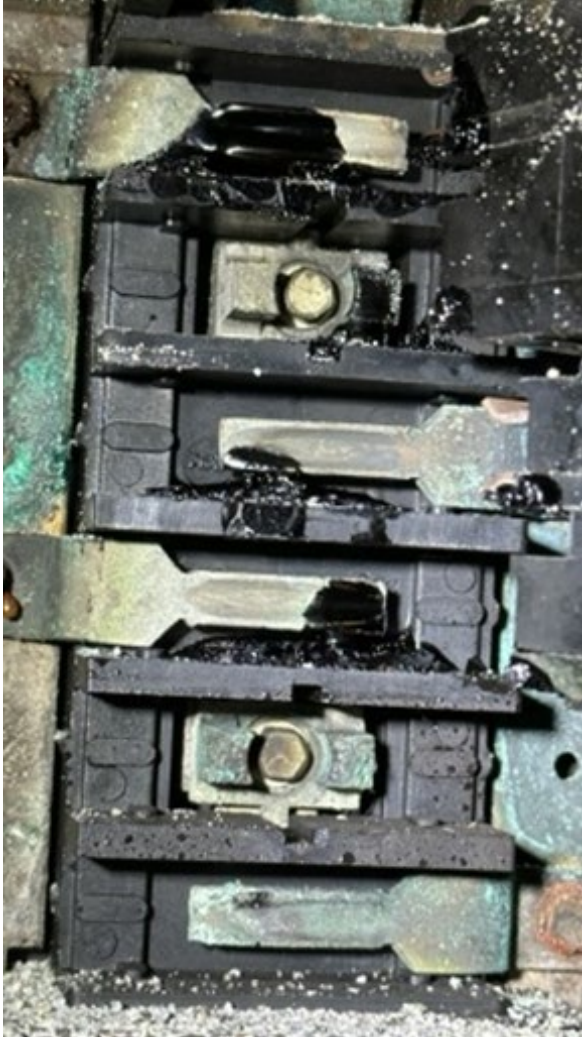
- 5. After the fire the owner's insurance company sent two representatives to the Qualifier 105. They removed the circuit breaker/s from the breaker box shown above. AMFS did not have representatives present during that visit. Based on inspection following departure of the owner's insurance company personnel, owner's insurance company also removed much of the ceiling and bulkheads with tools including a reciprocating saw to access and remove the wiring providing power to Stateroom J. There is a picture on page 8 of the technical document of the removals area.

Photograph 2. Portside circuit breaker box, breakers removed. Upper left mounting position had melted plastic from the breakers at the box/breaker contact points.

7. Due to the owner's insurance company's removal of the circuit breaker/s and associated wiring, AMFS could not determine which outlets, lights or equipment were being fed by the at-issue breakers but the wiring that came from this breaker box went into the athwartship passage way to other areas of the aft stateroom compartment, including the overhead of Stateroom J.
