National Transportation Safety Board

RRD24MR002

SURVIVAL FACTORS- CRASHWORTHINESS INVESTIGATION

Group Chair's Factual Report

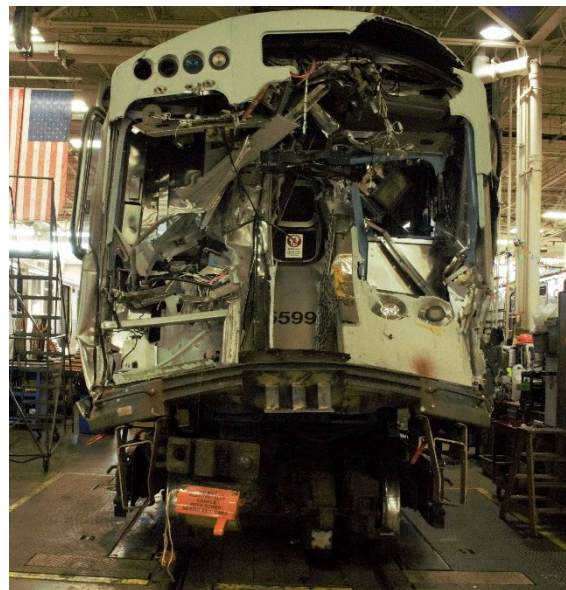
Figure 7 Photograph taken looking at the lead train car, 5599, that struck the snow removal vehicle and shows the resulting collision damage. (Source: NTSB)

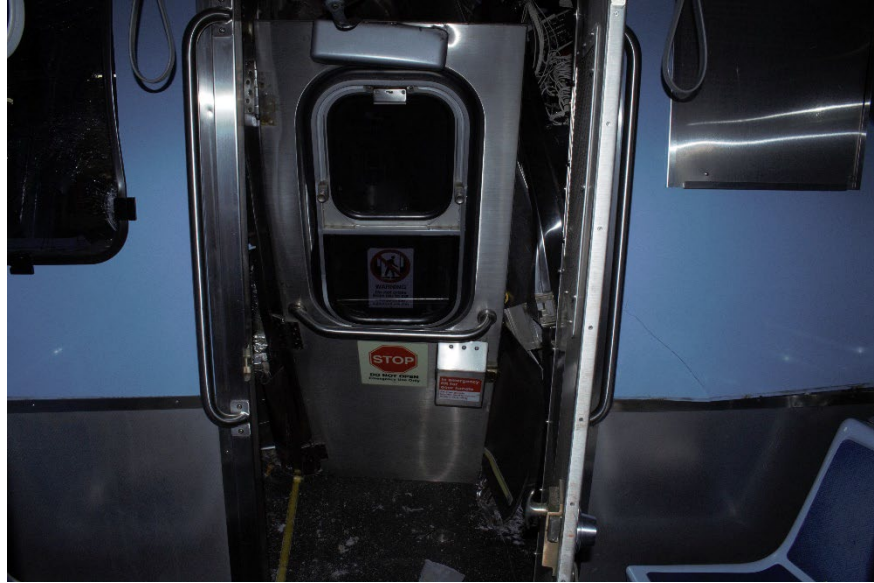
Figure 8 Photograph of the end car door of Train Car 5599 that was shoved inward into the operator's compartment space during the collision. The operator's compartment door that swung open and into the passenger compartment following the impact with the snowplow is visible in the foreground. (Source: NTSB)

The post-accident examination of Train Car 5599 revealed that the passenger compartment of the train car did not sustain any reduction in the occupant survivable space. However, the operator's compartment sustained extensive intrusion damage and only minimal occupant survivable space existed post-accident.

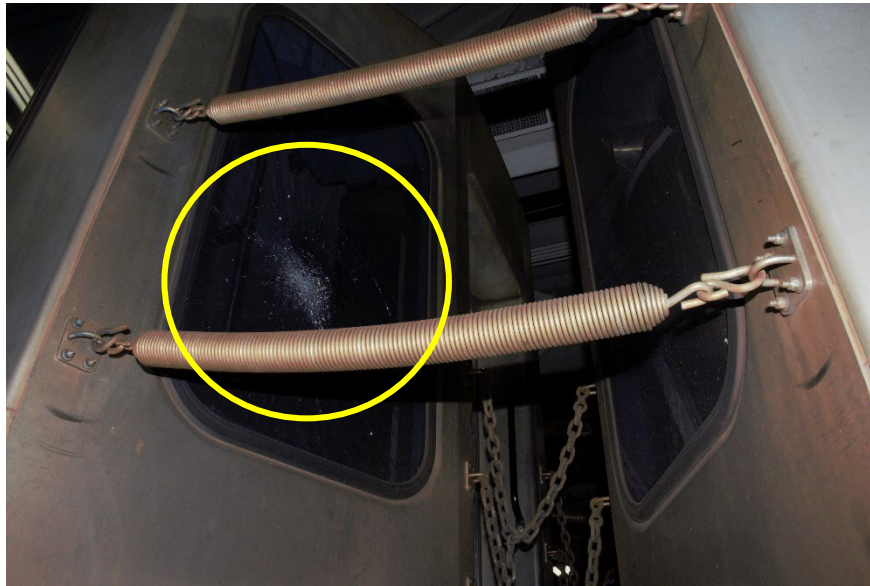
Train Car 5600, the even or "B" Car was coupled to the lead car so that its rear was coupled forward and connected to the rear of the "A" Car. The train car operator's compartment was empty and located at the farthest end of the car. Post-accident examination of the train car found evidence that the two train cars made contact collision and damage occurred to both cars' anti-climbers and end sills. The inspection of the car revealed damage to the two front-facing windows, which were found smashed, adjacent to the end of the train car that was coupled to the lead car. This damage was determined to have been caused by the impact with the occupants of the train car, sitting adjacent to the windows, who were thrown against the glass during the collision. **Figure 9** is a photograph taken from the exterior of Train Car 5600 showing the smashed front window on the right side of the car caused by the impact with a passenger's head who was seated inside of the train car.

Figure 9 Photograph taken from the exterior of Train Car 5600 showing the smashed right front window, highlighted in yellow, caused by the impact with an occupant inside of the train car. (Source: NTSB)

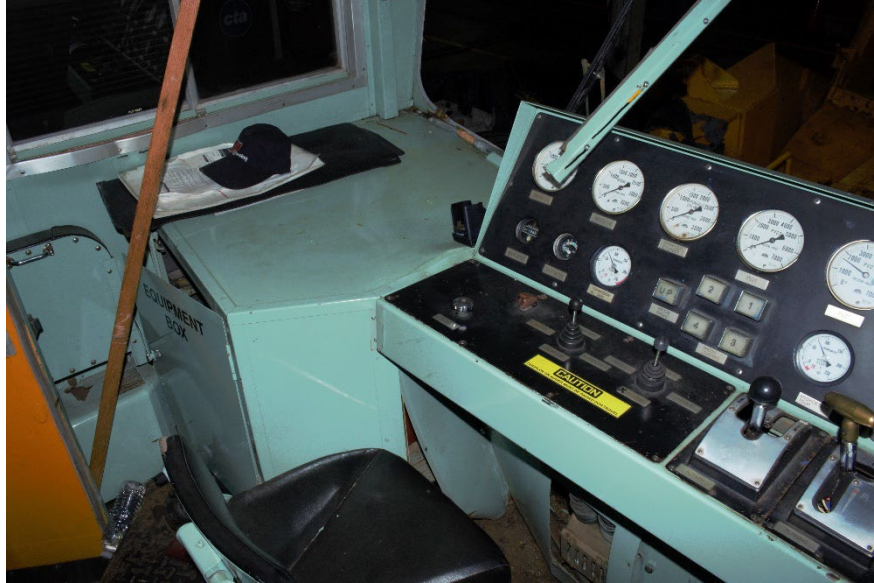
Figure 10 Photograph of the interior cab of the snow removal vehicle at End No. 2 showing the equipment box that the employee was thrown across before being ejected out of the windshield. (Source: NTSB)

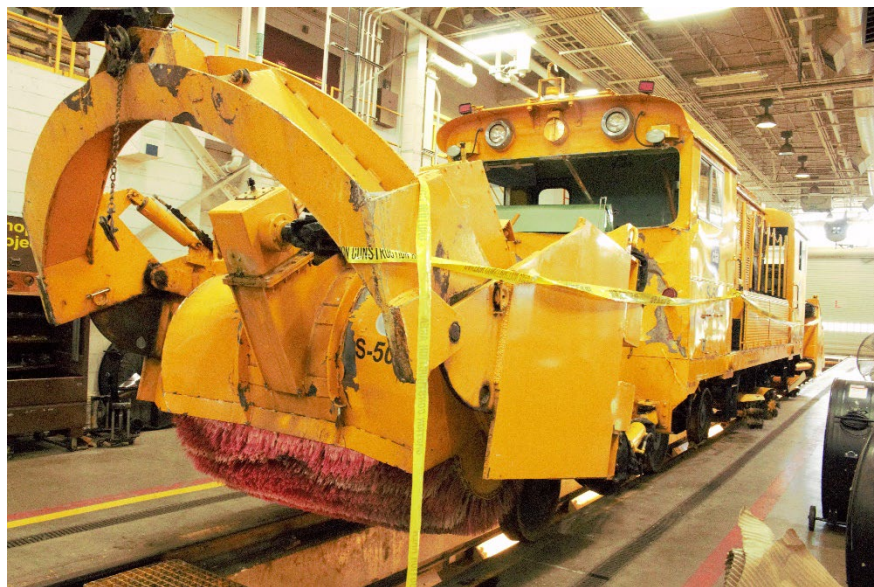
Figure 11 Photograph taken at the Skokie maintenance shop of the Snow Removal Vehicle S-500 with the area of impact with the train, the brush assembly, in the foreground and the windshield of the cab where the employee was ejected, in the background. (Source: NTSB)

After the examination of the snow removal vehicle, to include obtaining measurements of the interior space, it was determined that the damage sustained by the vehicle during the collision with the train did not compromise the survivable space available to the vehicle's occupants.

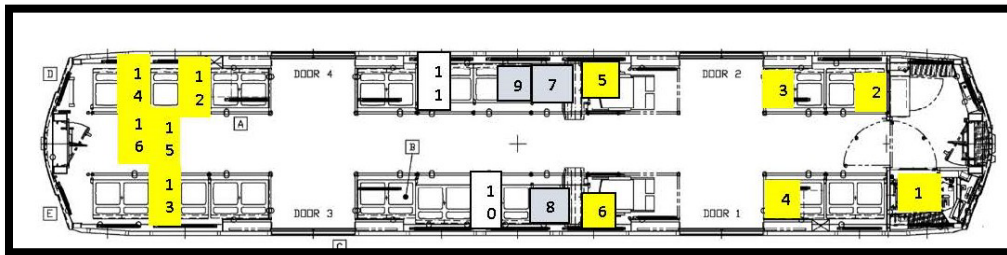
Figure 12 is a diagram showing the pre-accident location of the occupants in Train Car 5599 and those who sustained injury highlighted in yellow.

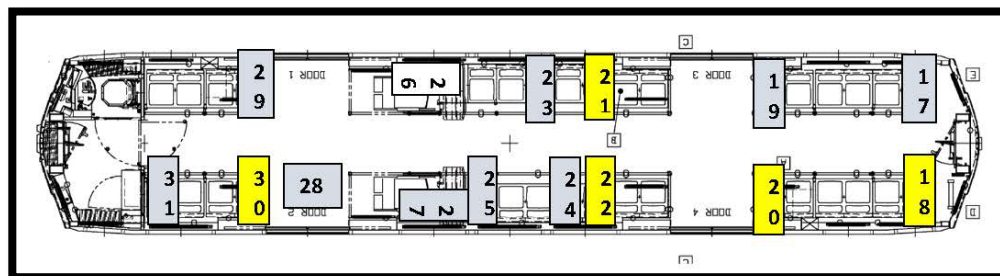
Figure 13 is a diagram showing the pre-accident location of the occupants in Train Car 5600 and those who sustained injury highlighted in yellow.

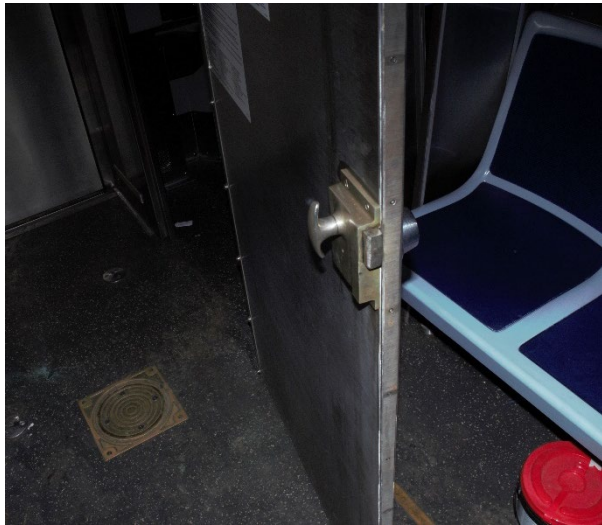
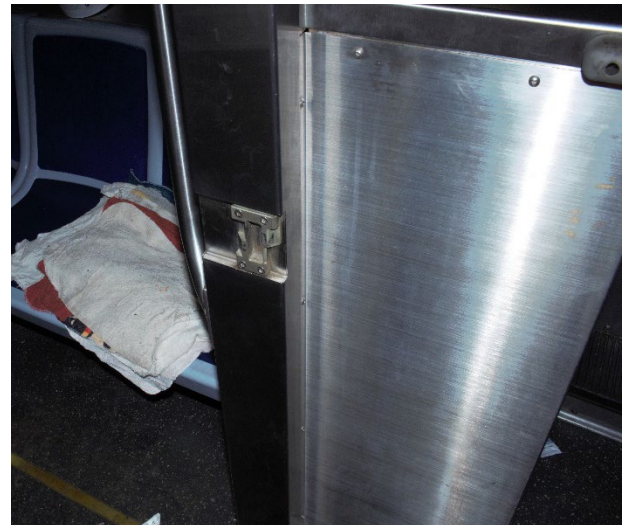
Table 3 details the pre- and post-accident location of the occupants in Train Car 5599. In addition, the table provides the severity of the injuries and the circumstances that caused the resultant injury. It was noted that one of the seriously injured occupants in Car 5599 received additional injuries when the door locking mechanism securing the operator’s compartment door in the lead car, failed, allowing the door to swing open, into the passenger compartment striking a passenger in the head. In addition, the open door allowed the passenger to travel a farther distance during the accident and resulted in the passenger coming to final rest partially inside of the operator’s compartment of the train. The operator compartment door on Car 5600 also swung open during the accident.

Figure 14 and 15 Photographs of Train Car 5600 operator's compartment door latching mechanism and the frame catch that sprung open during the accident. (Source: NTSB)

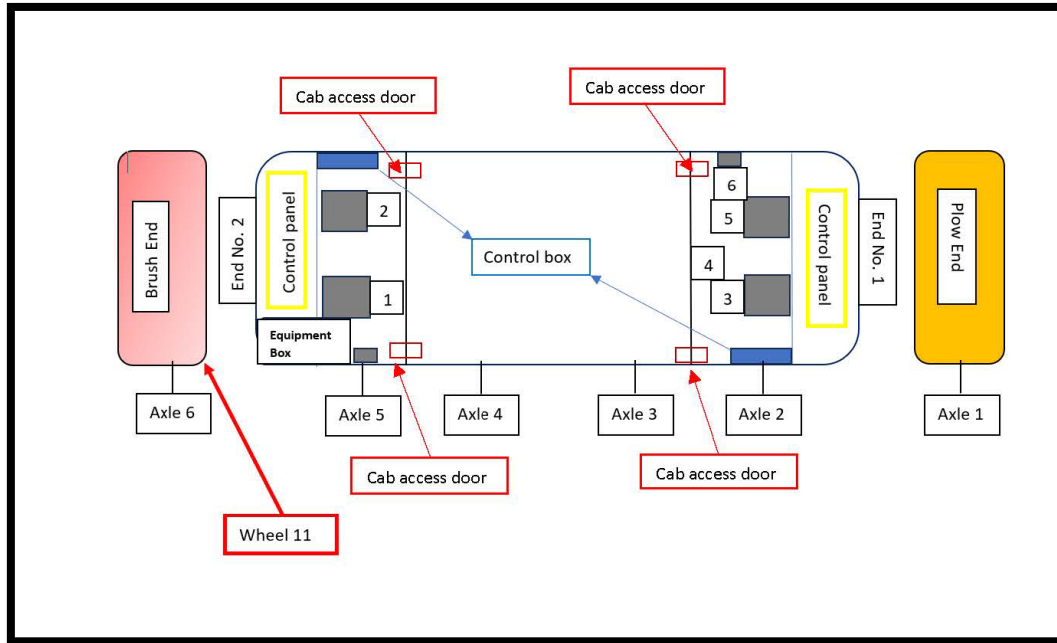
the ejection of one of the employees standing up in the interior of cab End No. 2. **Figure 16** is a diagram of the snow removal vehicle showing the two cabs on each end, interior seating positions, the exterior location of the axles and the location where the ejected employee was found lying underneath the vehicle adjacent to Wheel 11.

Figure 16 is a diagram of the snow removal vehicle showing the interior design and exterior axles and the location of the final rest position underneath the vehicle adjacent to Wheel 11 of the ejected occupant.
