**NATIONAL TRANSPORTATION SAFETY BOARD**  
Office of Railroad, Pipeline, and Hazardous Materials Investigations  
Washington, D.C. 20594

### Group Chairman's Factual Report of the Investigation<sup>1</sup>

#### – Railroad Equipment Crashworthiness<sup>2</sup> –

NTSB Number:	HWY22MH009
Location (Jurisdiction):	Clarendon Hills, IL (DuPage County)
Date / Approx. Time of Accident:	May 11, 2022 / 08:16 (a.m.) CDT <sup>3</sup>
Brief Synopsis:	commuter train collision with highway vehicle (box truck) at a highway grade crossing
Train Equipment Owner / Operator:	Metra / Metra
Railroad (Property Owner):	BNSF
Accident Site (Location):	BNSF Chicago Subdivision - Main Line, Track #3, at (approximately) MP 18.32, which occurred at the Prospect Street grade crossing

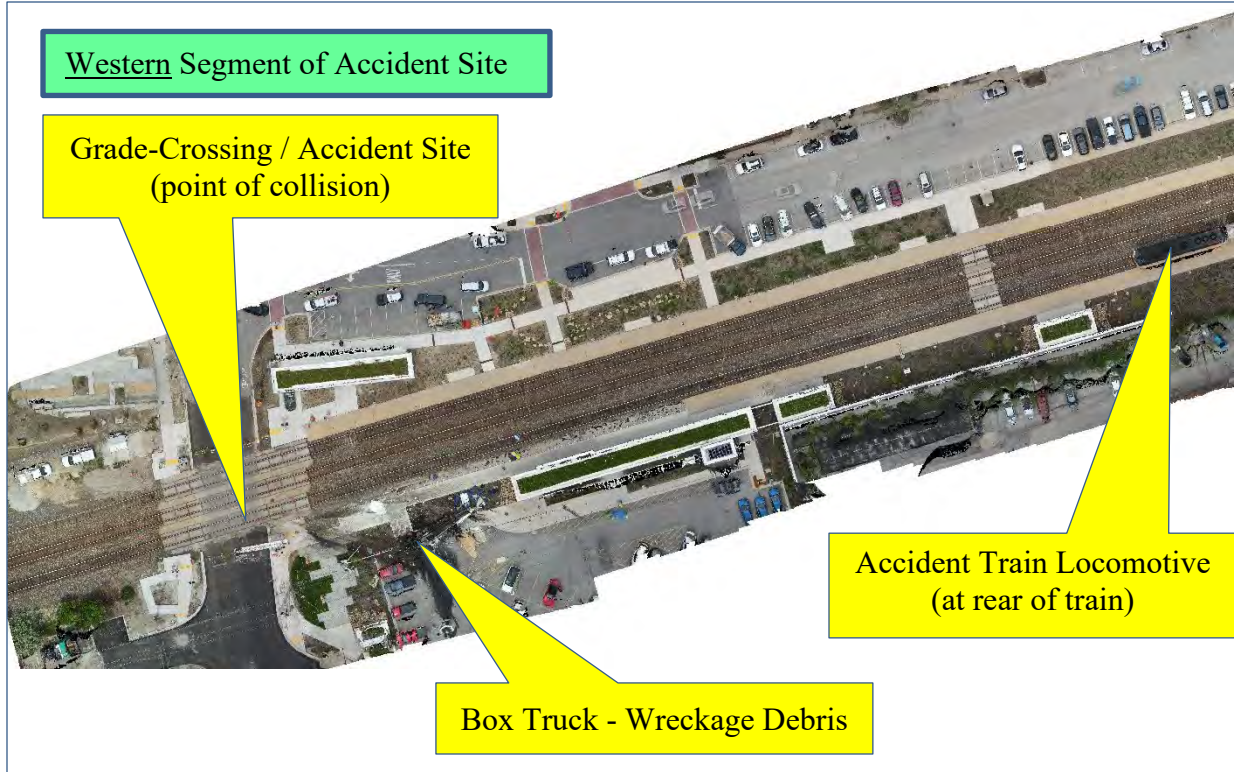
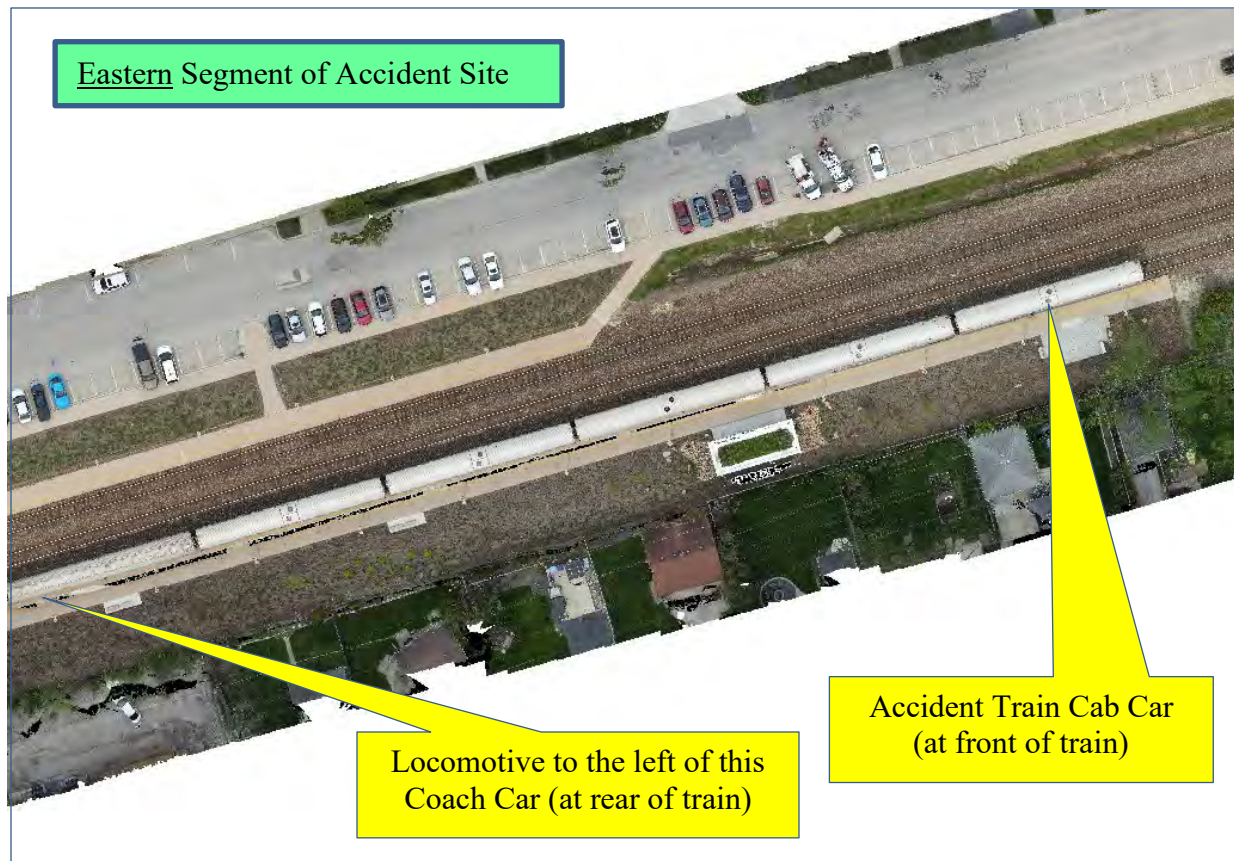
Exhibit 5.

Annotated aerial imagery [Site Map], describing the wreckage distribution in the wreckage debris field
