National Transportation Safety Board

HWY22MH009

TECHNICAL RECONSTRUCTION

Group Chair's Factual Report

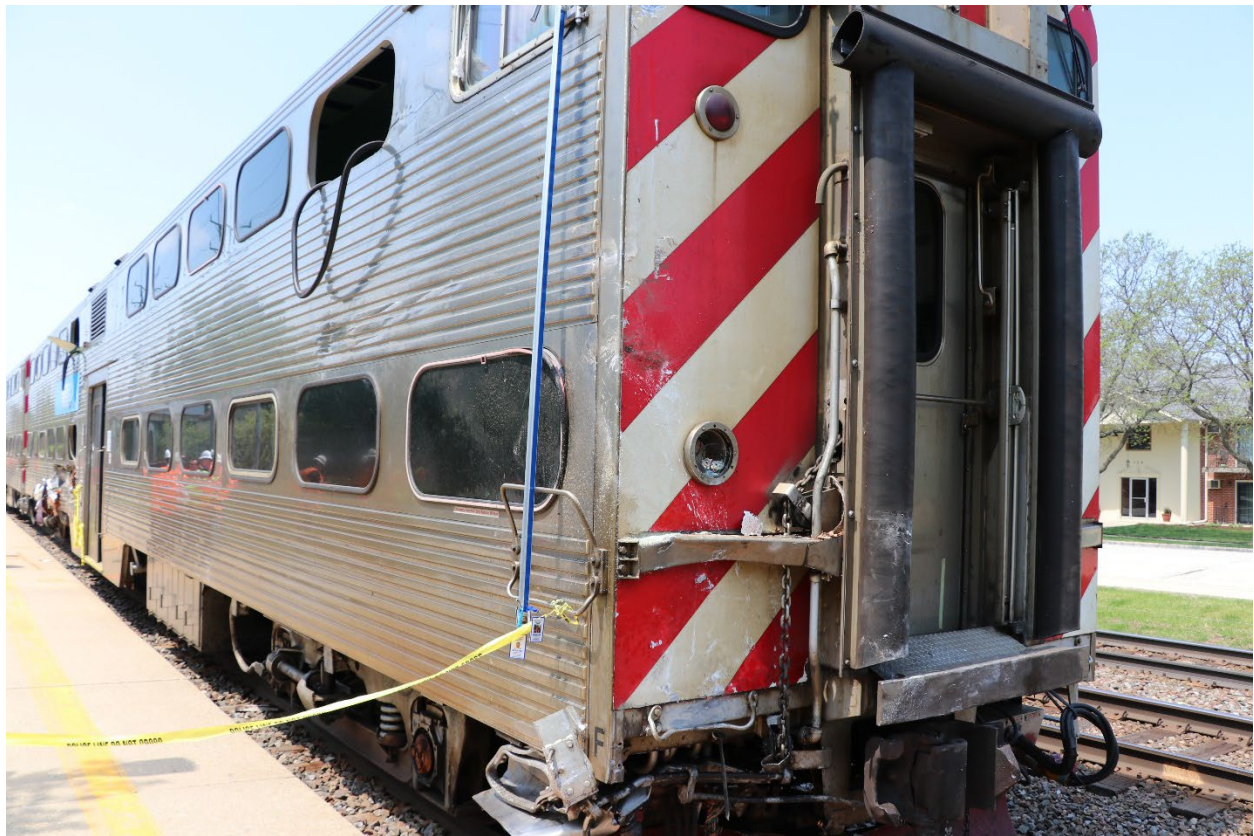
Figure 1. Photograph of cab car taken during on scene investigation.

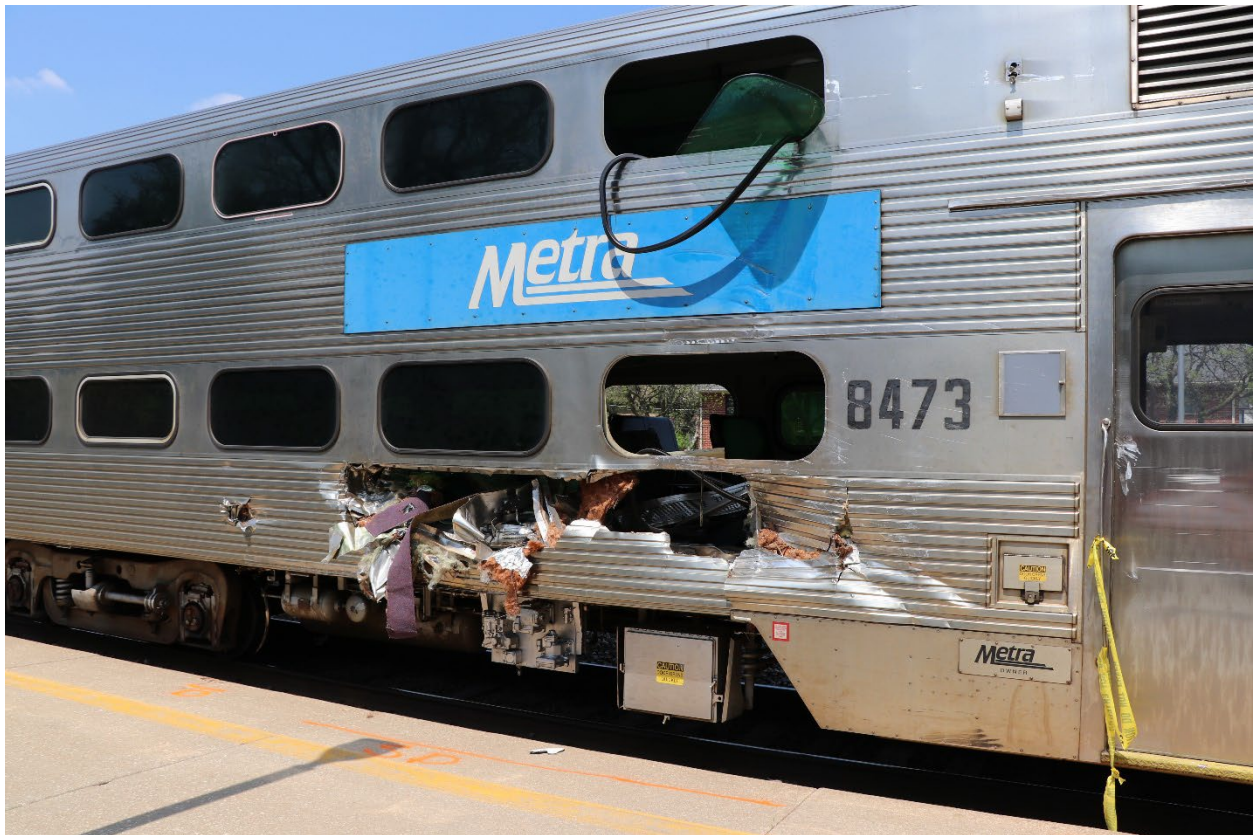
Figure 2. Photograph depicting the damage to the right side of the cab car.

Direct impact occurred on the right front and right side of the cab car. The damage to the front extended inboard a distance of 4.8 feet and upward a distance of about 9.0 feet. The right side of the snow plow, sill step, and hand brake equipment all exhibited rearward displacement. The uncoupling rod exhibited impact damage as well as the 480 junction. The right-side end structure cross beam was deformed and displaced rearward. Just above the end structure cross beam was the right-side cab signal. The glass and bulb were shattered, and the bracket was damaged. The right-side mirror was missing, and the bottom support arm was broken and displaced rearward.

On the right side of the cab car were two areas which were consist with impact damage from the International. The first area was approximately 5.9 feet from the front of the cab car and was located between the engineer's side window and the first upper passenger window and was in line with damage identified at the highest point on the front of the cab car. The damage consisted of three scratch marks with two of them containing a black mark. The first upper passenger window had been dislodged and was missing with the rubber seal hanging outside the window frame. Approximately 42.0 feet from the front of the cab car, on the rear vestibule door was apparent contact damage. Scrape marks with white paint transfer was visible on the door and the passenger grab rail was bent. The lower right sidewall had been torn open exposing the interior of the cab car. The breach began approximately 4.0 feet aft of the vestibule doors and extended rearward for about 9.0 feet and expanded vertically for about 1.6 feet. There was a second puncture in the sidewall about 3.3 feet rearward of the large breach. There were scrapes and scratches extending upward from the sidewall breach to the upper passenger window. The lower passenger window was missing along with the rubber seal. The upper passenger window had been pushed inward into the passenger area and the seal was hanging along the lower frame.

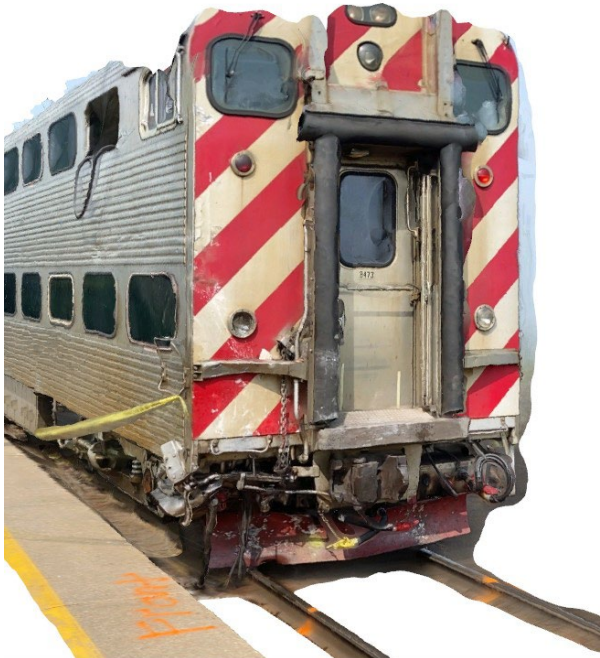
Figure 3. Screen capture of 3D point cloud depicting damage incurred during the collision.

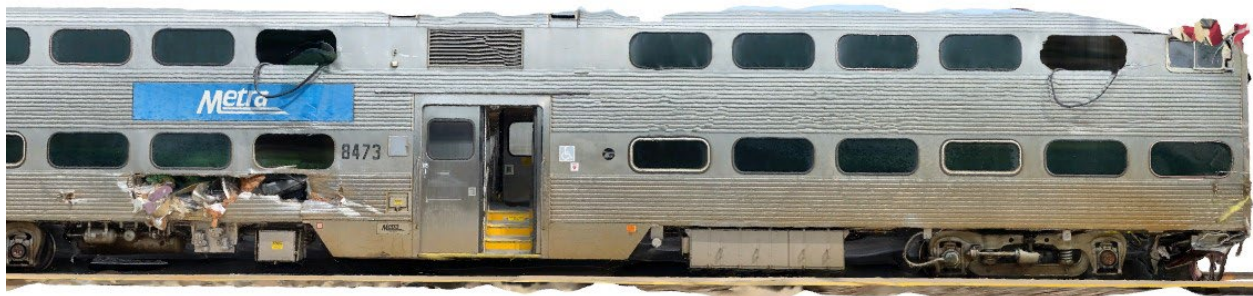
Figure 4. Screen capture of 3D point cloud depicting the damage to the right side of the lead cab car. (The appearance of damage to the top of the train is due to lack of information when rendering the 3D point cloud).

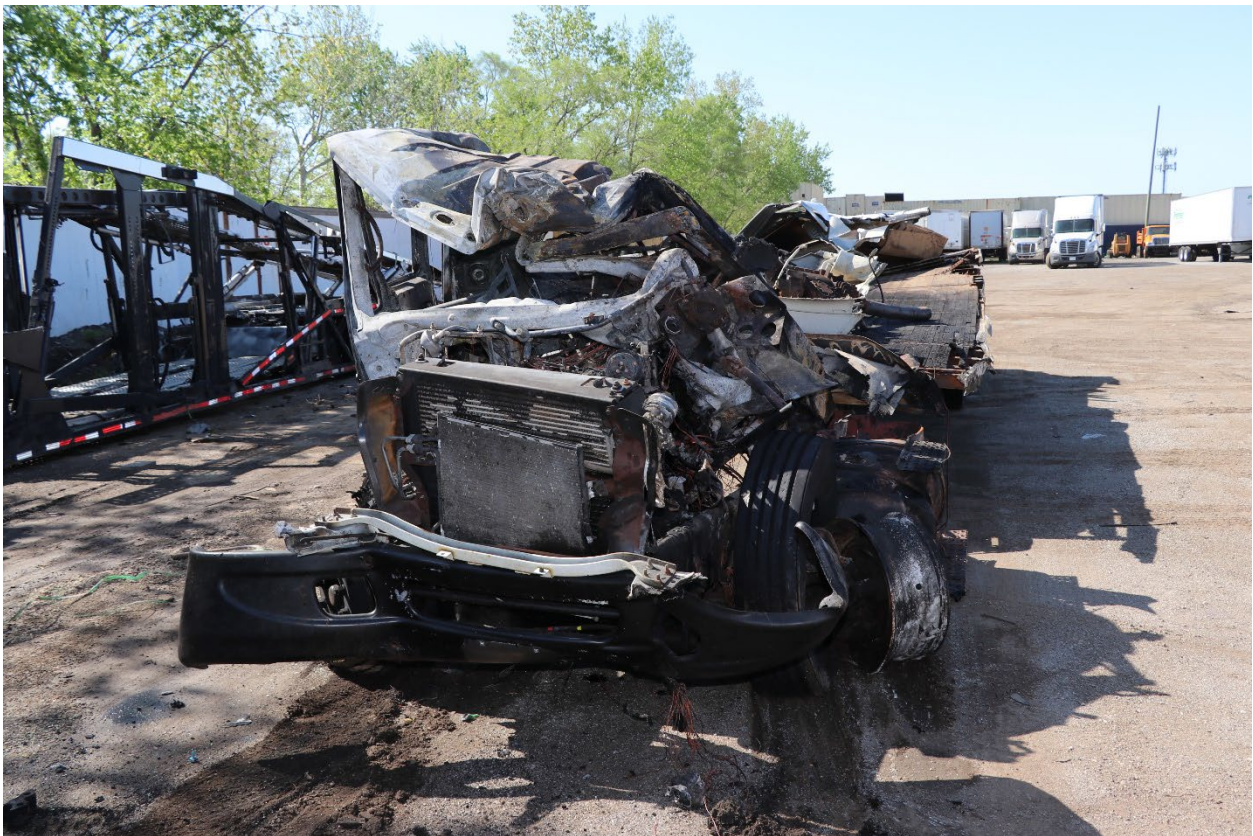
Figure 5. Photograph depicting the damage to the front and left side of the 2004 International box truck.

As a result of the impact the front of the truck was displaced laterally towards the passenger (right) side resulting in an offset angle of approximately 8.0° . The driver's side of the cab was collapsed downward and towards the passenger's side and the hood was torn off. The left front tire had separated from the wheel assembly and the left side of the front bumper was bent upward and inward towards the engine compartment. A post-crash fire ensued resulting in the cab of the truck as well as the engine compartment receiving thermal damage. The bed portion also received thermal damage.

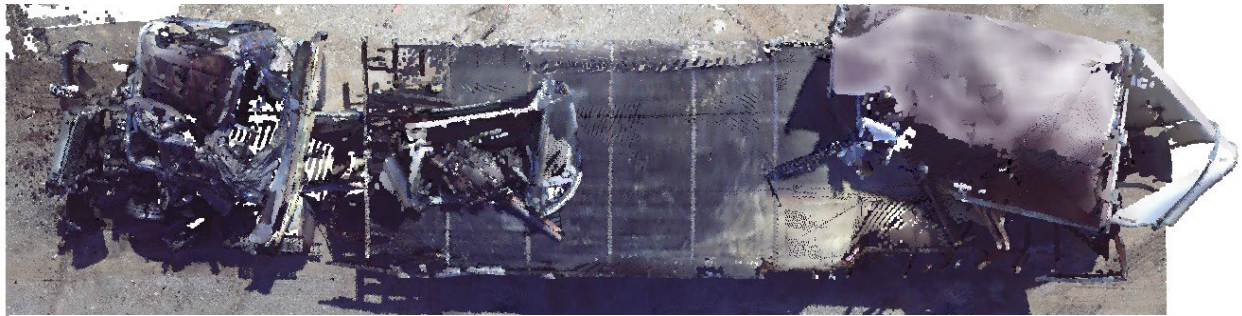
Figure 6. Image of the rendered three-dimensional point cloud depicting the damage sustained by the International.

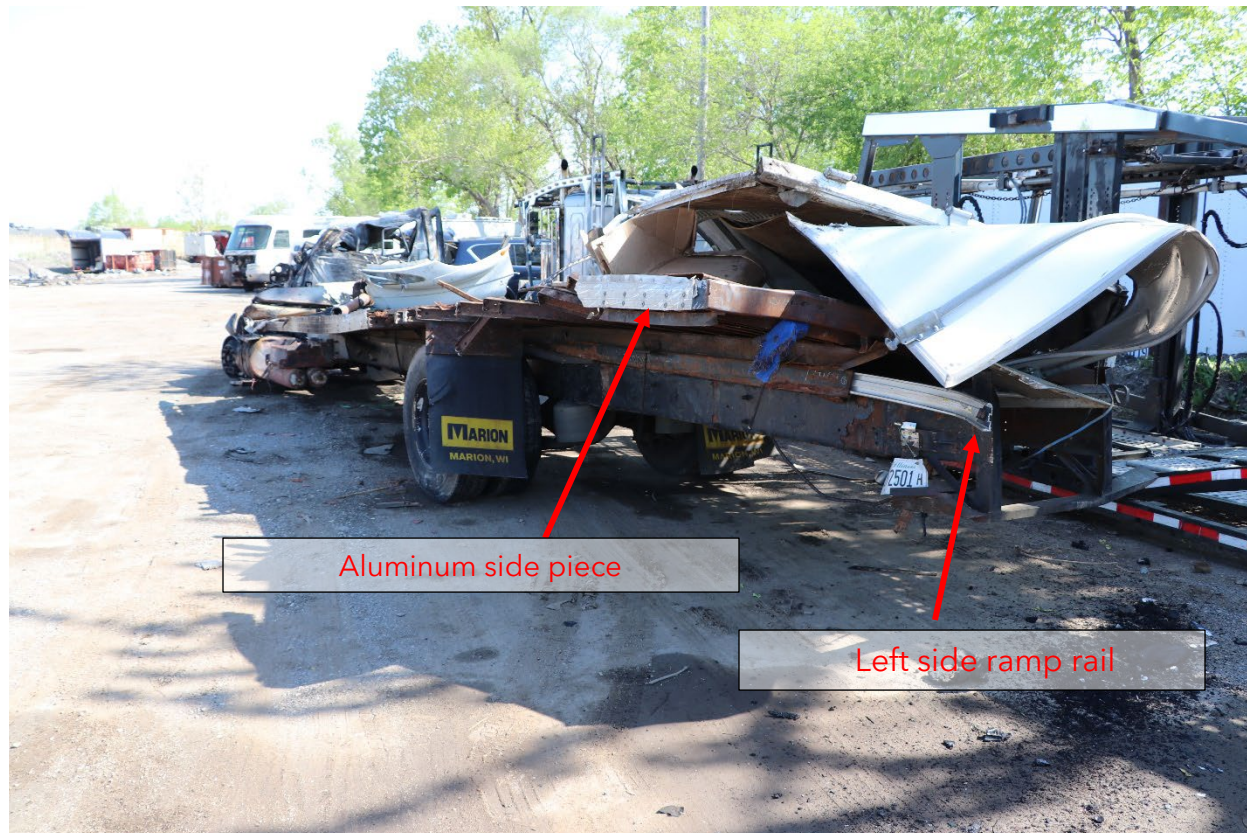
Figure 8 depicts the damage to the rear of the truck where a second impact area was identified. The frame rail was displaced laterally to the right side (passenger side) at an angle of approximately 12.5° . The left rear corner of the deck had been pushed upward and the left side of the rear end protection device was bent inward towards the center of the truck. Also noted was damage to the loading ramp. The left side rail had been torn from the ramp and displaced downward. Along the left rear side of the

bed was approximately 3.0 feet of aluminum from the box portion still bolted on. There were diagonal scratches throughout the length of the aluminum piece.

Figure 8. Photograph of the left rear depicting the area of the second impact.

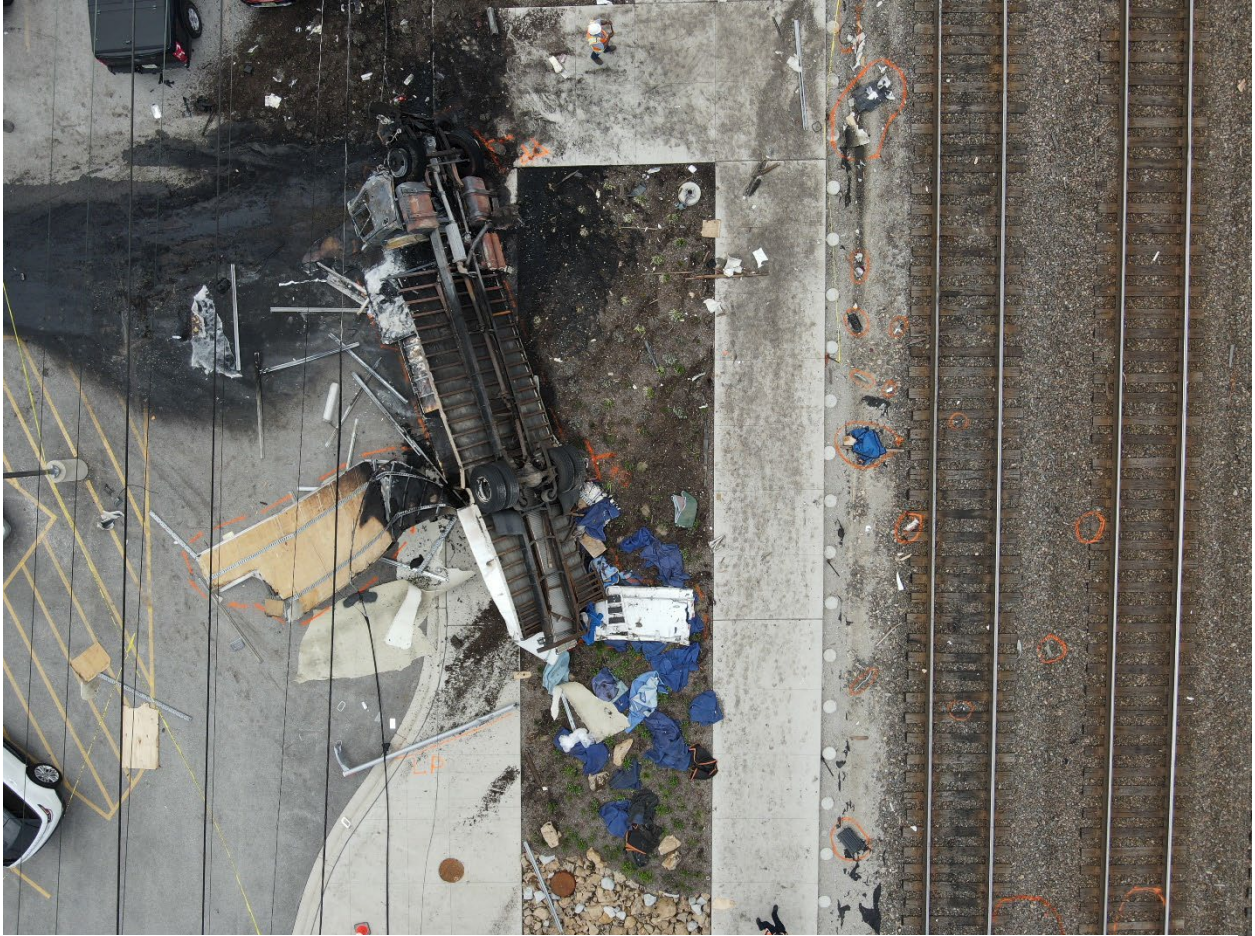
Figure 9. Photograph showing overhead view of the International in its position of final rest. Evidence was outlined by law enforcement personnel. (Source: Metra Police Department).

In its position of final rest, the truck had rotated approximately 110° clockwise relative to its original direction of travel. The truck came to rest on a sidewalk and partially in a parking lot that was southeast of the grade crossing. The front of the truck was approximately 33 feet south of track #3 and 96 feet east of South Prospect Road. The truck had overturned onto its left side.

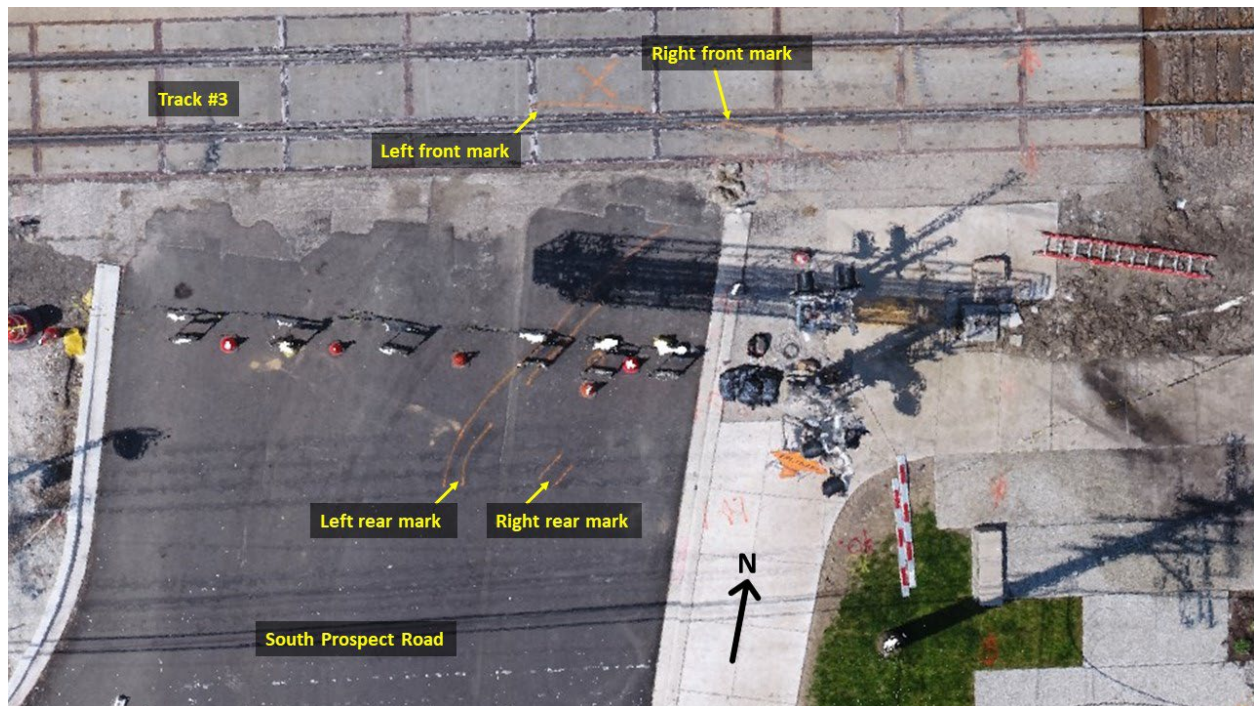
The onset of roadway evidence consisted of tire friction marks created by the left and right side rear dual tires as well as the left and right front tires. The rear marks initiated about 24 feet south of track #3 and 15.3 and 11.6 feet west of the eastern edge of the roadway for the left and right-side tires respectively. The left front mark began about 1.2 feet north of the southern rail of track #3 and was in line with the rear left mark. The right front mark began on the southern rail of track #3 and was in line with the rear right mark. Figure 12 is a screen capture of the 3D point cloud depicting the tire friction marks. The marks were highlighted with orange spray paint by law enforcement.

Figure 12. Screen capture of 3D point cloud depicted the location of the tire friction marks.

The front marks displayed a clockwise arced path of travel. The beginning of the rear marks showed a clockwise arced path of travel which transitioned too straight. The marks change directions clockwise approximately 27° relative to the

trucks original heading. Southeast of the tire friction marks was a black smear mark, scrapes, and fluids that led to the final rest of the truck.

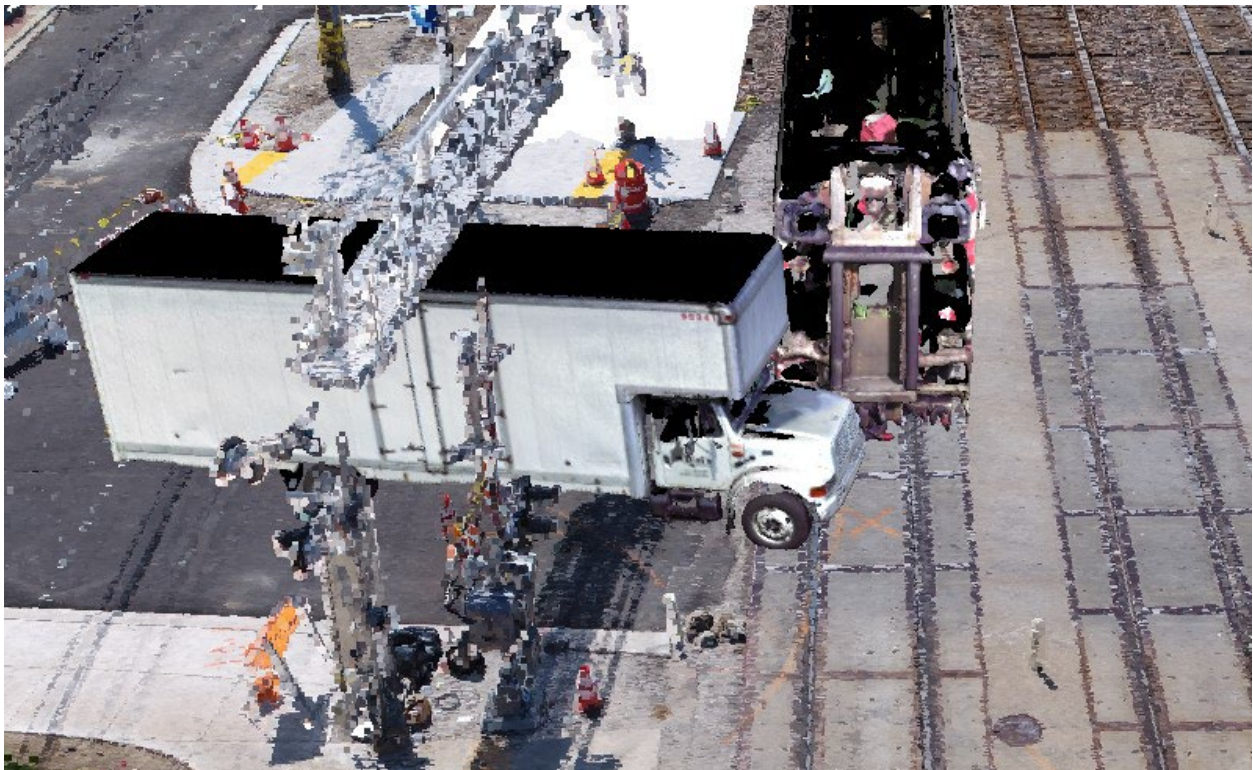
At impact, approximately 3.0 feet of the front of the truck overlapped the train right of way. Figure 13 is a screen capture of the 3D point cloud depicting the position of the truck and train at impact. The truck was an exemplar truck that had been scanned at the company's headquarters. The train was the collision cab car. Location of the truck was based on the tire friction marks identified at the scene.

Figure 13. Screen capture depicting location of truck when impacted by the Metra train.
