National Transportation Safety Board

HWY22MH009

VEHICLE FACTORS

Group Chair's Factual Report

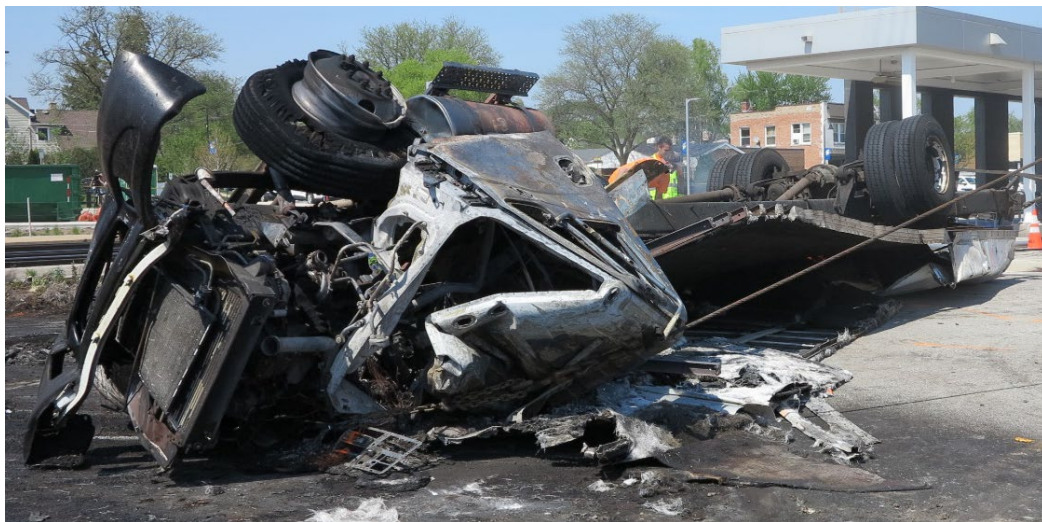
Figure 1: Photograph of the truck taken at the crash scene.

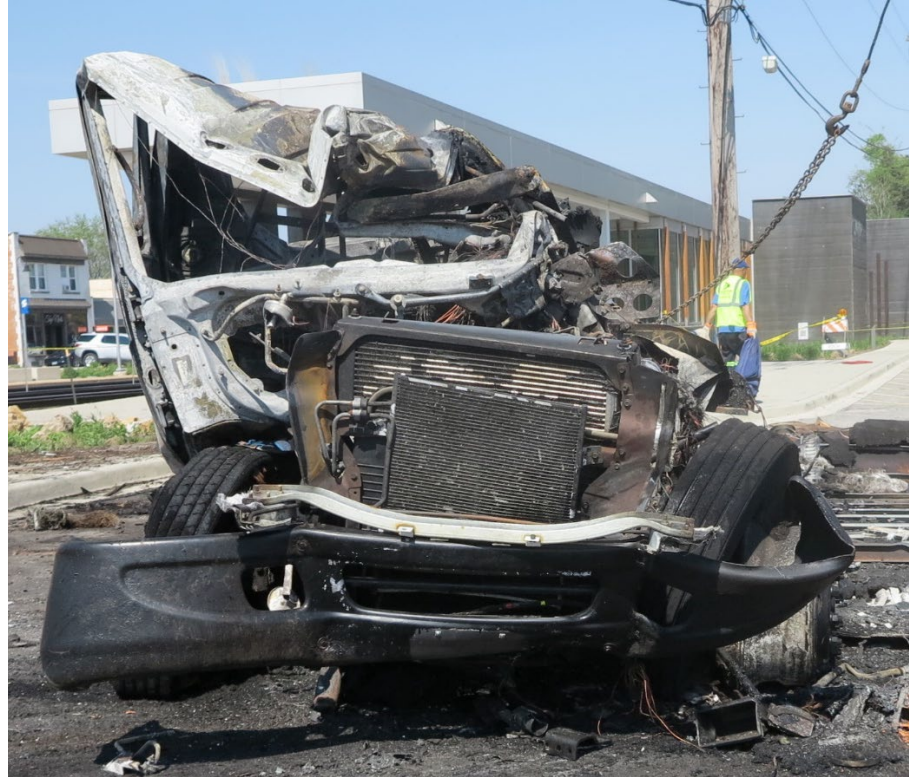
The complete truck sustained crash damage: the engine and passenger compartments sustained post-crash fire and thermal damage. All combustible materials, from the front bumper to the rear of the cab, were consumed by the post-crash fire. The hood had separated from the truck and was located a short distance away. The cab of the truck was crushed and displaced to the right, and both diesel fuel tanks were ruptured and empty, see **Figure 2**. Both frame rails were bowed towards the right.

Figure 2: Photograph of truck at crash scene after turned upright.

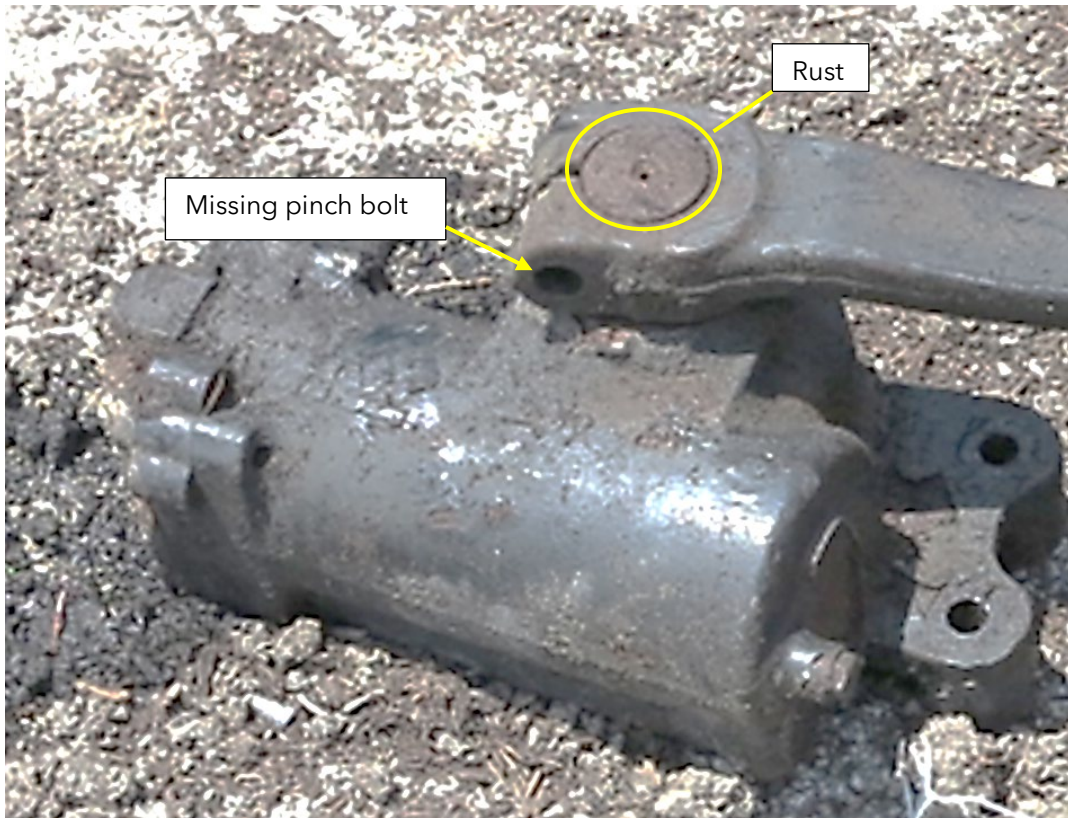
Sometime during the crash sequence, the steering gear and lower steering arm had separated from the truck and were located a short distance away. The drag link ball joint stud, which had been mounted to the left side upper steering knuckle arm, was broken. The pitman arm was loose on the sector shaft, and the pinch bolt securing the pitman arm to the sector shaft was missing. There was rust around the splined connection between the pitman arm and sector shaft, which is indicative of a pre-existing condition, see **Figure 3**.

Figure 3: Photograph of the steering gear box, sector shaft, and pitman arm

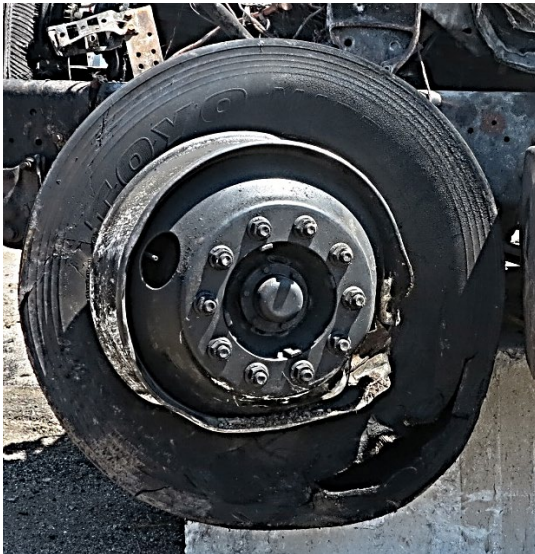
- The tire mounted to the left side of axle 1 sustained crash, fire, and thermal damage, see **Figure 4**.
- The outboard sidewall of the left-front tire was punctured.
- The wheel mounted to the left side of axle 1 sustained substantial crash damage.
- The tire mounted to the right side of axle 1 sustained crash, fire, and thermal damage, see **Figure 5**.
- Both inboard and outboard sidewalls of the right-front tire were missing.
- Both inside and outside tires mounted on the right side of axle 2 sustained abrasions in their respective tread areas along with rubber having been torn from their outboard shoulders.

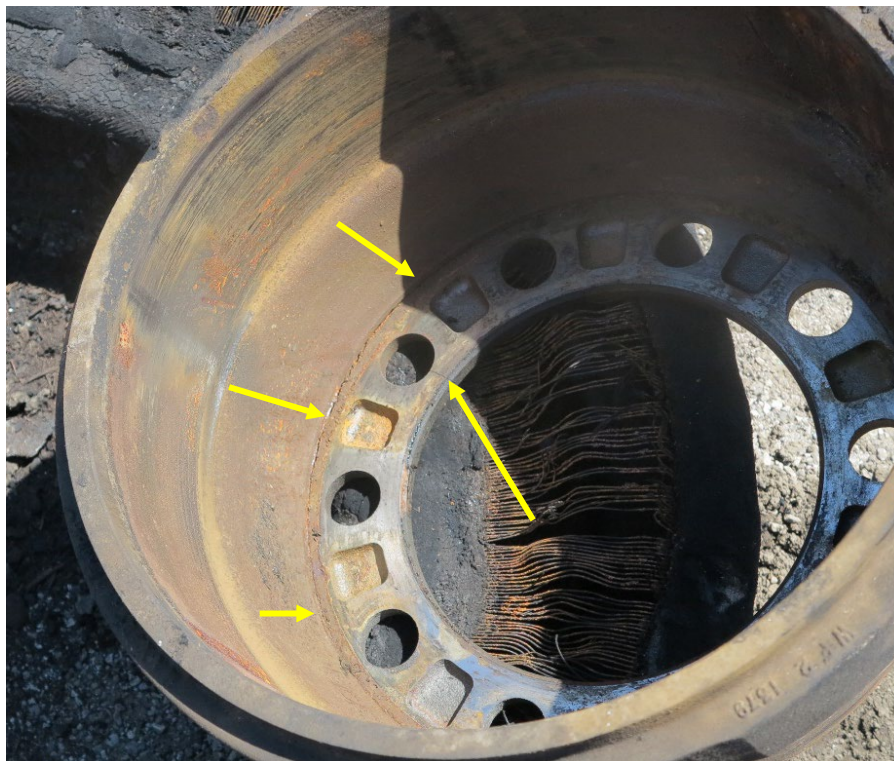
The left-front brake drum was cracked through one wheel stud hole, and along the diameter of the drum face, see **Figure 6**. It was undetermined if all or part of the drum crack was pre-existing or because of the crash.

Figure 6: Photograph of the cracked left-side brake drum

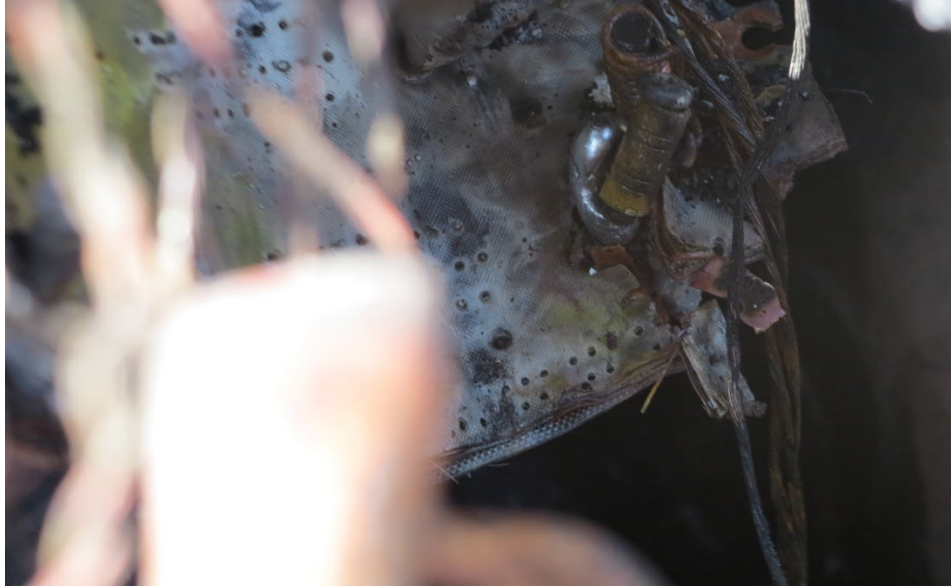
The Engine Control Module (ECM), which had been mounted on the left side of the engine, had been consumed by the post-crash fire, see **Figure 7**.

Figure 7: Photograph of fire damaged ECM circuit board.
