# National Transportation Safety Board

RRD23FR001

## **COMBINED GROUP FACTUAL REPORT**

At approximately 9:21 pm on October 14, 2022, two contractor employees from JPC Group Inc. were struck and killed by a westbound Port Authority Transit Corporation (PATCO) train called Westbound #1 on track 2 on the Benjamin Franklin Bridge in Camden, New Jersey.

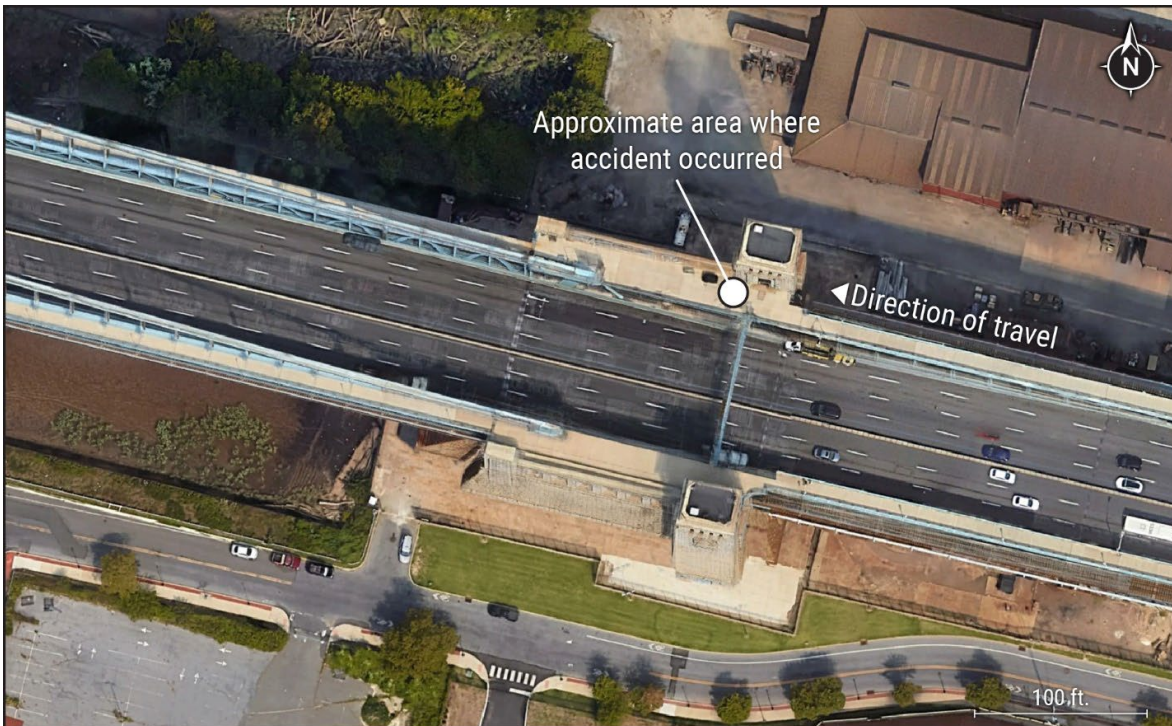
There was a planned outage on track 2 for contract concrete work. However, at the time of the accident, track 2 had not been taken out of service when the contractors entered the bridge in a close clearance area. The striking train was traveling at a recorded speed of 33 mph. The train was put into emergency braking, stopping about 1 ½ car lengths from where the 2 contractors were struck.

**Figure 1.** Overhead view of the accident location

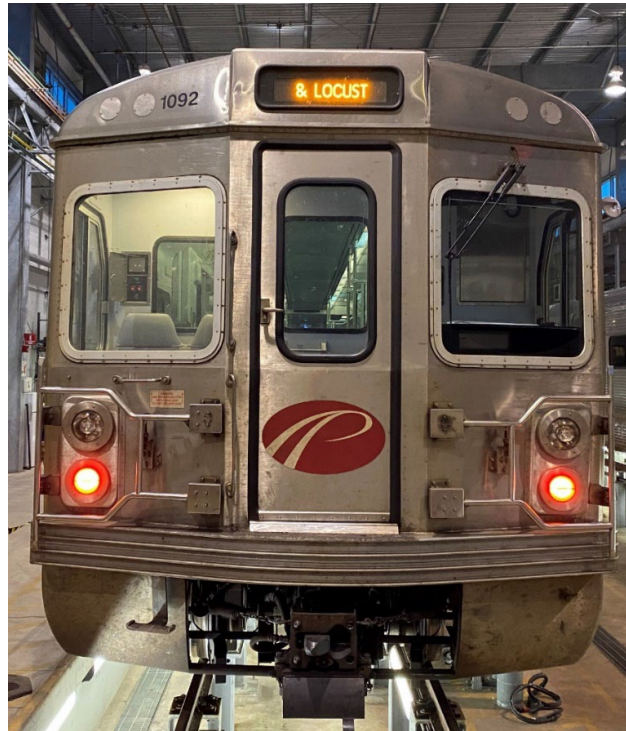
On October 17, 2022, NTSB investigators visited PATCO's facility in Lindenwold, NJ to examine the lead transit railcar 1092. Investigators observed testing of the three actions the brake system will go into emergency braking, and all three were functioning as intended.

**Figure 4.** - Lead Railcar 1092
