Norfolk Southern Railway Train Derailment with Subsequent Hazardous Materials Release and Fires

East Palestine, Ohio
February 3, 2023

Accident Overview

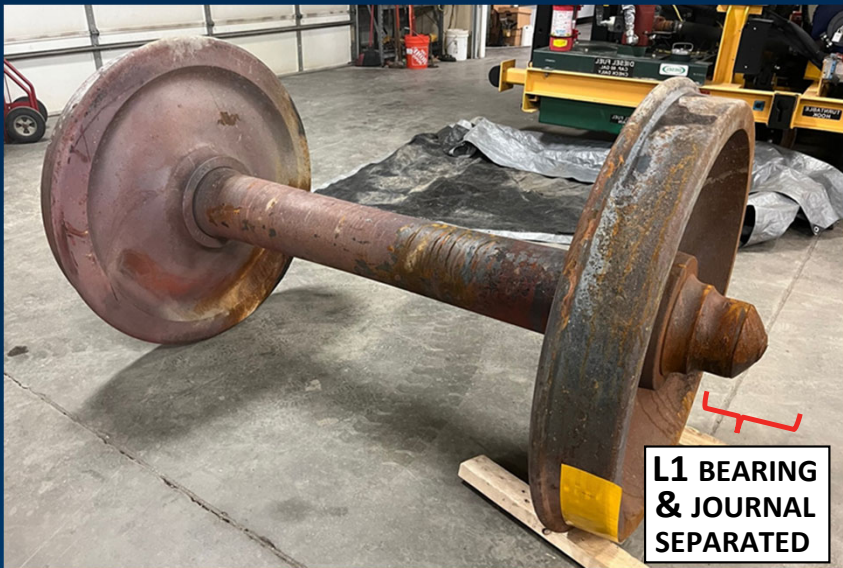
Wheel Set 1

L1 Journal

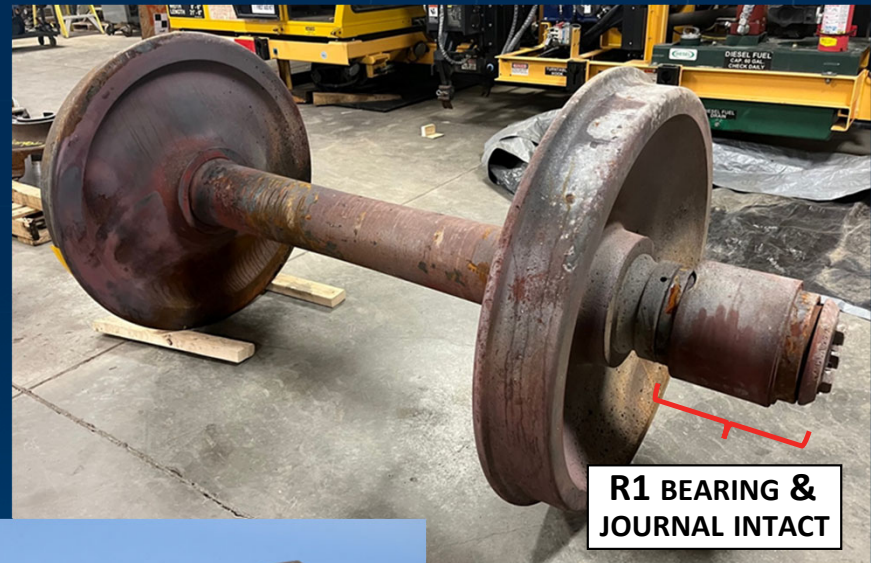
Wheel Set 1 –
Opposite View

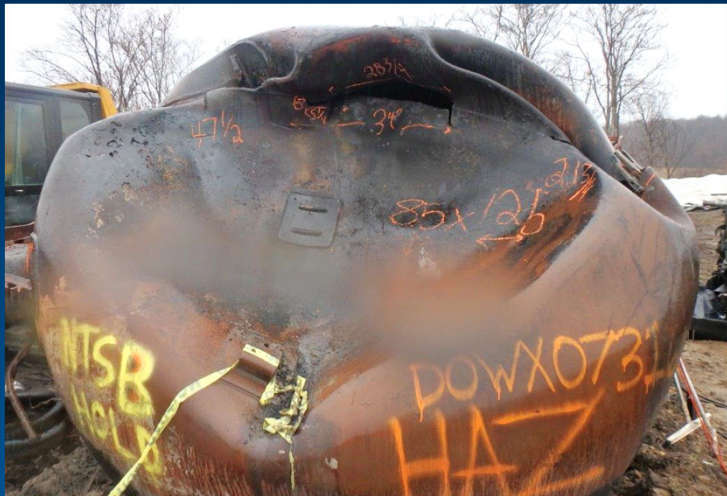
DOWX73168 cracked tank head

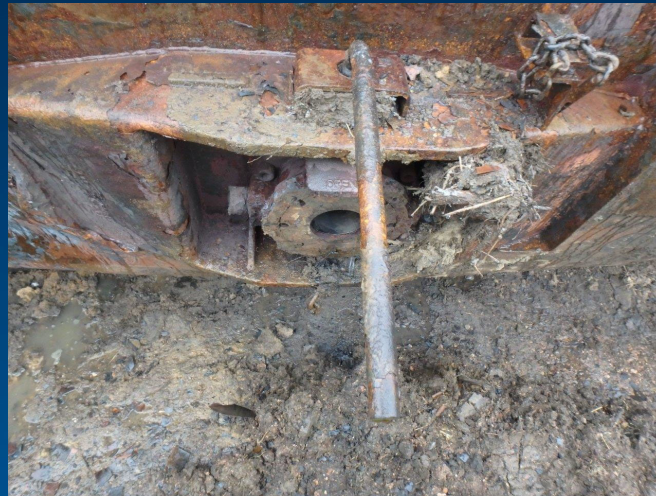
SHPX211226 open bottom outlet

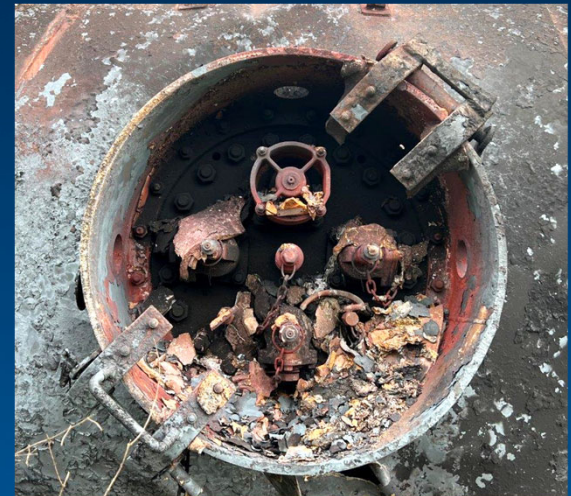
OPX80235 missing aluminum PH cover

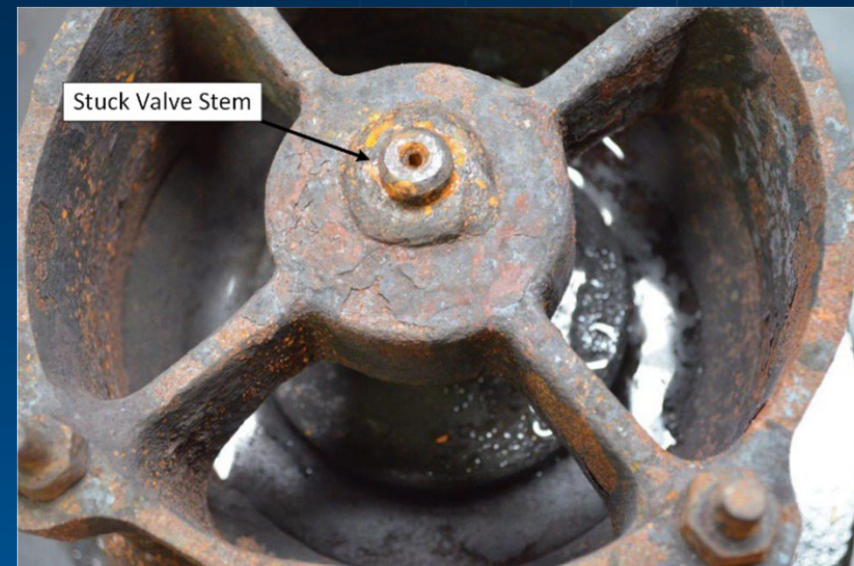
- No polymerized material obstructed pressure relief devices
- Several O-rings were heat damaged
- Valve and pressure relief device components for one tank car destroyed by fire
- Pressure relief device components were severely corroded
