**NATIONAL TRANSPORTATION SAFETY BOARD**  
Office of Aviation Safety  
Washington, D.C. 20594

**Airworthiness Group Chairman's Factual Report**

DCA19FA089

Operator: CommutAir flight 4933, dba United Express  
Location: Presque Isle Airport (KPQI), Maine  
Date: March 4, 2019  
Time: 1129 eastern standard time  
Airplane: EMB-145XR, registration N14171

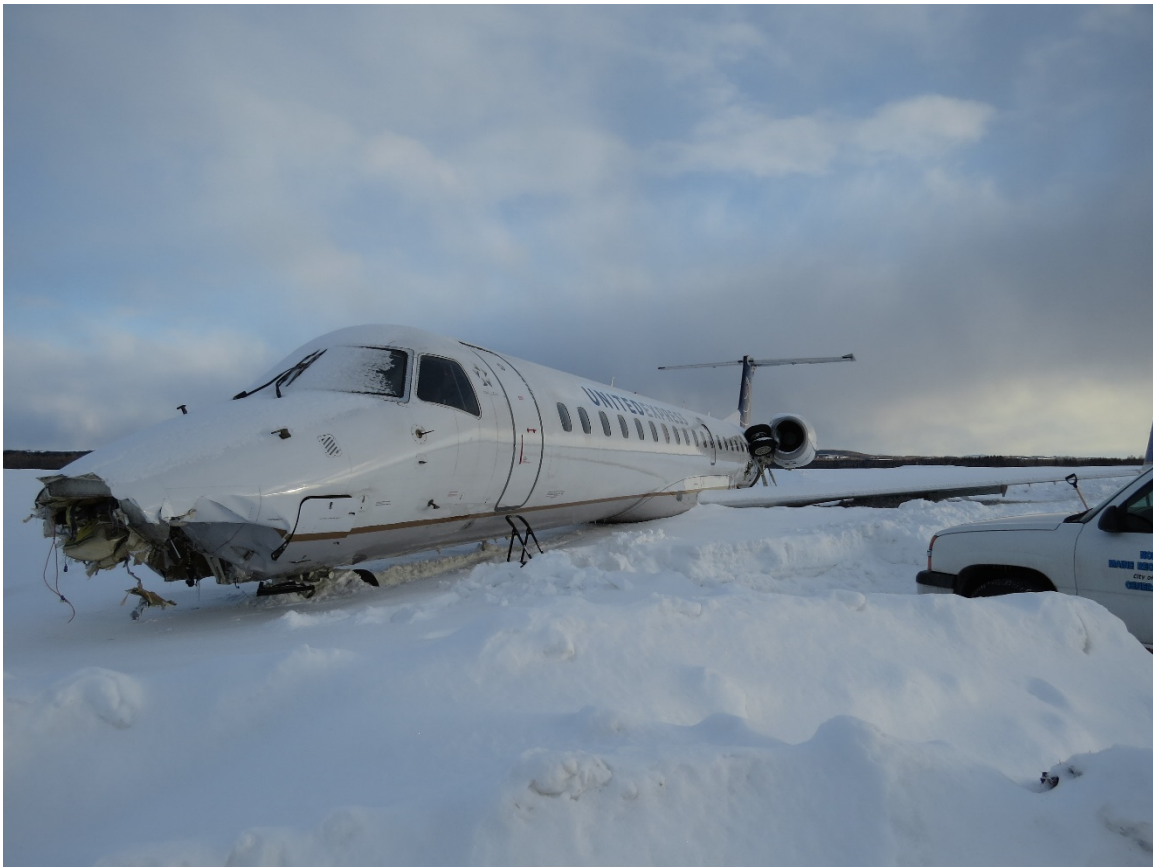
The aircraft came to rest on packed snow to the right of runway 1 (see figure 1).

Figure 1  
Overall view of the aircraft

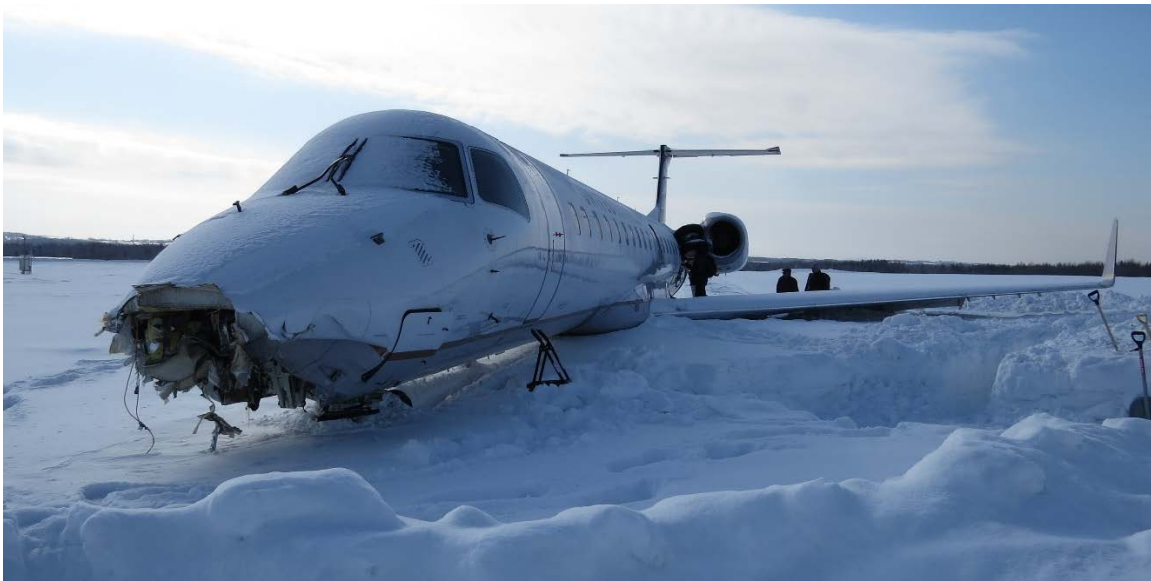
The nose cone, radar, glide slope antenna, and nose gear doors were all missing.

The nose of the aircraft was damaged up to the point of the first bulkhead on the upper side and damaged or missing back through the nose gear position on the bottom.

The nose gear wheels were found aft of their normal position. The exact broken/damaged components could not be determined due to visibility restrictions (see figure 2).

Figure 2  
Aircraft nose area damage

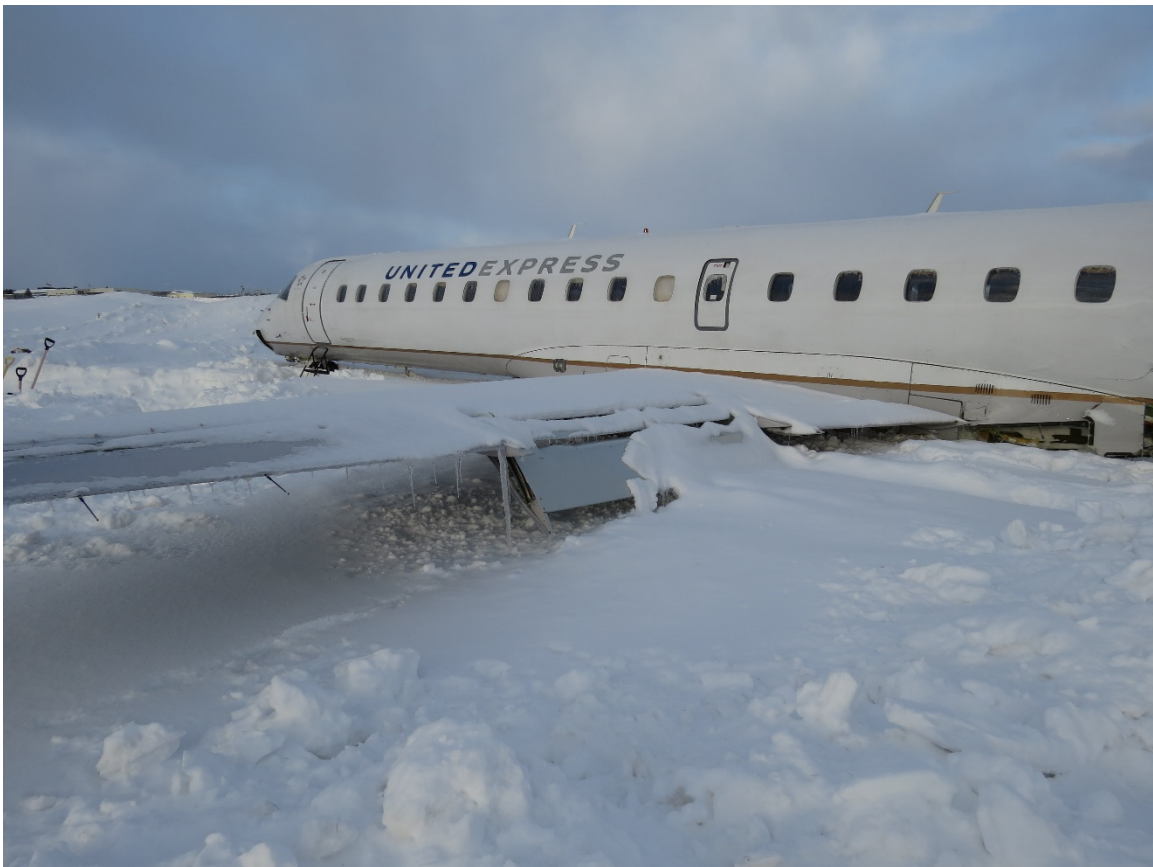
The left wing inboard flap was found to be in a position where the flap trailing edge was above the full retracted position, and the flap was shifted aft (see figures 3 and 4).

Figure 3  
Left wing trailing edge

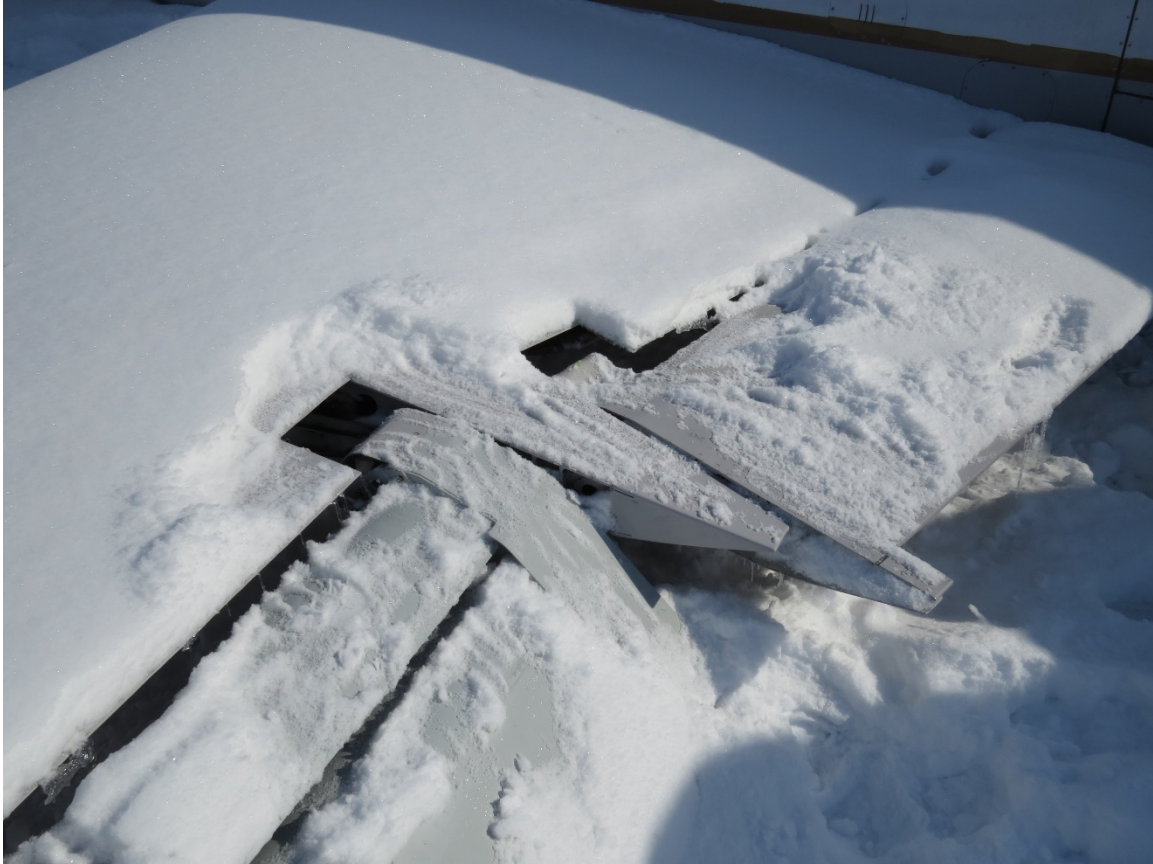
The left wing outboard flap appeared to be extended – the exact extension angle could not be determined. The inboard jackscrew was broken, and there was a crack in the aft most flap panel close to the outboard edge.

Figure 4  
Left inboard and outboard flaps

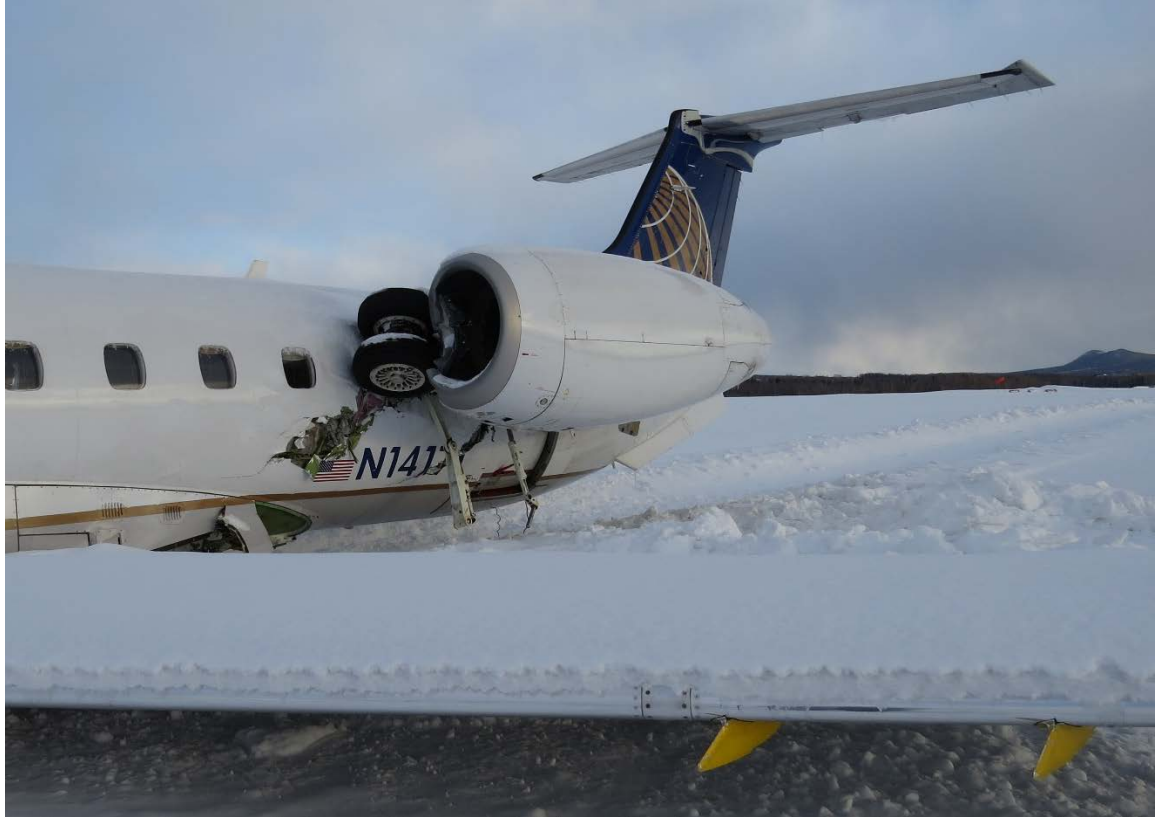
Figure 5

The left main gear was found lodged between the left engine nacelle and fuselage. There was ripped and damaged fuselage structure in the area of the gear, and the fuselage was distorted around the gear wheels. The landing gear trunnion was found to have penetrated into the left engine gear box (see figures 5 and 6).

Left main landing gear lodged between left engine nacelle and the aircraft fuselage

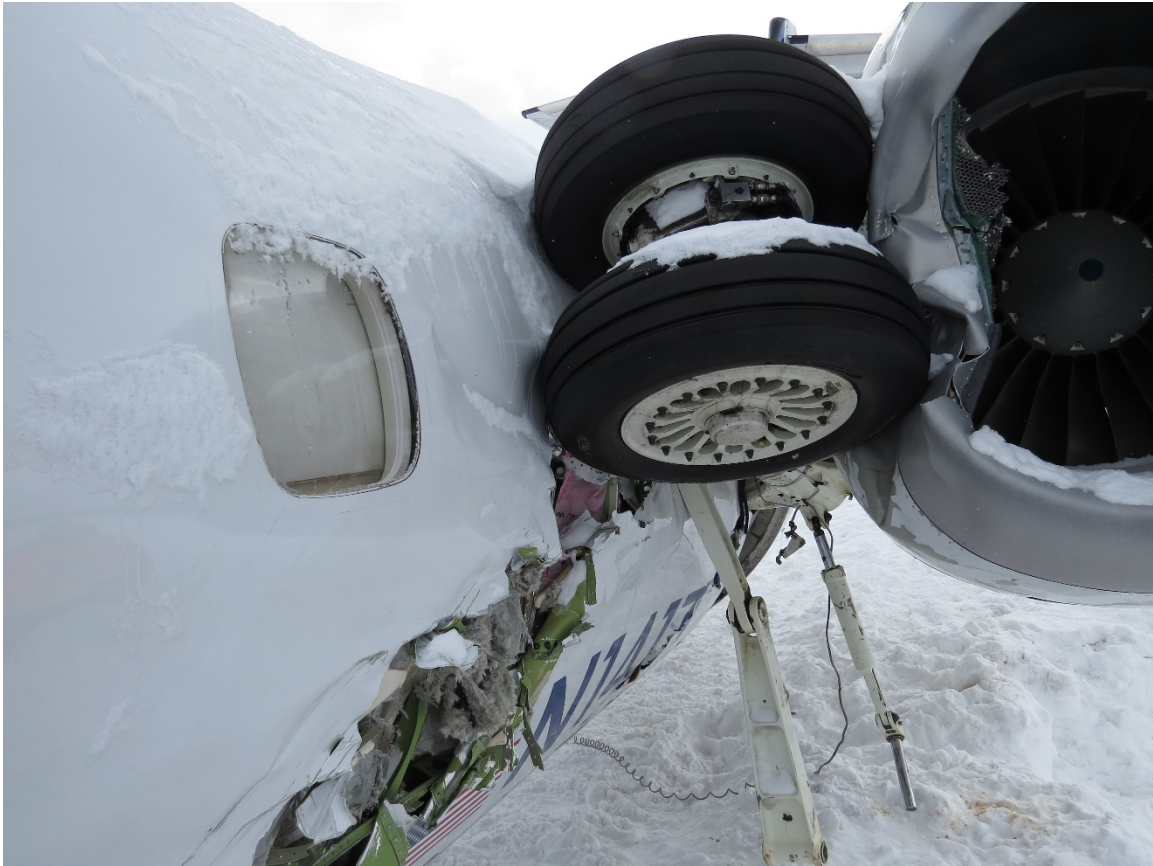
Figure 6

Left main landing gear lodged between left engine nacelle and the aircraft fuselage – close up view

The left engine inlet and nacelle were distorted around the wheel location. There was rotational scoring in the engine inlet in the area of the fan blades. The fan blades could be rotated using minimal force. Approximately ½ of the fan blades had leading edge damage (nicks or gouges).

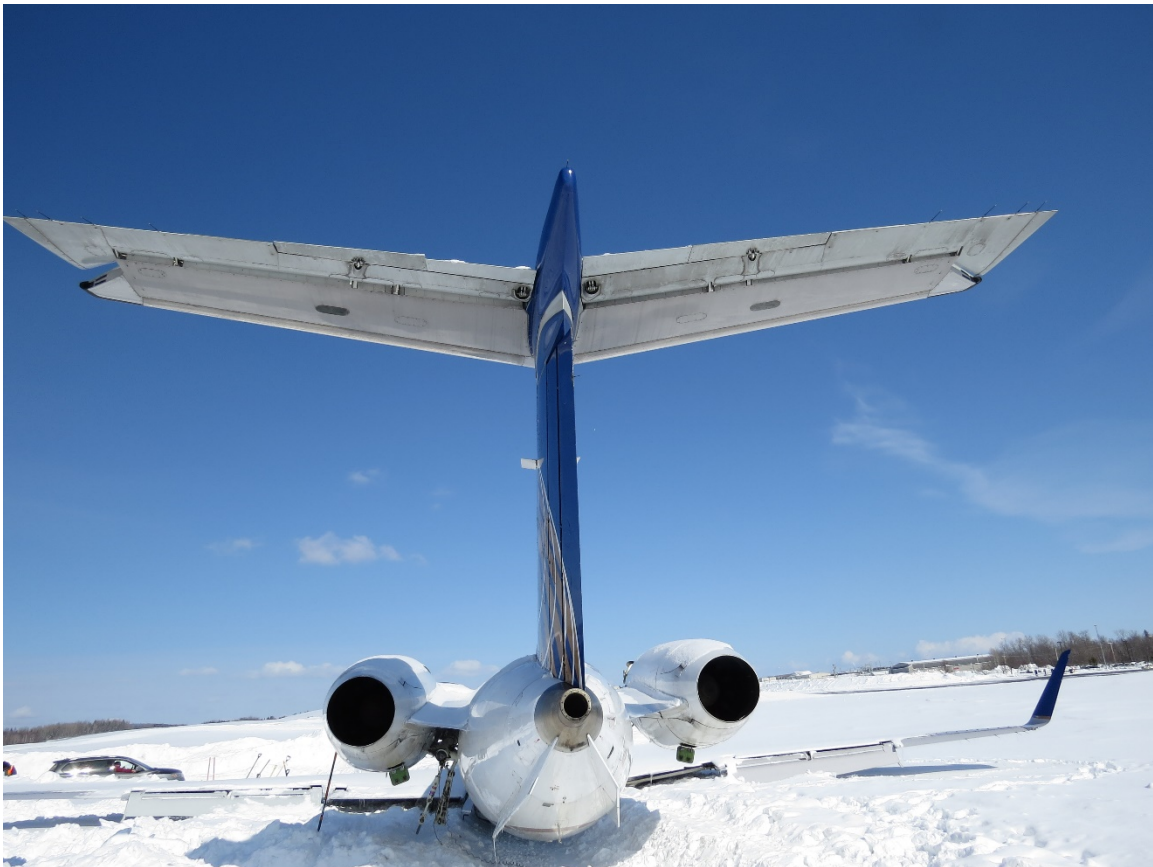
The aft fuselage appeared to be undamaged. The APU inlet appeared to be intact and undamaged (see figure 7).

Figure 7  
Aft fuselage and tail area

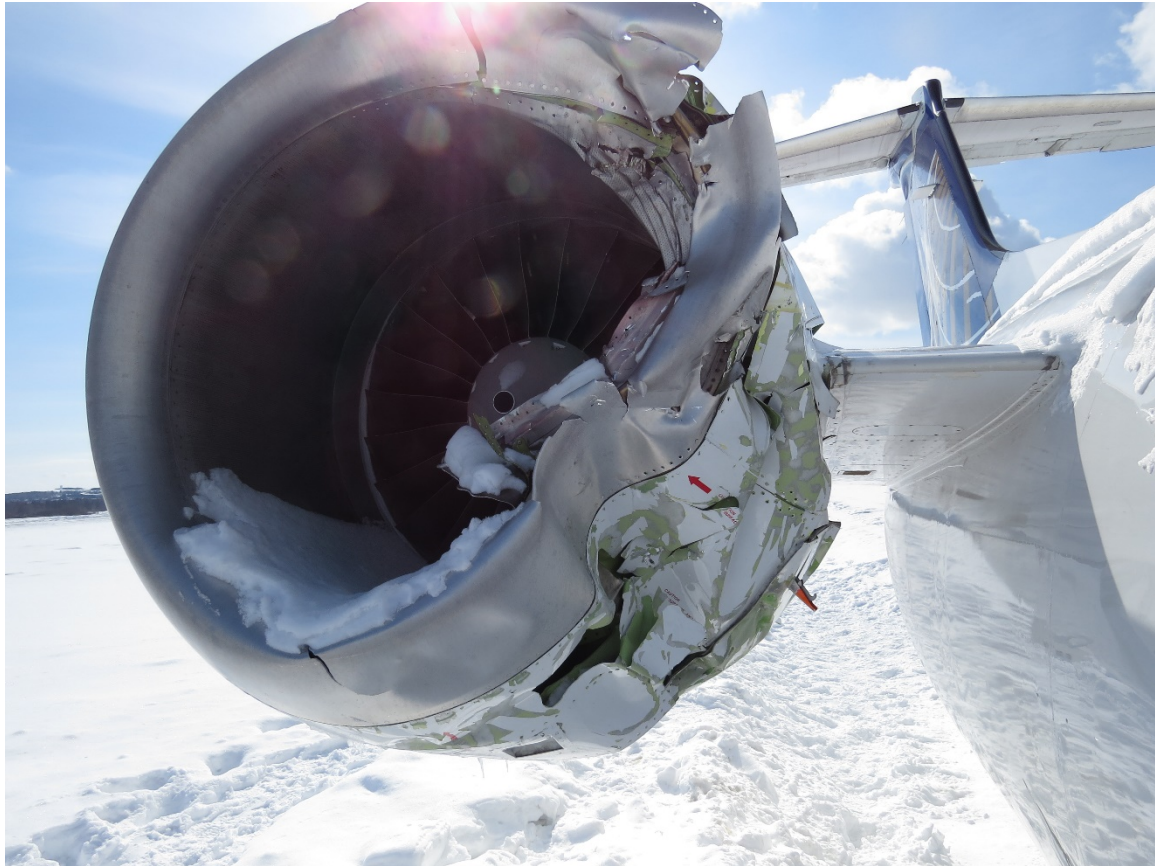
The right engine inlet was damaged on the inboard side (see figure 8). There were some marks that appeared to be consistent with rubber scuff marks noted on the fuselage in the area adjacent to the right engine inlet. There was rotational scoring in the engine inlet in the area of the fan blades. The fan blades could be rotated using minimal force. Approximately  $\frac{1}{2}$  of the fan blades had leading edge damage (nicks).

Figure 8  
Right engine nacelle damage

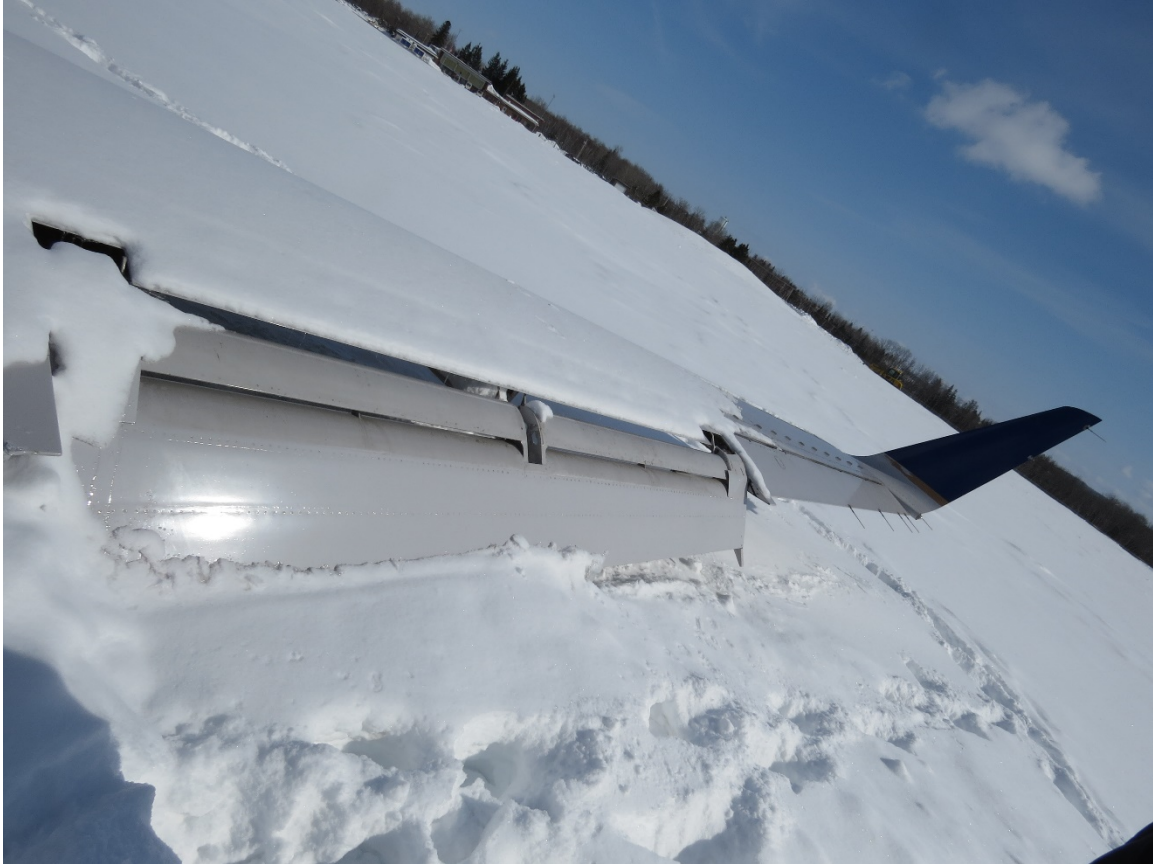
The right wing outboard flap appeared to be extended – the exact extension angle could not be determined (see figure 9). The inboard jackscrew was broken, and there was a crack in the aft most flap panel close to the outboard edge.

Figure 9  
Right wing outboard flap and aileron

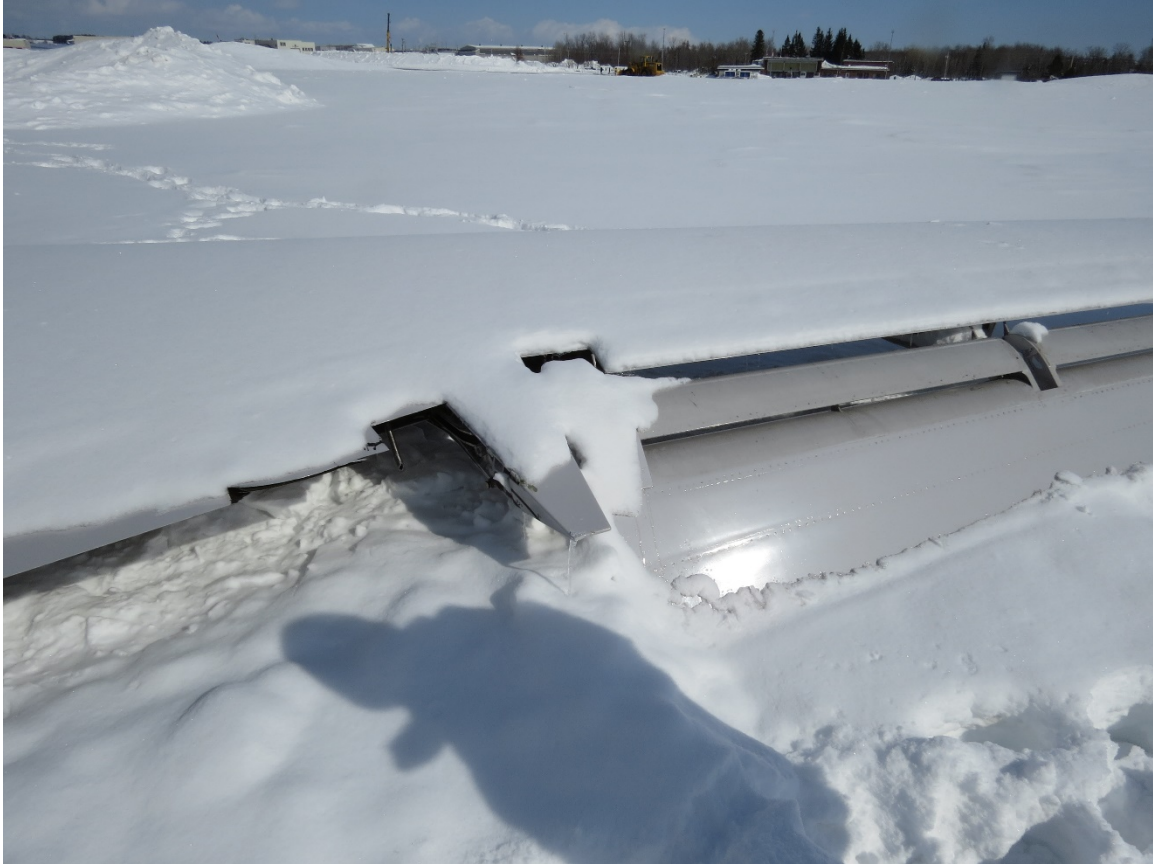
The right wing inboard flap was missing. The inboard jackscrew was missing, and the outboard jack screw was broken (see figure 10).

Figure 10  
Right wing inboard flap position

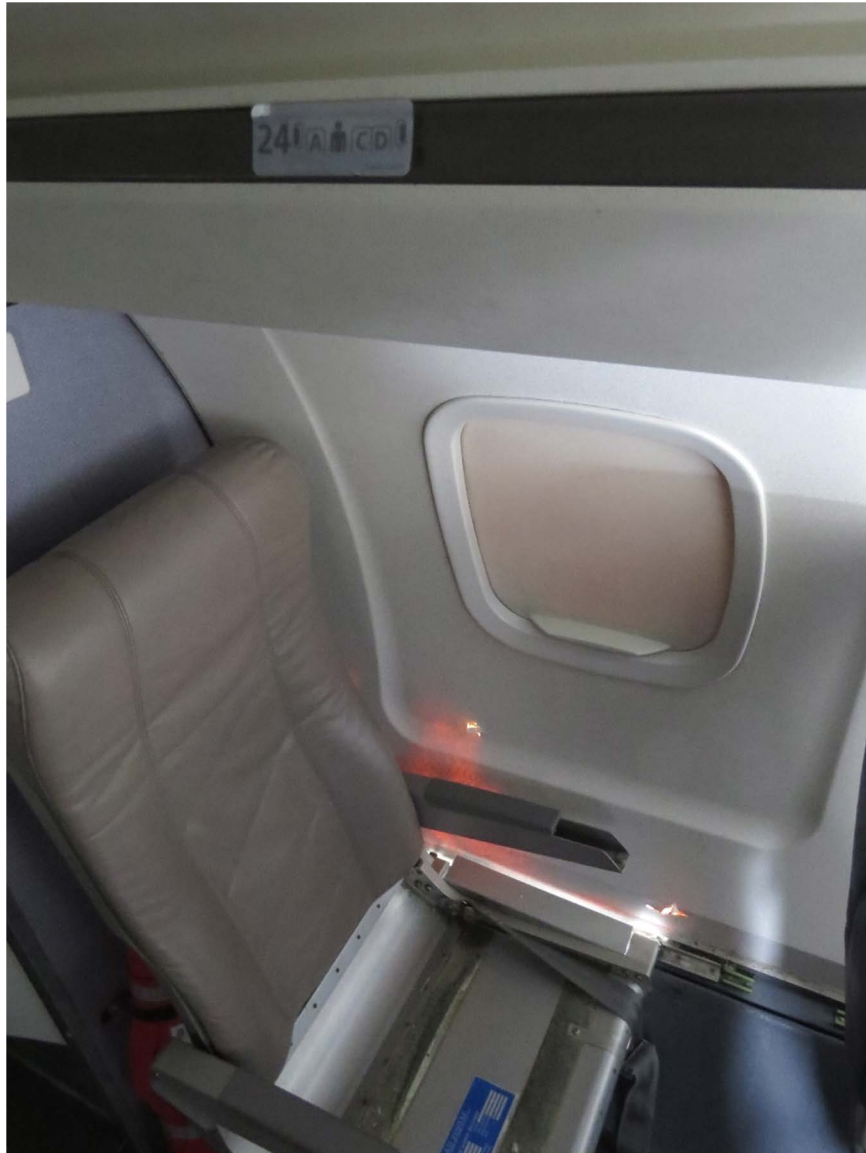
On the fuselage cabin wall in the area of seat 24A, two small penetration holes were noted. Both of these holes appeared to have composite material present across the diameter of the holes (see figure 11).

Figure 11  
Fuselage penetration points in the area of seat 24A

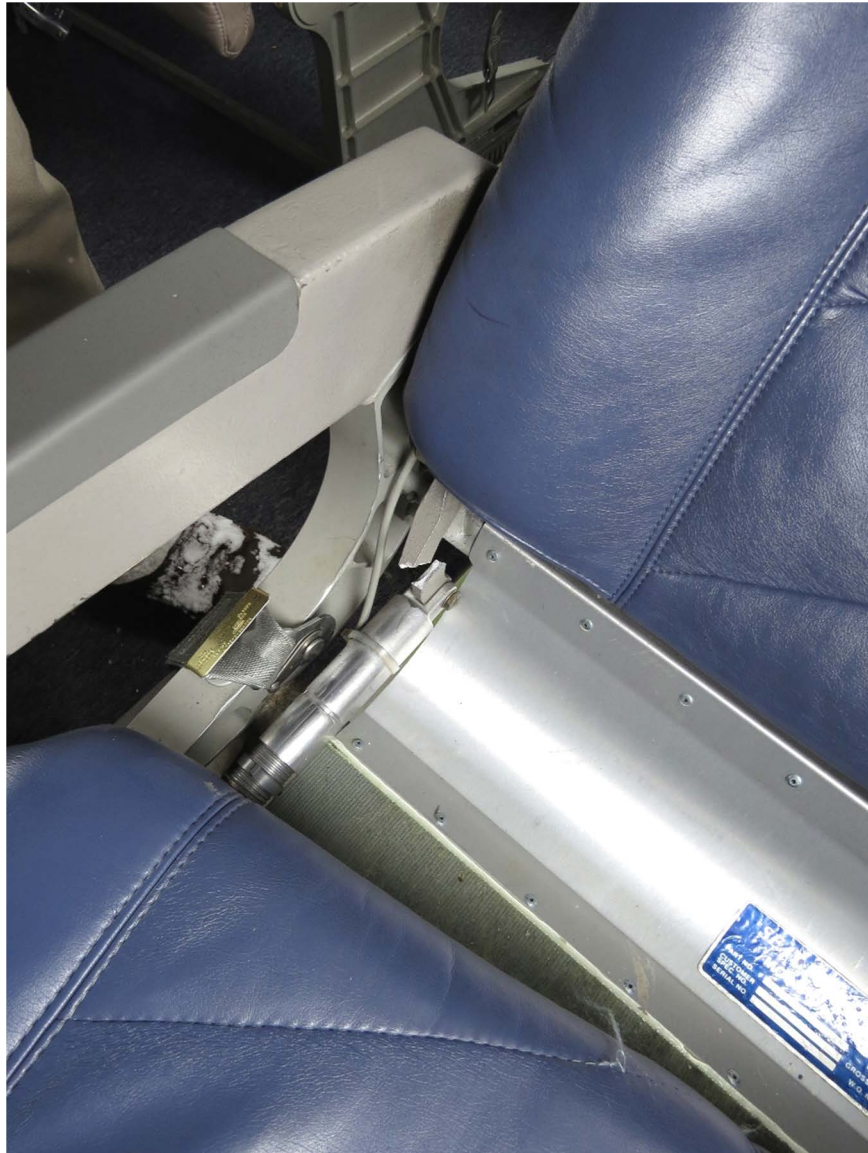
There were 5 seats noted (9A, 8A, 9D, 7C, and 3C) where the lower seat hinge on the recline actuator was broken (see figure 12).

Figure 12  
Broken recline actuator hinge on seat 9A
