Gas Development Laboratory  
Failure Analysis Report

Examination of 6" IPS PE pipe and 1¼" IPS Tapping Tee  
Address: 340 Elwood Ave., Hawthorne, NY

Report Number: GT-11-029

Gas Incident Number: GCE-1209

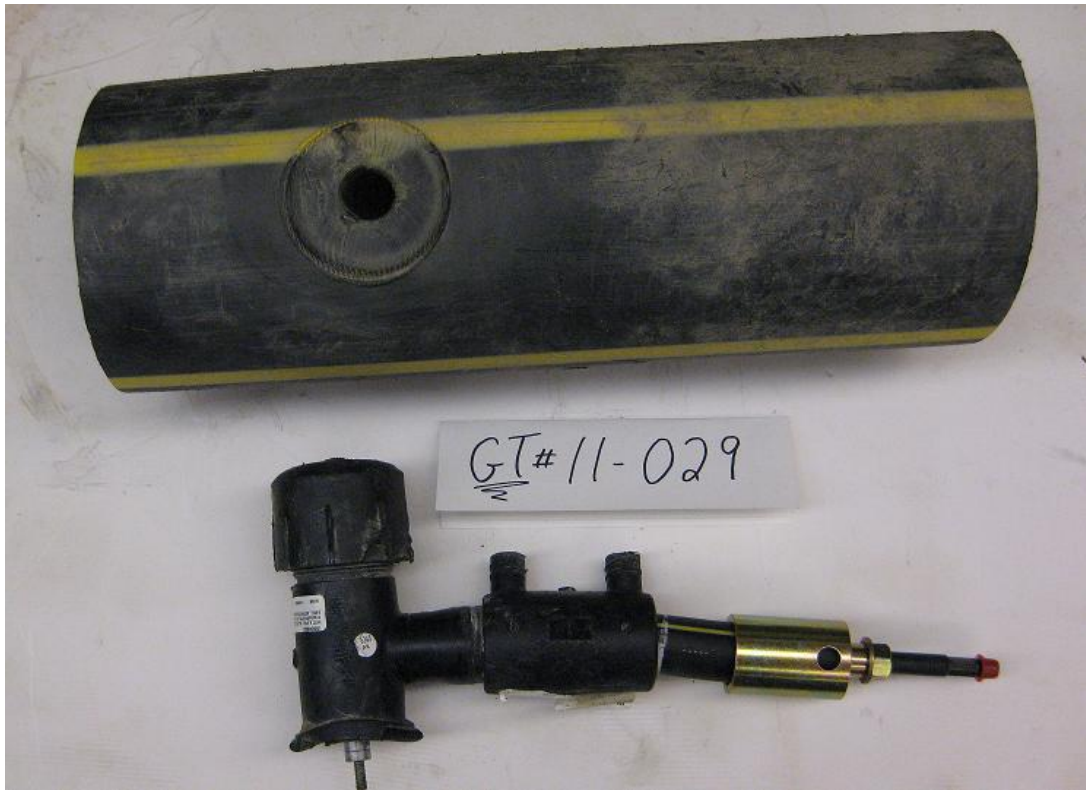
The sample consisted of a 20" length of 6" IPS Performance pipe. Separated from the 6" pipe was a 1 1/4" IPS x 1" IPS Central Plastics Tapping Tee. Electrofused onto this tapping tee was a 1 1/4" x 1" EF Reducer that was connected to a 6" length of 1" IPS Performance pipe. (See Figure 1)

Figure 1 –Overall picture of sample

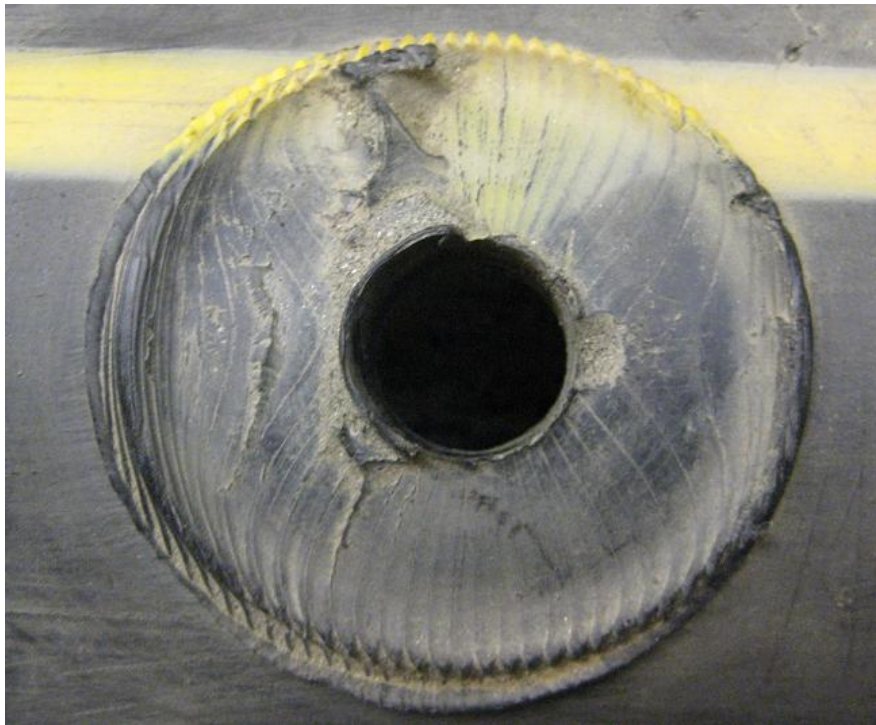
Upon initial visual inspection, the fusion area on the 6" pipe, where the Tapping Tee connected to the main, showed obvious signs of cold fusion. The fused area on both the main and the tapping tee was very smooth and showed signs of poor adhesion between the two components. (See Figures 2-3) It is likely that during the fusion process, excessive pressure was applied to the tapping tee, thereby not allowing the two materials to form the proper molecular bonding between the 2 heated surfaces. In addition, only two melt beads were observed partially along the edge of the fused area on the pipe. It is typical of a sound fuse to have three melt beads present at the edge of the entire fusion area. (See Figures 4-5) In addition, upon further inspection of the 6" pipe, no scraping patterns were observed around the fusion area. (See Figure 6) In order to ensure a good fuse, the fusion area must be properly prepared to remove the oxide layer on the surface of the pipe to promote good adhesion. This preparation involves scraping the pipe where the fusion will take place. The absence of scrape marks around the fusion area further reveals the quality of the installed fuse.

The lab has determined that the probable cause for the leakage of the sample was the cold fuse present between the 6" PE main and the Central Plastics Tapping Tee. The Lab did not witness the occurrence of the leak in the field, and therefore cannot definitively state where the leakage originated. However, due to the installation of the Tapping Tee occurring within the prior year and the observation of the cold fuse present on the sample, it is likely that the leak originated at the cold fuse. This cold fuse was the result of poor preparation and poor installation of the tapping tee onto the main. The fusion area on both components did not appear to be scraped and showed little sign of adhesion. Additionally, only two melt beads were present at the edge of the fusion area instead of the correct three beads, and no scraping was observed on the 6" pipe around the fusion area. Further signs of poor workmanship were noted on the EF Reducer and 1" pipe attached to the tapping tee. Both components were positioned at a downward angle suggesting that they were misaligned during installation. Also, the portion of 1" pipe that had been inserted into the EF Reducer was not sufficiently scraped during installation. All of these findings suggest that the necessary steps were not taken during the installation of the subject components.

Figure 2 – Picture of fusion area on 6" PE main

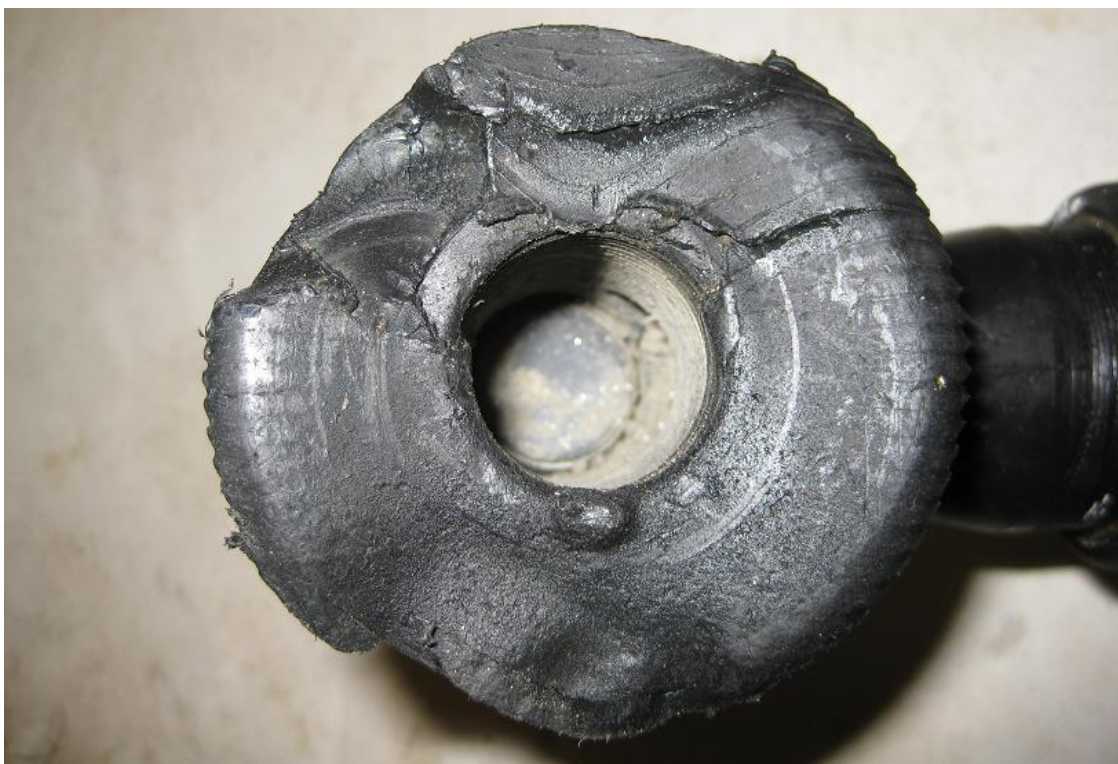
Figure 3 – Picture of fusion area on Tapping Tee

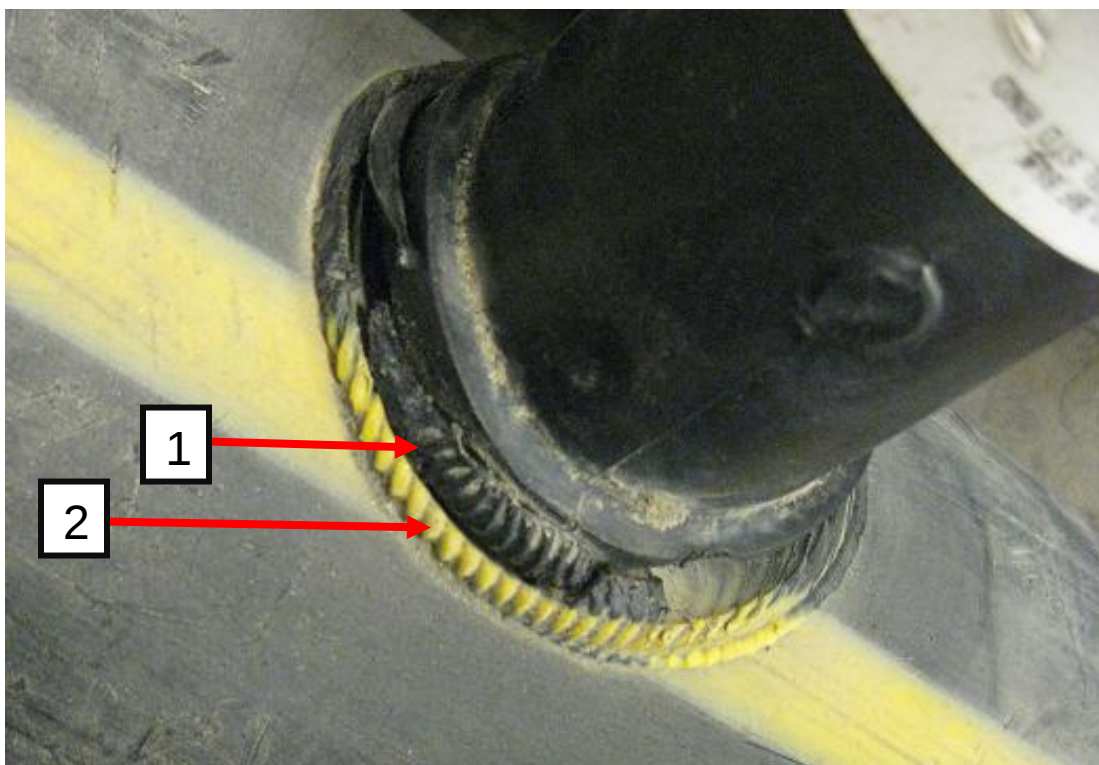
Figure 4 – Picture of two bead melt pattern on subject sample

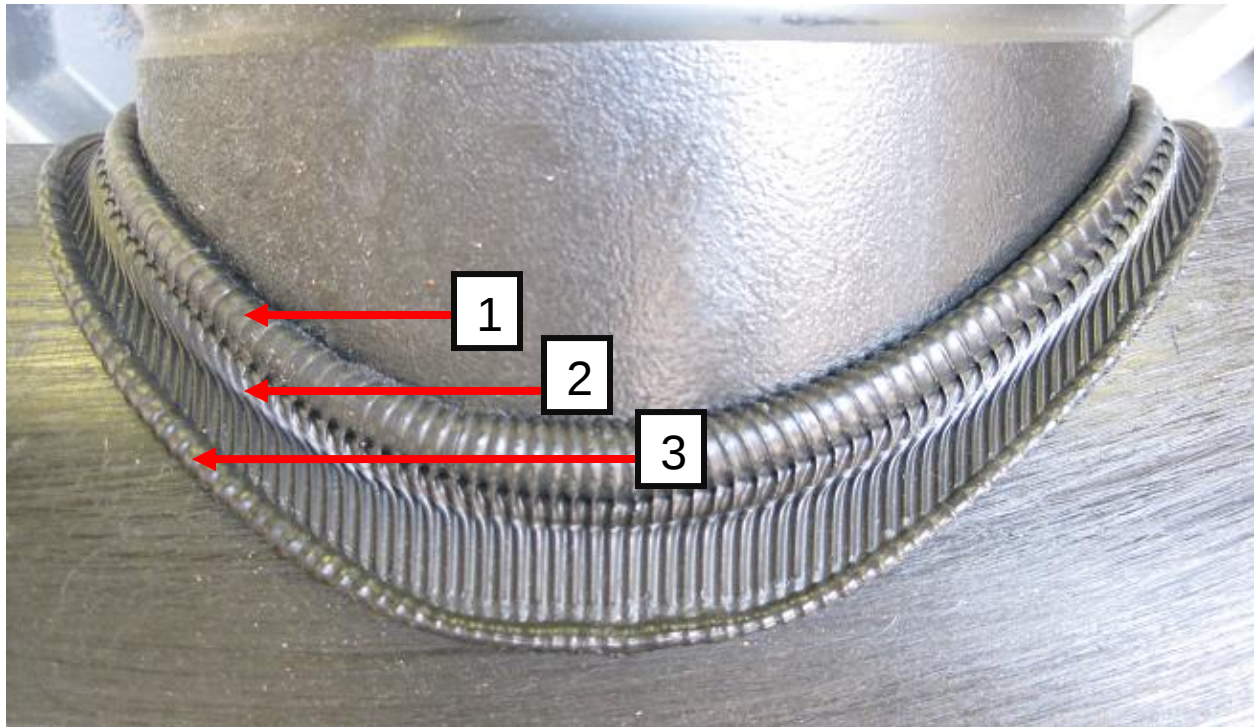
Figure 5 – Picture of correct three bead melt pattern  
(Fuse performed by Development Lab)

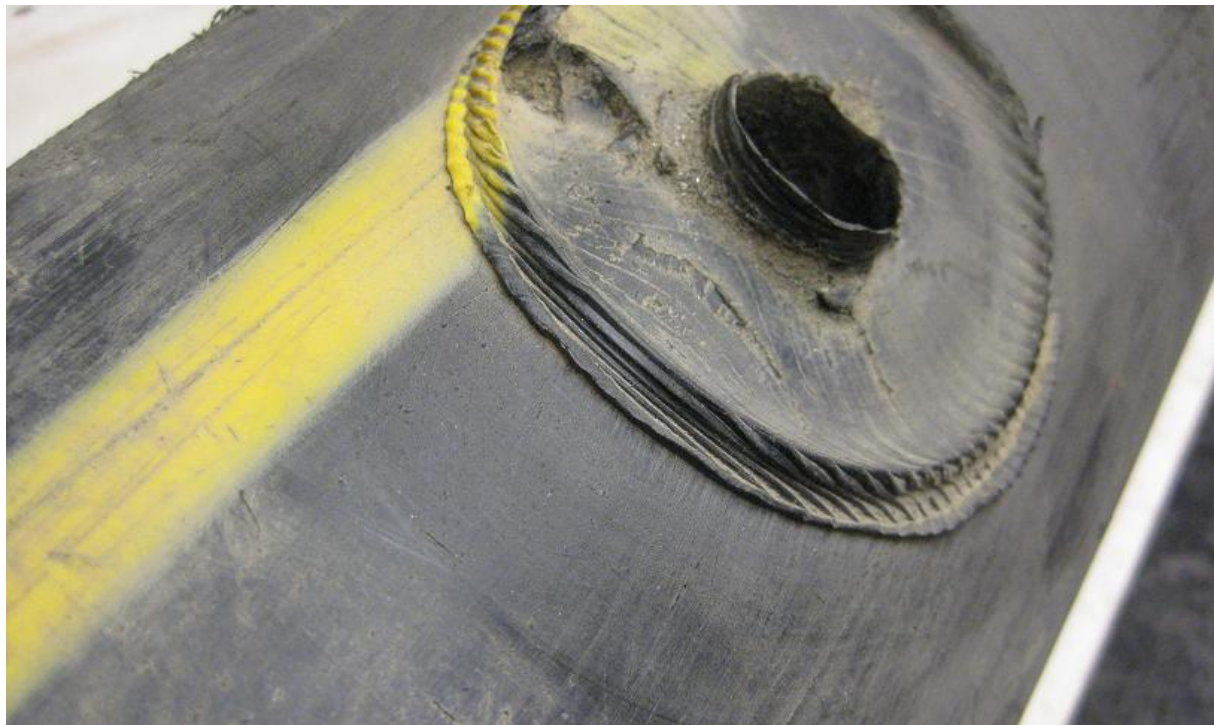
Figure 6 – Picture of pipe surrounding fusion area with no signs of scraping

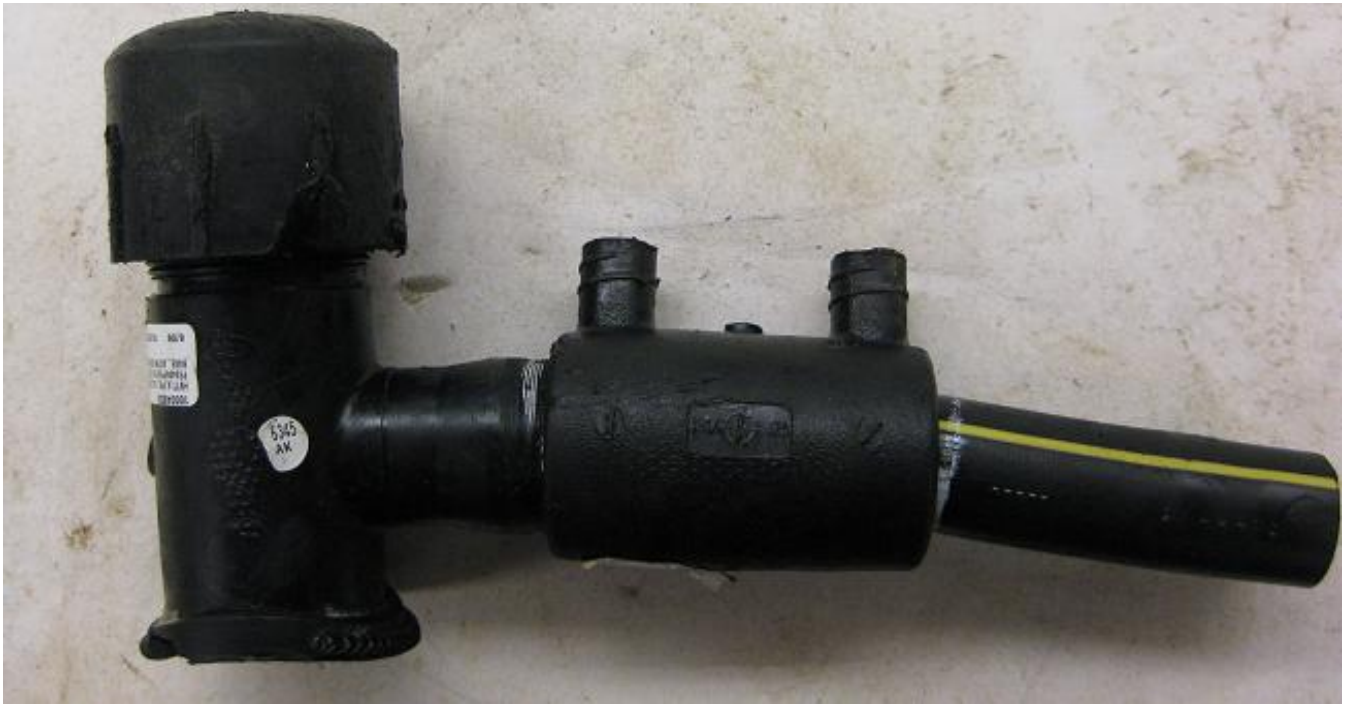
The 1 1/4" x 1" EF Reducer along with the 6" length of 1" pipe was also inspected for any irregularities. Upon inspection, the EF Reducer and the 1" pipe were not installed perpendicular to the tapping tee. They were positioned downward and appeared to have been misaligned during installation. (See Figure 7) It is imperative that these components are properly aligned during the electrofusion process to ensure successful fusion of the plastic. Furthermore, the 1 1/4" outlet of the tapping tee showed signs of rotational scraping that appeared to have been done properly. The scraping on the 1" pipe, however, was not performed uniformly and sections of unscraped

Figure 7 –Picture of misaligned pipe and reducer on tapping tee

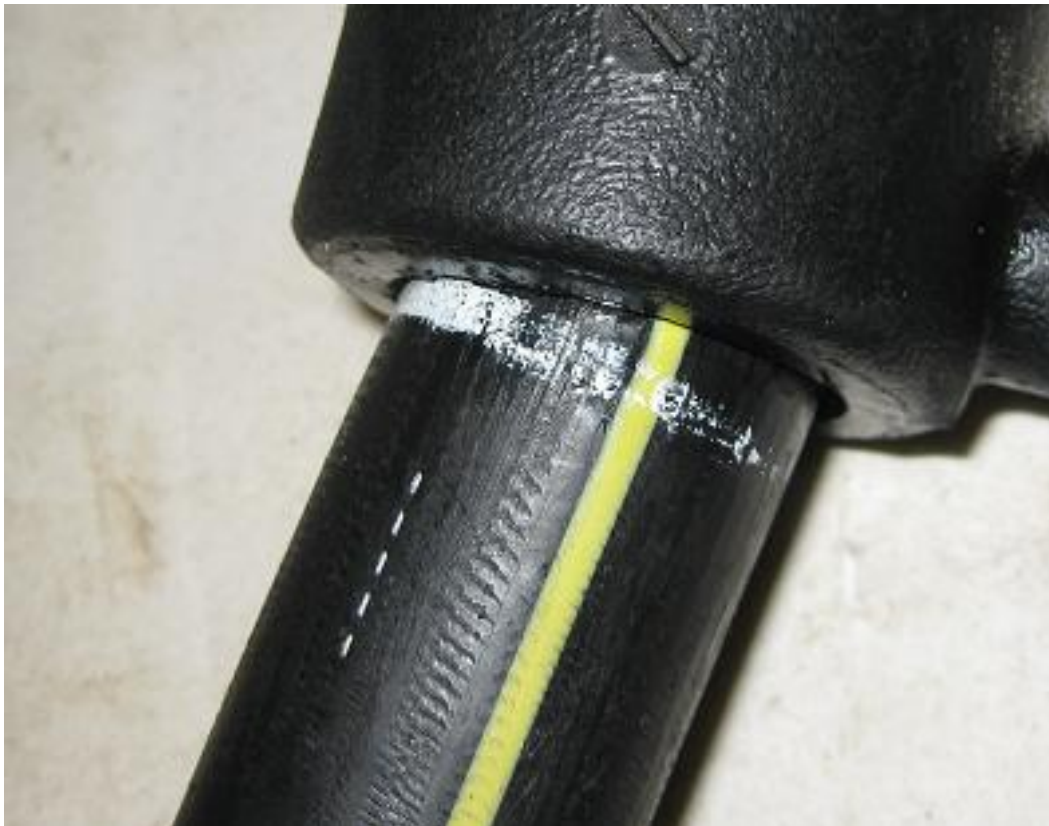
pipe were present in the fused area. (See Figure 8) This inadequate scraping further reveals the poor craftsmanship involved in the installation of this tapping tee.

Figure 8 –Picture of insufficiently scraped 1" PE pipe

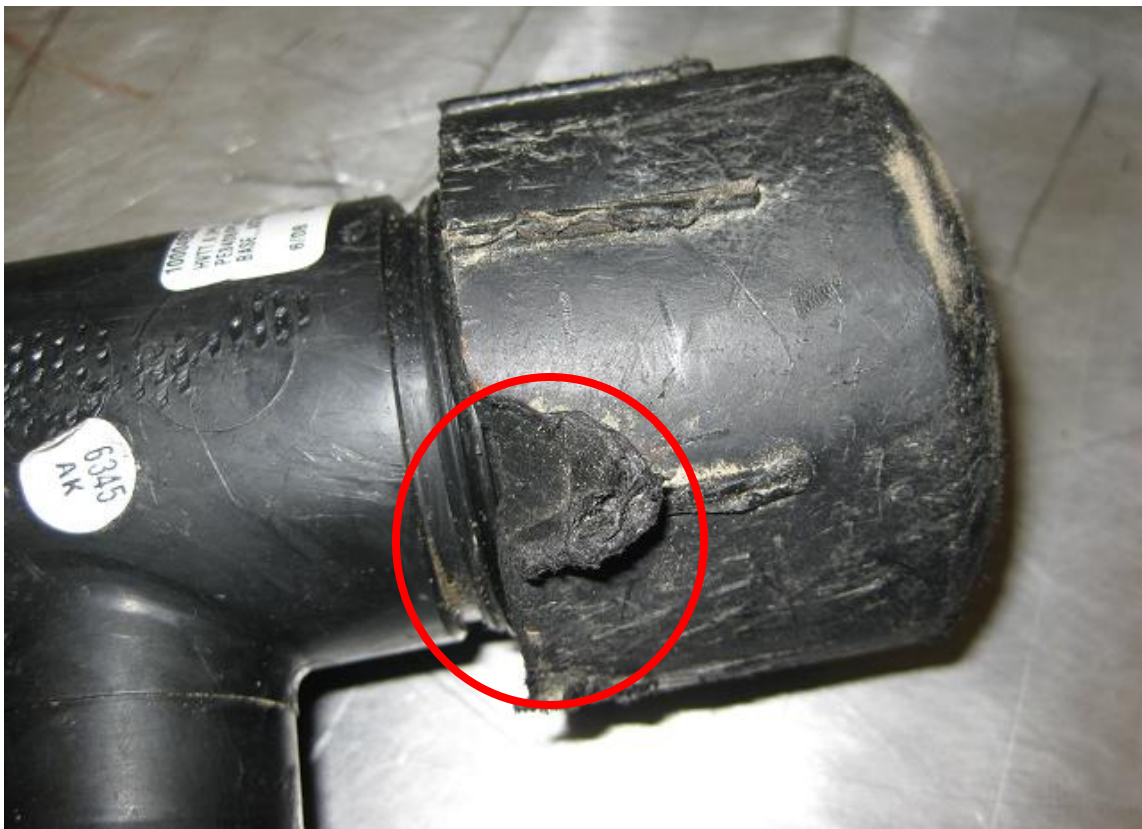
In addition, the cap on the 1 ¼" IPS x 1" IPS Central Plastics Tapping Tee was damaged on the cap's outer edge. A ½" section of material was observed to be cut from the cap. (See Figure 9) This damage was only present on the outside surface of the cap and was not the source of a leakage. This damage may have been caused by the pickup digger during the excavation of the tee. If the pickup digger did hit the tee during excavation, this force on the tee would explain why the tee dislodged from the main. With the tee insufficiently fused onto the main, any slight force would have knocked the tee from the main. However, according to the Field Supervisor, 90% gas readings were found when bar holing for the leak. When the leak was pinpointed, leak detector was sprayed inside the bar hole and the solution began to bubble immediately. This substantial leak would suggest that the tee was almost completely removed from the main prior to any excavation.

Figure 9 –Picture of damaged cap on Tee
