National Transportation Safety Board

Regulatory Oversight Factual Report

Dec. 2, 2014

Location: East Harlem – Manhattan, New York

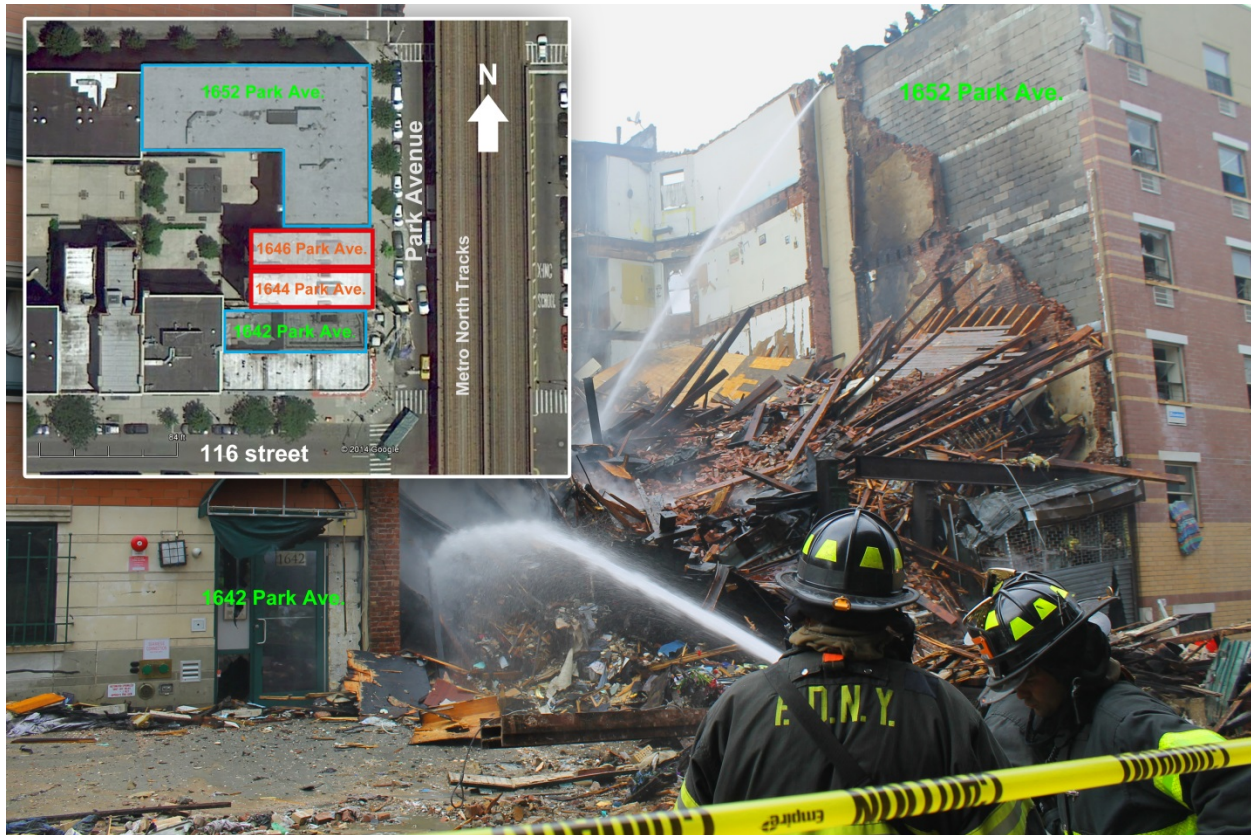
Figure 1: Photograph (looking west) of the accident scene with Google Earth inset showing the collapsed buildings 1646 and 1644 Park Avenue. Credit: FDNY.

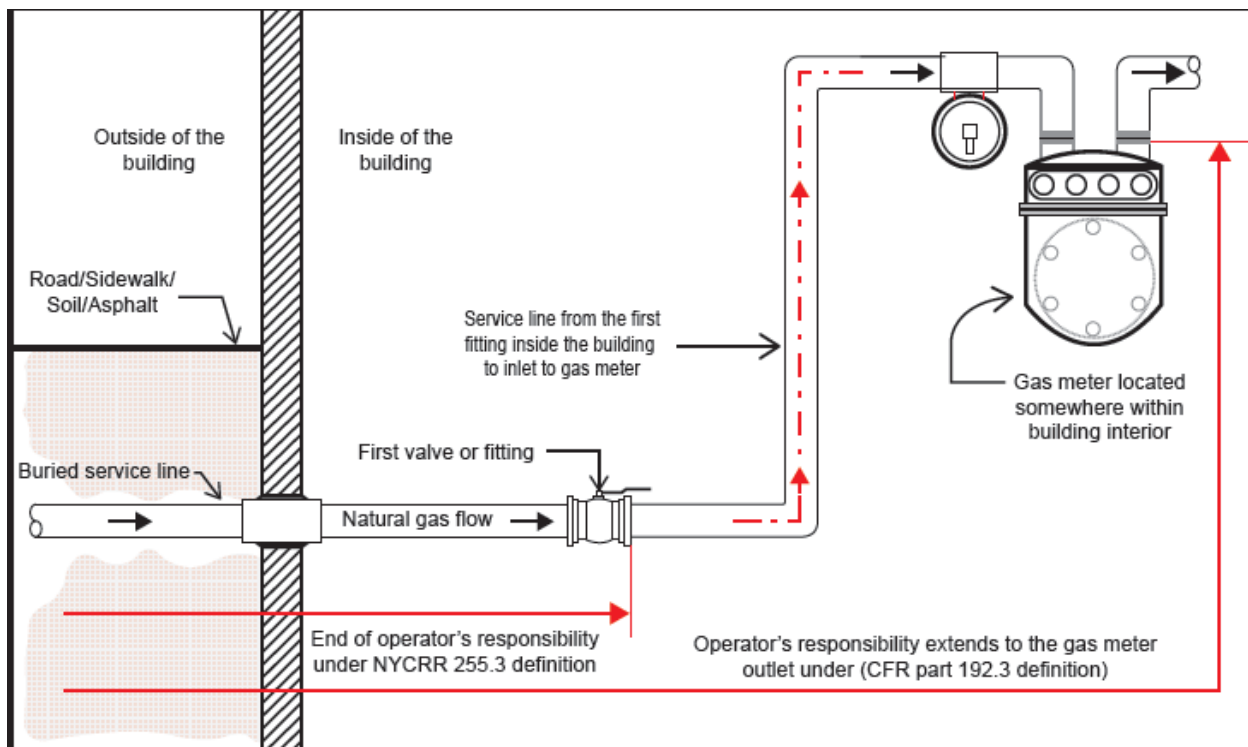
The first discrepancy noted was in the definition of service line. Under 49 CFR part 192.3, the operator is responsible for a service line from the distribution main to the outlet of the gas meter, whereas under NYCRR part 255.3, the operator is responsible for the service line up to the first fitting entering the building. The distinction between the two definitions is limited to cases where the gas meter is located inside a building, as is common in New York City. Under this scenario and the NY state regulation, the operator's responsibility to maintain a service line ends at the first fitting beyond the wall; there is no leak survey or maintenance for that portion of the service line that falls between the first fitting inside the building and the gas meter (see figure 2).¹² Under the Administrative Code of City of New York part 27-896, this interior plumbing may be installed by either a licensed master

Figure 2: Schematic showing discrepancy between the federal code definition of Service Line and the NY State definition of service line, when a gas meter is installed inside of a building.
