National Transportation Safety Board

Natural Gas Distribution Pipeline Leak and Resulting Multi-Story Structures Explosion
Harlem, New York

Operations Group Factual Report

DCA-14-MP-002

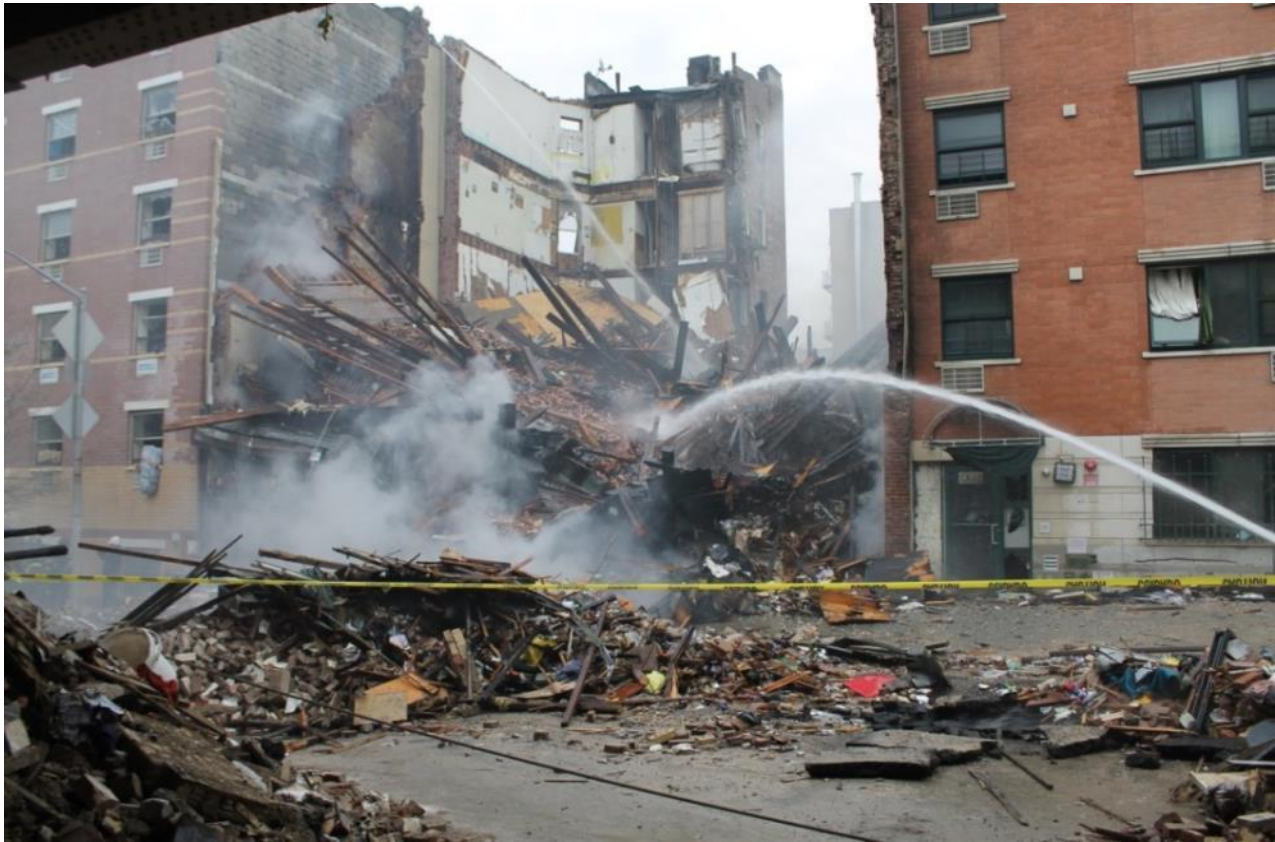
Figure 1. Explosion damage to 1644 and 1646 Park Avenue.

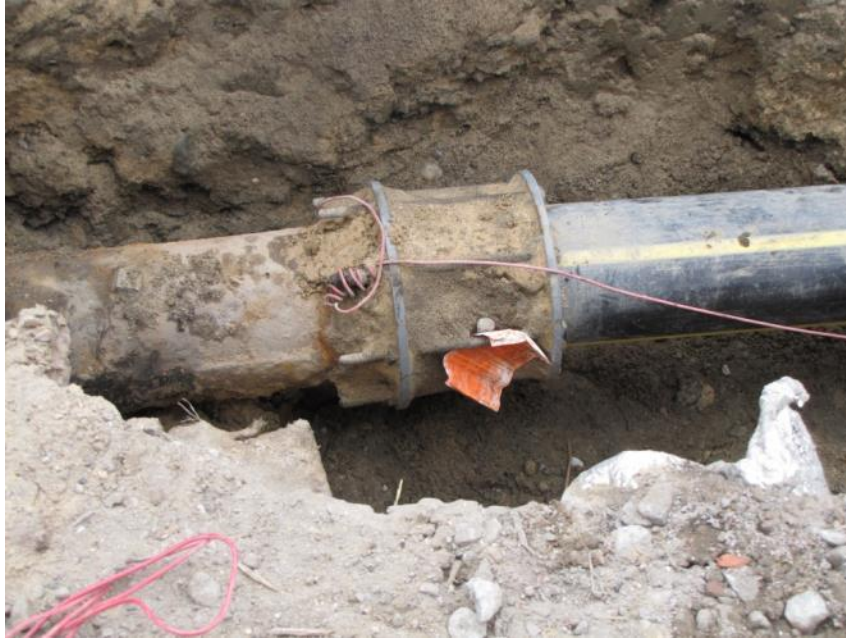
Figure 3: North end of 8-inch HDPE gas main joined to 8-inch cast iron pipe to the left with 8-inch steel mechanical coupling in front of 1644 Park Avenue.

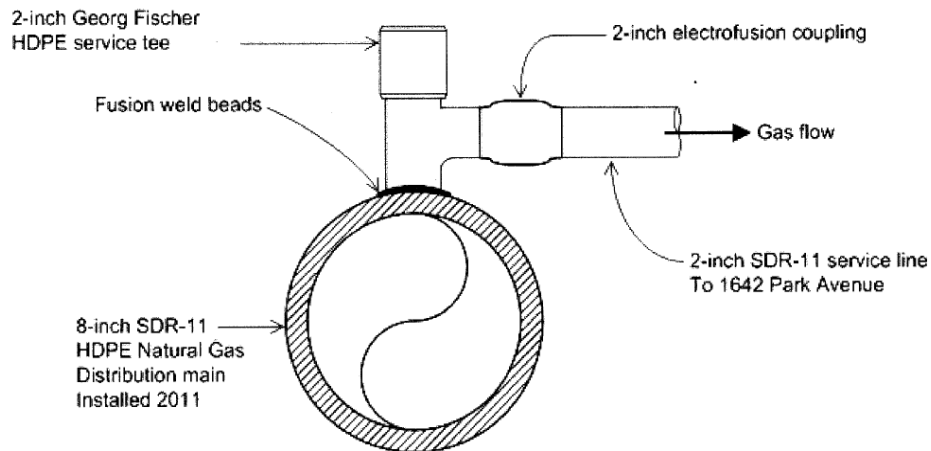
The 2-inch HDPE service pipe installation to 1642 Park Avenue was tied in to the segment of the new 8-inch HDPE gas main with a fusion-tapped service saddle tee as shown in figure 4.

Figure 4: Drawing shows cross section of 2-inch service saddle tee assembly electrofused on top of the 8-inch HDPE gas main at 1642 Park Avenue.

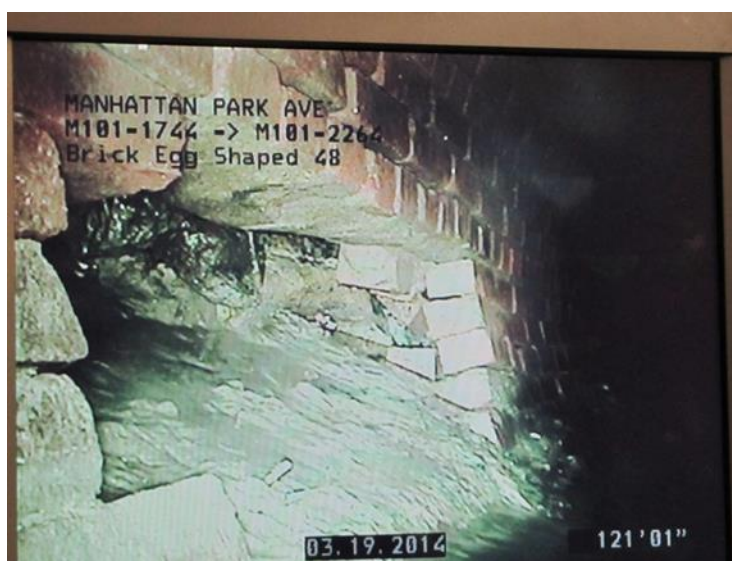
Another sewer main inspection conducted on March 28, 2014, was used to explore the relationship between holes or voids observed in front of 1642 Park Avenue excavation, where segments of 8-inch HDPE gas main and 2-inch HDPE gas service, saddle tee, and 12-inch pipe cast iron water main were excavated and extracted, and the 12-inch by 40-inch sewer main opening⁶¹ observed in front of 1644 and 1646 Park Avenue. The robotic camera entered the sewer main from the upstream manhole, and was driven south on Park Avenue toward the downstream manhole. The inspection was completed with observation of several missing bricks in the sewer main wall that coincided with the previous inspections on March 19, 2014, figure 6.

Figure 6: Damaged east side of sewer main wall (12 inches by 40 inches) in front of 1644 and 1646 Park Avenue. Source: NYCDEP

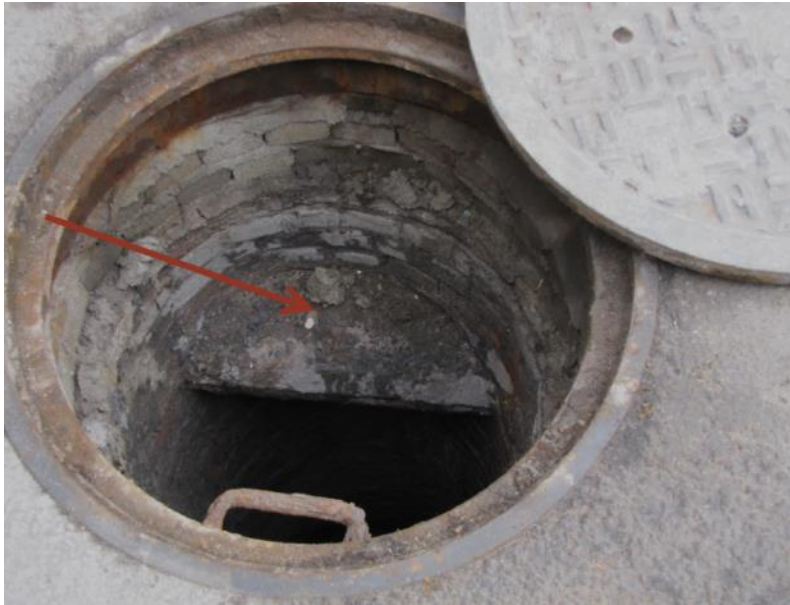
Figure 7: 8-inch cast iron pipe that travel through upstream manhole sewer main at 1652 Park Avenue, as indicated with red arrow at about 1.5 feet below manhole lid and roadway grade.

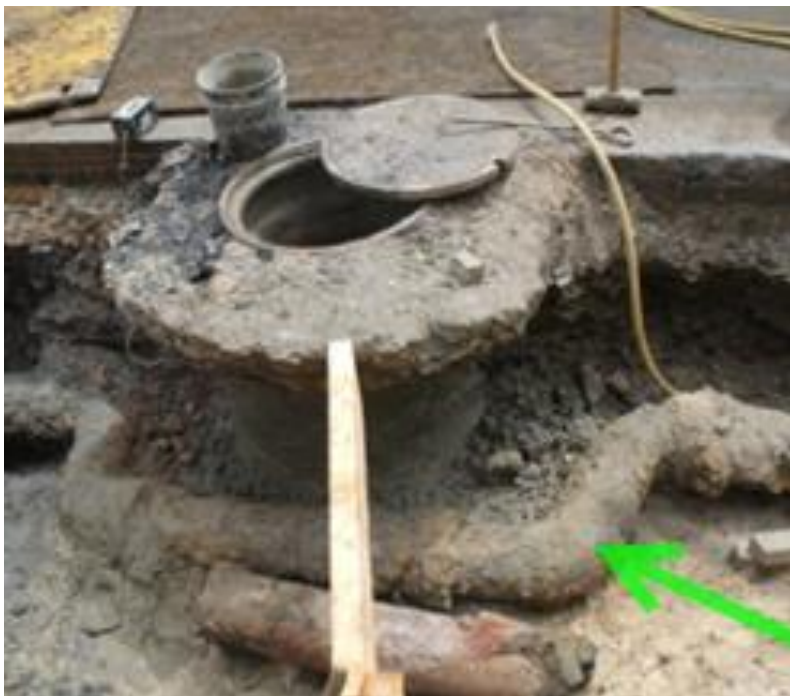
excavations and re-construction on May 5, 2014, to be an abandoned gas main while the cast iron gas main in service at the time of the accident was by-passed at the upstream manhole as shown in figure 8 with green arrow.

Figure 8: 8-inch cast iron gas main of Con Edison by-passed at upstream manhole of sewer main on Park Avenue, as indicated with green arrow. Source: NYPSC

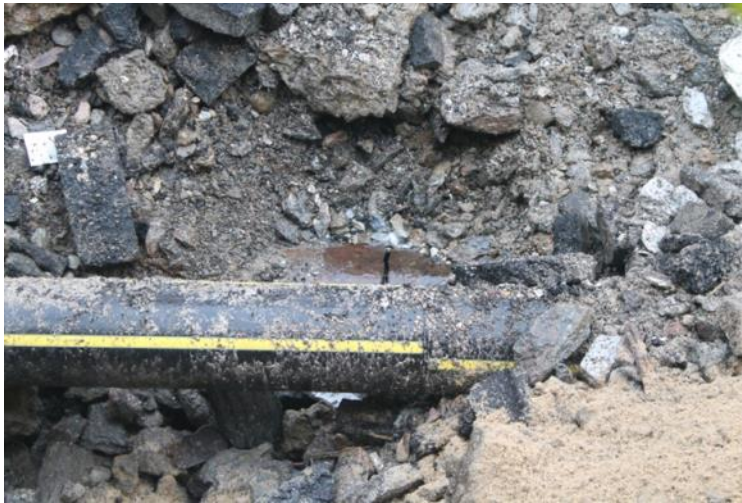
Figure 9: The exposed 8-inch HDPE gas main and 12-inch cast iron water main cracked location.
Source: NYPSC

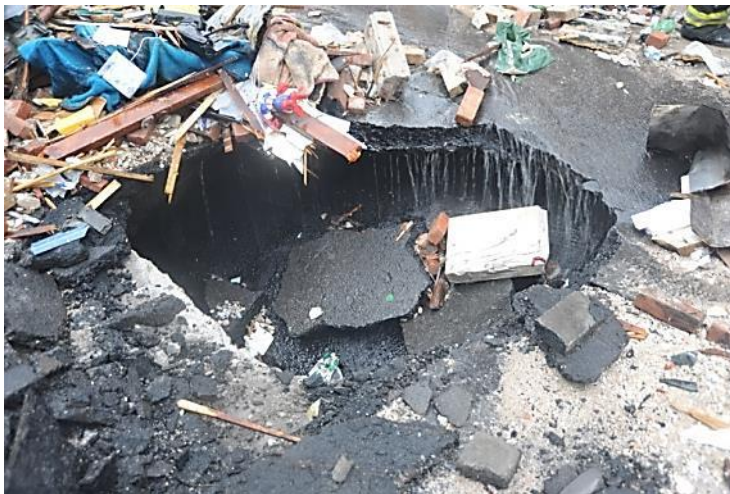
Figure 10: Sink-hole at the location of the 12-inch cast iron water main break. Source: FDNY

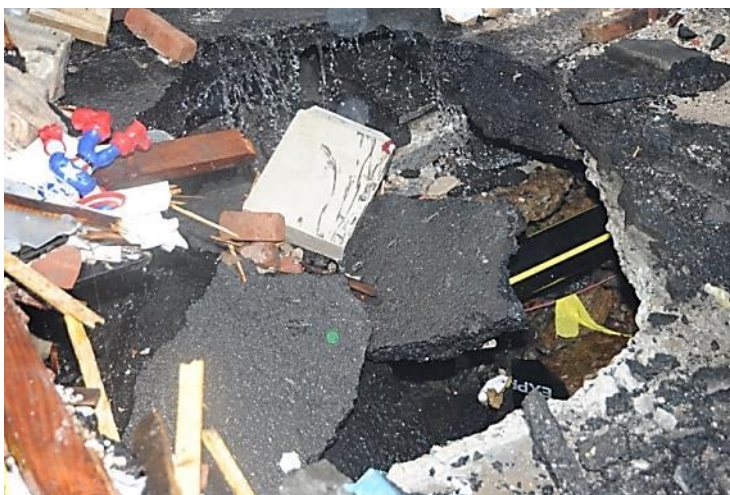
Figure 11: Sink-hole at 12-inch cast iron water main break location showing 8-inch HDPE gas main. Source: FDNY

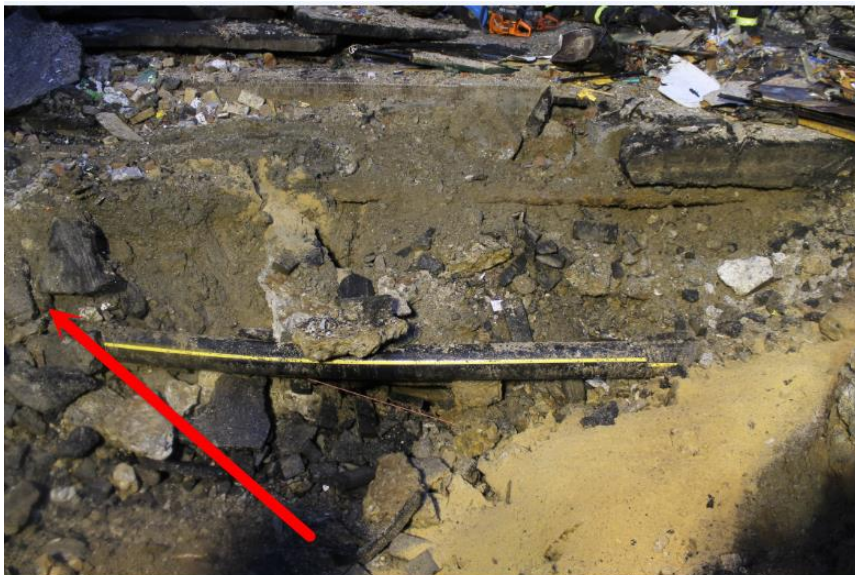
Figure 12: The exposed 8-inch HDPE gas main and top of 2-inch HDPE service saddle tee indicated with a red arrow, in front of 1642 Park Avenue. Source: NYPSC.

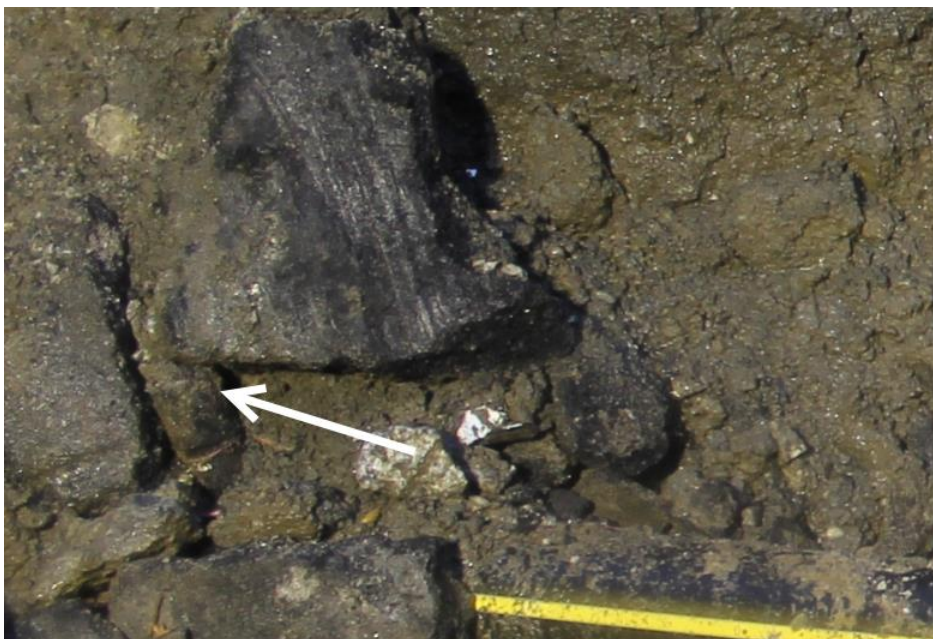
Figure 13: Close view of exposed 8-inch HDPE main and top of 2-inch HDPE service saddle tee indicated with a white arrow, in front of 1642 Park Avenue. Source: NYPSC.

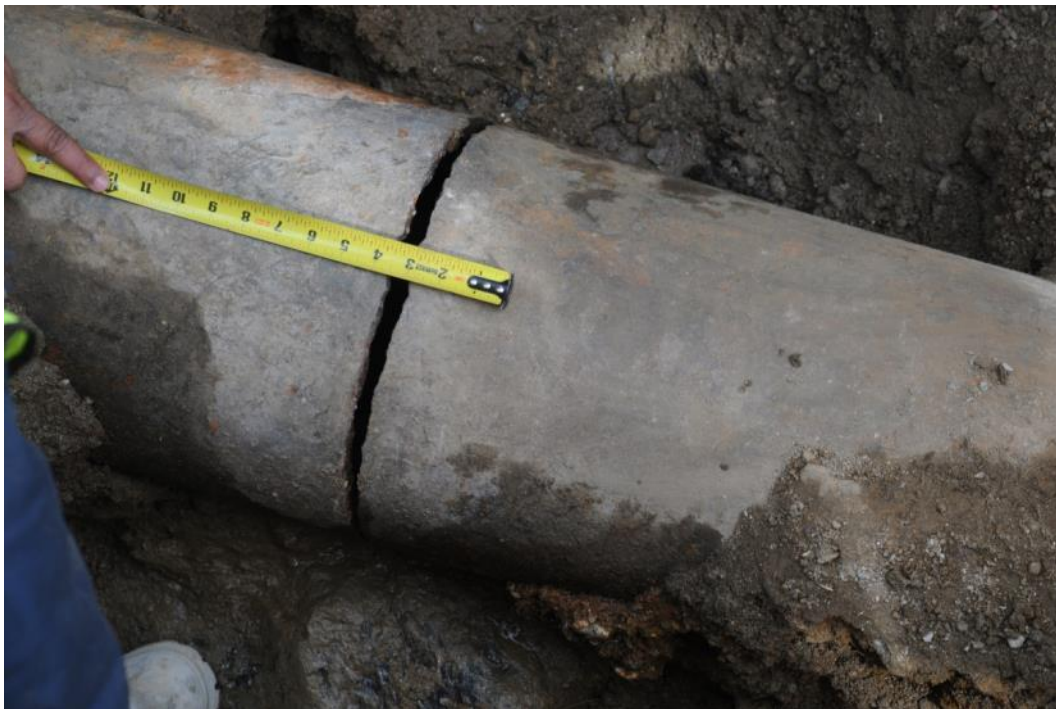
According to City of New York, they believe that after the two segments of the 12-inch water main were extracted from the excavation, the soil condition shown in figure 18 “remained undisturbed, without signs of subsidence except at the location where the water main experienced a nearly 360 degree” circumferential crack.

Figure 14: 12-inch cast iron water main pipe with circumferential crack top view. Source: NYCDEP

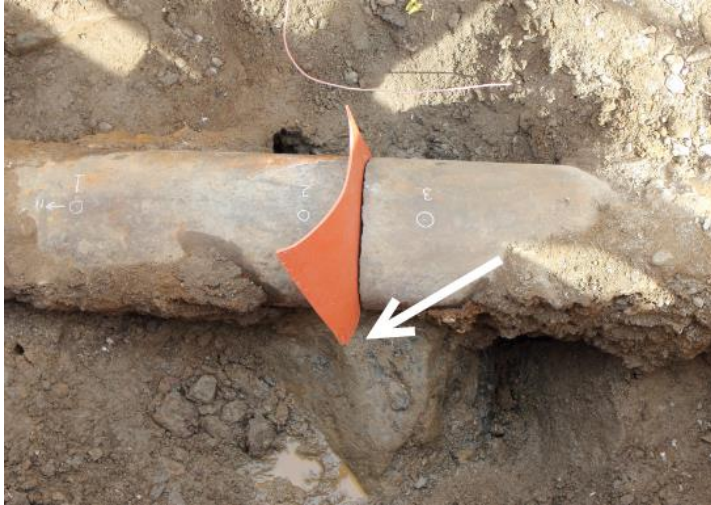
Figure 15: 12-inch water main cracked location directly located on top of rock.

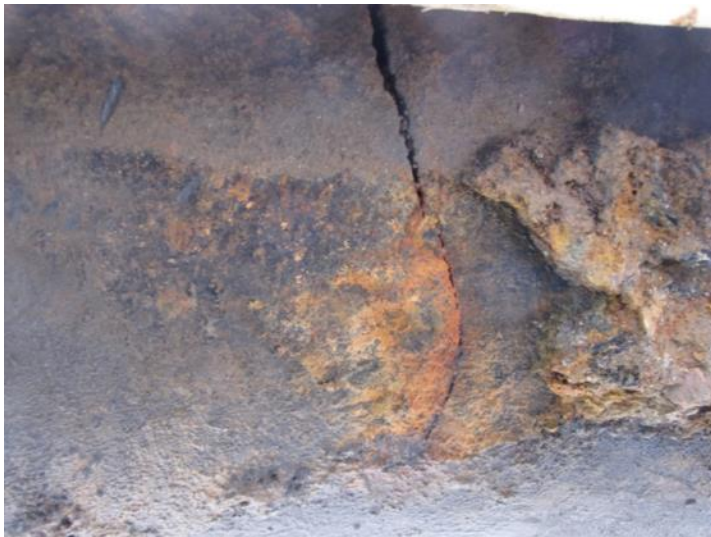
Figure 16: 12-inch water main pipe with circumferential crack bottom view.

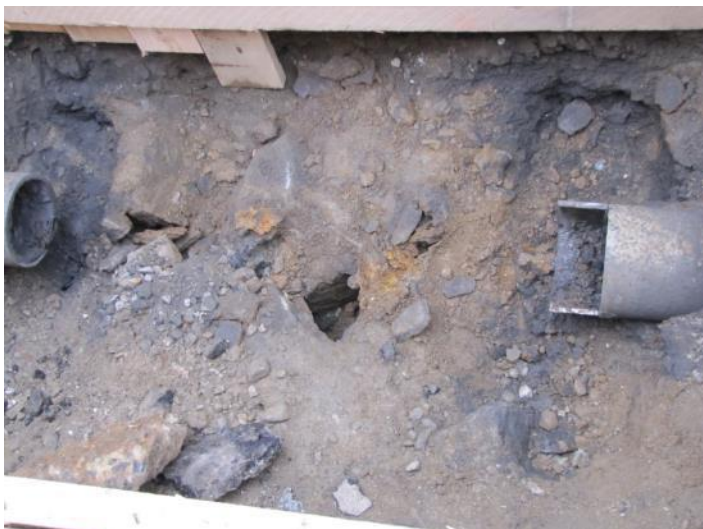
Figure 17: Holes (hole-A) exposed in the rocky soil after water main pipe segment was removed.

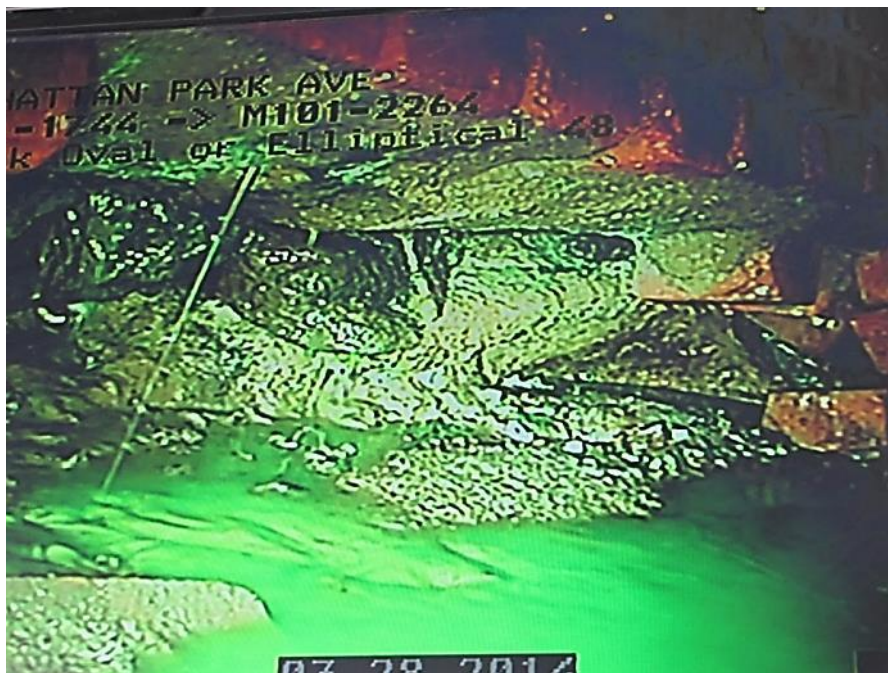
To conduct the test, water from a water truck hose and florescent green colored dye were introduced into the holes under the water main. Within minutes the robotic video camera captured volume flow of the florescent green dyed water solution flowing into the sewer main through the 12-inch by 40-inch damaged wall (figure 18). The dyed water also penetrated through other sewer main wall cracks along 1642, 1644, and 1646 Park Avenue locations.

Figure 18: Florescent Green dyed water solution entering the sewer main at (hole-B) the damaged east sidewall. Source: NYCDEP

The water flow test established the fact that the holes in the ground under the water pipe in front of 1642 Park Avenue provided a direct, unimpeded water flow path into the sewer main.

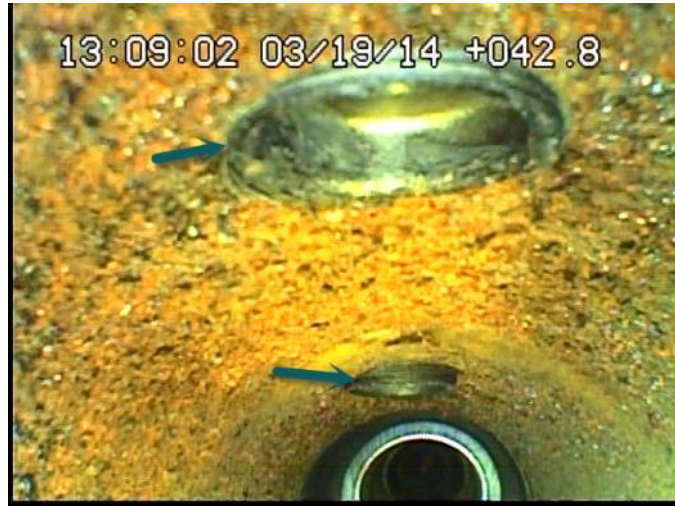
Figure 19: Internal camera inspection of 8-inch gas main pipe shows two 2-inch plugs at about 43 feet and 44 feet. Source: Con Edison

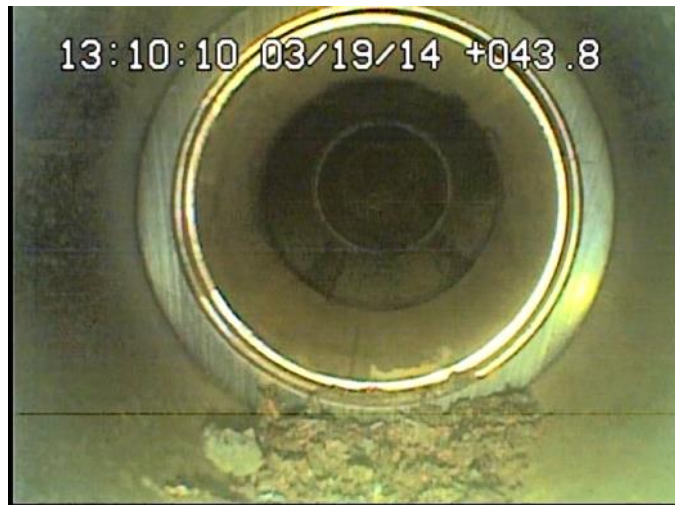
Figure 20; shows the internal view of the cast iron to PE pipe transition in the 8-inch HDPE gas main. The joining material was by means of the steel mechanical compression coupling (manufactured by Dresser).

Figure 20: Internal camera inspection of 8-inch gas main pipe shows transition from cast iron to HDPE. Source: Con Edison

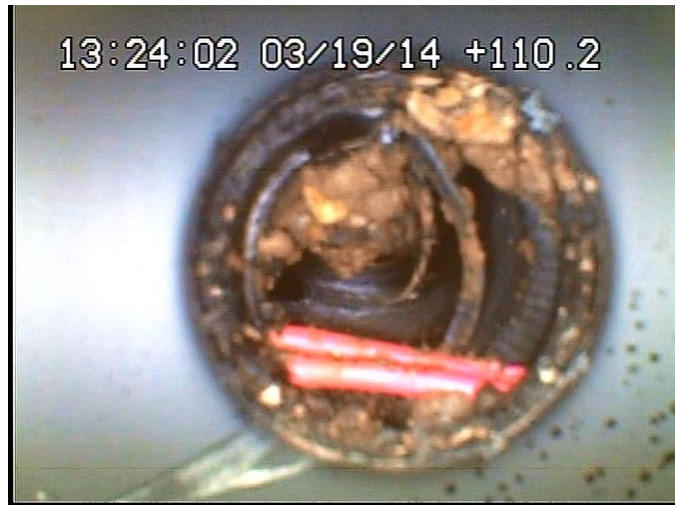
Figure 21; shows the internal view of the separated service saddle tee to 1642 Park Avenue. The inspection was conducted using a robotic camera inserted into the 8-inch gas main at Pit#2. The service tee was located at about 110.2 feet from Pit #2. Soil and other earth materials penetration were shown to have entered inside the 8-inch HDPE gas main and 2-inch service tee through the separation of the service saddle tee fusion from the main. The red colored tracer wire was observed in the gap between the service saddle tee fusion surface and the gas main. This condition was present on March 19, 2014, before the re-excavation of the gas main and service pipeline connection at this address on March 20, 2014.

Figure 21: 8-inch HDPE gas main disconnected 2-inch service tee on the main HDPE and red tracer wire. Source: Con Edison

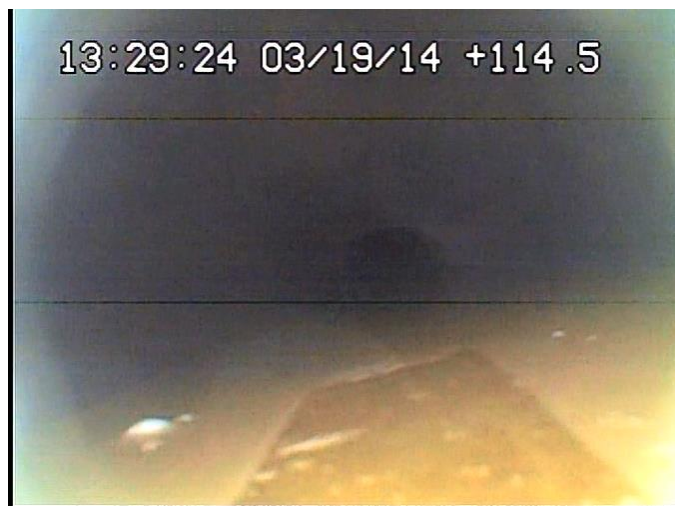
Figure 22 of the internal view of the 8-inch HDPE gas main is shown filled with water⁷³ at about 114.5 feet from Pit #2. The water and debris contents prevented the robotic camera to move beyond that point during the gas main inspection. Relevant information about the gas main attributes before 1644 and 1646 Park Avenue service tees was however, gathered.

Figure 22: 8-inch gas main pipe with pool of water in the main PE pipe. Source: Con Edison

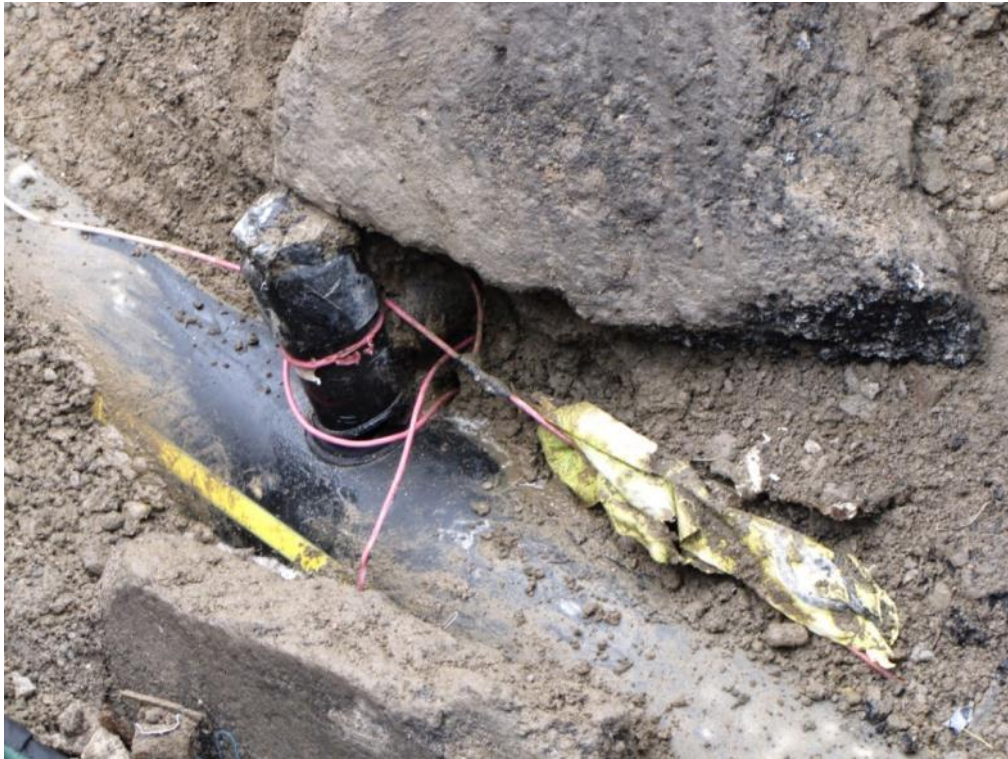
Figure 23 shows the 2-inch HDPE gas service saddle tee connection at 1642 Park Avenue that has been separated from the 8-inch HDPE gas main. On excavation, it was observed that a piece of asphalt from post-accident excavations on March 12, 2014 during re-stabilization of the roadway for fire department recovery activities had fallen and rested on top of the service saddle tee cap. This asphalt piece measured about 14 - 20 inches wide by 19 inches high and 6.5 inches thick. There was another piece of asphalt that lay against the gas main, and opposite the service tee. A red colored tracer wire was wrapped around the service saddle tee.

Figure 23: Separated gas service saddle tee at 1642 Park Avenue.

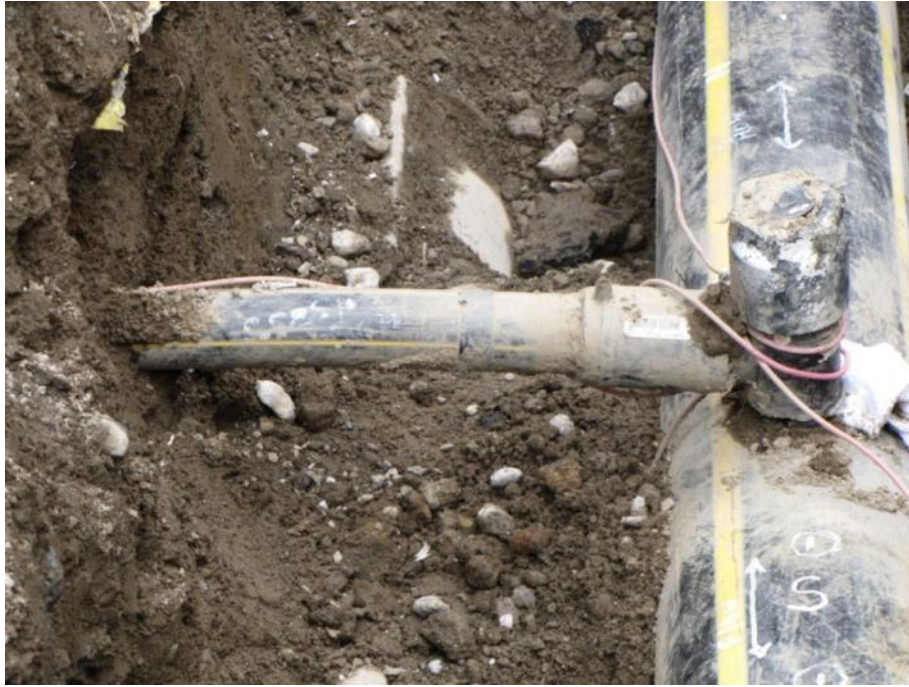
Figure 24 shows further excavations around the 2-inch HDPE gas service saddle and the 8-inch HDPE gas main. The 2-inch HDPE gas service line to 1642 was observed from west to east direction with the service saddle tee over the 8-inch HDPE gas main.

Figure 24: 2-inch separated HDPE service line at saddle tee.

The 2-inch HDPE gas service saddle tee curved from the service line over the 8-inch HDPE pipe gas main. There was a gap of about $\frac{1}{4}$ -inch between the main and saddle tee. This $\frac{1}{4}$ -inch gap continued to increase as the service line recovered from the downward curvature as the backfill was removed, and then lifted up as seen in figure 25. The 8-inch HDPE gas main was observed to have moved downward, going south to north from the service saddle tee location on the main.

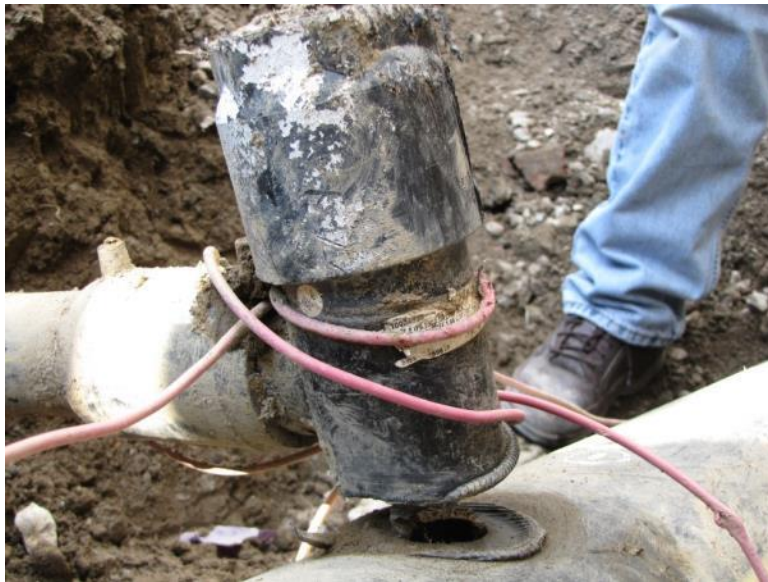
Figure 25 shows the completely separated 2-inch HDPE service saddle tee from the 8-inch HDPE gas main. The service saddle tee contains dents and gouges. The photo also shows the tracer wire wrapped around the service line and service tee, down to the 8-inch HDPE gas main.

Figure 25: Separated 2-inch saddle tee from the HDPE main.

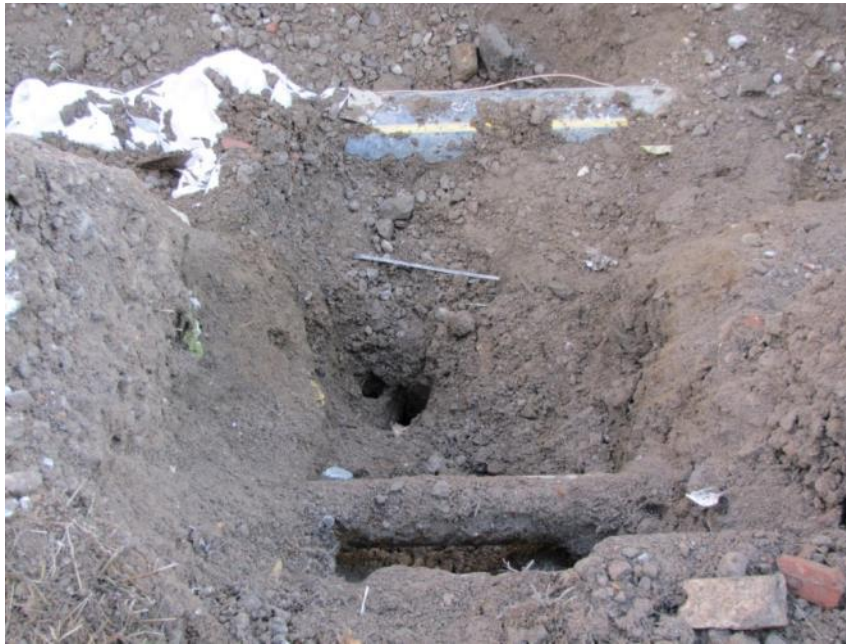
Figure 26 shows the surrounding excavated area to the 1642 Park Avenue near the 2-inch HDPE gas service line connection (covered with off-white colored nylon material). The 8-inch HDPE pipe gas main is seen as a black colored and yellow striped pipe. These areas were observed to be made of porous soil and small diameter gravel (crush and run) backfill materials⁷⁴, and had large holes below and near the gas main and water main.

Figure 26: Porous soil and large holes at 1642 Park Avenue near the gas main.

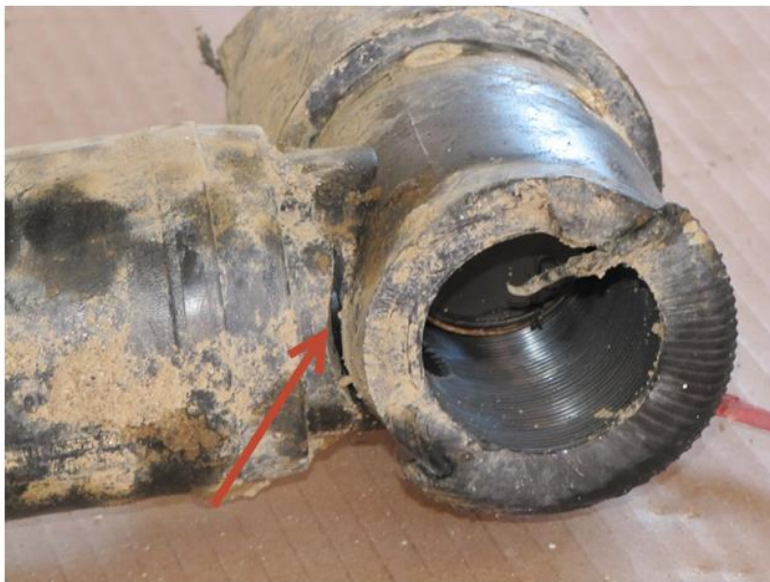
Figure 27 shows the underside of the service tee after it was removed from the excavation. A large crack at the junction between the main body of the service tee and the outlet fitting is indicated with a red arrow.

Figure 27: Underside of the saddle tee showing the tee to gas main fusion surface and crack in the service line connection port (red arrow).

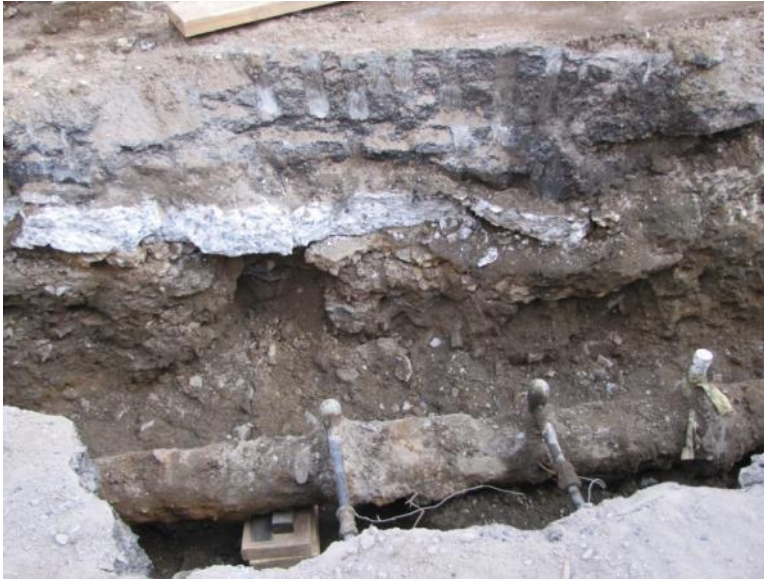
Figure 28: Service tees to 1646 and 1644 Park Avenue below about 12 inches of concrete road underlay with about 18 inches thick asphalt paving.

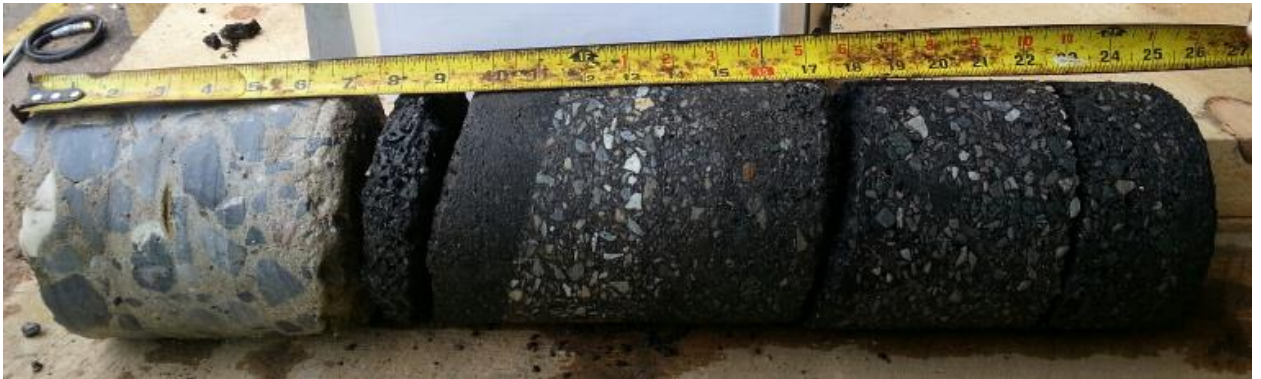
Figure 29: Core #4 road pavement sample from front of 1646 Park Avenue near incident properties service tees. Source: Con Edison.

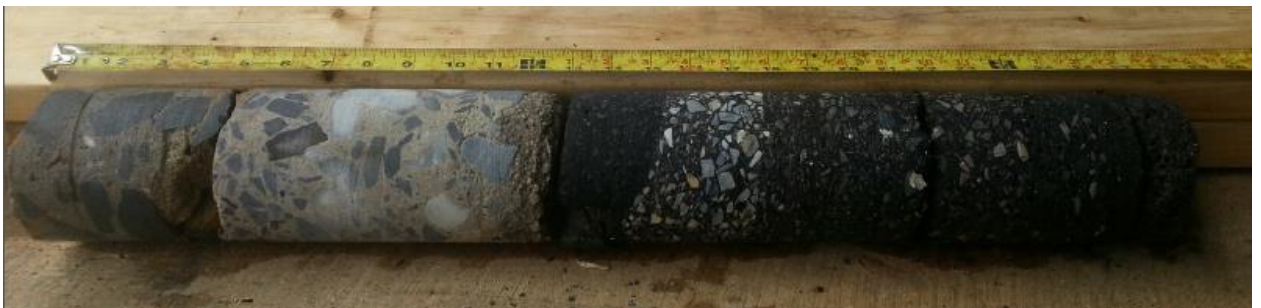
Figure 30: Core #6 road pavement sample from front of 1646 Park Avenue near incident properties service tees. Source: Con Edison.

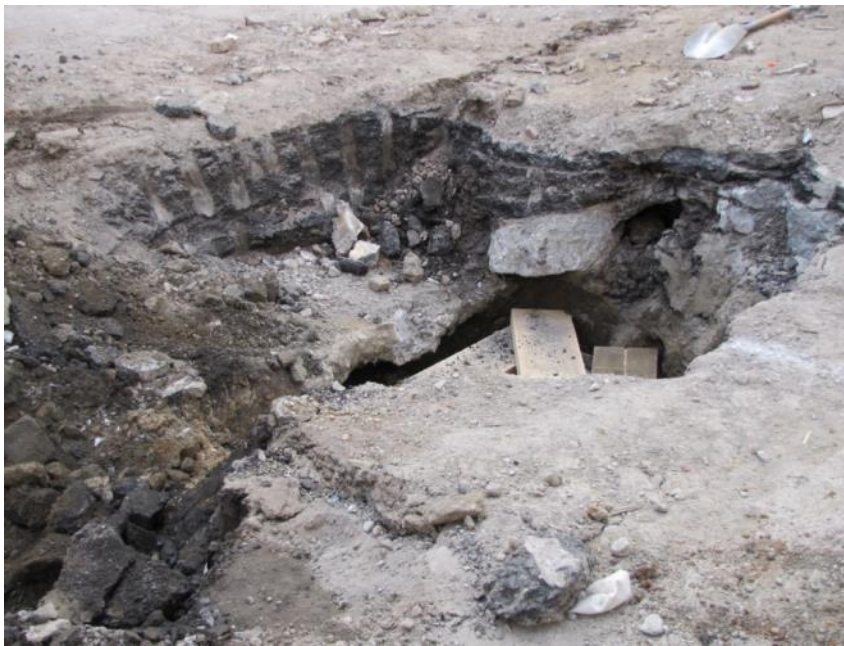
Figure 31 show an excavation to locate the gas service tees to 1644 and 1646 Park Avenue. The trench revealed a large horizontal void under the concrete road under-lay. The surroundings also showed road depressions of misaligned concrete and asphalt layers of varying thickness from paving, and re-paving at this location.

Figure 31: Excavation showed layered roadway and large horizontal void in front of 1644 and 1646 Park Avenue.

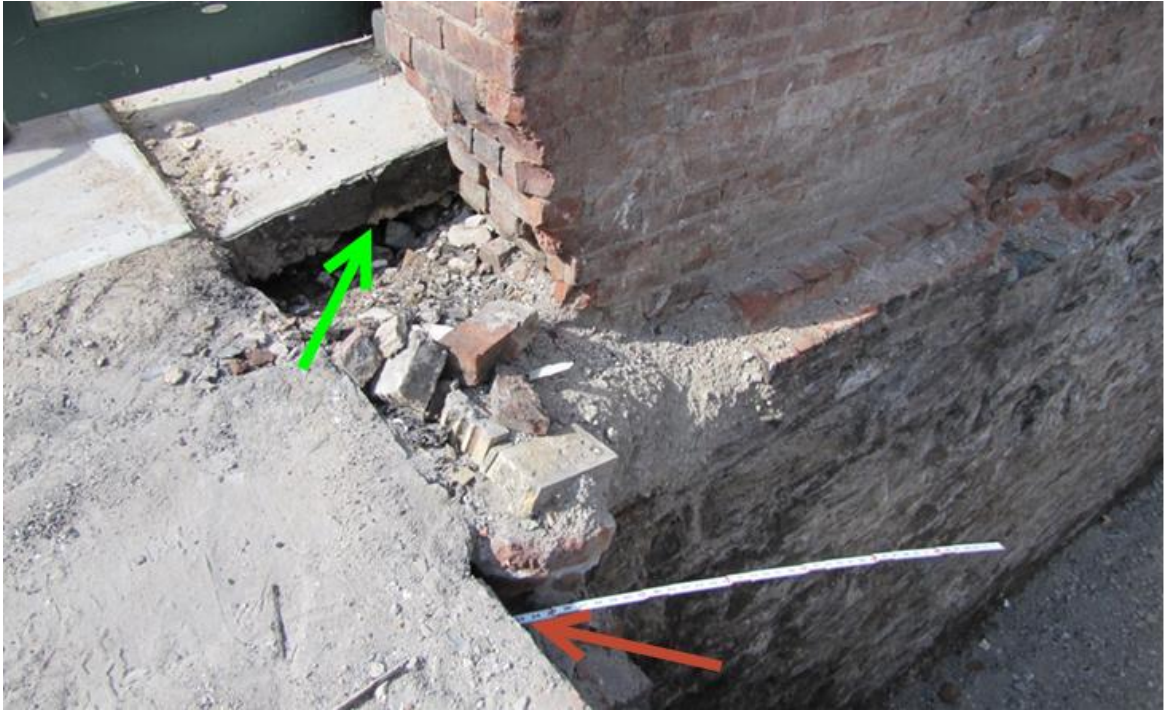
Figure 32 shows openings under the front slab of 1644 Park Avenue sidewalk. Penetration of the carpenter ruler into this gap under the sidewalk was to a depth of about 35 inches before obstructions indicated in red arrow. The position of this opening was adjacent to the front brick building walls before the incident. A visual inspection into the large hole shows a clean opening without debris except coagulated soil and uneven concrete surfaces.

Figure 32: Underneath slab openings at 1642 and 1644 Park Avenue.

Also, figure 32 shows another gap, opening having more than 72 inches horizontal penetration indicated with a green arrow. Camera examination of this opening showed it was greater than 85 inches horizontally.

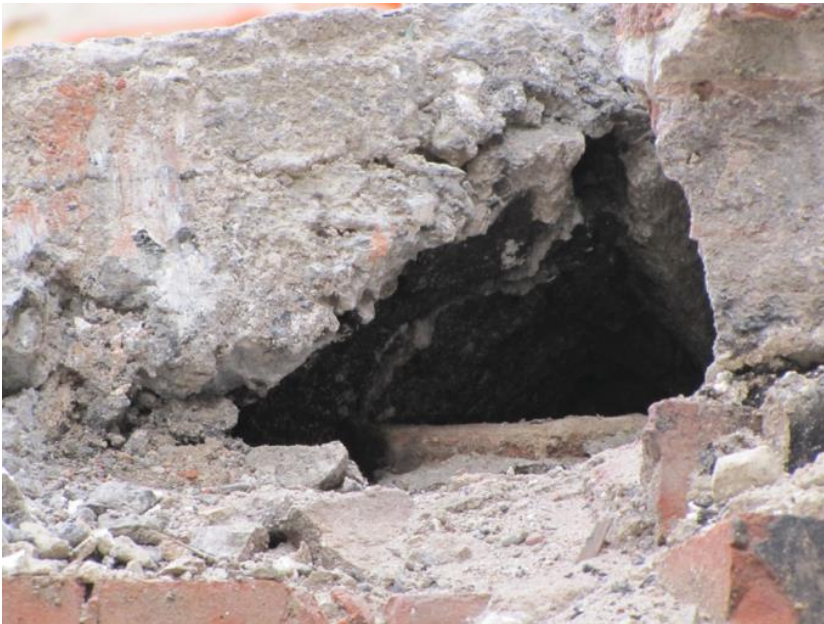
Figure 33 shows direct view into the opening shown in figure 32, red arrow. The opening ran under the 1642 Park Avenue concrete sidewalk. Both openings as indicated in figures 32 and 33 ran toward the buried gas main and service tees with gaps of at least 4 inches high under the sidewalks as they reached the curb line and pavement.

Figure 33: Hole at 1644 Park Avenue frontage under sidewalk slab.
