Continental Motors

ENGINE EXAMINATION REPORT

ENGINE MODEL	TSIO-520-JcNB
ENGINE SERIAL NUMBER	218873-R
AIRCRAFT MAKE & MODEL	Cessna 414A
AIRCRAFT SERIAL NUMBER	414A0821
AIRCRAFT REGISTRATION	N414RS
FILE NUMBER	18-357

EXAMINATION		ACCIDENT DATA	
DATE	03/08/2019	NTSB ACCIDENT #	WPR19FA079
FACILITY	Air Transport	NTSB INVESTIGATOR	Maja Smith
ADDRESS	[REDACTED] Phoenix, Arizona 85009	FAA INVESTIGATOR	Benjamin Harris
		ACCIDENT DATE	02/03/2019
		ACCIDENT LOCATION	Yorba Linda, California

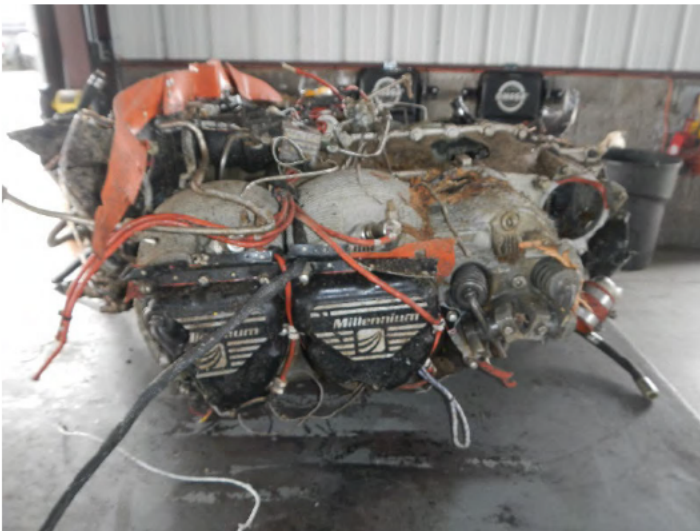
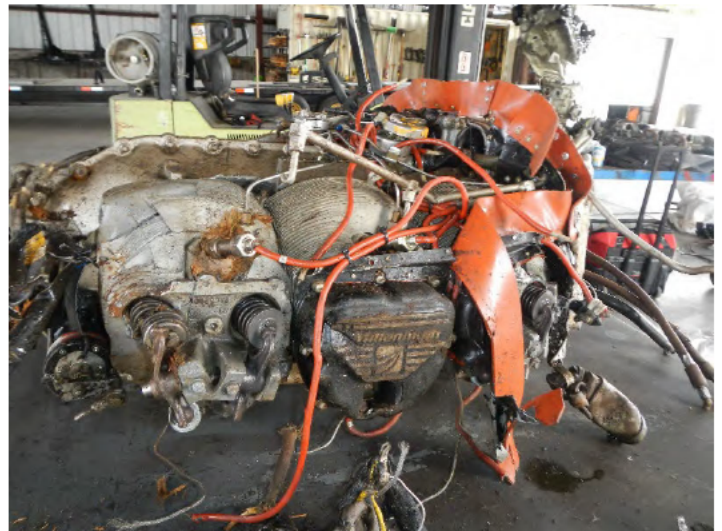
The engine was separated from the nacelle and the propeller, left magneto, alternator, vacuum pump, starter motor, and throttle body were separated from the engine. There was a hole in the crankcase over the #5 connecting rod area, but the fractures appeared as though the case was punctured from the outside-in. Wood debris was observed in the area of the puncture. The oil sump was displaced up around the bottom of the engine. The crankshaft was fractured at the nose seal and the fracture surface was jagged and irregular, consistent with overload. The #2, #5, and #6 cylinders heads were fractured. There was no evidence of lubrication distress on any of exposed components.

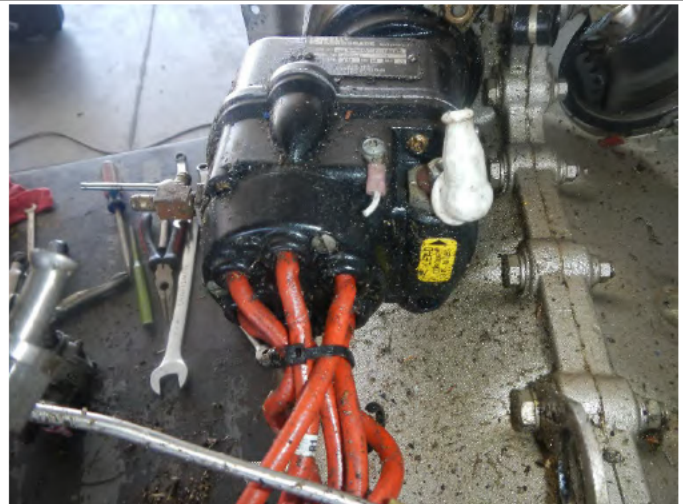
The right magneto remained attached to the engine and manual manipulation of the unit did not result in any slipping. The magneto's ignition harness was cut to remove damaged ends, and a functional test was performed. Rotation of the crankshaft resulted in an audible snap of the impulse coupling as well a spark from each ignition lead in firing order with no pre-accident anomalies noted.

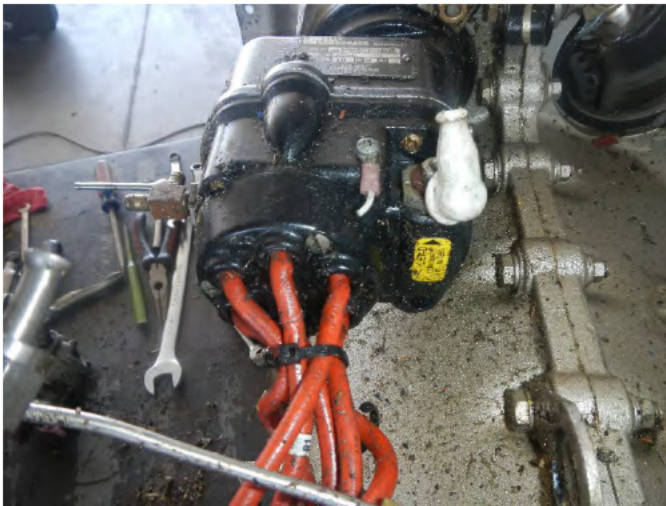
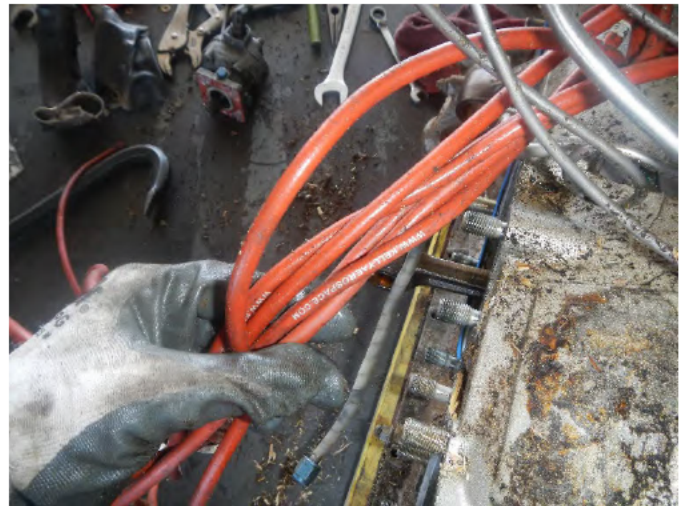
The right ignition harness remained attached to the magneto. The leads were damaged near their terminal ends. The right ignition harness was used for functional testing of the right magneto with no pre-accident anomalies noted. The left ignition harness was separated from its magneto but most of the leads remained attached to their respective sparkplugs.

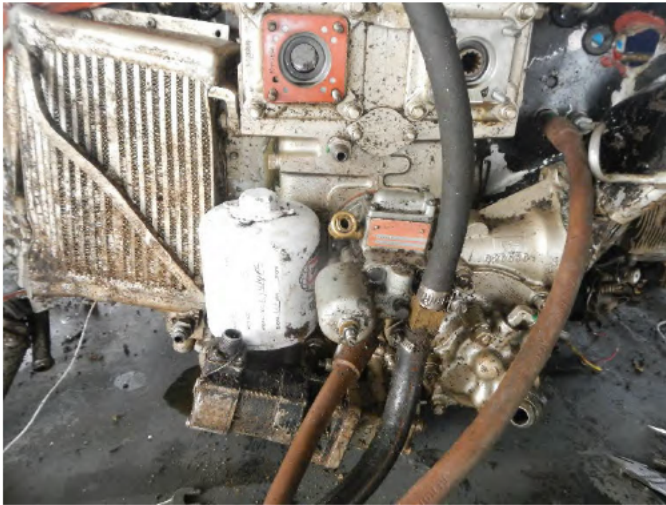
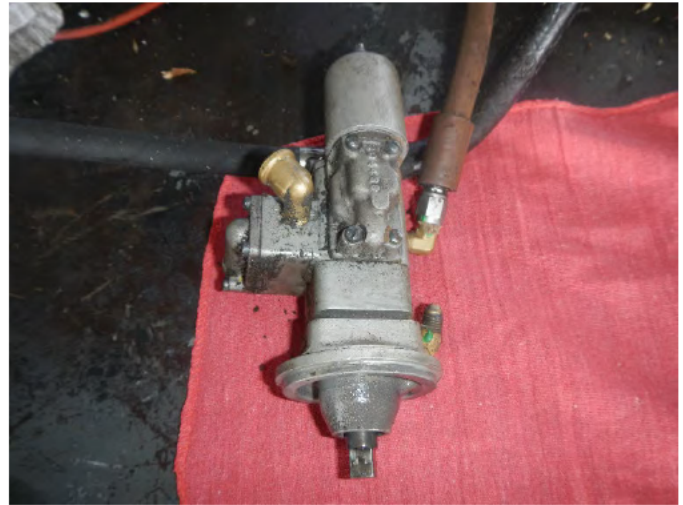
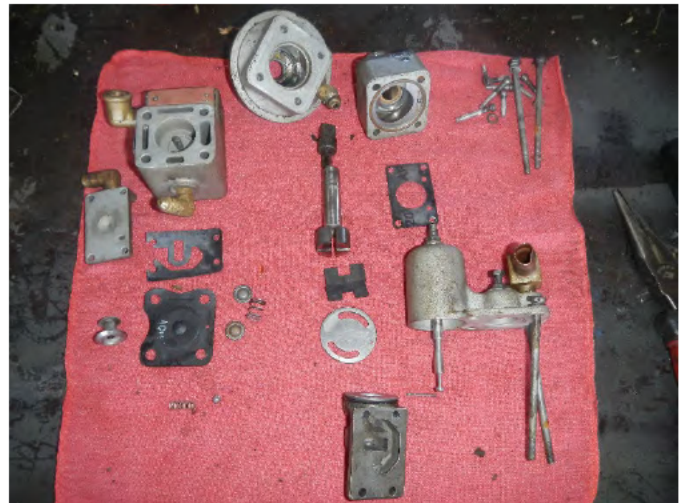
Condition: The engine-driven fuel pump remained attached to the backside of the engine. The inlet fuel line fitting was fractured. The pump was removed and the drive coupling was intact. The drive coupling was manually rotated and the pump shaft rotated freely with no binding noted. The pump was disassembled with no pre-accident anomalies noted.

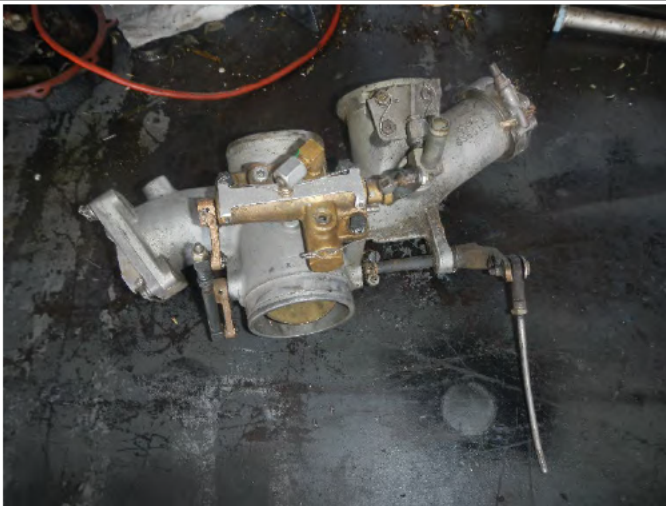
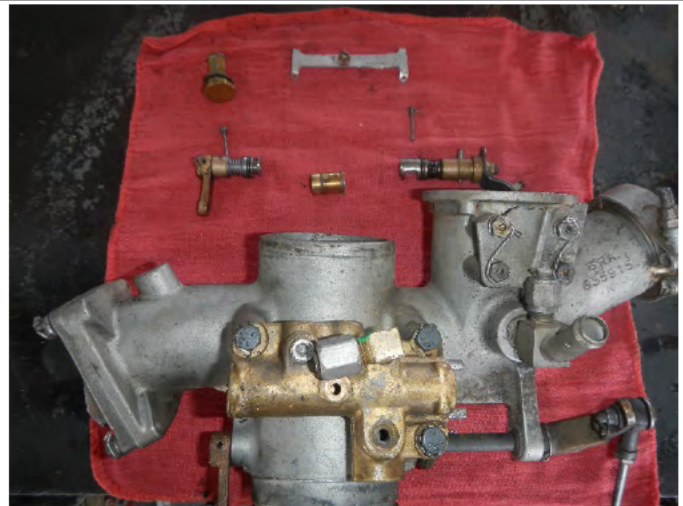
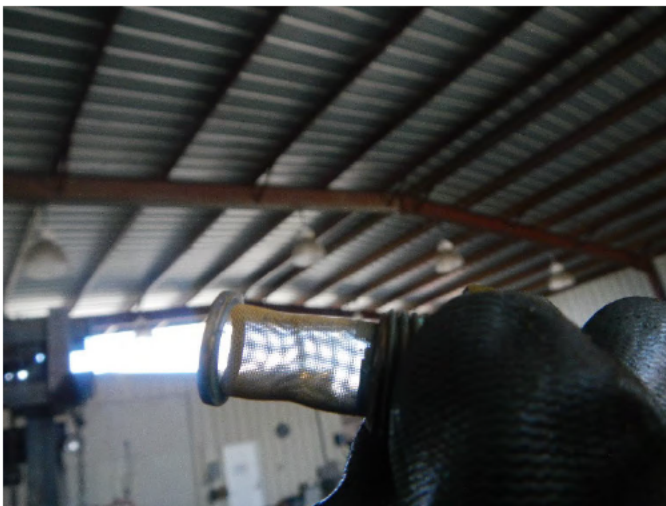
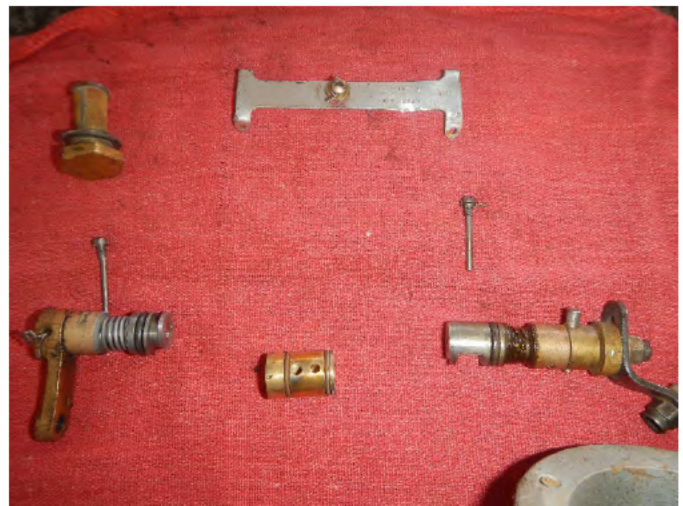
The throttle body was separated from the engine. The throttle control cable rod end remained attached to the throttle lever. The mixture control cable was separated from the lever. Manual rotation of the levers resulted in smooth rotation of the shafts with no binding noted. The inlet and outlet fuel fittings were separated from the metering unit. The metering unit was disassembled and no pre-accident anomalies were noted with the throttle and mixture cams or the metering plug. The fuel inlet screen was clear.

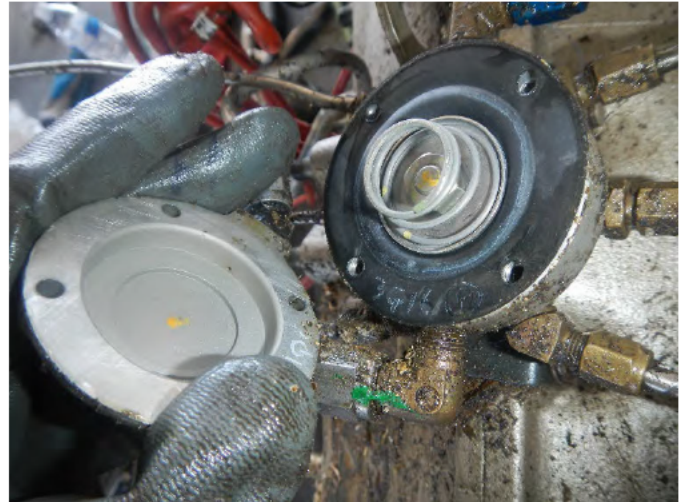
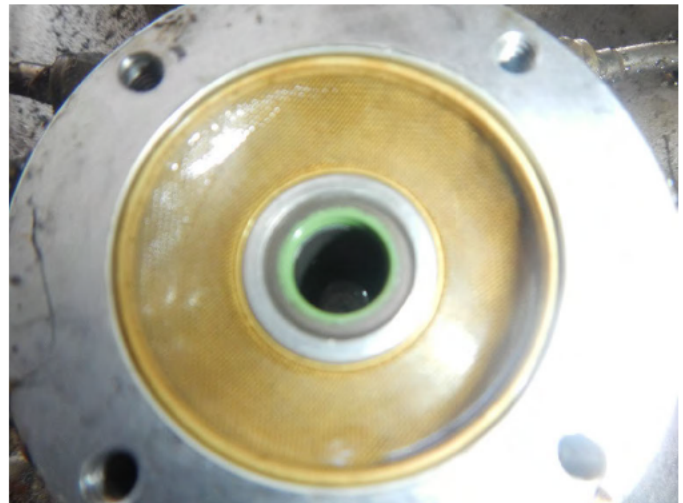
The fuel manifold valve remained secured to the topside of the engine and all fuel lines remained secured in place. The cap was removed and the spring, diaphragm and plunger remained intact. The screen was clear and blue aviation fuel was observed in the housing.

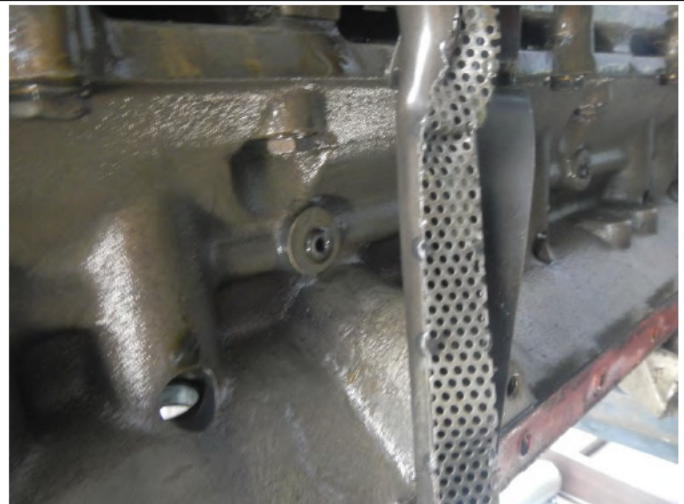
Condition: The pickup tube and screen were deformed and displaced up toward the bottom of the engine. No pre-accident anomalies or blockages were noted.

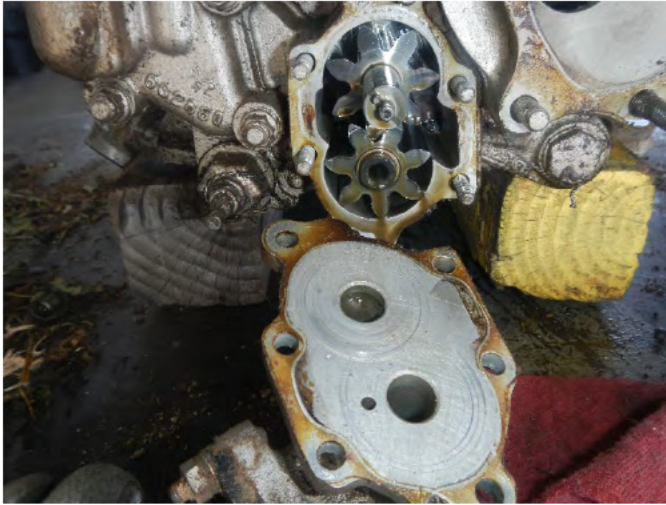
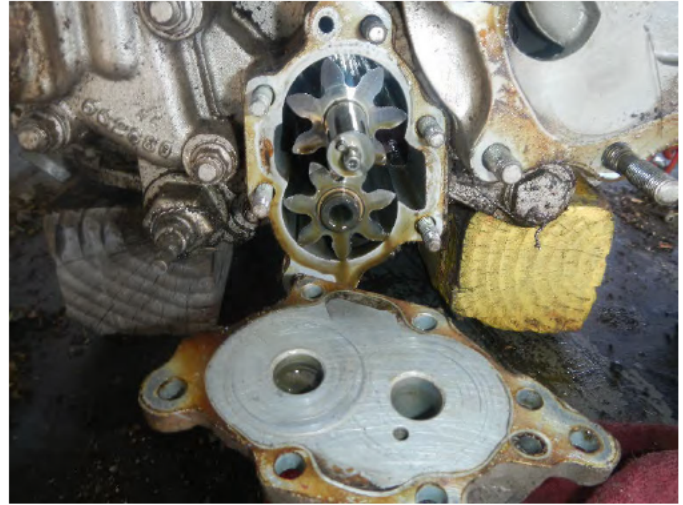
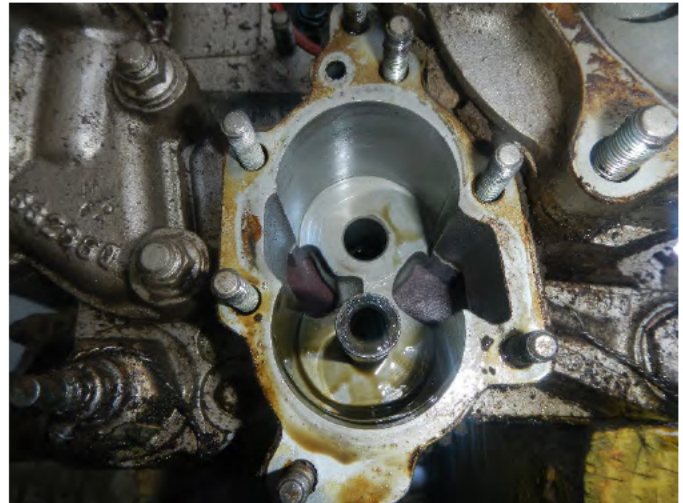
The oil pump remained attached to the crankcase. The pump was disassembled and all components were covered with residual oil. The gears were intact and there was no sign of hard particle passage on the pump walls. Rotational scoring was noted on the pump housing cap.

The scavenge pump remained attached to the back side of the starter adapter. The pump was disassembled and no pre-accident anomalies were noted.

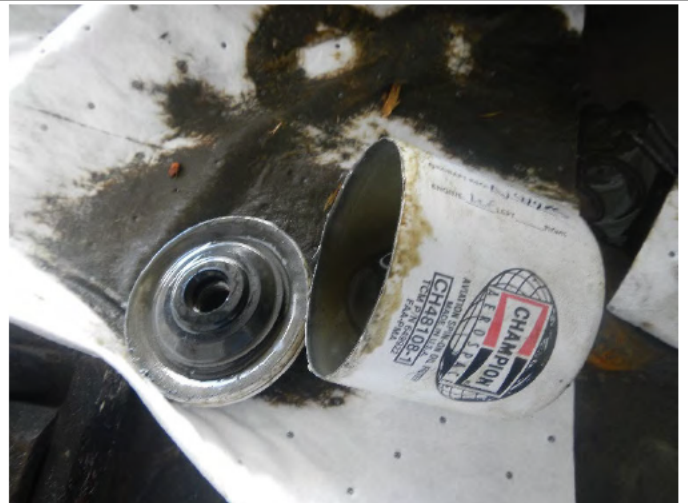
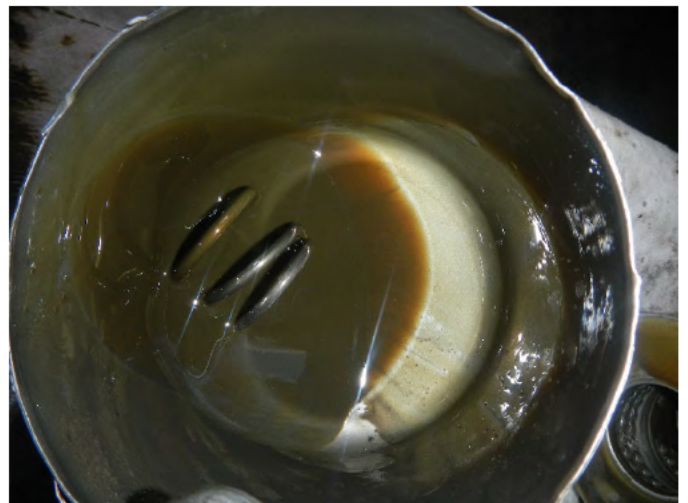
The oil filter remained secured to the oil filter adapter and the safety-wire was intact. The filter was removed and cut open to find relatively clean residual oil and no observable metallic debris between the filter pleats.

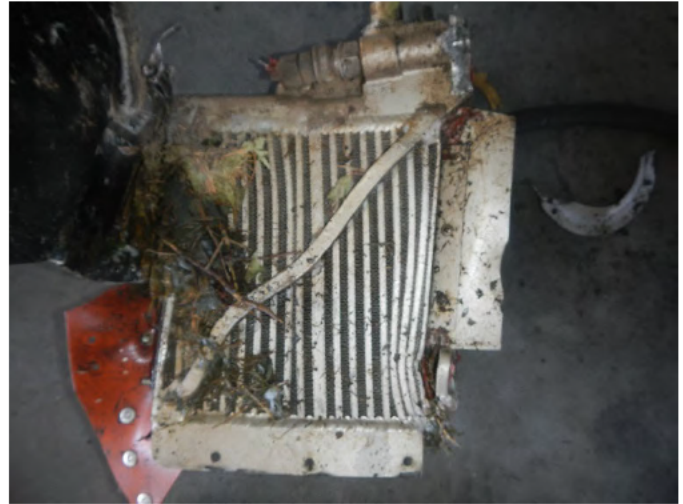
The oil cooler sustained impact-related deformation damage and its mounting bracket was fractured. Removal of the cooler from the engine revealed no pre-accident anomalies.

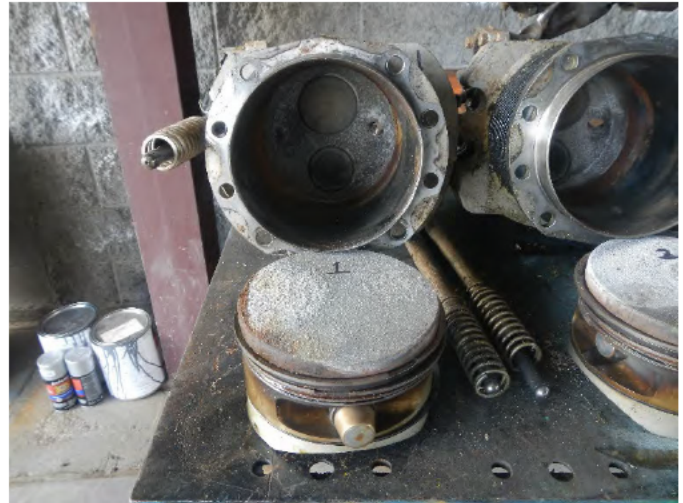
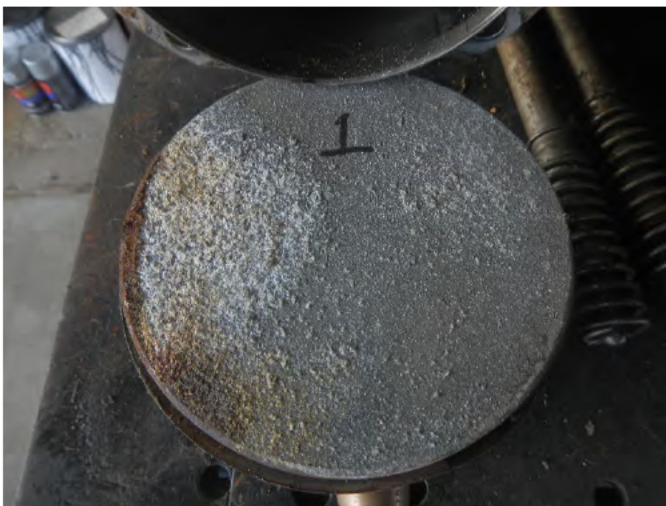
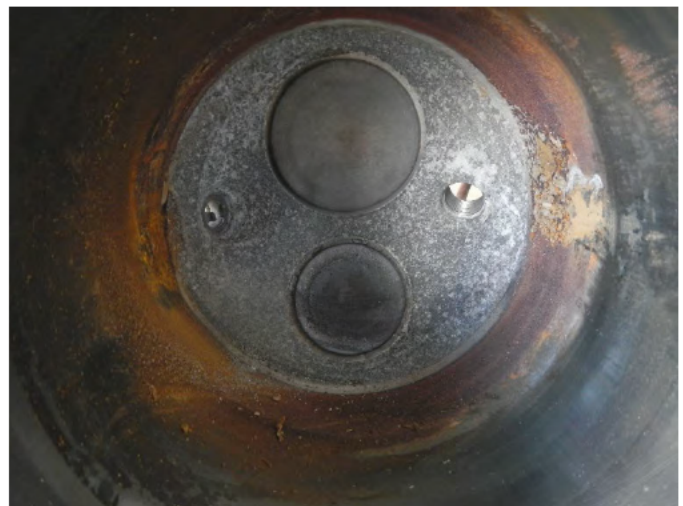
CYLINDER #1

The cylinder remained secured to the crankcase with no external pre-accident anomalies noted. The rocker cover was fractured on the exhaust side. Removal of the remaining cover revealed no pre-accident anomalies with the rockers and valve springs. Removal of the cylinder revealed corrosion on the piston, barrel and cylinder, but no pre-accident anomalies with any of the cylinder components.

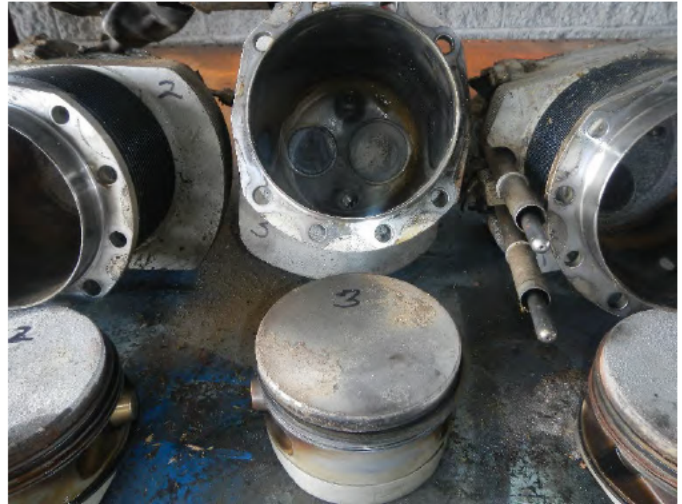
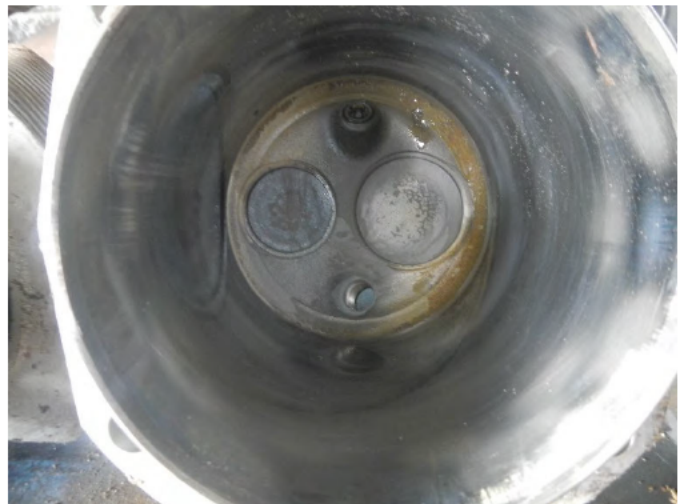
CYLINDER #3

The cylinder remained secured to the crankcase with no external pre-accident anomalies noted. The rocker cover was fractured on the bottom side. Removal of the remaining cover revealed no pre-accident anomalies with the rockers and valve springs. Removal of the cylinder revealed no pre-accident anomalies with the piston, barrel cylinder head, valves, or valve seats.

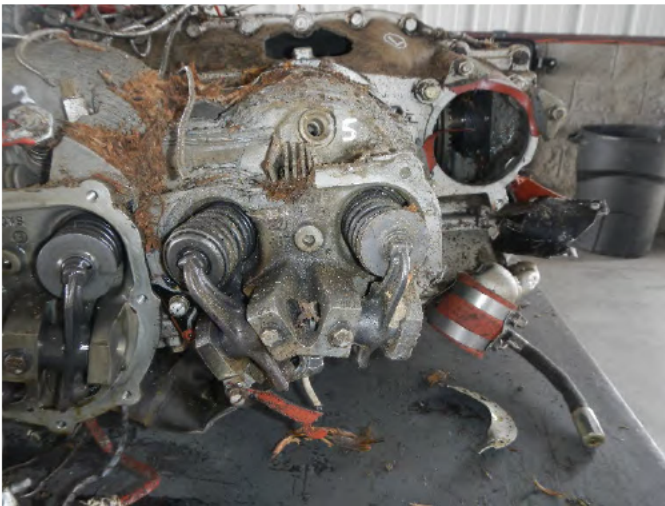
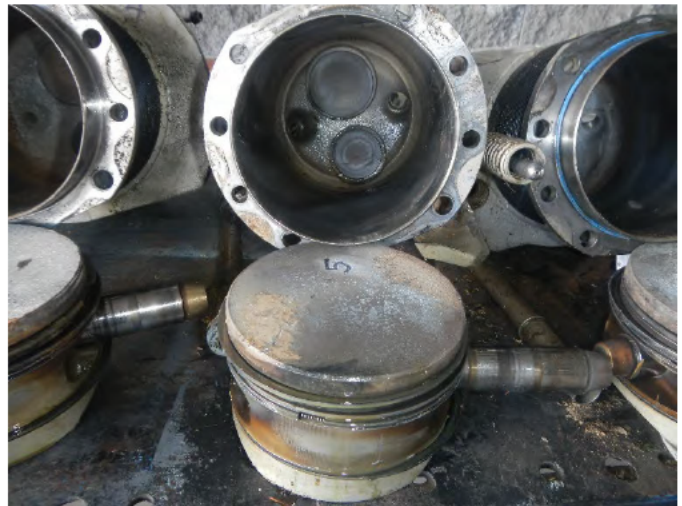
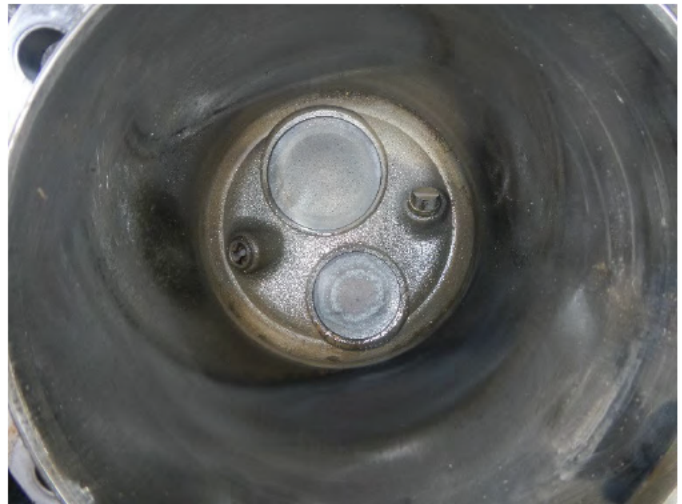
CYLINDER #5

The cylinder remained attached to the crankcase, but numerous cooling fins were fractured as was the bottom area of the cylinder head (in the pushrod area). Wood fragments were embedded in between some fractured cooling fins. There were no pre-accident anomalies noted with the rockers or valve springs. Removal of the cylinder revealed no pre-accident anomalies with the piston, barrel, cylinder head, valves and valve seats.

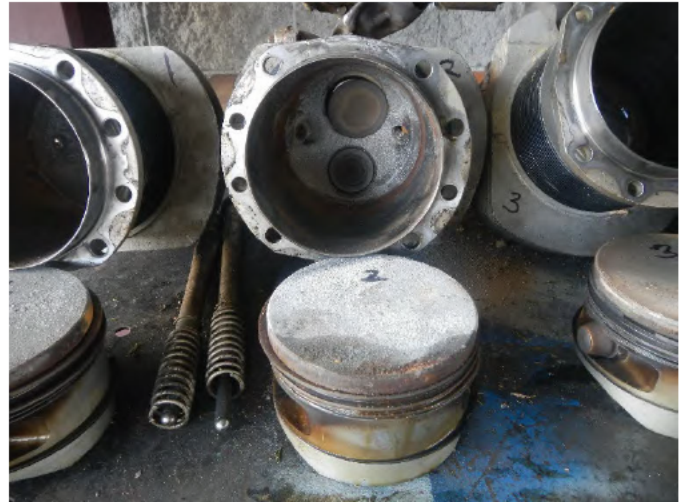
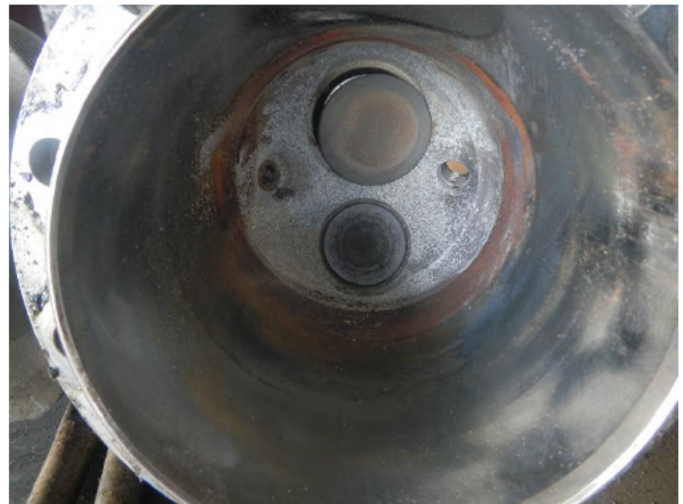
CYLINDER #2

Condition: The cylinder remained secured to the crankcase with no external pre-accident anomalies noted. The rocker cover was fractured as was the bottom of the cylinder head. The cylinder head had another irregular and jagged fracture line that intersected the intake valve area and displaced the intake valve. There were no pre-accident anomalies with the rockers and valve springs. Removal of the cylinder revealed corrosion on the piston, barrel and cylinder, but no pre-accident anomalies with any of the cylinder components.

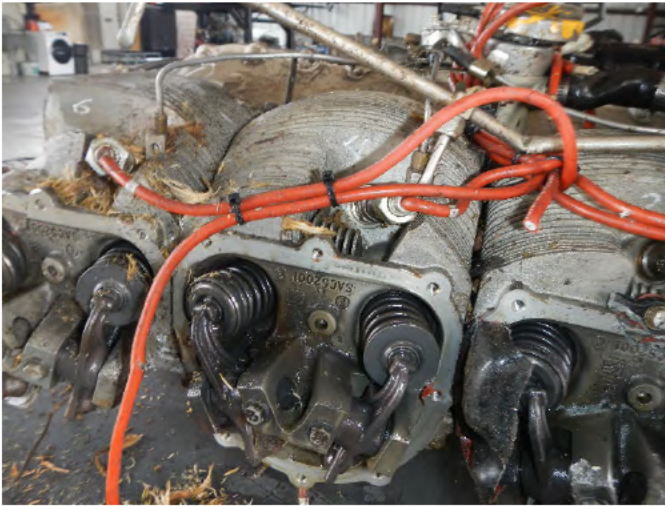
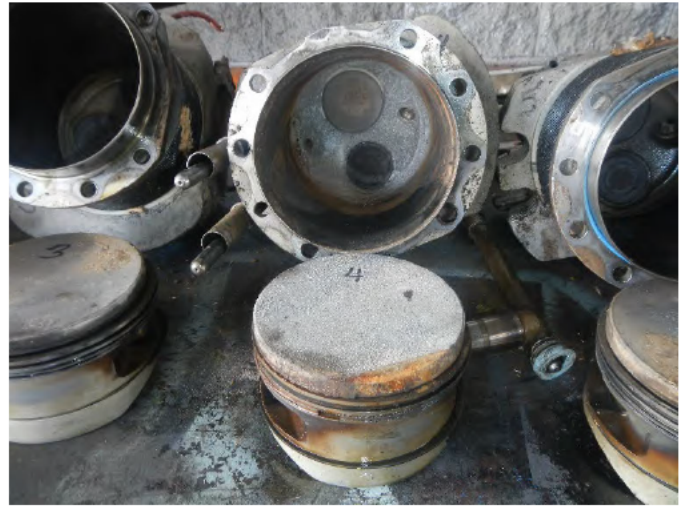
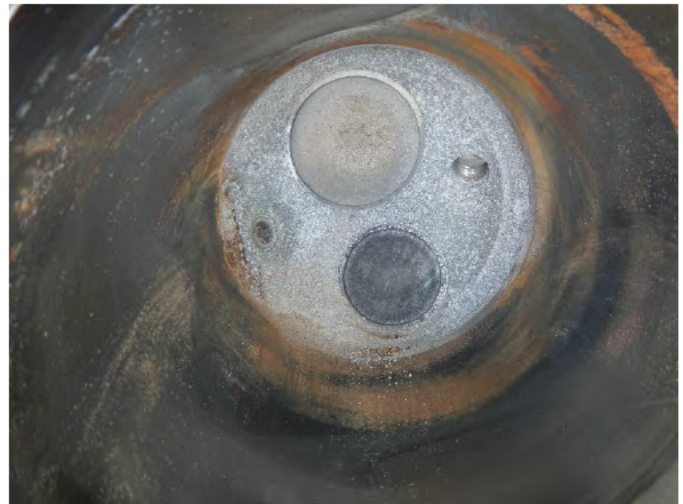
CYLINDER #4

Condition: The cylinder remained secured to the crankcase with no external pre-accident anomalies noted. The rocker cover was fractured. Removal of the remaining cover revealed no pre-accident anomalies with the rockers and valve springs. Removal of the cylinder revealed corrosion on the piston, barrel and cylinder, but no pre-accident anomalies with any of the cylinder components.

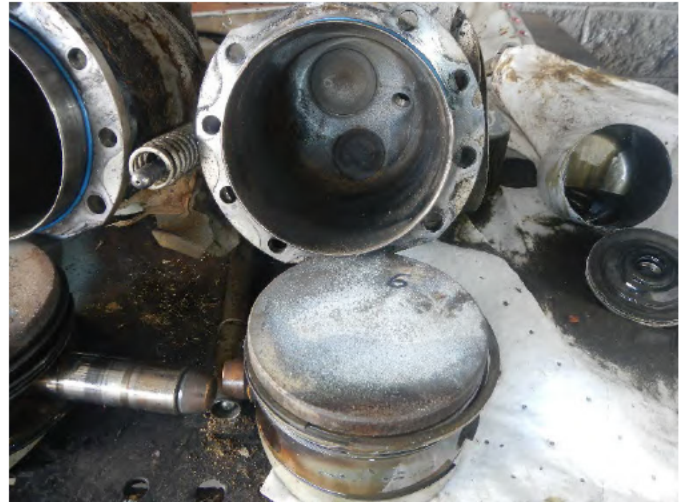
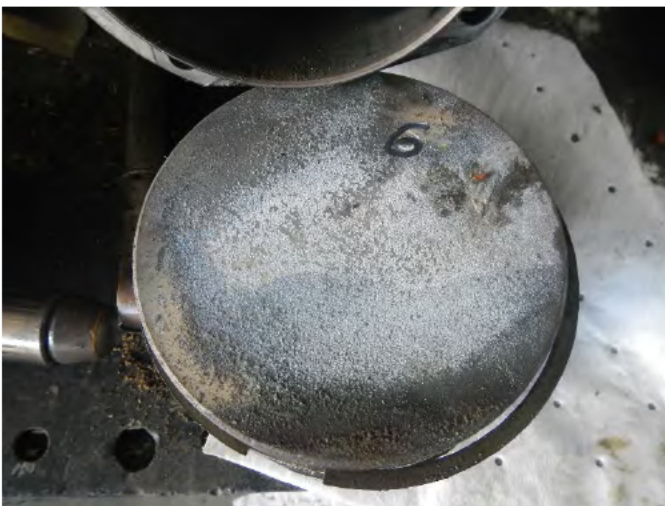
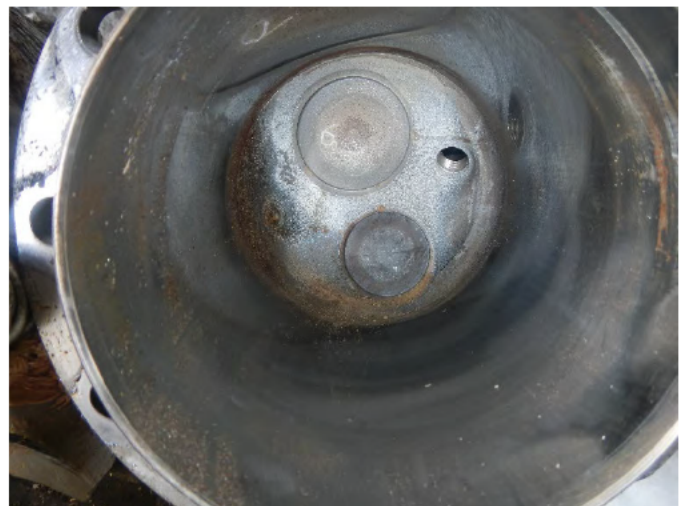
CYLINDER #6

Condition: The cylinder remained attached to the crankcase, but numerous cooling fins were fractured as was the left side of the cylinder head. The exhaust rocker, valve stem, and valve springs were deformed. Wood fragments were embedded in between some fractured cooling fins and around the top sparkplug. There were no pre-accident anomalies noted with the rockers or valve springs. Removal of the cylinder revealed corrosion on the piston, barrel and cylinder, but no pre-accident anomalies with any of the cylinder components.

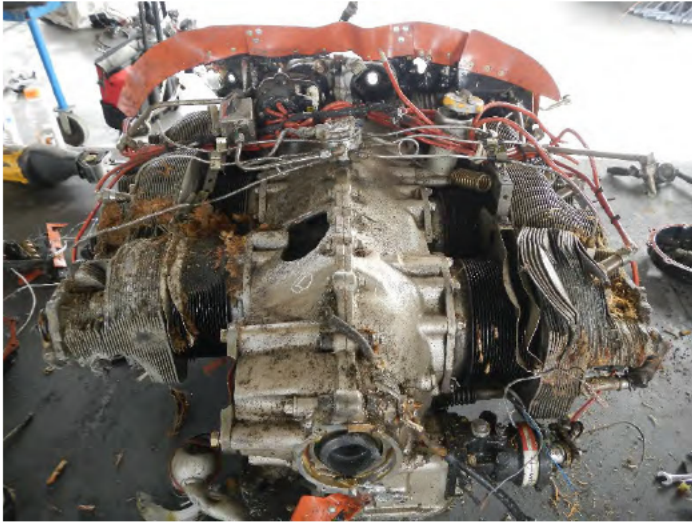
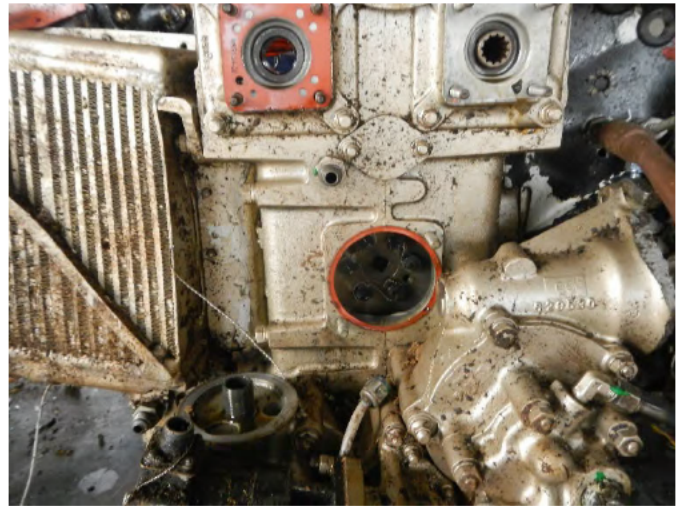
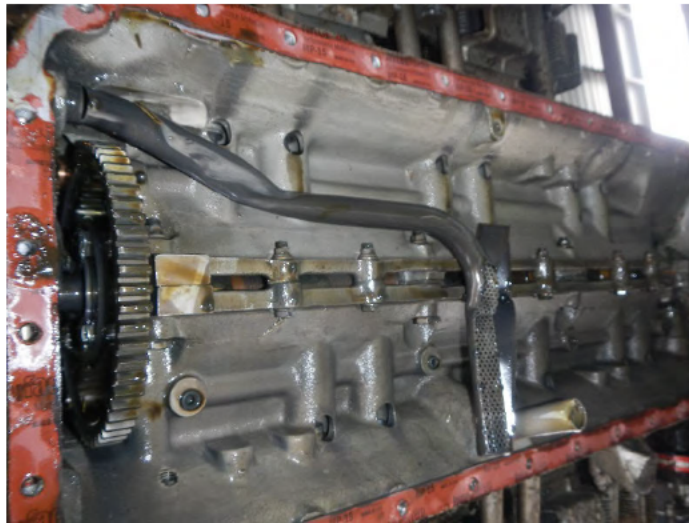
CRANKCASE	Casting Number:	1-3-5: AEC653921	2-4-6: AEC653920	S/N: 2G382
Condition:	The crankcase halves remained attached and all the cylinders remained secured in place. There was a puncture from the outside-in over the #5 connecting rod area and wood debris was observed inside the crankcase in that area.

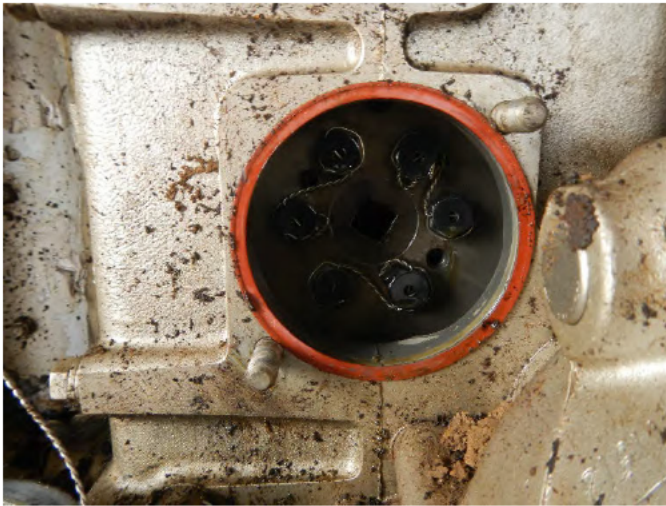
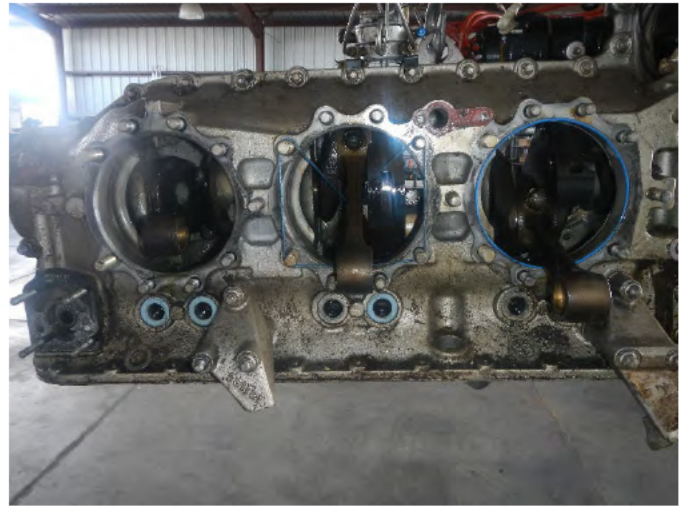
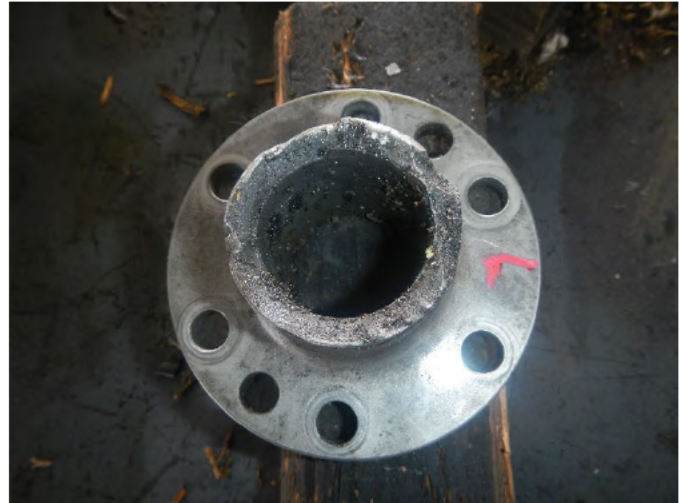
The crankshaft was fractured at the nose seal. The fracture was irregular and jagged consistent with overload. The alternator face gear remained attached to the crankshaft and no pre-accident anomalies were noted with the gear teeth. The crankshaft gear was bolted in place and the safety-wire was intact. The connecting rods remained secured in place and all rotated freely on the crankshaft when they were manually manipulated with no signs of discoloration or thermal distress. Once the wood debris was removed from the front of the crankcase, the crankshaft rotated freely with no binding noted from any of the main bearings.

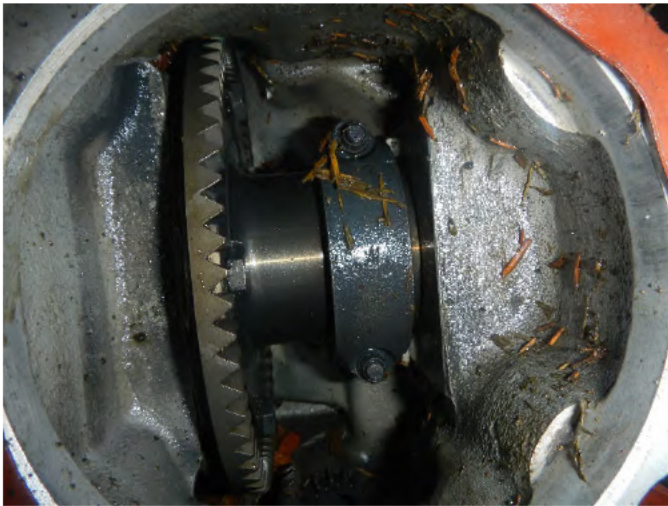
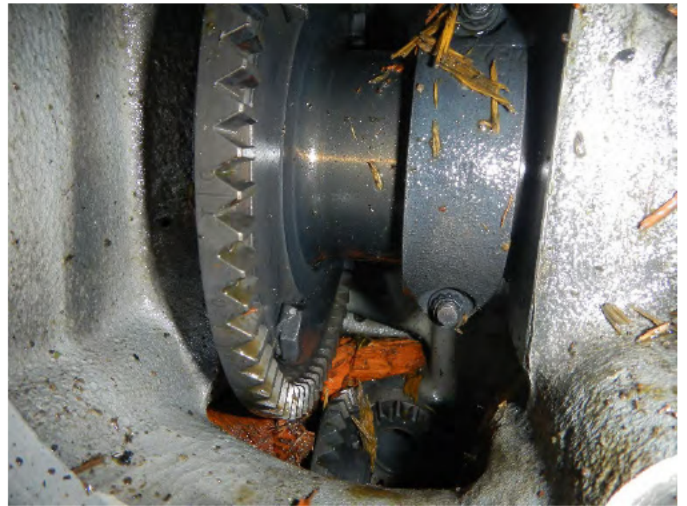
The oil transfer collar was in place and did not display any pre-accident anomalies.

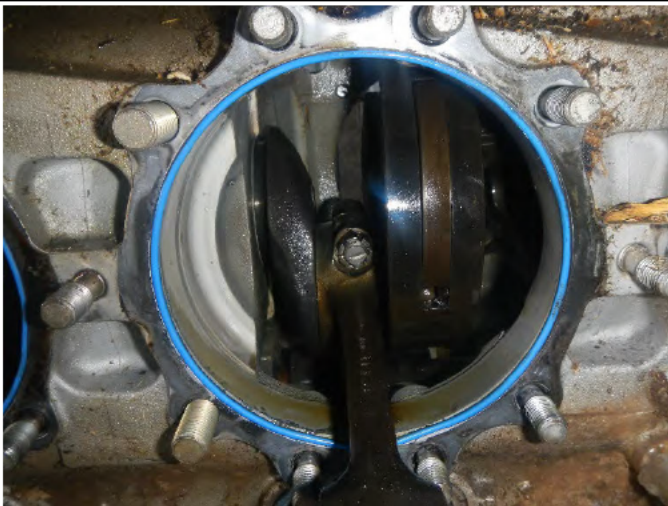
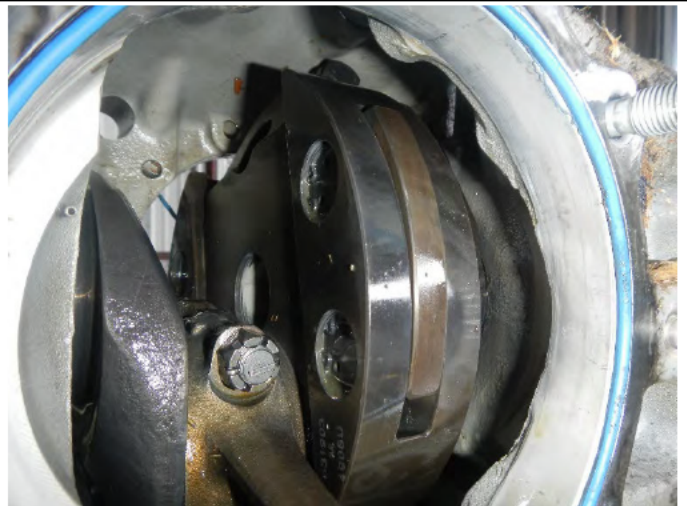
The counterweights remained secured to the crankshaft. There were no pre-accident anomalies noted with the counterweights.

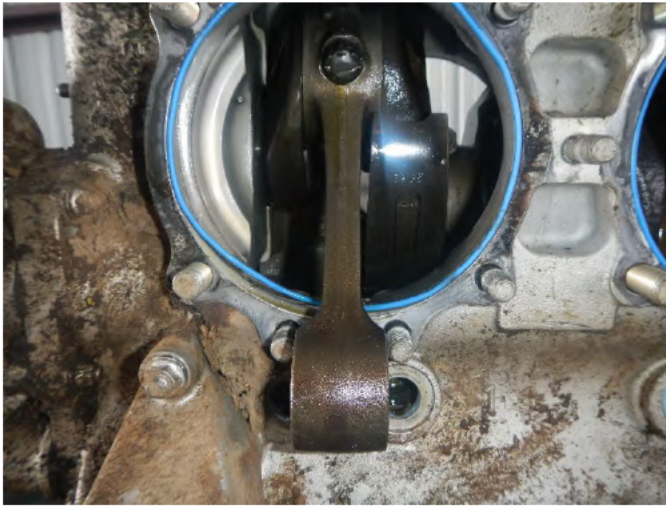
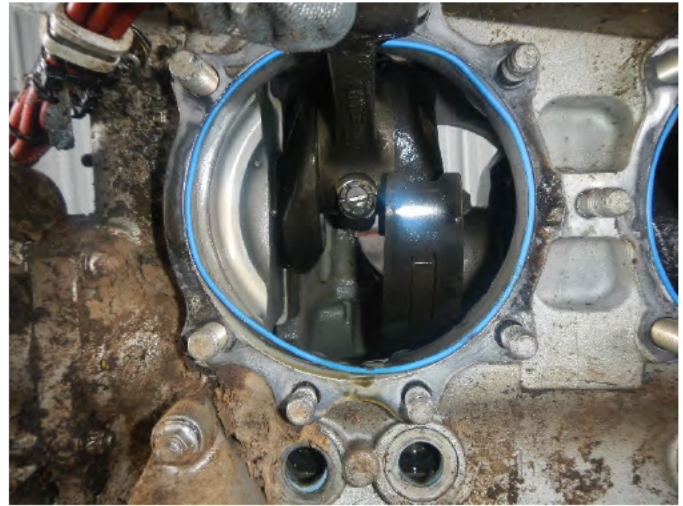
#1 CONNECTING ROD

The connecting rod remained in place on the crankshaft with no signs of thermal discoloration or operational distress. Manual manipulation of the connecting rod during crankshaft rotation revealed no binding of the connecting rod bearing.

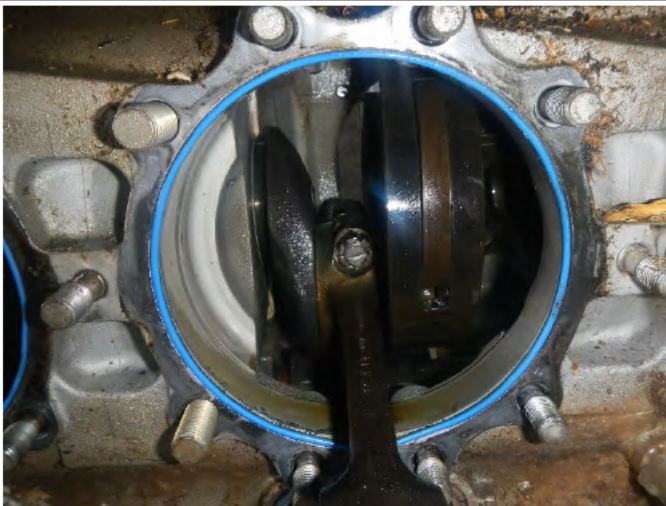
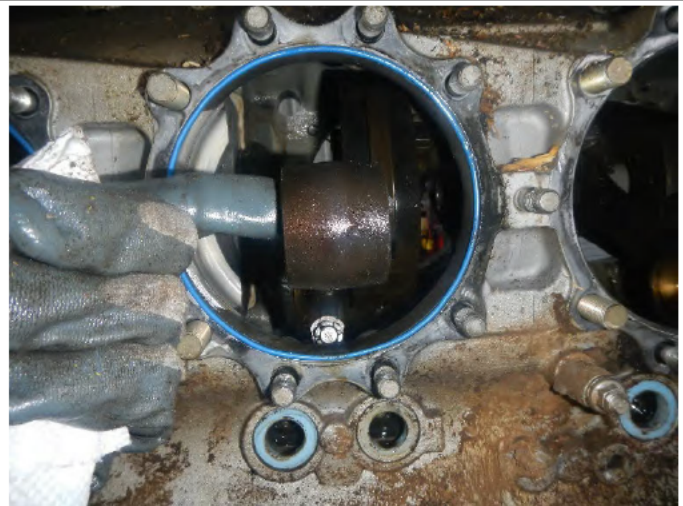
#3 CONNECTING ROD

The connecting rod remained in place on the crankshaft with no signs of thermal discoloration or operational distress. Manual manipulation of the connecting rod during crankshaft rotation revealed no binding of the connecting rod bearing.

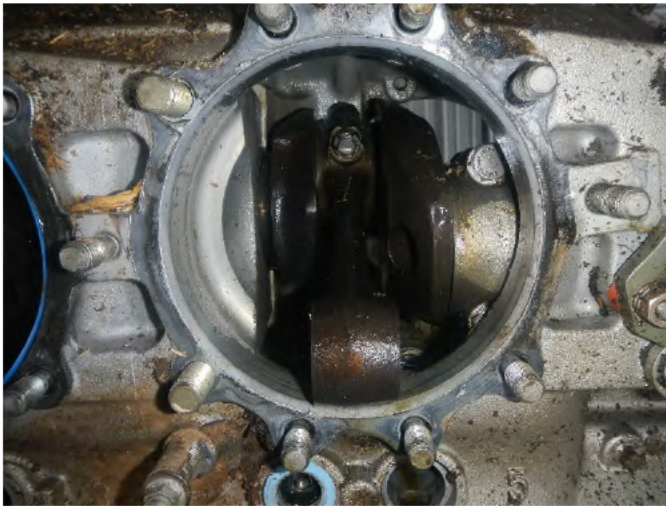
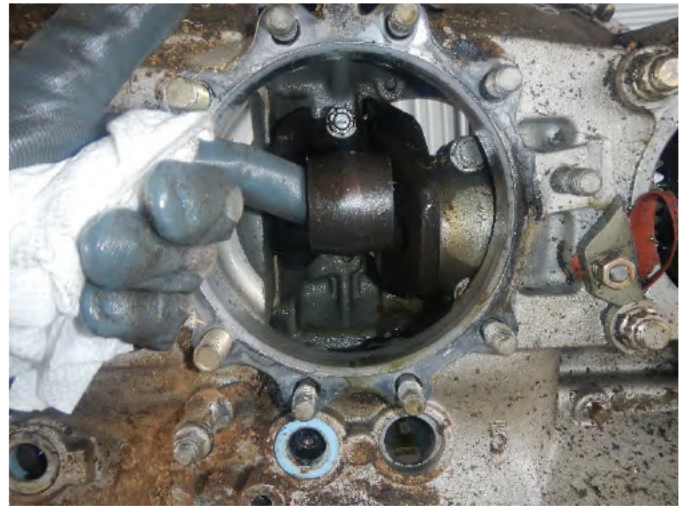
#5 CONNECTING ROD

The connecting rod remained in place on the crankshaft with no signs of thermal discoloration or operational distress. Manual manipulation of the connecting rod during crankshaft rotation revealed no binding of the connecting rod bearing.

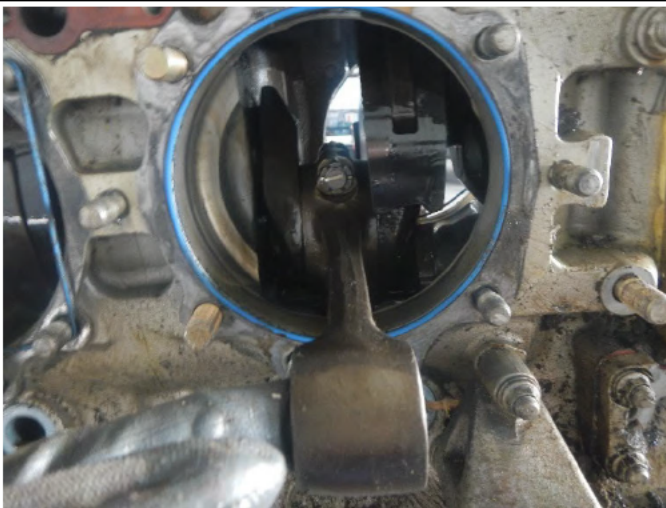
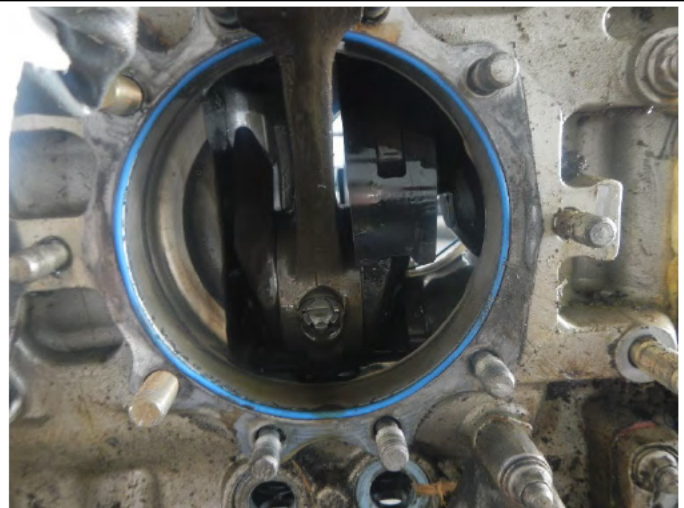
#2 CONNECTING ROD

The connecting rod remained in place on the crankshaft with no signs of thermal discoloration or operational distress. Manual manipulation of the connecting rod during crankshaft rotation revealed no binding of the connecting rod bearing.

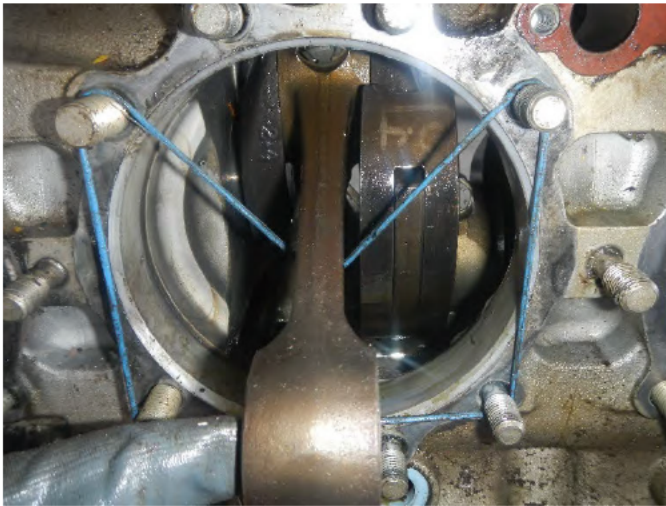
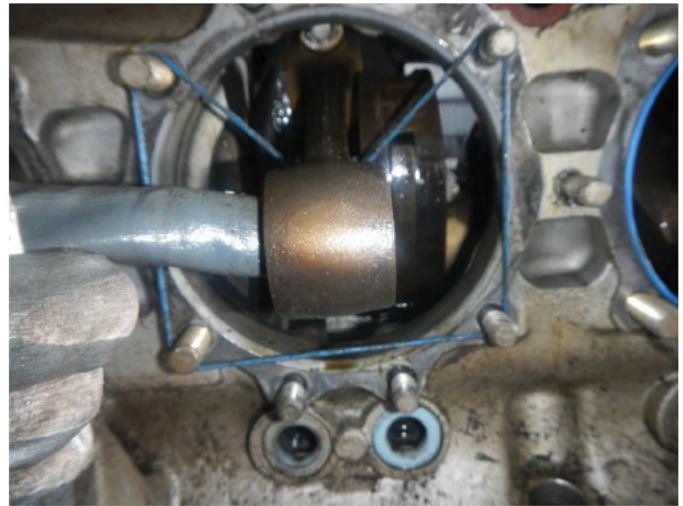
#4 CONNECTING ROD

The connecting rod remained in place on the crankshaft with no signs of thermal discoloration or operational distress. Manual manipulation of the connecting rod during crankshaft rotation revealed no binding of the connecting rod bearing.

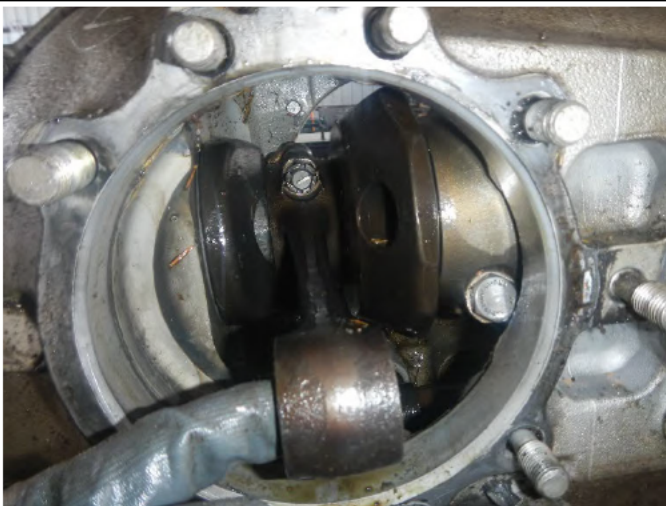
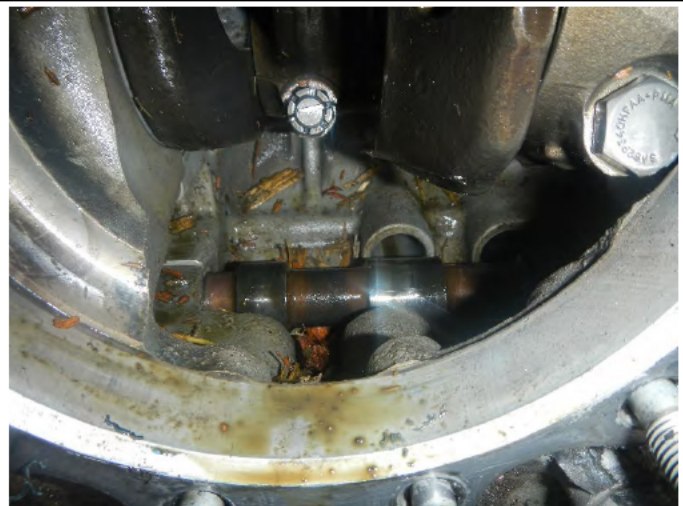
#6 CONNECTING ROD

The connecting rod remained in place on the crankshaft with no signs of thermal discoloration or operational distress. Manual manipulation of the connecting rod during crankshaft rotation revealed no binding of the connecting rod bearing.
