Continental Motors

ENGINE EXAMINATION REPORT

ENGINE MODEL	TSIO-520-JcNB
ENGINE SERIAL NUMBER	218873-R
AIRCRAFT MAKE & MODEL	Cessna 414A
AIRCRAFT SERIAL NUMBER	414A0821
AIRCRAFT REGISTRATION	N414RS
FILE NUMBER	18-357

EXAMINATION		ACCIDENT DATA	
DATE	03/08/2019	NTSB ACCIDENT #	WPR19FA079
FACILITY	Air Transport	NTSB INVESTIGATOR	Maja Smith
ADDRESS	[REDACTED] Phoenix, Arizona 85009	FAA INVESTIGATOR	Benjamin Harris
		ACCIDENT DATE	02/03/2019
		ACCIDENT LOCATION	Yorba Linda, California

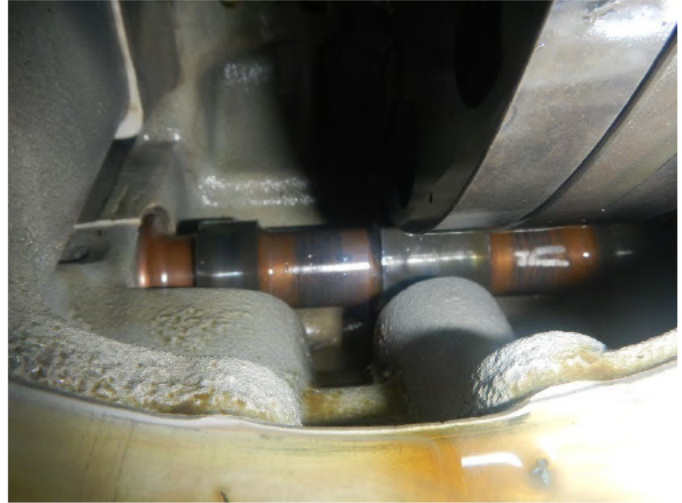
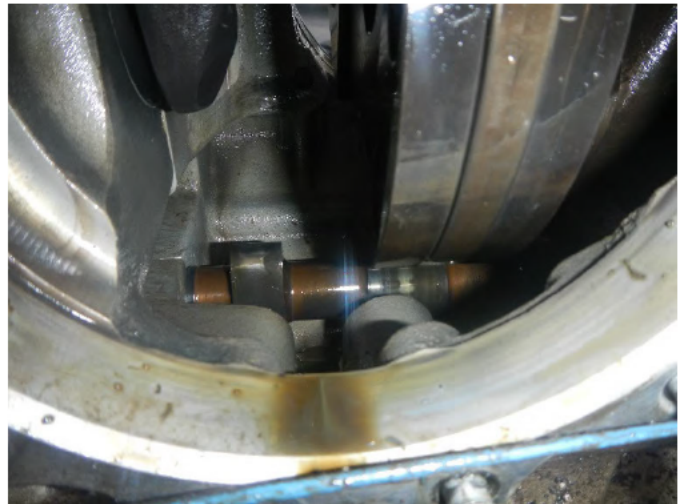
The camshaft remained intact with no pre-accident anomalies noted. Rotation of the crankshaft resulted in a coinciding rotation of the camshaft with no pre-accident anomalies noted on the gear teeth and lobes.

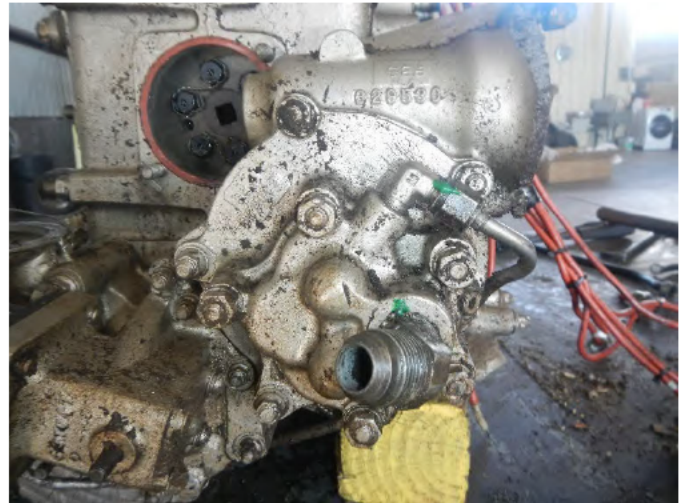
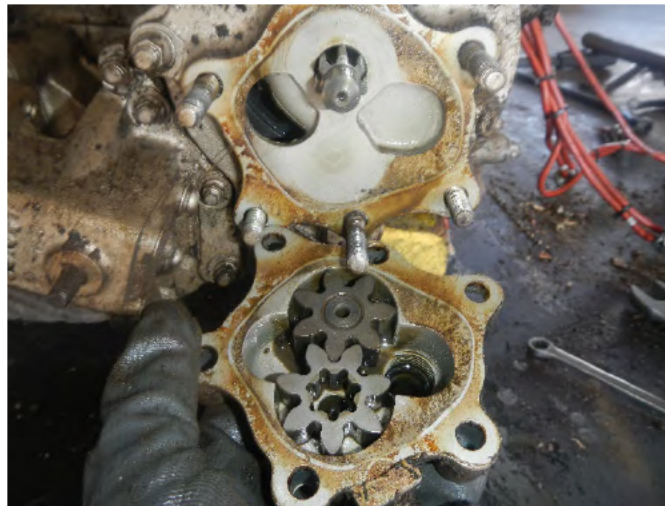
The starter adapter remained secured to the backside of the engine and manual rotation of the crankshaft resulted in rotation of the adapter gear and scavenge pump.

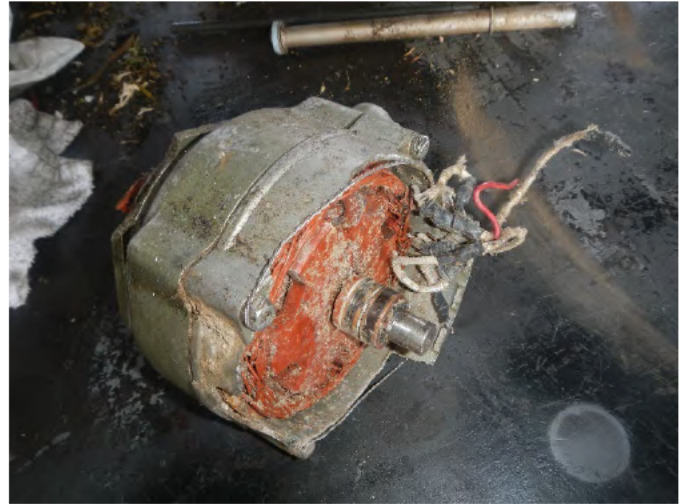
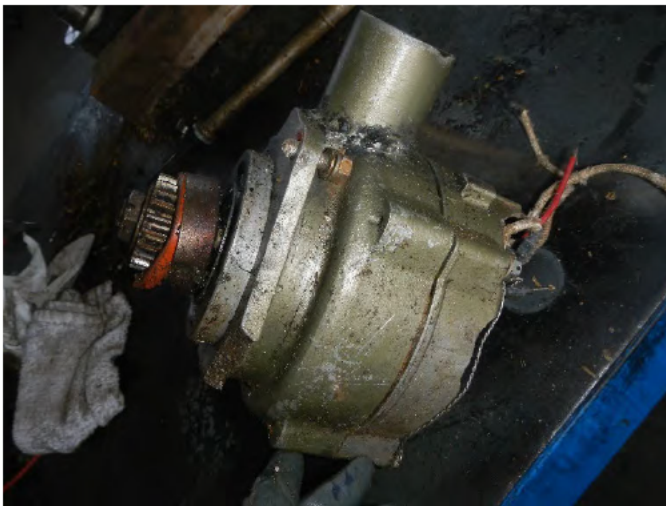
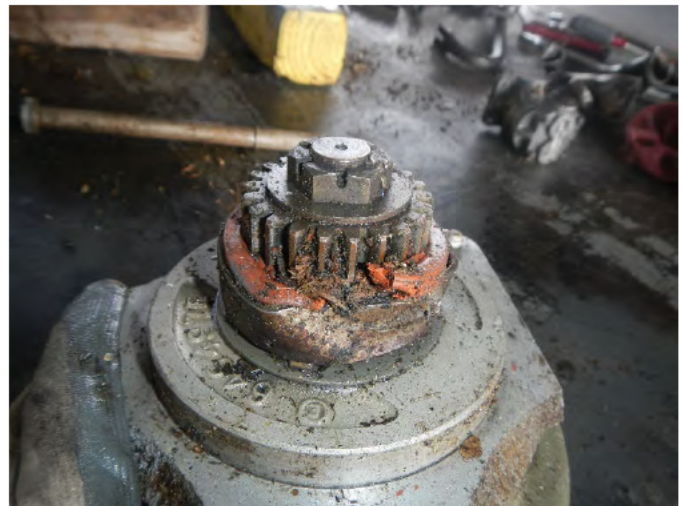
The alternator was separated from the engine and the housing was fractured. There were no pre-accident anomalies noted with the alternator. The drive coupling remained secured in place, though it sustained impact damage to one side that deformed the cup and elastomer.
