ENGINE EXAMINATION REPORT

| ENGINE MODEL | TSIO-520-NB |
| ENGINE SERIAL NUMBER | 244794-R |
| AIRCRAFT MAKE & MODEL | Cessna 414A |

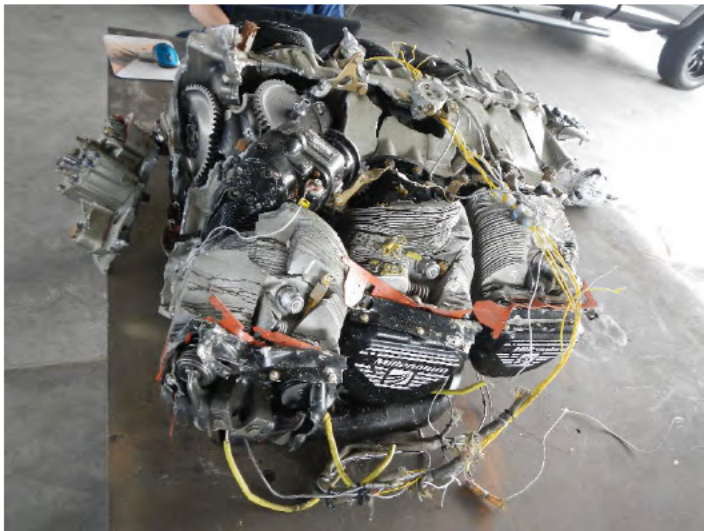
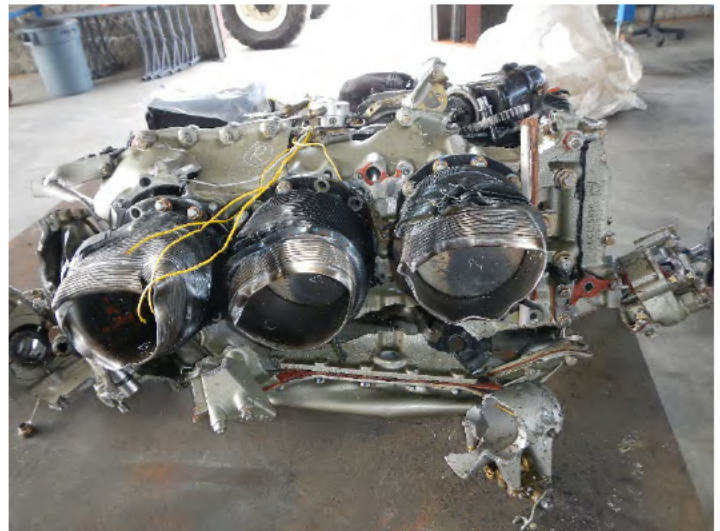
EXTERNAL ENGINE CONDITION

The engine was separated from the nacelle and all systems but the fuel manifold valve housing and oil pump were separated from the engine. The crankcase was fractured in multiple locations and the nose of the case was displaced to the bottom of the oil sump. The crankshaft was fractured in the same area as the crankcase nose fracture (at the oil transfer collar). All fracture surfaces were jagged and irregular, consistent with overload. The #2, #4, and #6 cylinders heads were separated from the barrels and the barrels were deformed down around their respective pistons. There was no evidence of lubrication distress on any of exposed components.

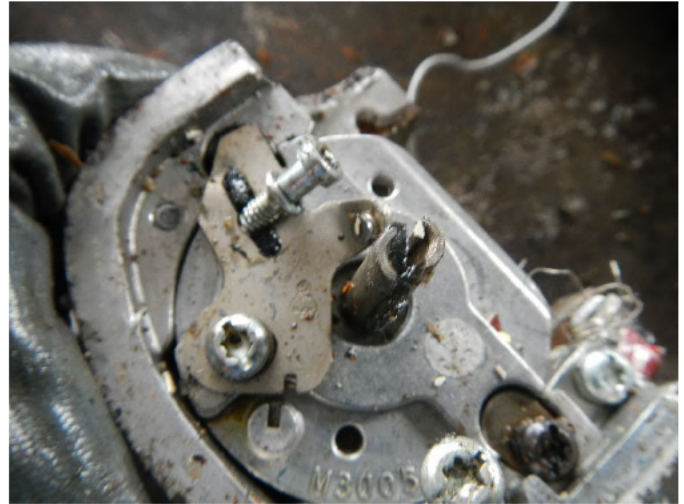
PAGE 6 of 31**MAGNETO**

The magneto was separated from the engine and the housing was fragmented with only the drive shaft and magnet observed.

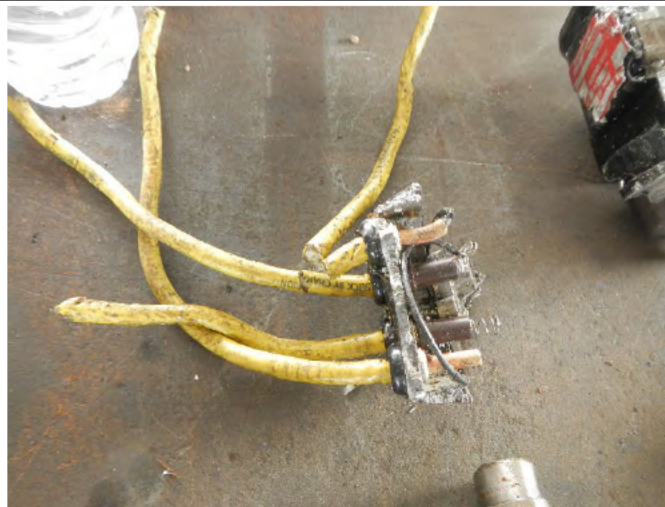
**IGNITION HARNESS**

The ignition harness was fragmented.

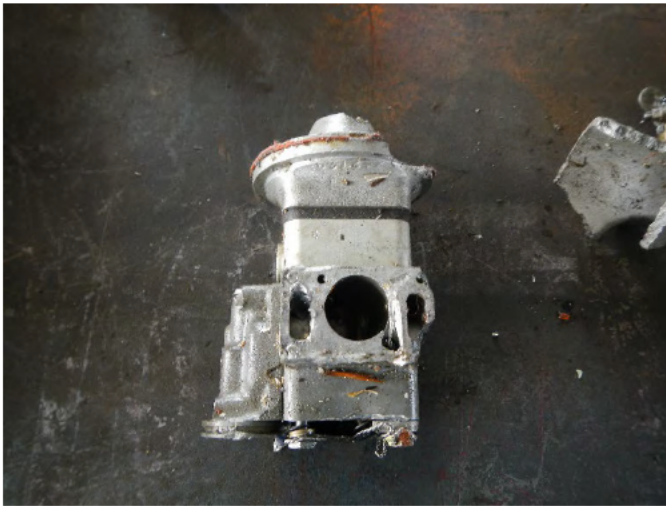
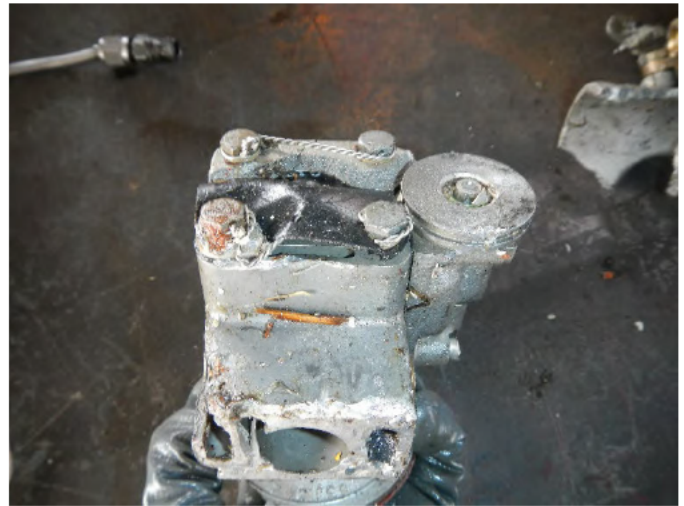
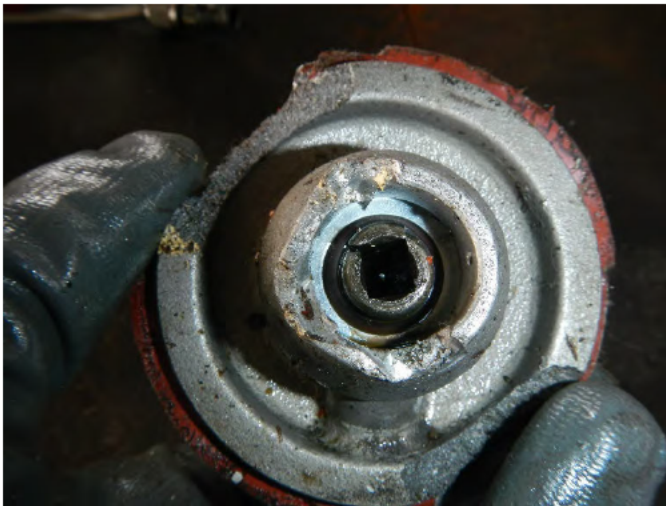
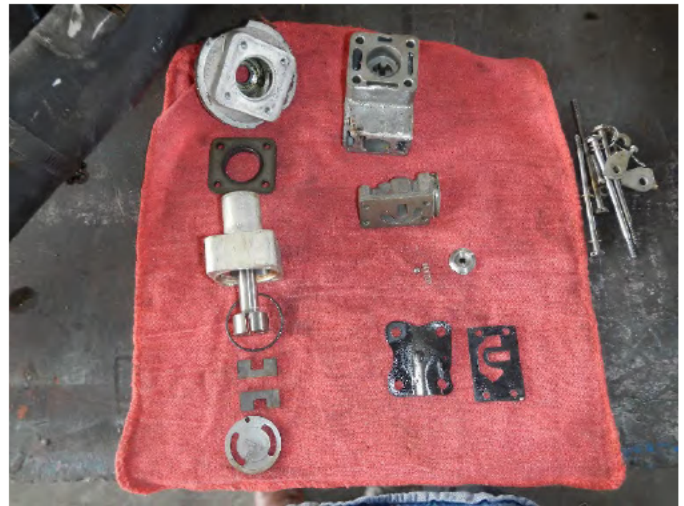
FUEL PUMP

Condition: The engine driven fuel pump was separated from the engine and the drive coupling was not observed; however, witness marks of the coupling were observed on the fuel pump. The pump drive shaft was manually rotated using a screw driver with no binding noted. The vapor return cap was missing, the aneroid bellow and housing were separated, and the low pressure relief valve cap was fractured. Disassembly of the pump revealed no pre-accident anomalies with the internal components.

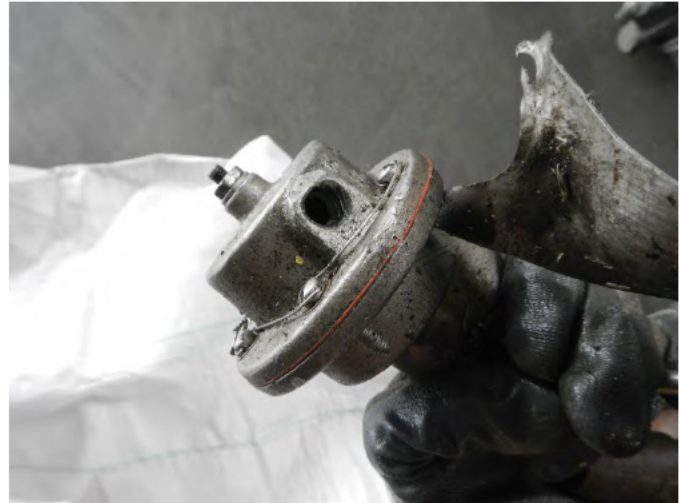
FUEL PRESSURE REGULATOR

The fuel pressure regulator's reference line fitting was separated. The fuel lines remained secured in place.

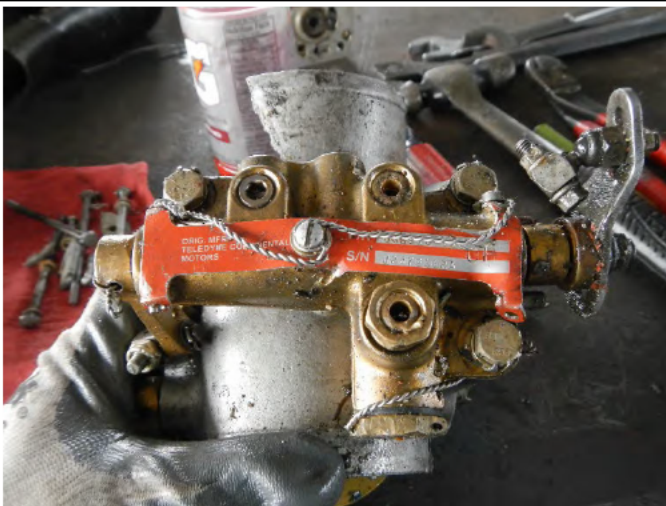
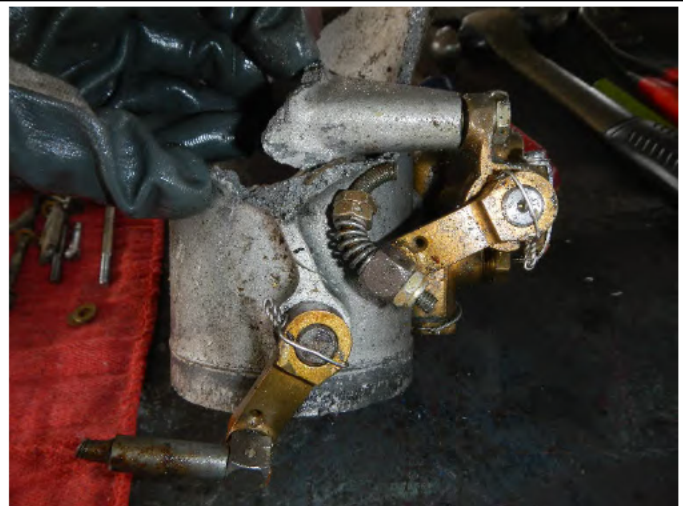
THROTTLE BODY METERING UNIT

The throttle body was fractured and separated from the engine. The throttle interconnect linkage was fractured and one half of the arm was bent 180 degrees. The unit was disassembled, and no pre-accident anomalies were noted with the throttle and mixture cams, the metering plug, and the inlet fuel screen.

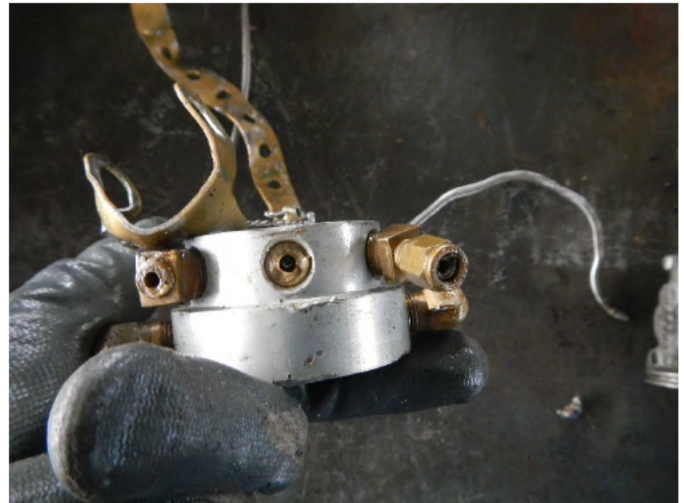
FUEL MANIFOLD VALVE

Condition: The fuel manifold housing remained attached to the engine, but the cap, diaphragm, plunger and screen were separated as were all the injector lines.

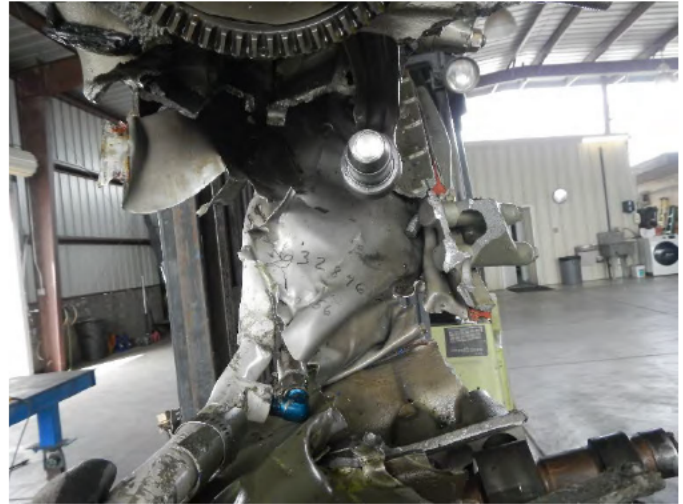
OIL SUMP

Condition: The oil sump was punctured, torn, and bent in half at the large crankcase fracture near the nose.

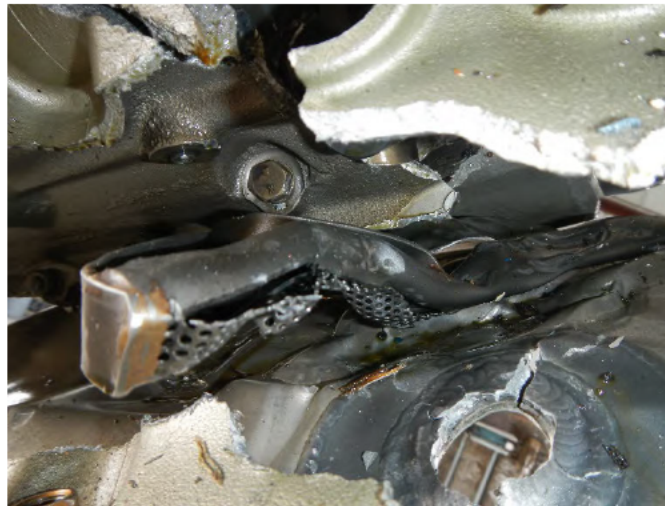
OIL PICK-UP TUBE & SCREEN

Condition: The pickup tube and screen were deformed and displaced up toward the bottom of the engine. Not pre-accident anomalies or blockages were noted.

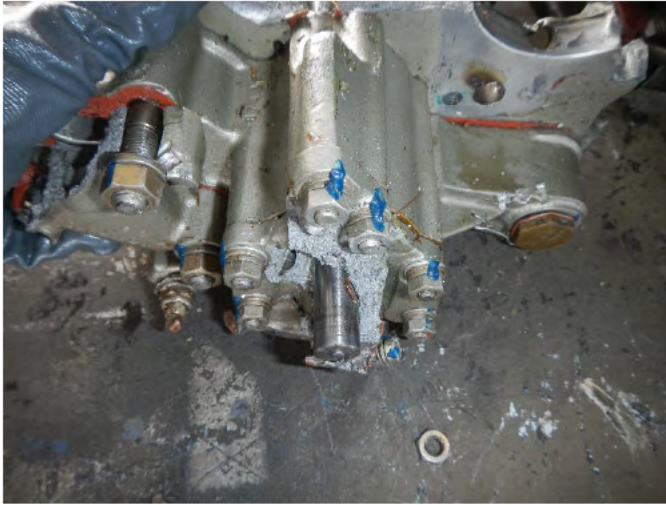
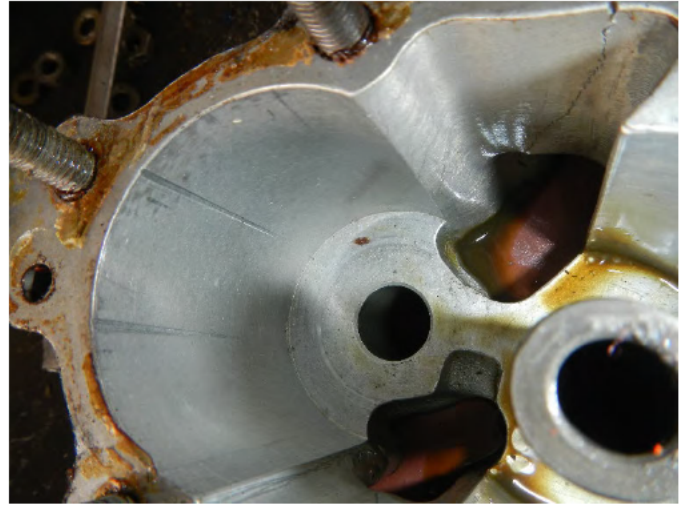
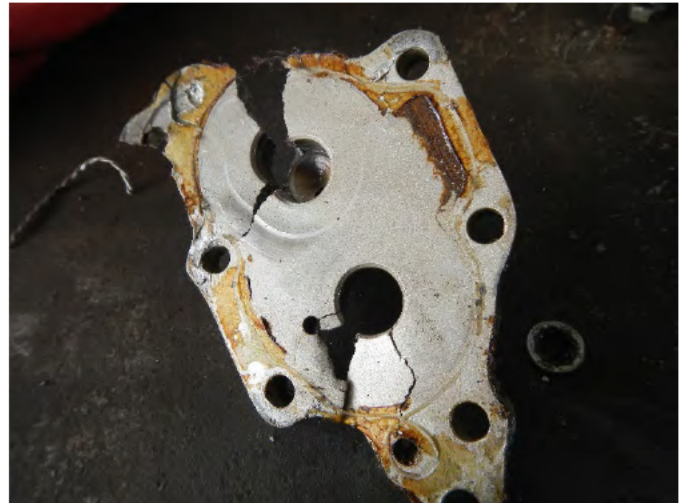
OIL PUMPS

Condition: The oil pump remained attached to a fractured segment of the crankcase. The pump was disassembled and all components were covered with residual oil. The gears were intact and there was no sign of hard particle passage on the pump walls.

The scavenge pump remained attached to the separated starter adapter. The pump was disassembled and no pre-accident anomalies were noted.

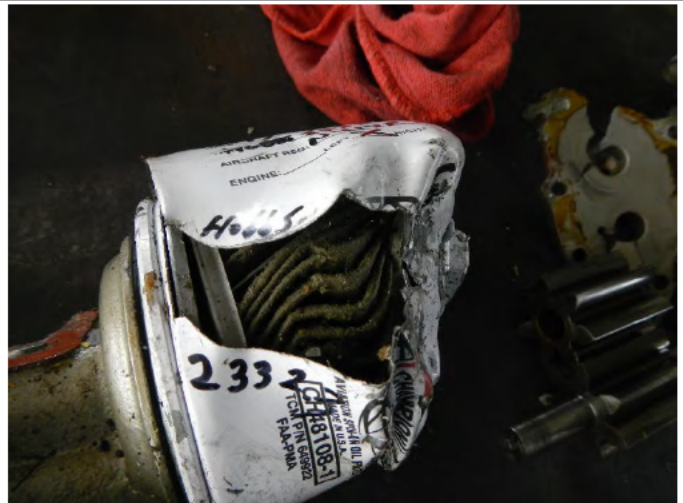
| Condition: | The oil filter remained attached to its separated adapter. The filter was torn open exposing the filter element. No pre-accident anomalies were noted. A date of January 4, 2019 and a Hobbs time of 2,332.3 hours were hand written on the filter. |

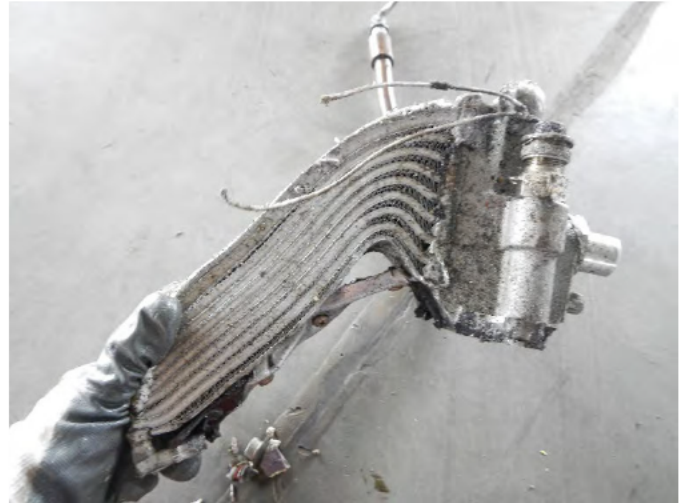
OIL COOLER

The oil cooler was separated and deformed with the top and bottom casings separated.

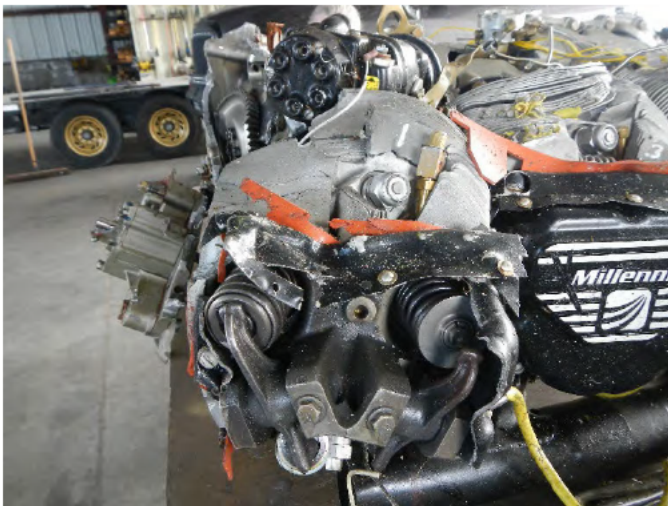
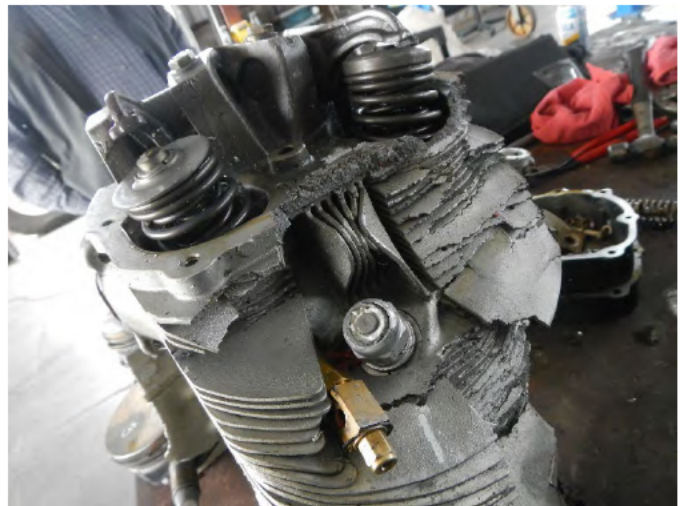
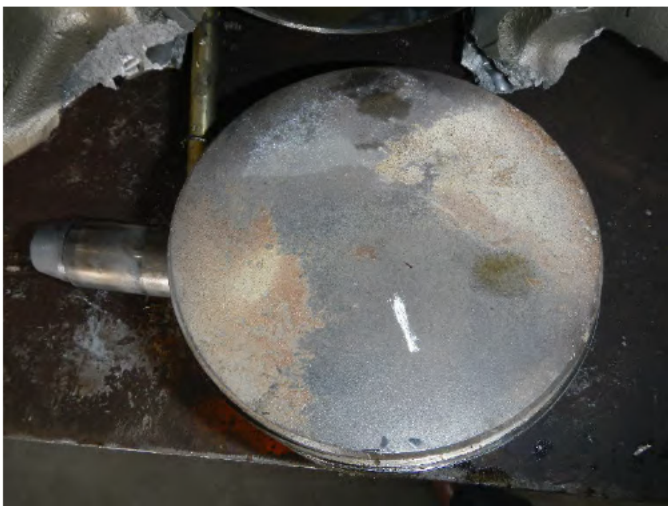
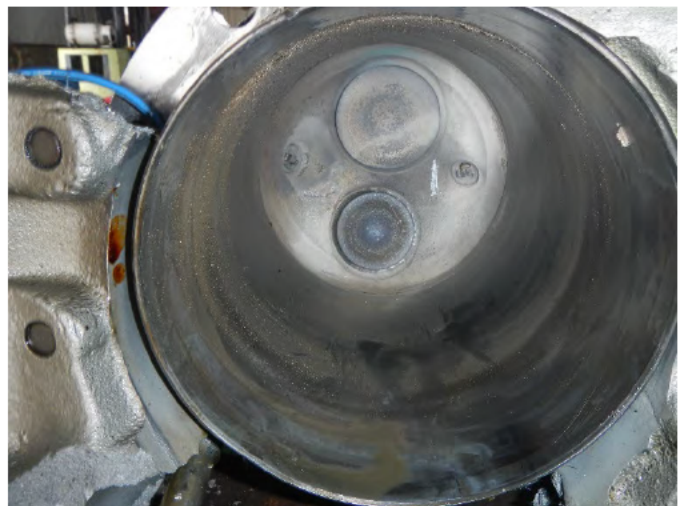
CYLINDER #1

Condition: The #1 cylinder sustained impact damage that fractured numerous cooling fins, the bottom pushrod area of the cylinder head, the rocker cover, and the top sparkplug barrel. The tip of the exhaust valve and valve springs were displaced slightly from the rocker. The valve springs did not display any pre-accident anomalies. The fuel injector nozzle was bent. The cylinder was partially displaced from the fractured crankcase with some of the studs and through-bolts pulled away from the case. The cylinder was removed and no pre-accident anomalies were noted with the sparkplugs, piston, barrel, valves or valve seats. One side of the piston skirt was fractured as was the oil control ring in that area.

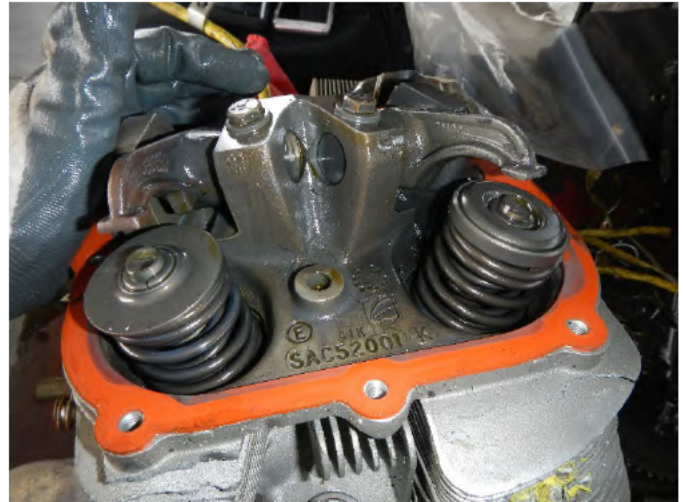
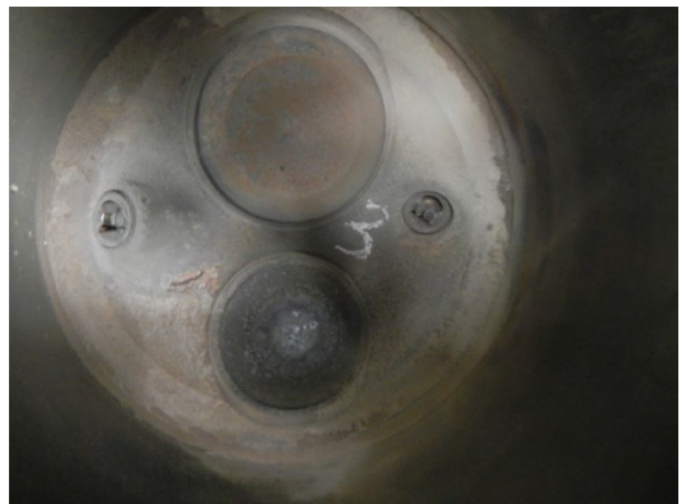
CYLINDER #3

Condition: The #3 cylinder sustained impact damage that fractured numerous cooling fins, the top sparkplug barrel, and the fuel injector nozzle. Removal of the rocker cover revealed no pre-accident anomalies with the rockers and valve springs. Some of the attaching hardware was displaced due to the fractured crankcase, but the top studs retained their torque putty. The cylinder was removed and no pre-accident anomalies were noted with the sparkplugs, piston, barrel, valves or valve seats. One side of the piston skirt was fractured as was the oil control ring in that area.

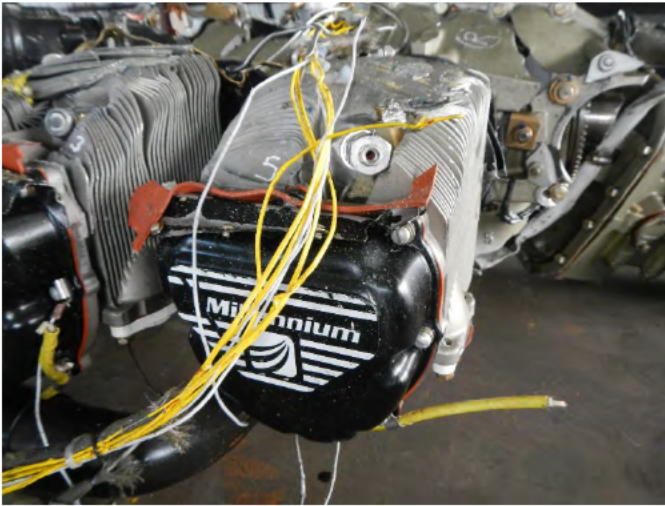
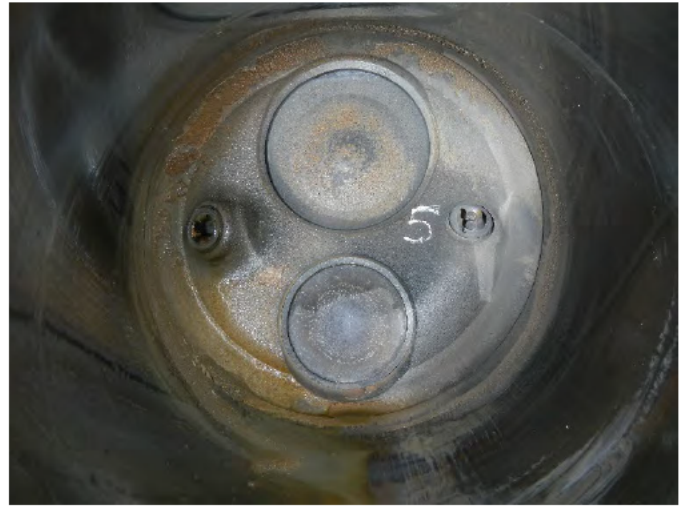
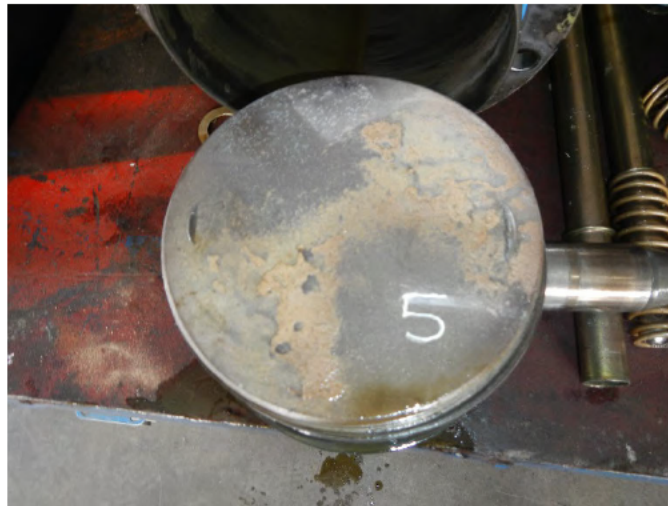
CYLINDER #5

Condition: The #5 cylinder sustained impact damage that fractured numerous cooling fins and bent the fuel injector nozzle. Some of the attaching hardware was displaced due to the fractured crankcase, but the top studs retained their torque putty. The cylinder was removed and no pre-accident anomalies were noted with the sparkplugs, barrel, valves or valve seats. The piston face displayed two semi-circular indentations consistent with valve strikes.

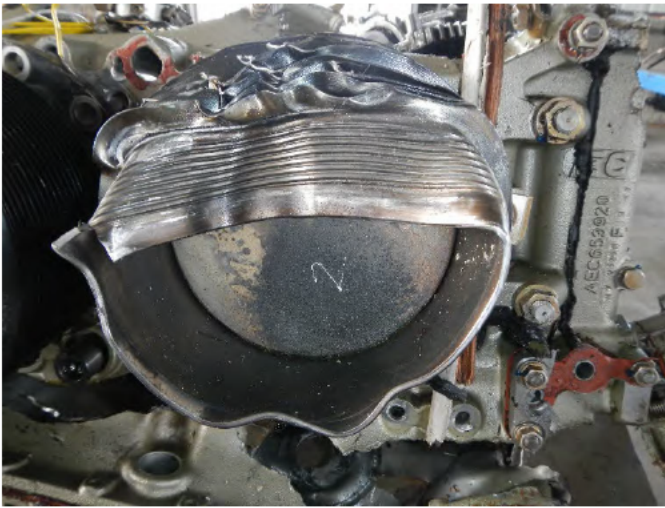
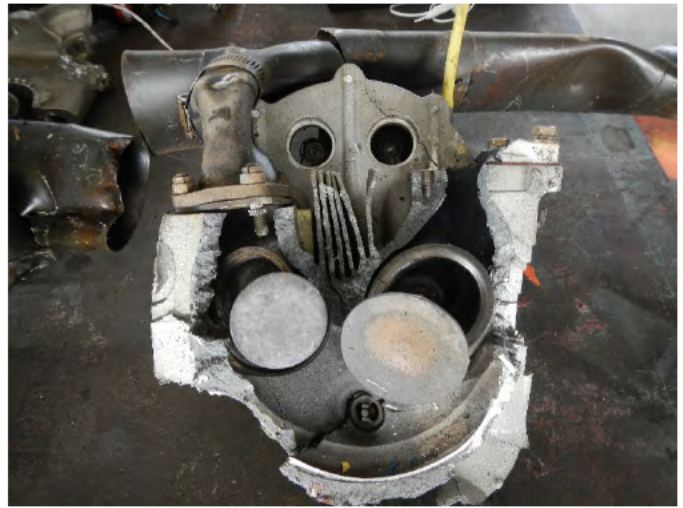
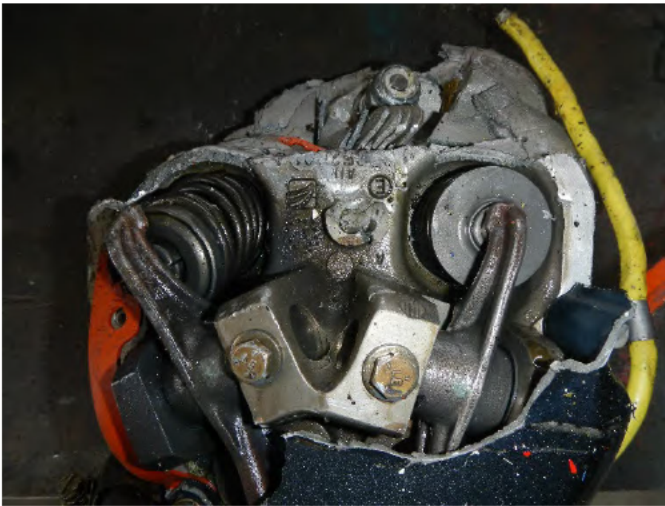
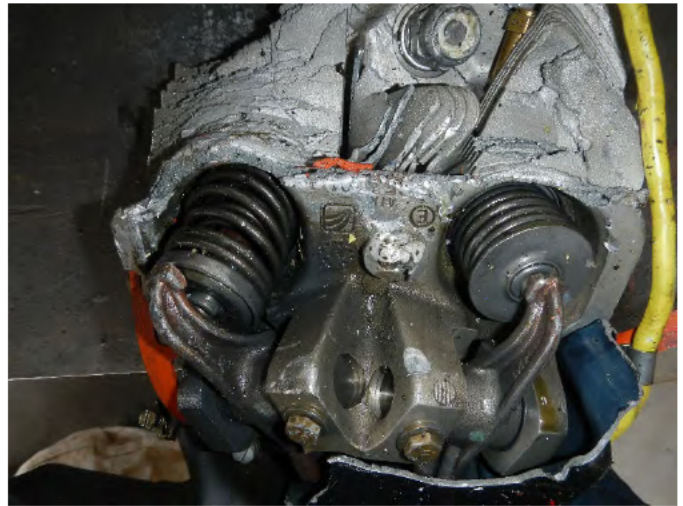
CYLINDER #2

Condition: The #2 cylinder remained partially attached to the fractured crankcase. The attaching hardware retained its torque putty. The barrel was bent down over the piston and the top cooling fins displayed deformation damage. The cylinder head was separated and found in the debris. The remnants of the cylinder head revealed no pre-accident anomalies with the rockers, valves, valve seats, and valve springs. The barrel and piston revealed no pre-accident anomalies.

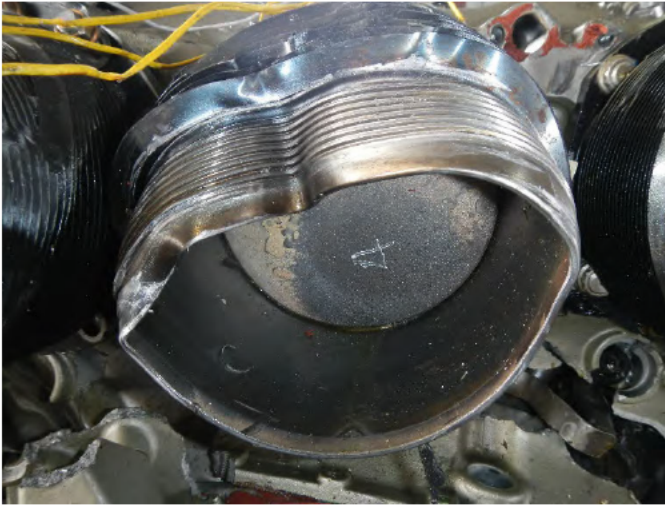
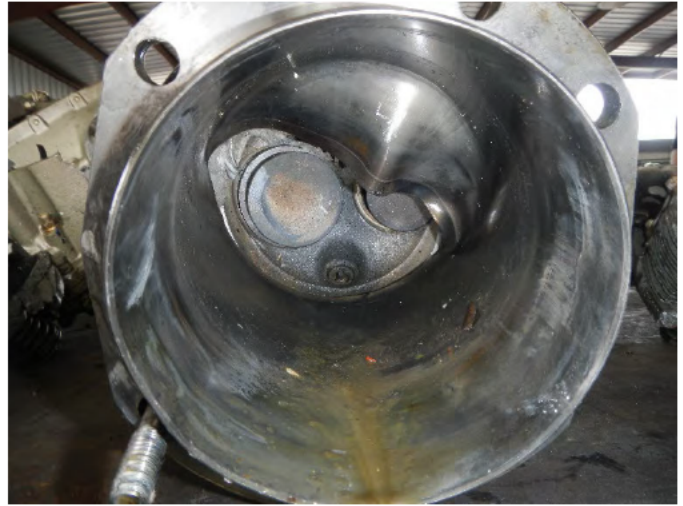
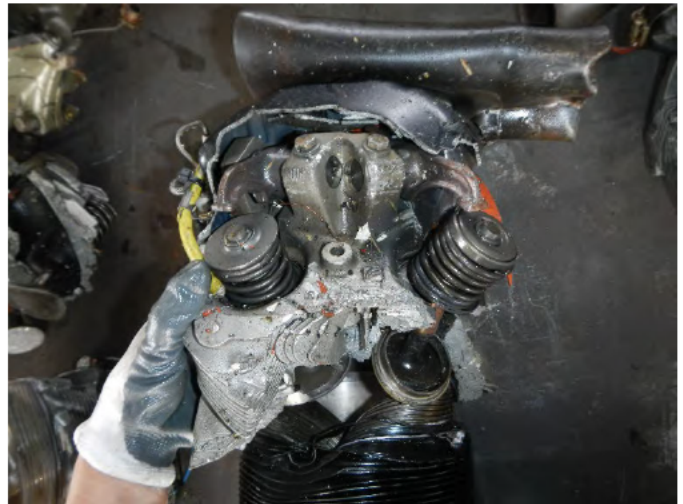
CYLINDER #4

Condition: The #4 cylinder remained partially attached to the fractured crankcase. Only one of the top attaching studs remained intact. The barrel was bent down over the piston and the top cooling fins displayed deformation damage. The cylinder head was separated and found in the debris. The remnants of the cylinder head revealed no pre-accident anomalies with the rockers, valves, valve seats, and valve springs. The barrel and piston revealed no pre-accident anomalies.

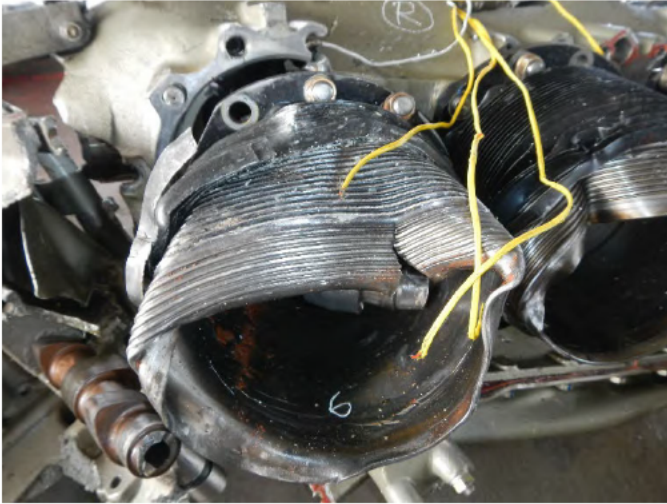
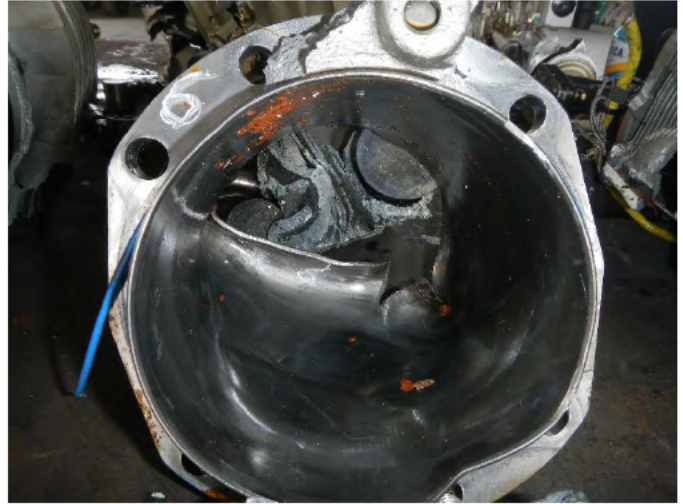
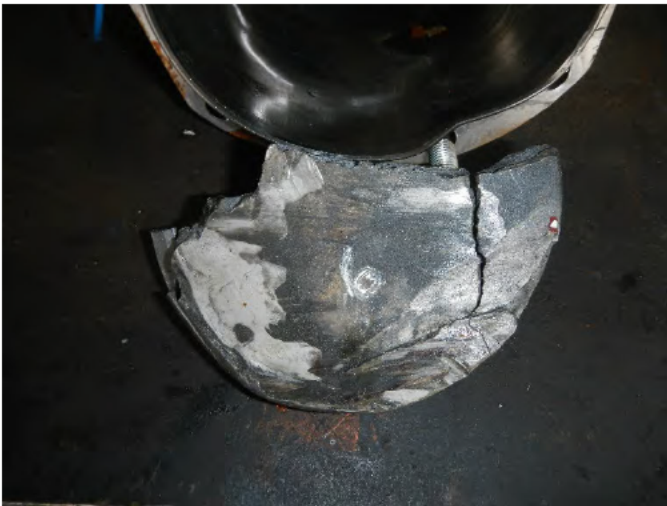
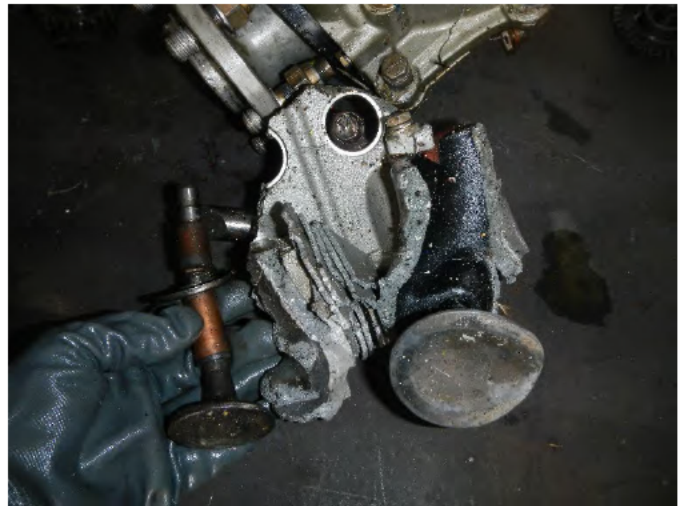
CYLINDER #6

Condition: The #6 cylinder remained in position but all of the attaching hardware was separated from the crankcase. The barrel was bent down and many of the top cooling fins were separated and displayed deformation damage. The piston was separated from the connecting rod and a portion was found in the debris. The observed piston segment sustained impact-related deformation damage. The piston pin remained attached to the connecting rod with no pre-accident anomalies noted. The cylinder head was separated and found in the debris. The remnants of the cylinder head revealed no pre-accident anomalies with the valves the rockers or the intake valve springs. The barrel revealed no pre-accident anomalies.

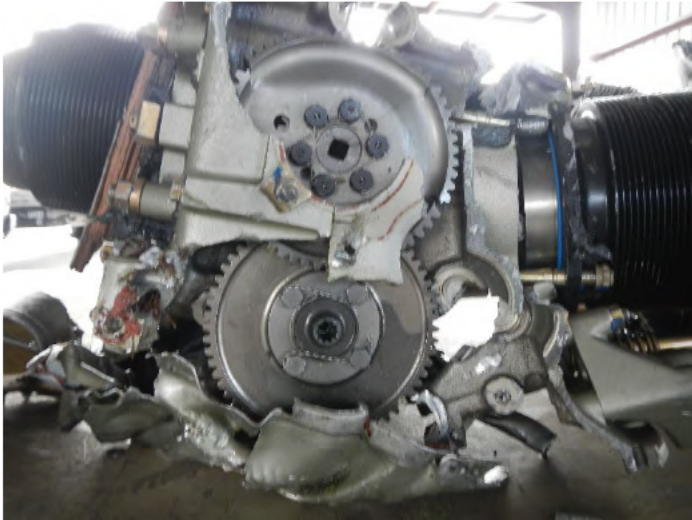
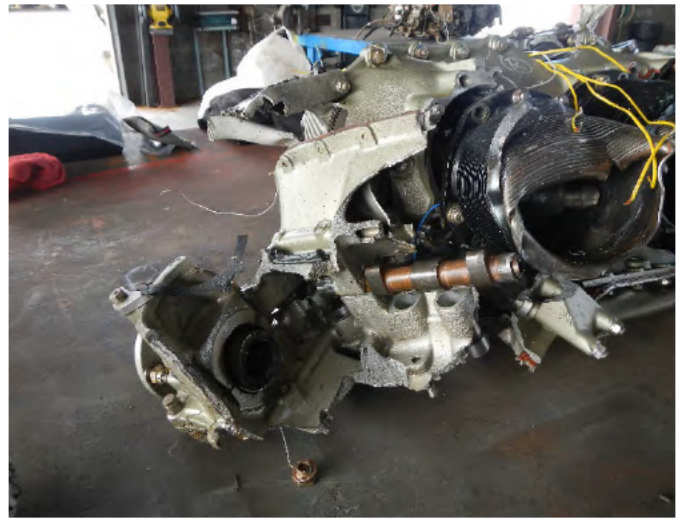
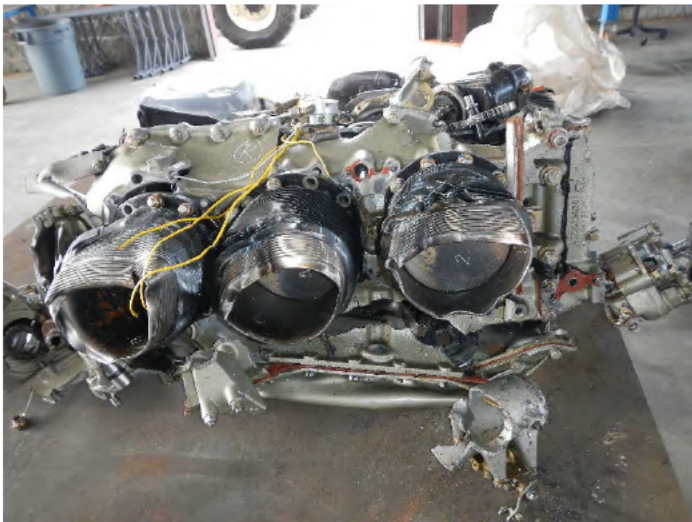
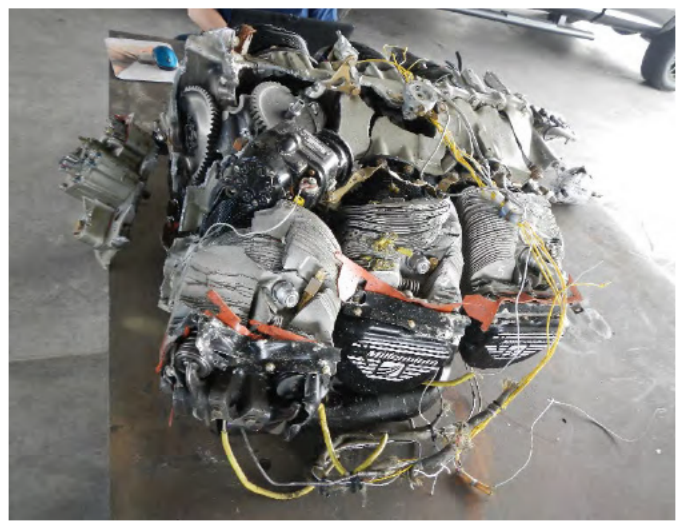
CRANKCASE ASSEMBLY

| CRANKCASE | Casting Number: | 1-3-5: Unknown | 2-4-6: AEC653920 | S/N: Unknown |
|---|---|---|---|---|
| Condition: | The crankcase was fractured in numerous locations and many of the mounting studs and through-bolts were torn free or displaced. All the fractures appeared to be impact related. The #1 main bearing was exposed with no pre-impact anomalies noted. There were no signs of any pre-accident anomalies and all components appeared to be well lubricated. | | | |

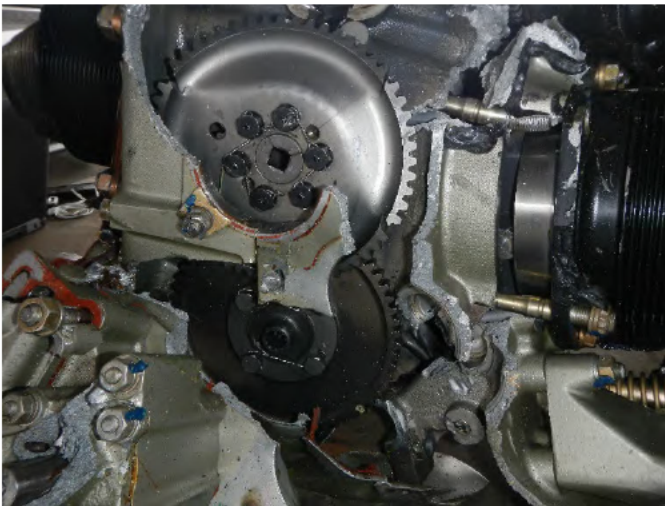
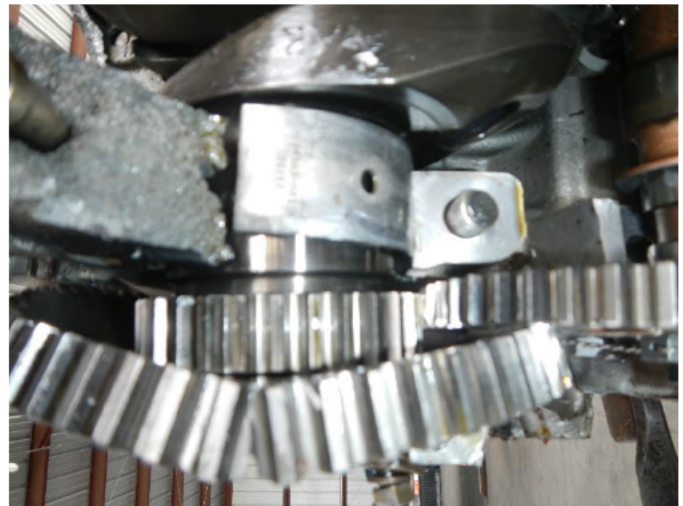
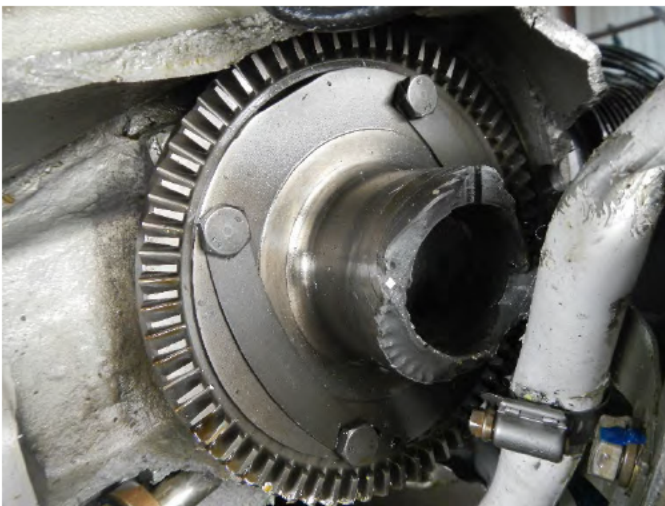
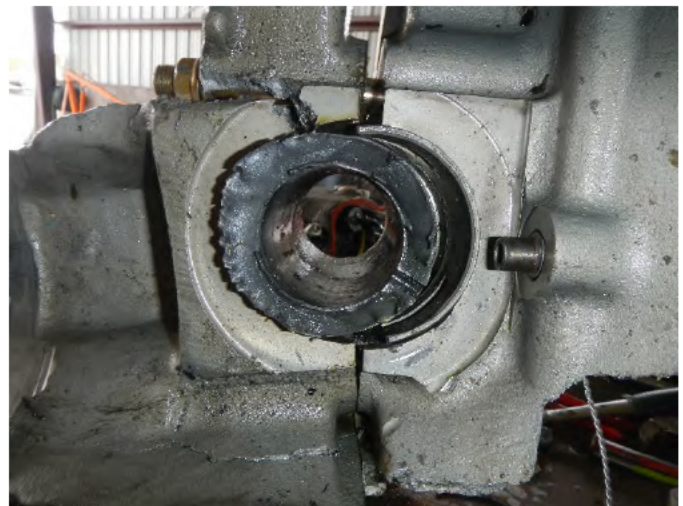
CRANKSHAFT

The crankshaft was fractured at the oil transfer collar area. The fracture was irregular and jagged and appeared to be displaced toward one side. The alternator face gear remained attached to the crankshaft and no pre-accident anomalies were noted with the gear teeth. The crankshaft gear was bolted in place and the safety-wire was intact, but the gear was bent forward on the topside. There were no pre-accident anomalies noted with the gear teeth. The connecting rods remained secured in place and all rotated freely on the crankshaft when they were manually manipulated (with the exception of the #2) with no signs of discoloration or thermal distress.

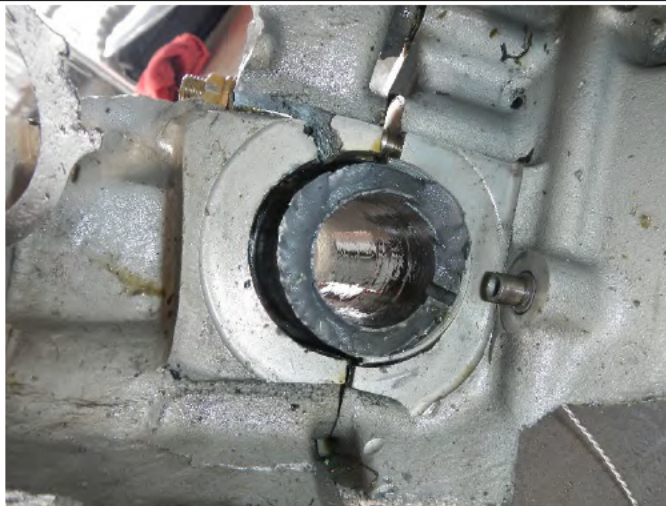
TRANSFER COLLAR

The crankshaft was fractured at the oil transfer collar area and the collar was not observed.

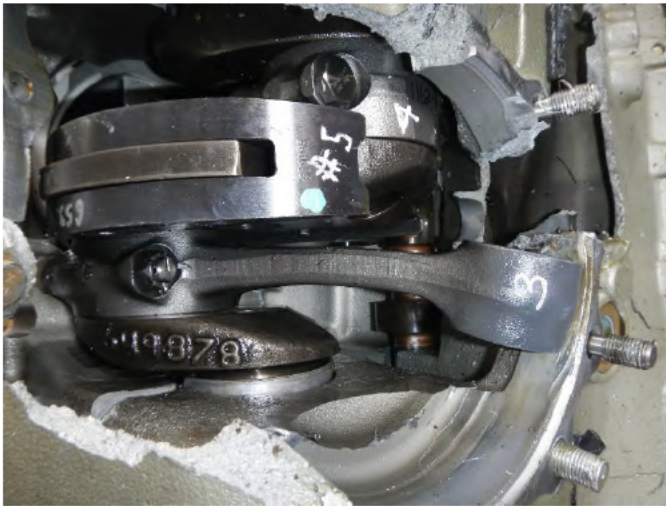
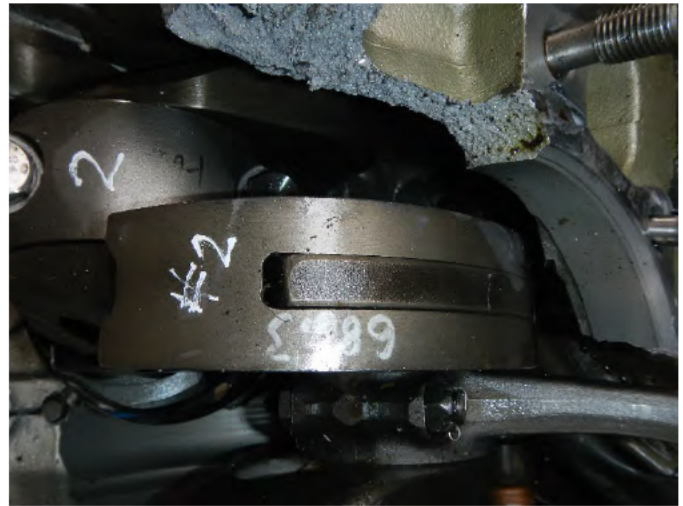
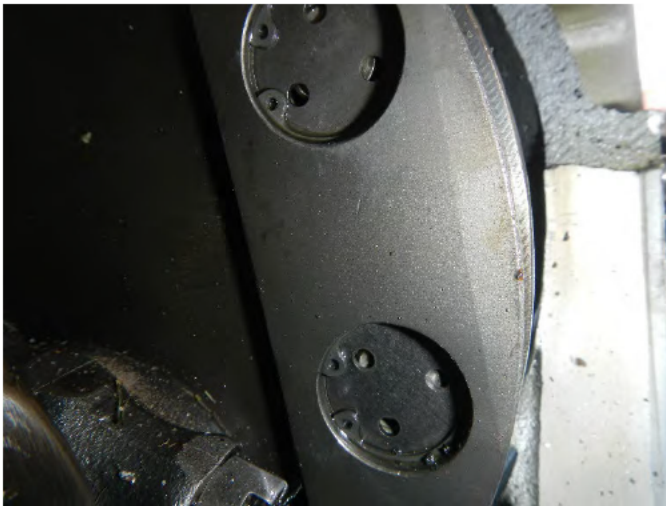
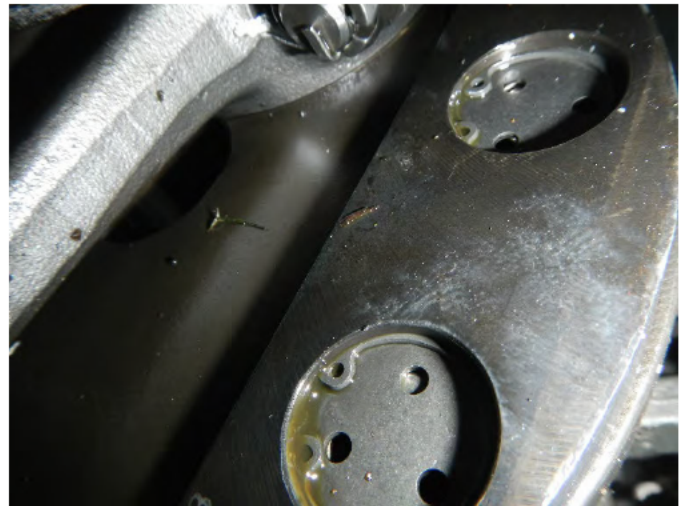
COUNTER WEIGHTS

The counterweights remained secured to the crankshaft. There were impact marks noted on the edges, consistent with contact with the fractured crankcase. There were no pre-accident anomalies noted with the counterweights.

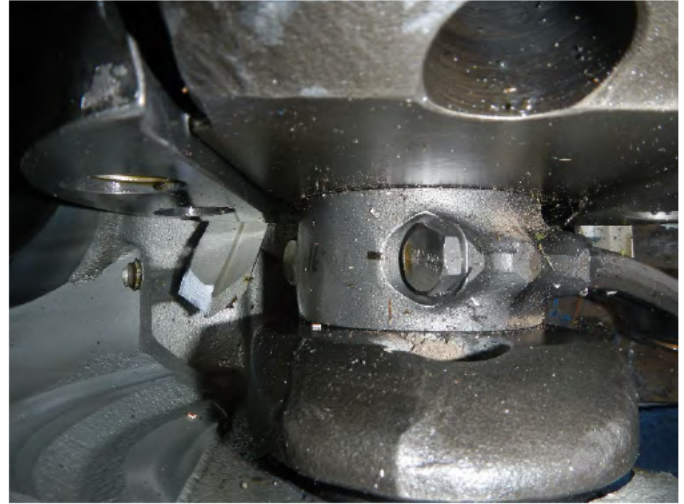
#1 CONNECTING ROD

The connecting rod remained attached to the crankshaft and the piston pin. It was bent aft with no sign of thermal discoloration. Manual manipulation of the connecting rod revealed no binding of the connecting rod bearing.

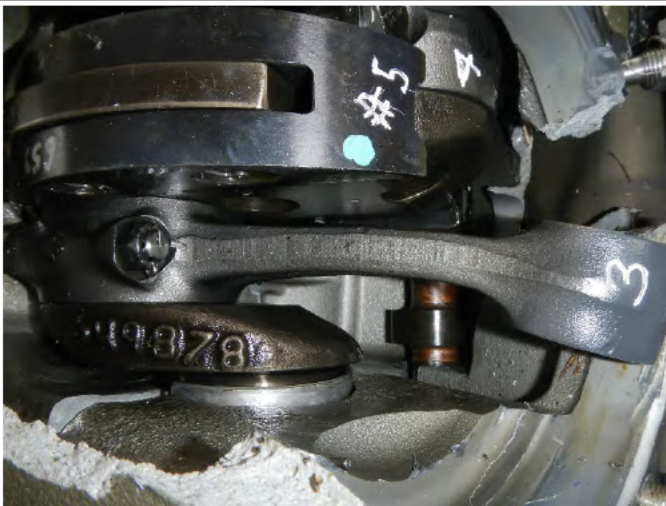
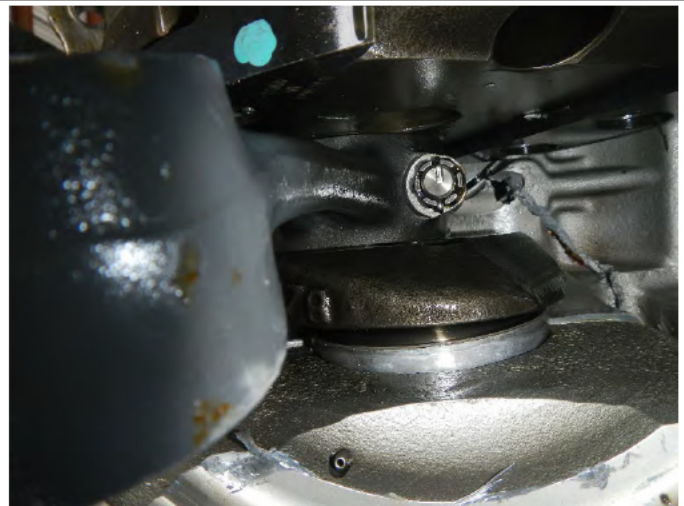
#3 CONNECTING ROD

The connecting rod remained attached to the crankshaft and the piston pin. It was bent aft with no sign of thermal discoloration. Manual manipulation of the connecting rod revealed no binding of the connecting rod bearing.

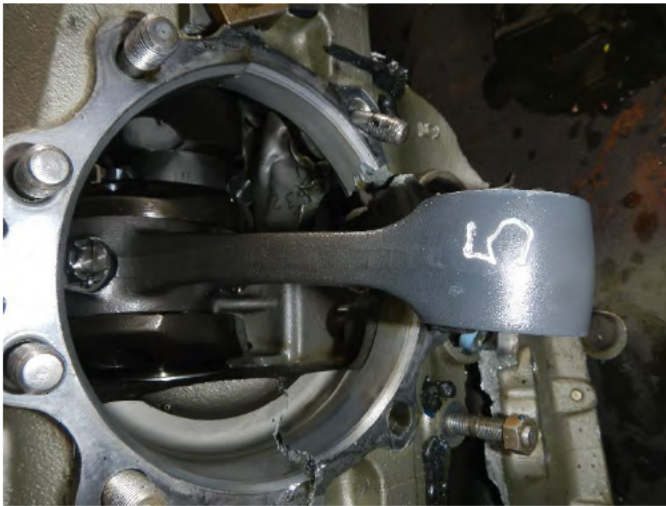
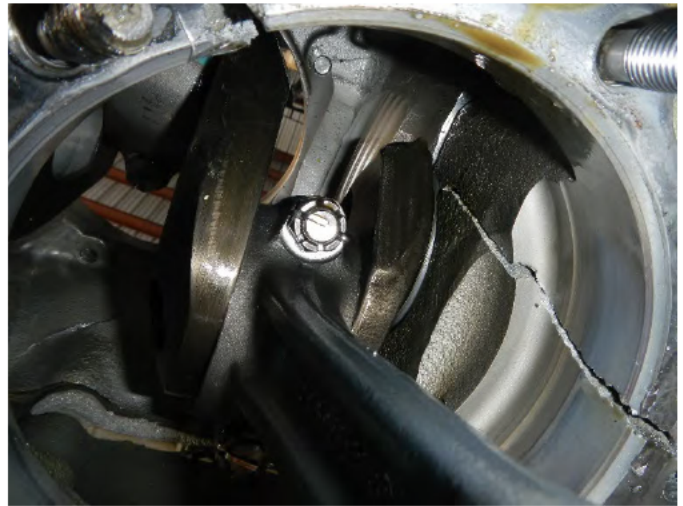
#5 CONNECTING ROD

The connecting rod remained attached to the crankshaft and the piston pin. It was bent aft slightly with no sign of thermal discoloration. Manual manipulation of the connecting rod revealed no binding of the connecting rod bearing.

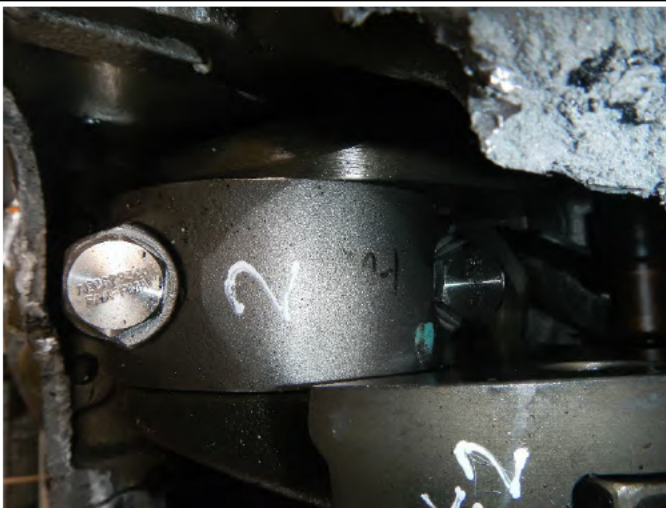
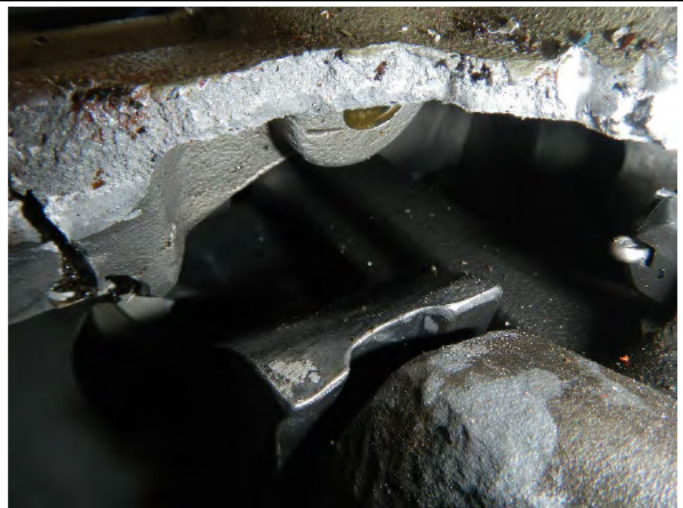
#2 CONNECTING ROD

The connecting rod remained attached to the crankshaft and the piston pin. There was no sign of thermal discoloration. The connecting rod could not be manipulated because the #2 cylinder could not be removed.
