ENGINE EXAMINATION REPORT

| ENGINE MODEL | TSIO-520-NB |
| ENGINE SERIAL NUMBER | 244794-R |
| AIRCRAFT MAKE & MODEL | Cessna 414A |

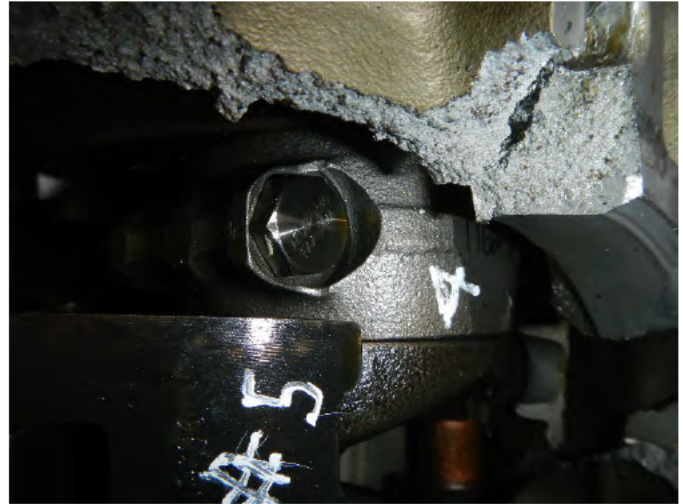
#4 CONNECTING ROD

The connecting rod remained attached to the crankshaft and the piston pin. The connecting rod was bent slightly, but there was no sign of thermal discoloration. Manual manipulation of the connecting rod revealed no binding of the connecting rod bearing.

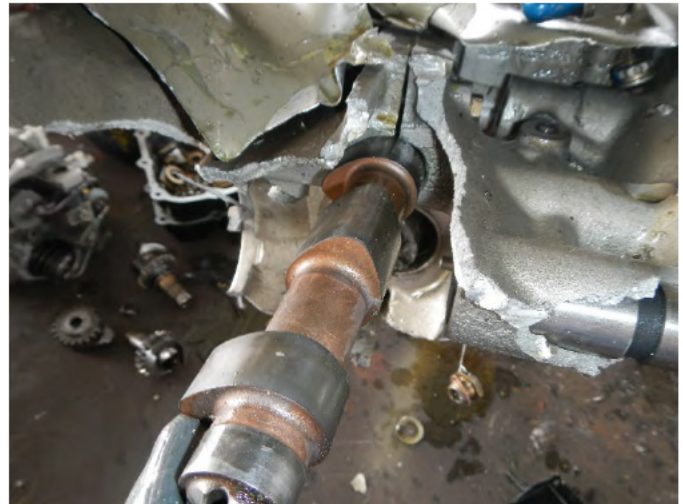
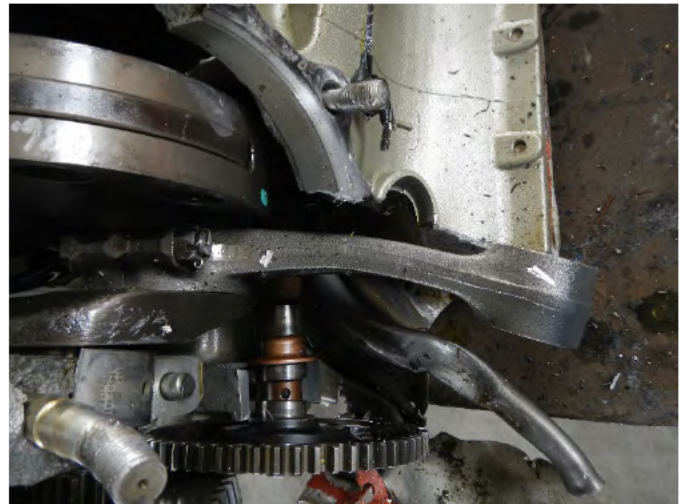
CAMSHAFT

Condition: The camshaft was fractured and bent in numerous locations. The camshaft gear remained attached and the safety-wire was intact. There were no pre-accident anomalies noted with the lobes.

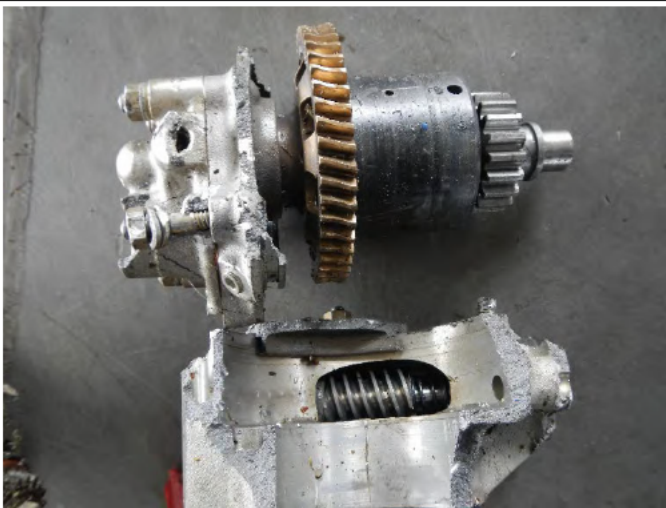
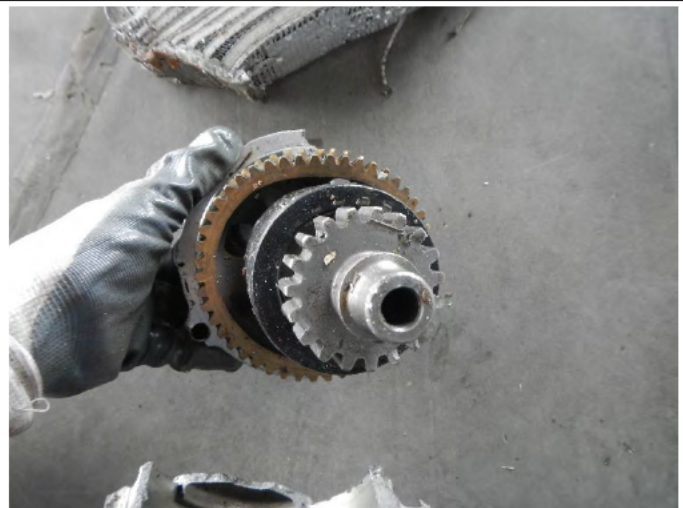
| STARTER ADAPTER | | | |

| Condition: | The starter adapter was separated from the engine and sustained impact related damage. There were no pre-accident anomalies noted. The scavenge pump remained attached to the housing and no anomalies were noted when it was disassembled. | | |

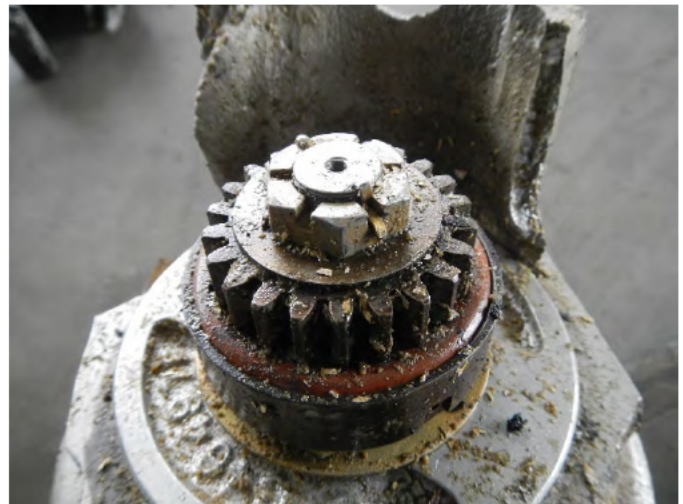
| Condition: | The alternator was separated from the engine and a portion of the crankcase remained attached. The unit sustained impact damage. There were no external pre-accident anomalies noted with the alternator. The drive coupling remained secured in place. | | |

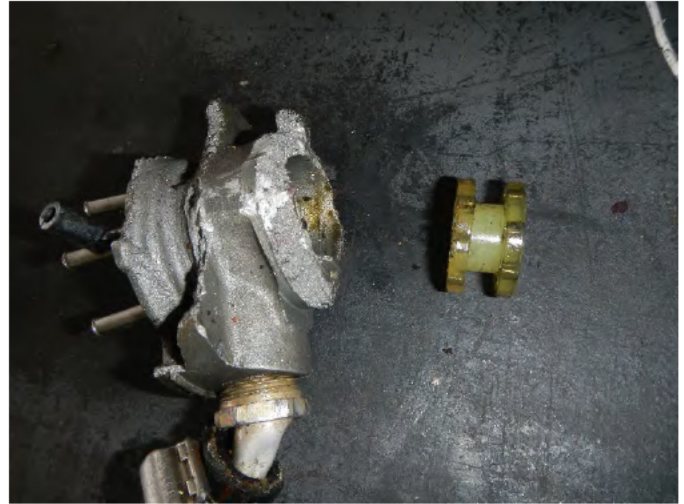
VACUUM PUMP

The vacuum pump was separated from the accessory end of the engine and it sustained significant impact deformation damage that fractured the housing and separated the drive mechanism. The drive coupling remained intact
