**SURVIVAL FACTORS GROUP CHAIRMAN'S
FACTUAL REPORT**

HWY14MH012

**NATIONAL TRANSPORTATION SAFETY BOARD
OFFICE OF HIGHWAY SAFETY
WASHINGTON, D.C.**

Location: New Jersey Turnpike (I-95) northbound near milepost 71.4; Cranbury, Middlesex County, New Jersey

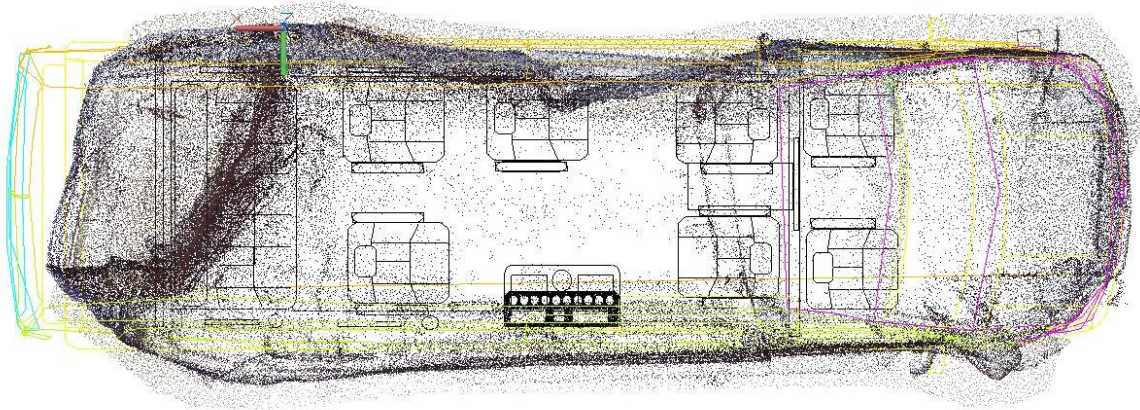
Severe impact damage forced the left rear taillight assembly to the proximity of the upper left rear wheel and displaced the rear axle forward. The left rear tire was flat and the left rear wheel was damaged. The right rear corner aft of the rear wheel was also crushed inwards with the maximum crush measuring about 5.6 feet at the lower left corner. The deformation of the limo van is illustrated in Figures 1 and 2, which consist of 3-D laser scan images of the accident

van with a wireframe overlay of a 3-D laser scan of an exemplar vehicle. The top view of the van shown in figure 1 also has an overlay of the interior seating layout.¹⁰

Figure 1. Top View of the Limo Van Illustrated from 3-D Laser Scans.

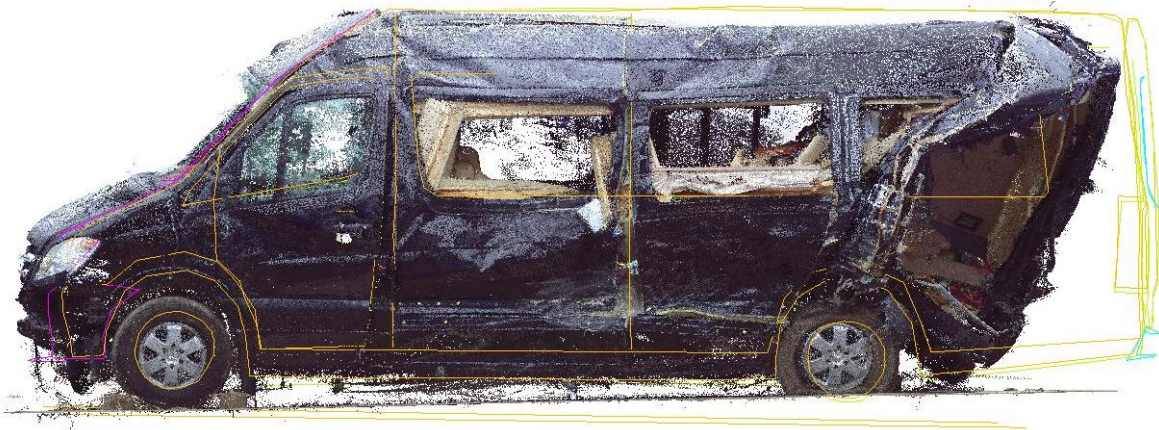
The driver side of the van was crushed inward along the entire length, with all windows broken out. The body seams of the van were ruptured, and dents extended from the side into the roof region. Heavy scraping was also evident. Running board mounting brackets were evident along the lower body portion, but the running board was missing. The driver side had three large window frames aft of the driver door; all were deformed, and all were missing glass. The first and second window frames aft of the driver door measured about 24 inches tall and 48 inches wide. The third window frame aft of the driver door was crushed inward from the bottom and aft edges. The remaining, roughly triangular-shaped opening measured about 10 inches at the front edge, 20 inches at the top edge, and about 28 inches along the diagonal edge.

Figure 2. Driver's Side View of the Limo Van Illustrated from 3-D Laser Scans.

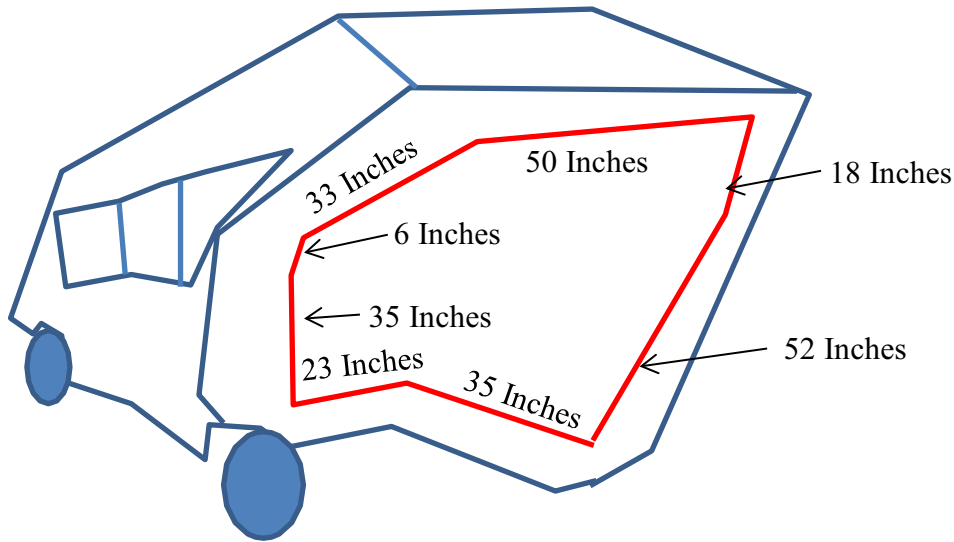
Figure 3. Illustration of Mercedes-Benz Rear Door Frame.

The rear doors were displaced from the van and the hinges exhibited signs of being cut. The doors were crushed and found with the center latch still closed. The center latch was about 34 inches from the base of the doors. The rear door windows were broken out. The left window frame was deformed and buckled inward with the crease about 12 inches from the bottom window edge. The deformed left window opening measured approximately 26 inches wide and 24.5 inches tall. The deformed right window opening measured approximately 30 inches wide and 27 inches tall. The rear door frame was crushed inwards with the dimensions and shape as illustrated in figure 3.

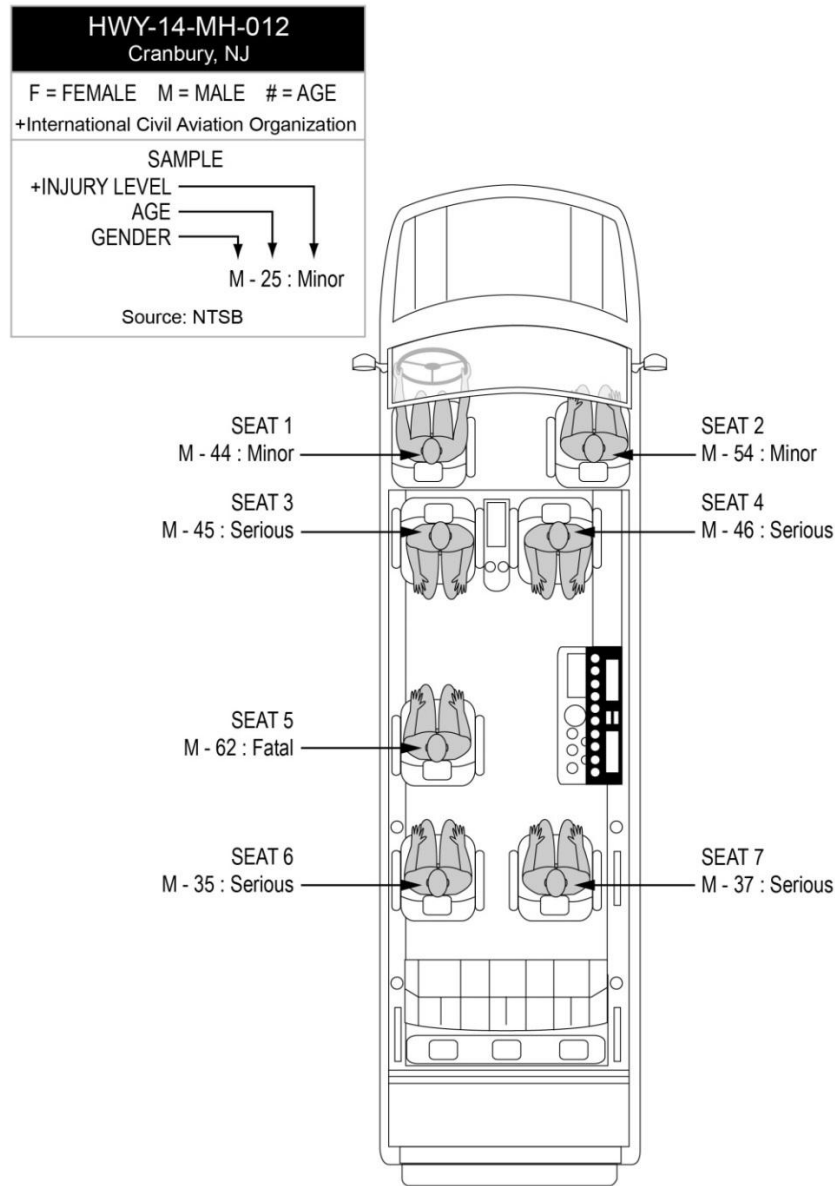
14.10.001.HW_Fig1b

The limo van had a driver and a passenger in the front cab area, and 5 passengers in the passenger compartment. The seat positions have been numbered, and the age, gender, and level of injury sustained by the occupants have been provided as shown in figure 4. The occupants of the limo van are referred to by their seat positions in following sections of this report.

Figure 4. Limo Van Seat Locations.
