Creaform Inspection Reports

Pittsburgh, PA

HWY22MH003

B1L Inspection Report

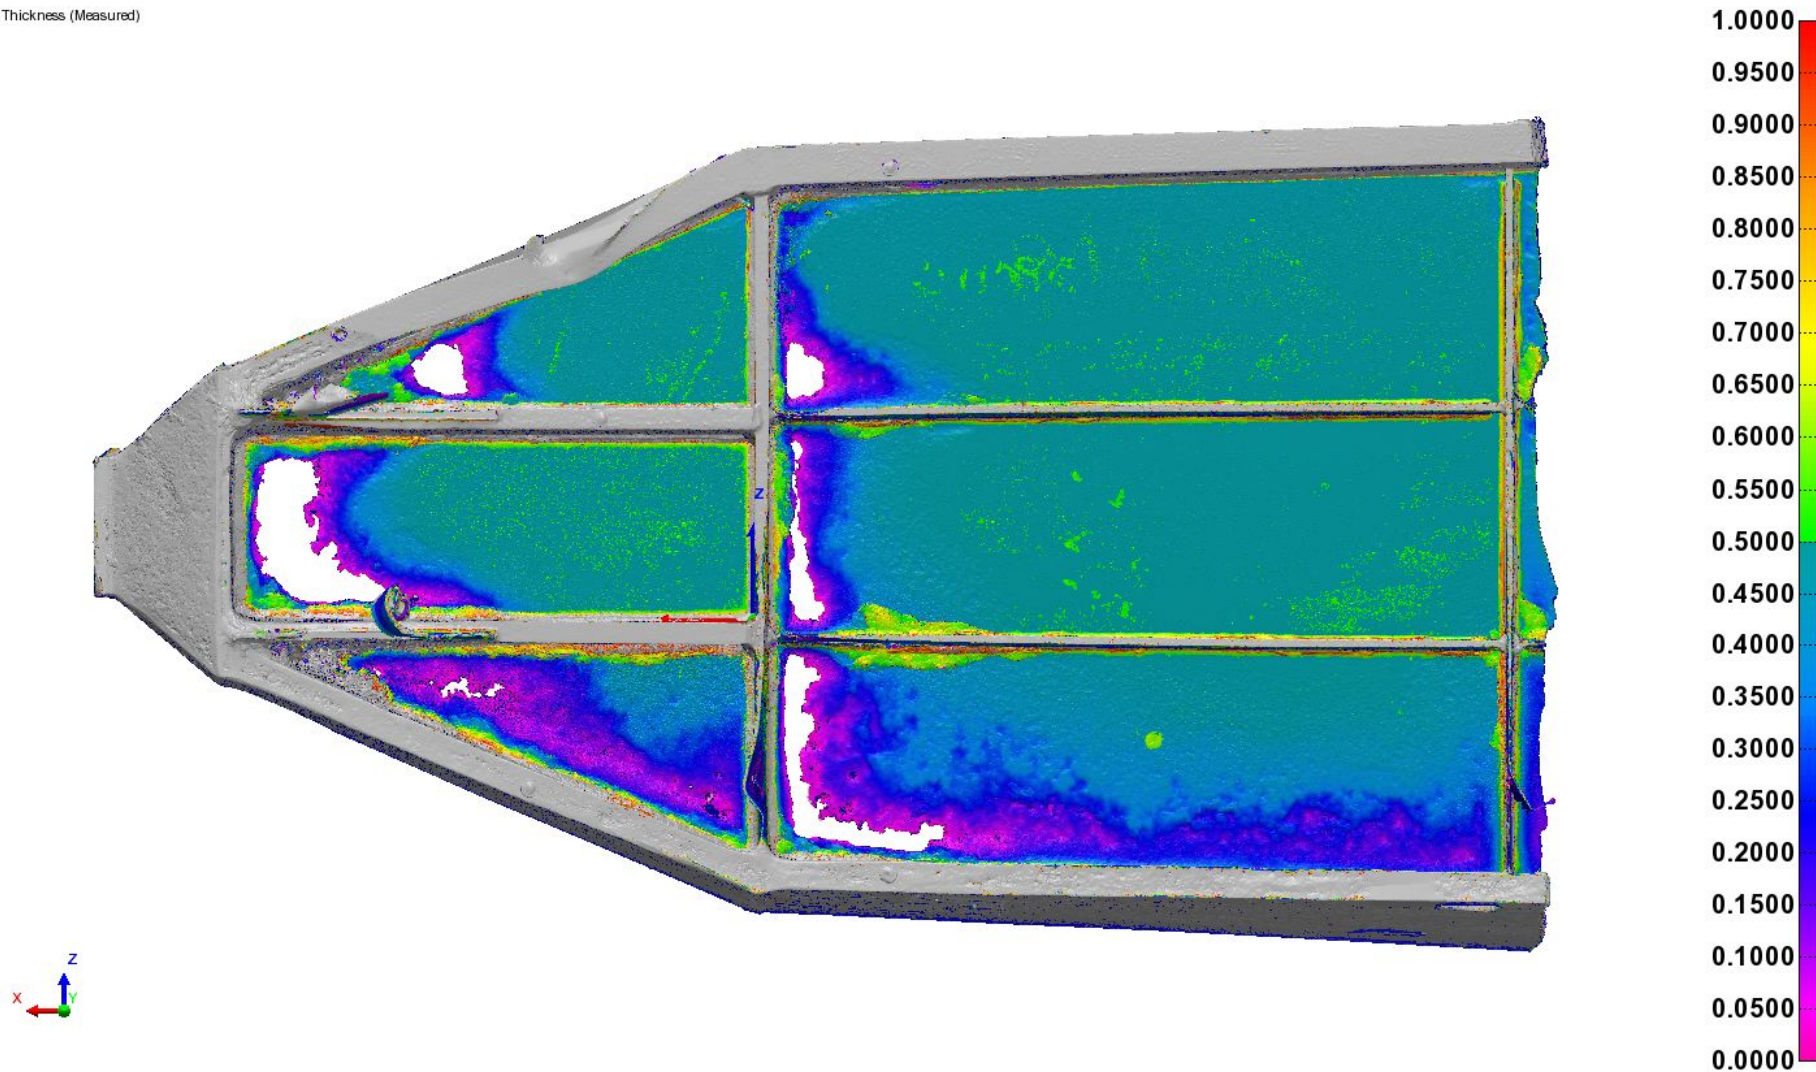
Elevation View - Front

Thickness (Measured)

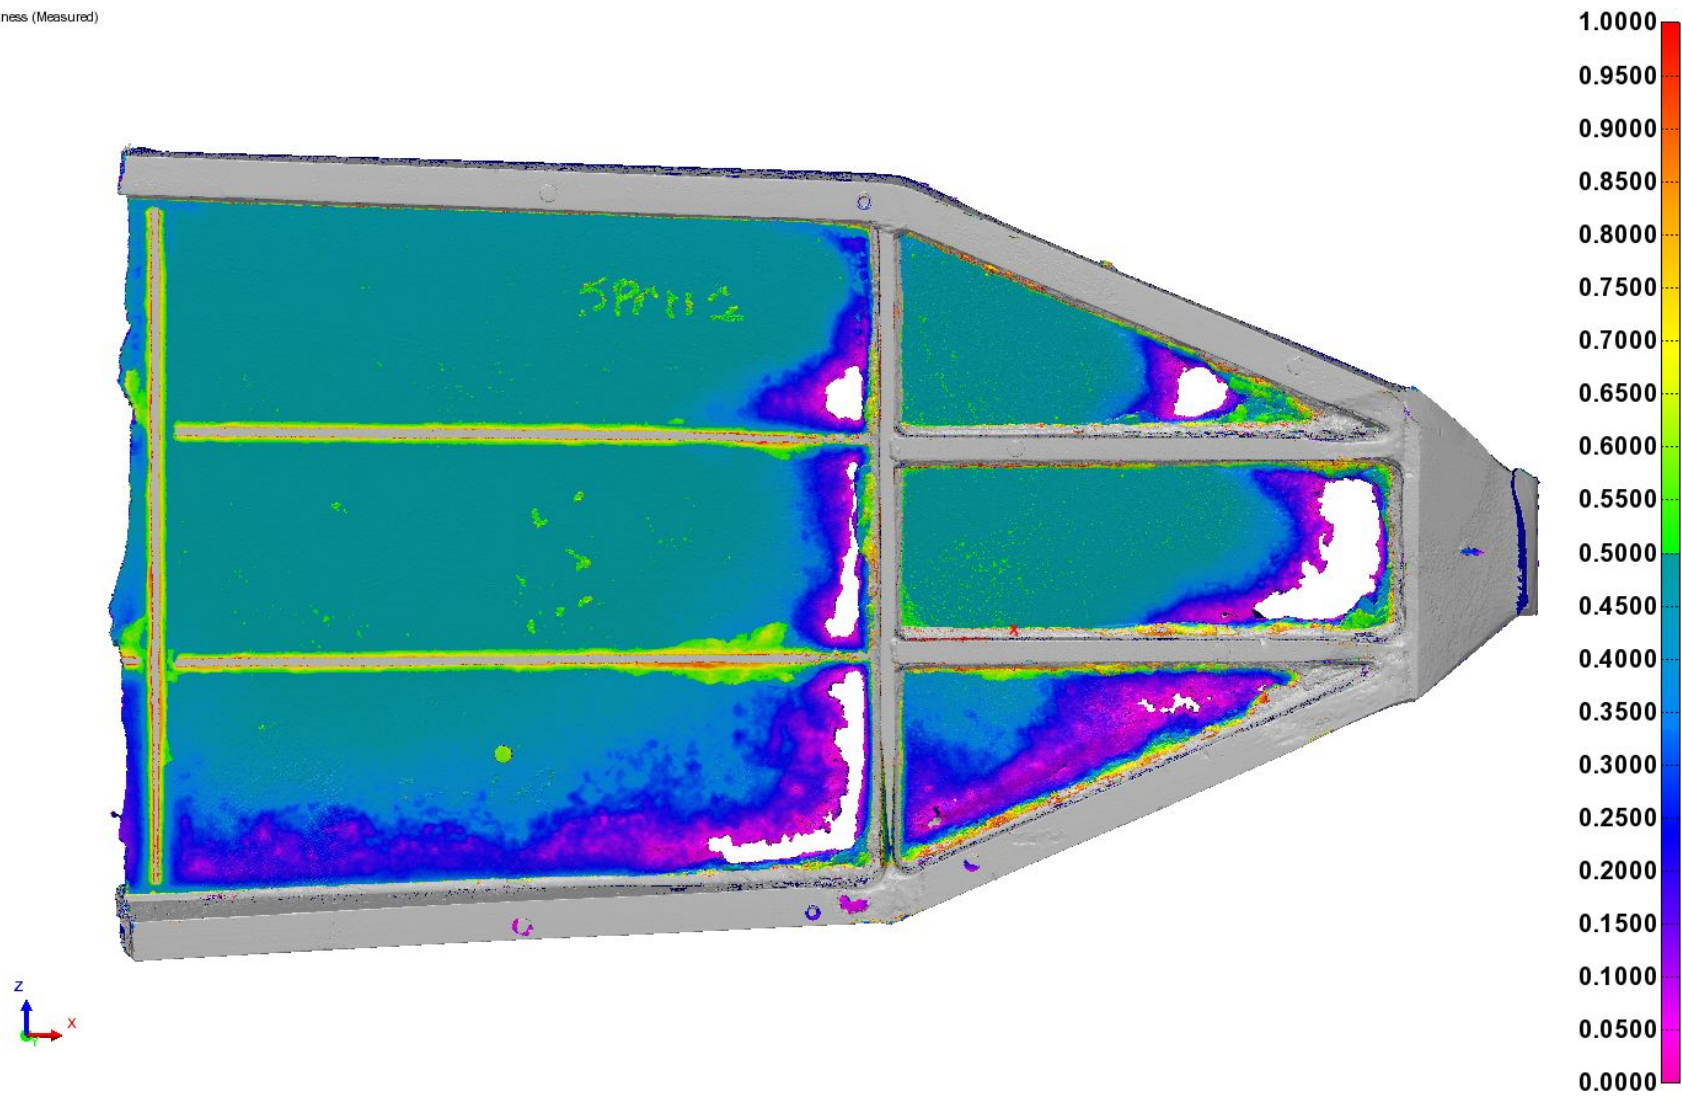
Elevation View - Back

Thickness (Measured)

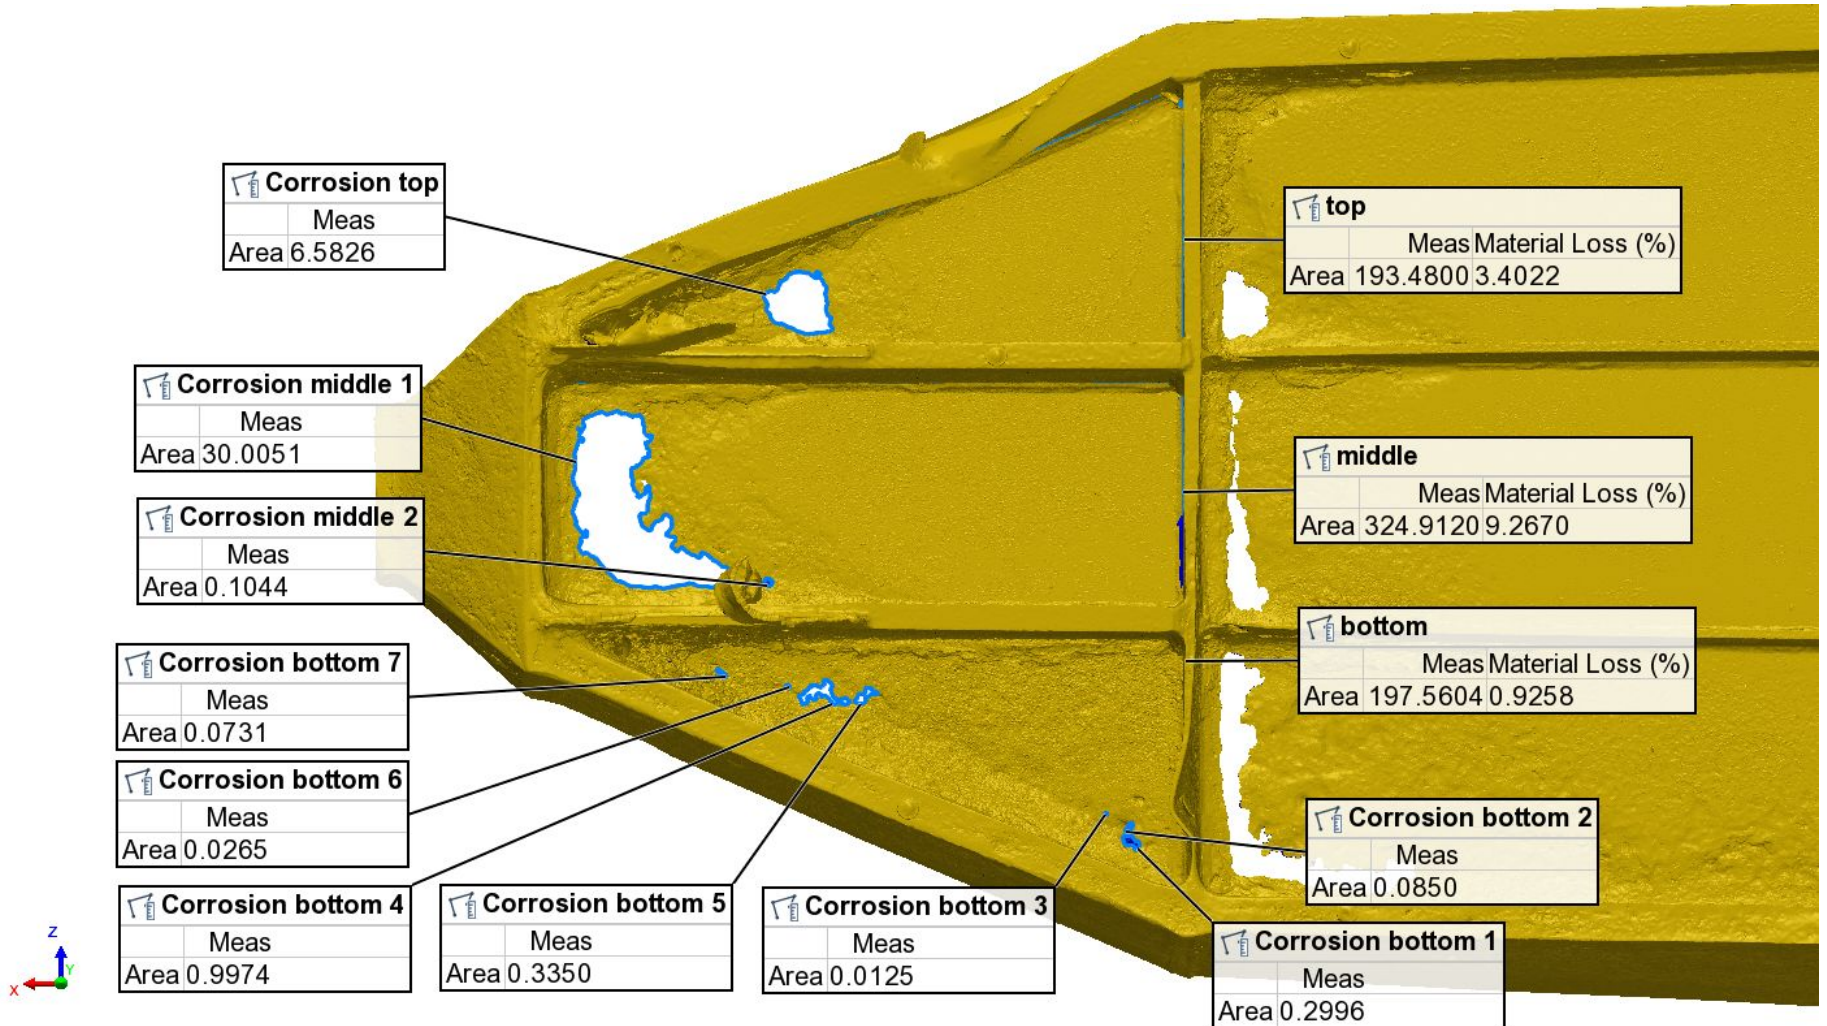
Material Loss - Shoe

Name	Control	Material Loss (%)	Meas
☞ Corrosion top	Area		6.5826
☞ top	Area	3.4022	193.4800
☞ Corrosion middle 1	Area		30.0051
☞ Corrosion middle 2	Area		0.1044
☞ middle	Area	9.2670	324.9120
☞ Corrosion bottom 1	Area		0.2996
☞ Corrosion bottom 2	Area		0.0850
☞ Corrosion bottom 3	Area		0.0125
☞ Corrosion bottom 4	Area		0.9974
☞ Corrosion bottom 5	Area		0.3350
☞ Corrosion bottom 6	Area		0.0265
☞ Corrosion bottom 7	Area		0.0731
☞ bottom	Area	0.9258	197.5604

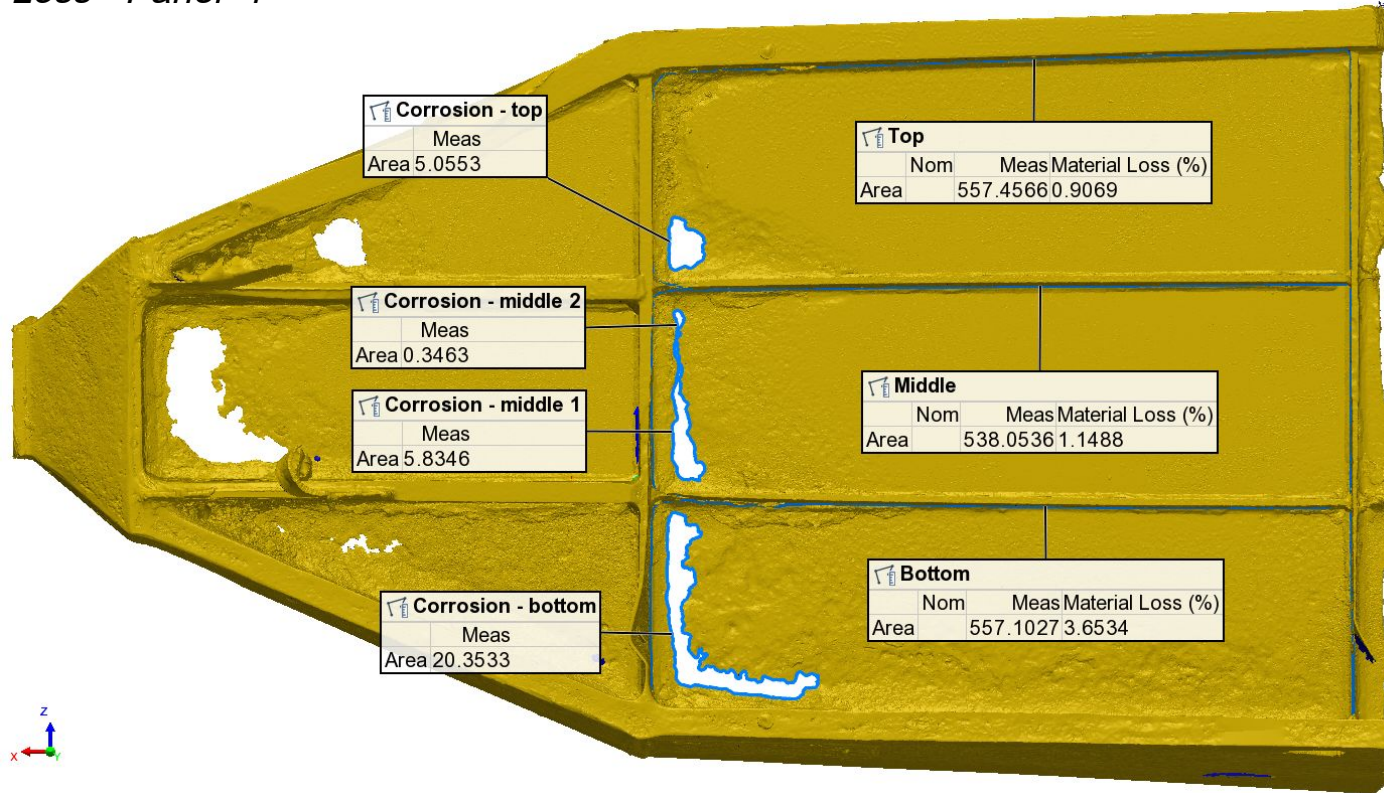
Material Loss - Panel 1

Name	Control	Material Loss (%)	Meas
☑ Corrosion - top	Area		5.0553
☑ Top	Area	0.9069	557.4566
☑ Corrosion - middle 1	Area		5.8346
☑ Corrosion - middle 2	Area		0.3463
☑ Middle	Area	1.1488	538.0536
☑ Corrosion - bottom	Area		20.3533
☑ Bottom	Area	3.6534	557.1027

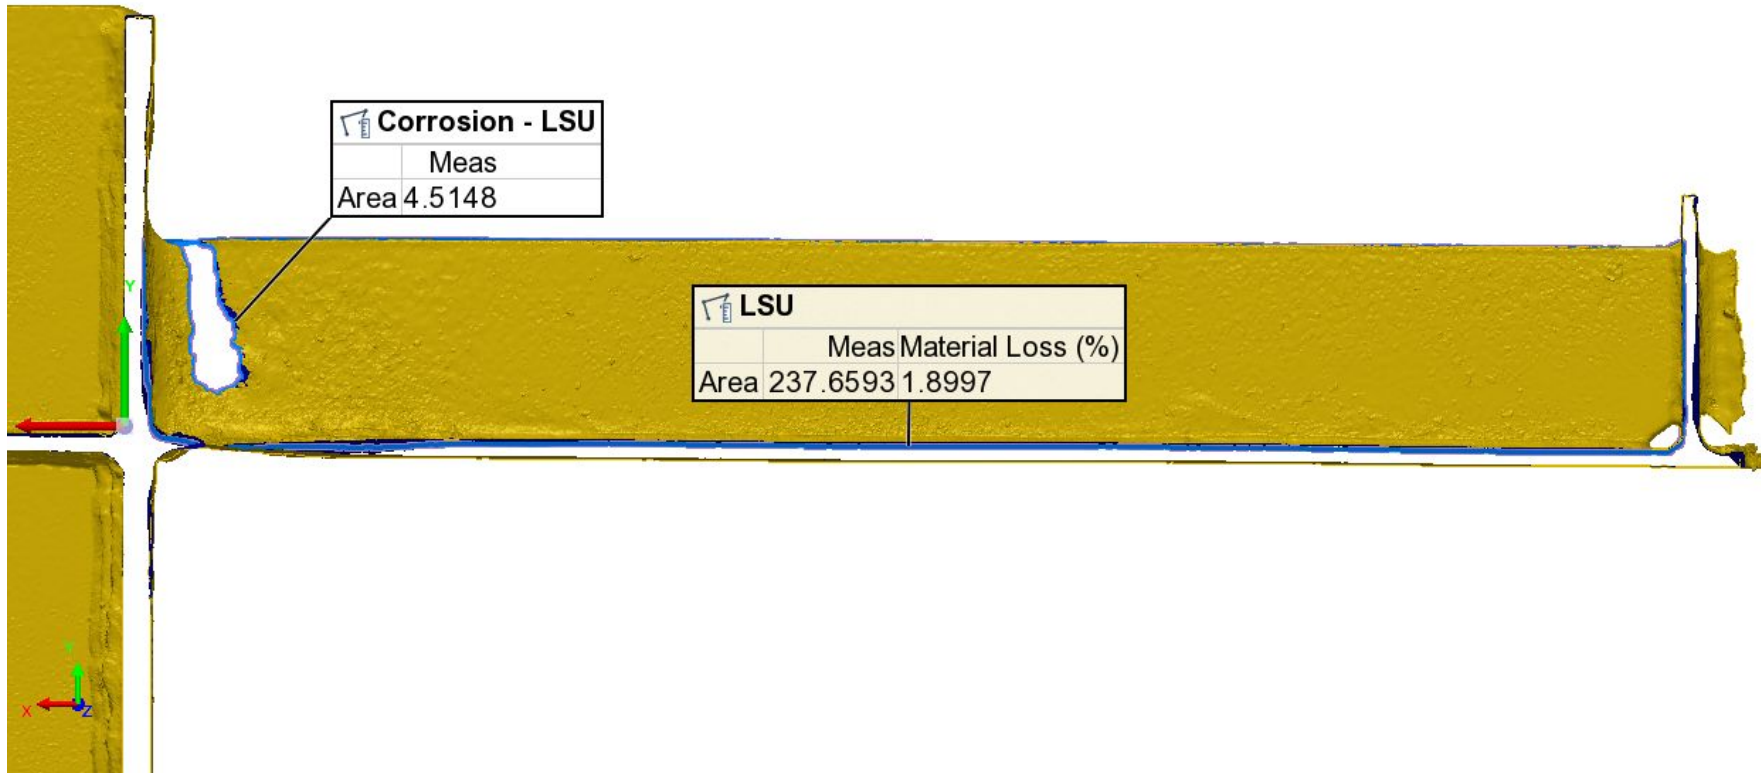
Material Loss - Longitudinal Stiffener - Panel 1 - Upper

Name	Control	Material Loss (%)	Meas
Corrosion - LSU	Area		4.5148
LSU	Area	1.8997	237.6593

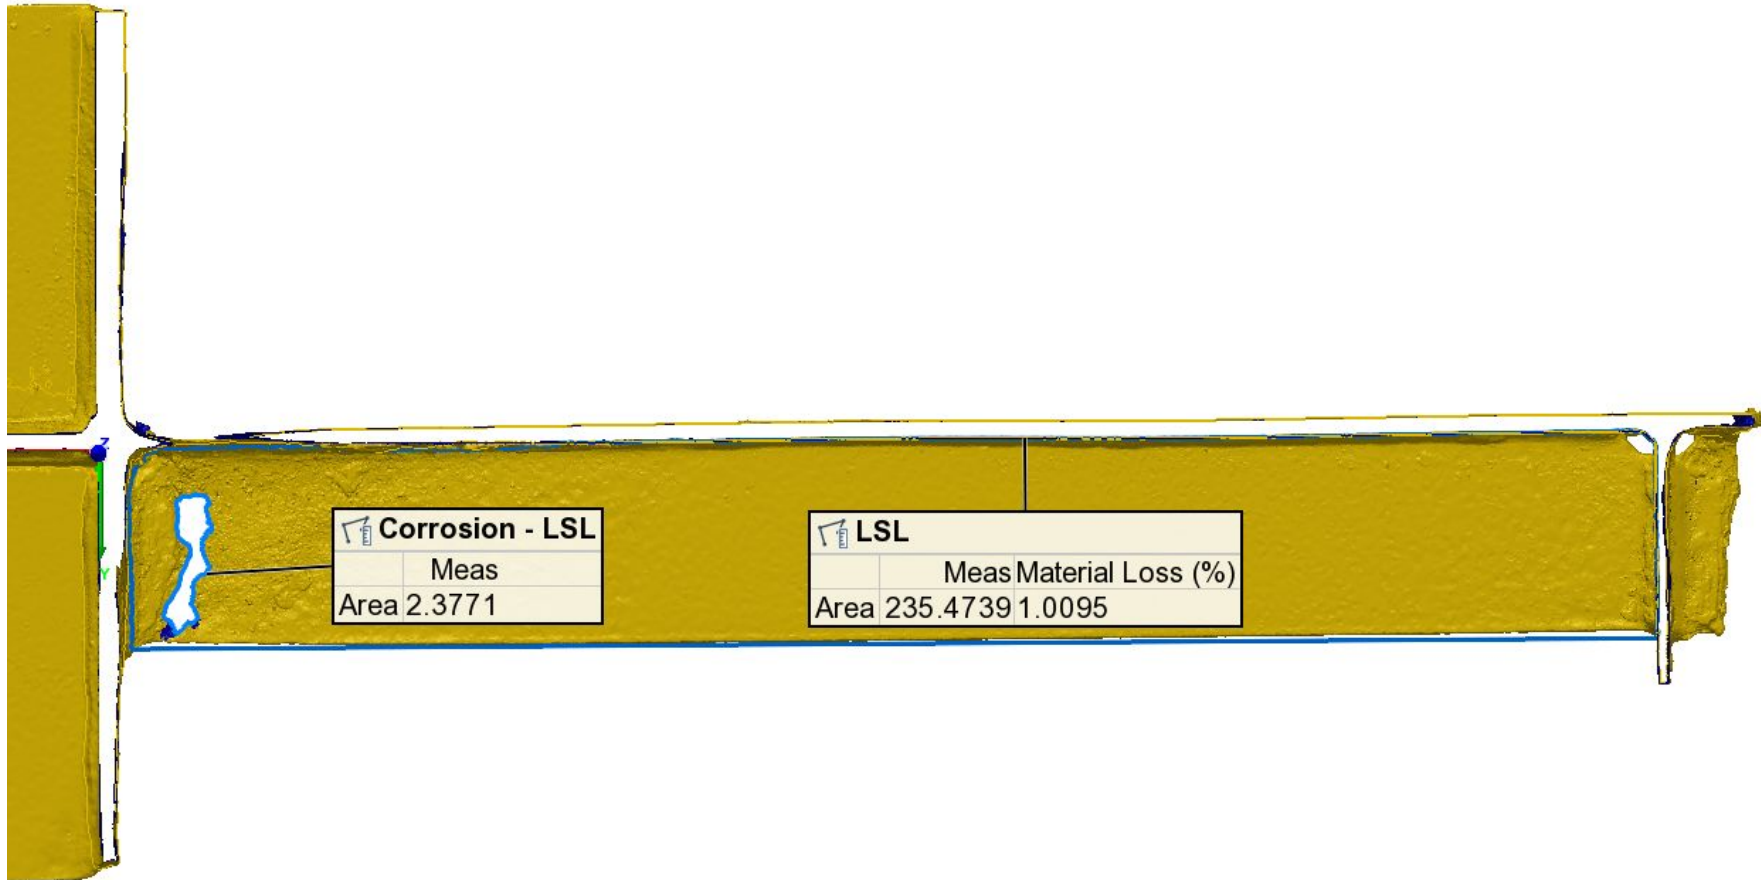
Material Loss - Longitudinal Stiffener - Panel 1 - Lower

Name	Control	Material Loss (%)	Meas
Corrosion - LSL	Area		2.3771
LSL	Area	1.0095	235.4739

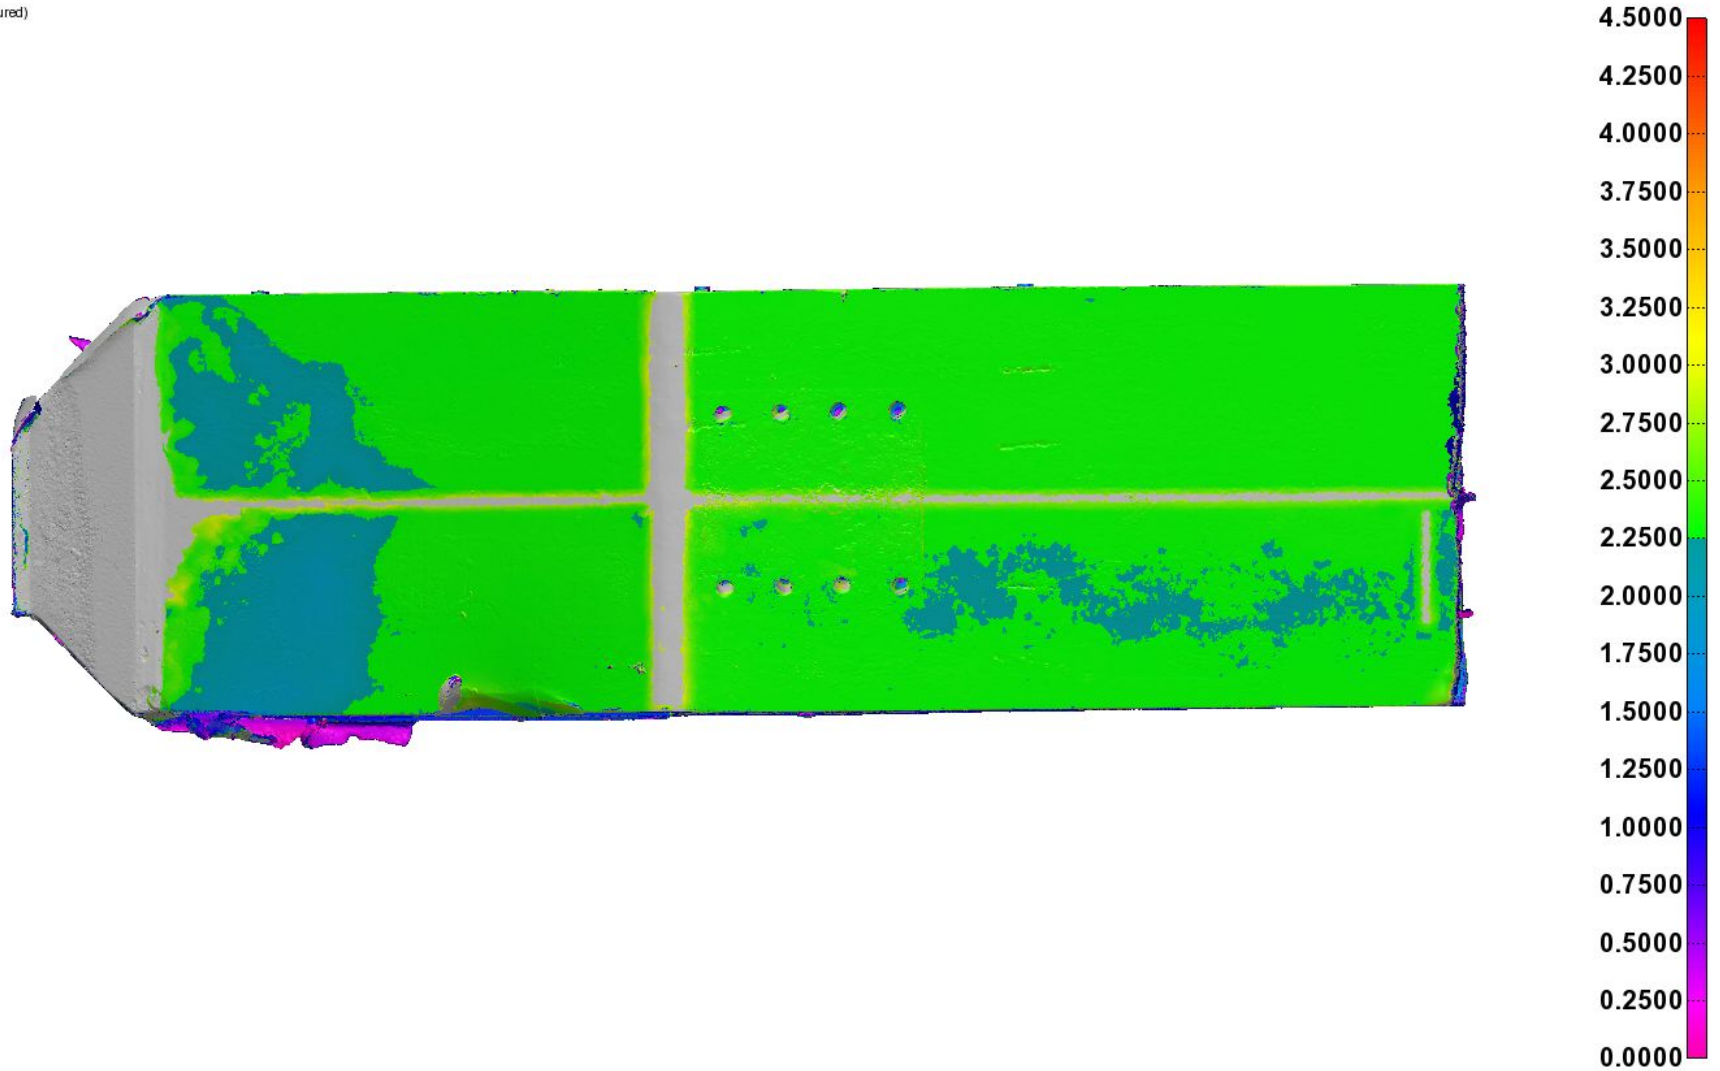
Flange Plate - Upper

Thickness (Measured)

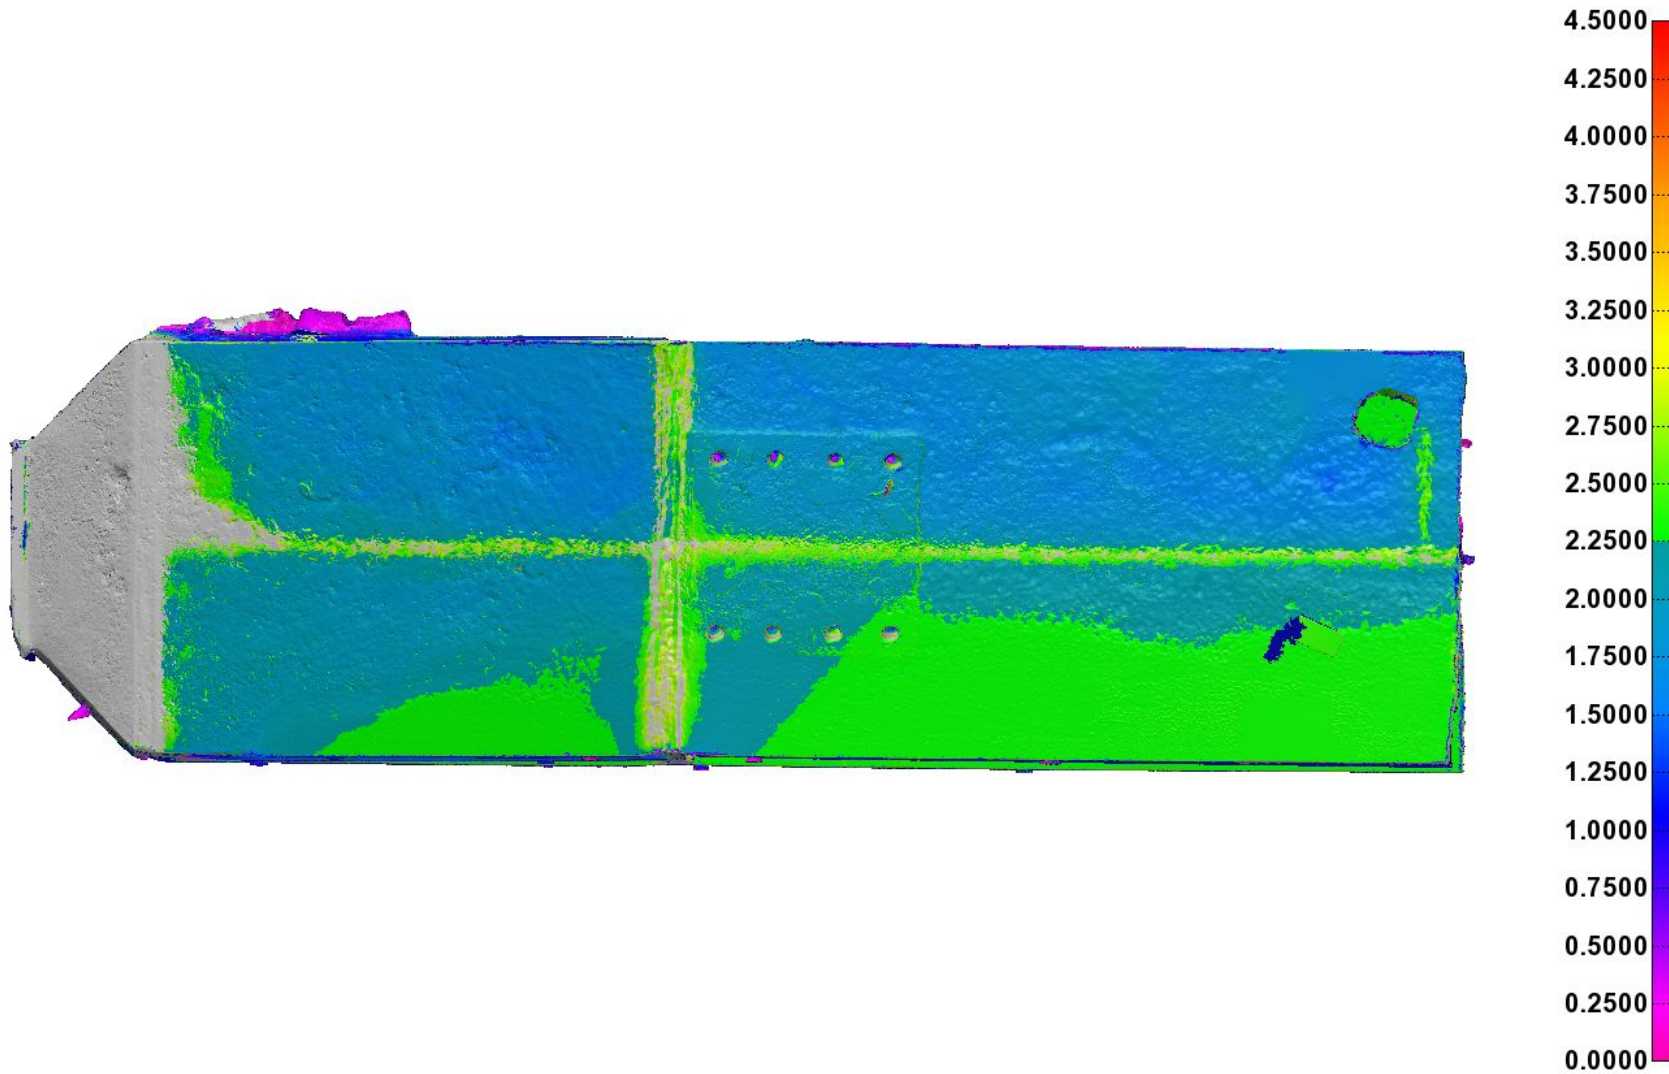
Flange Plate - Bottom

Thickness (Measured)

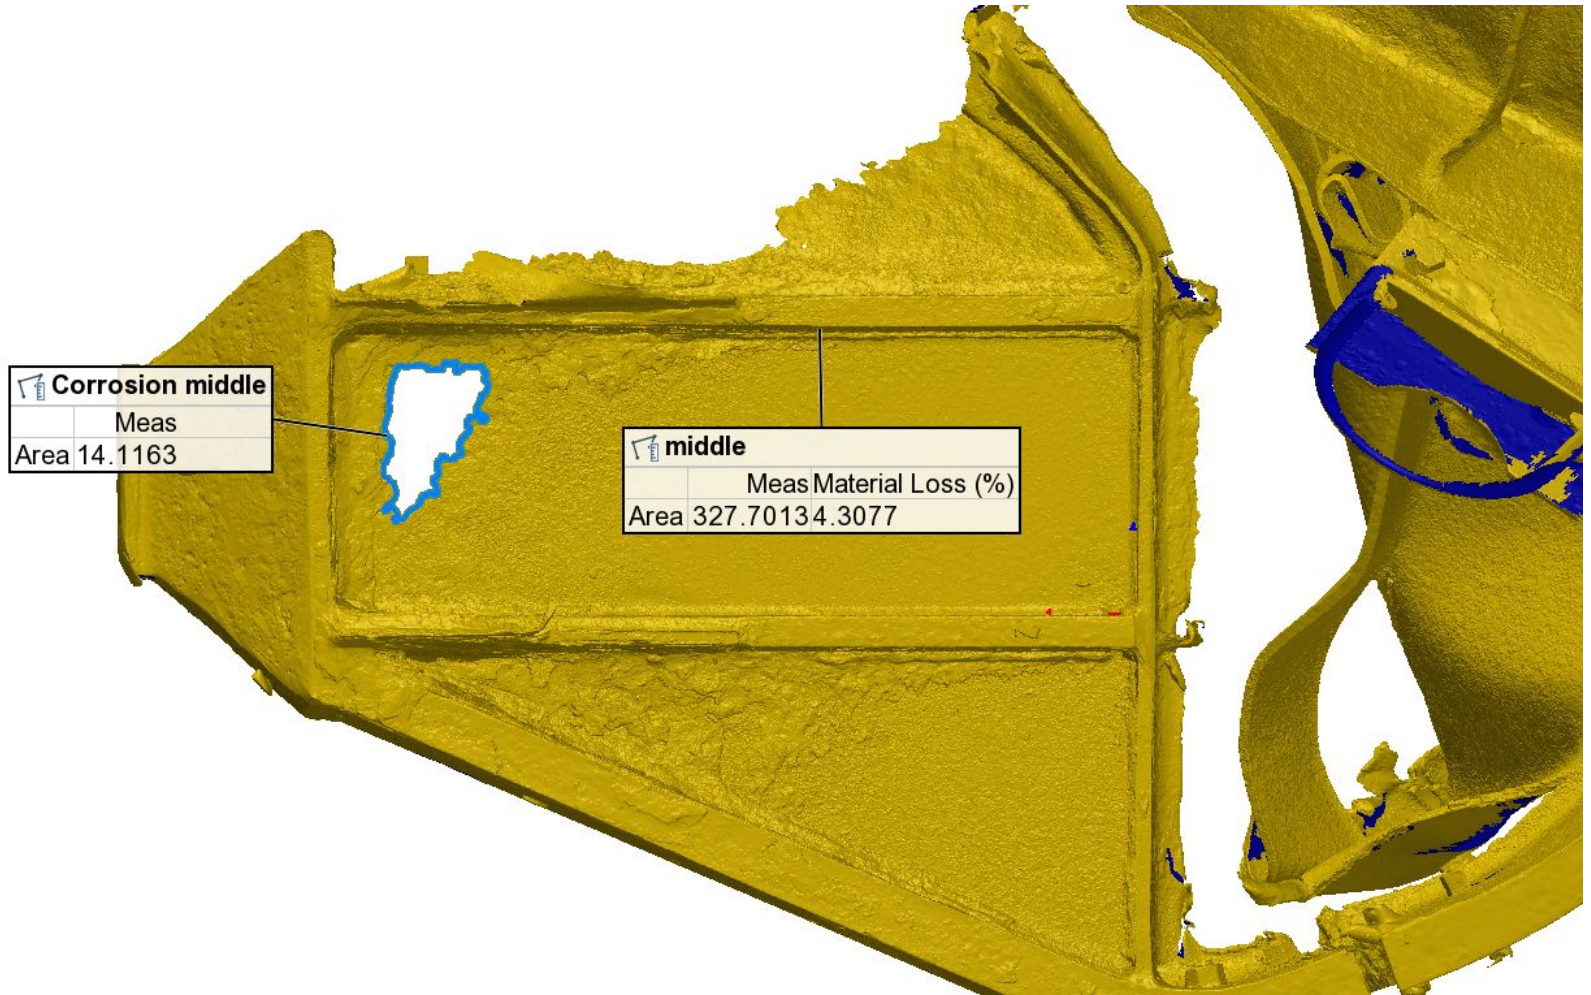
Material Loss - Shoe

Name	Control	Material Loss (%)	Meas
Corrosion middle	Area		14.1163
middle	Area	4.3077	327.7013

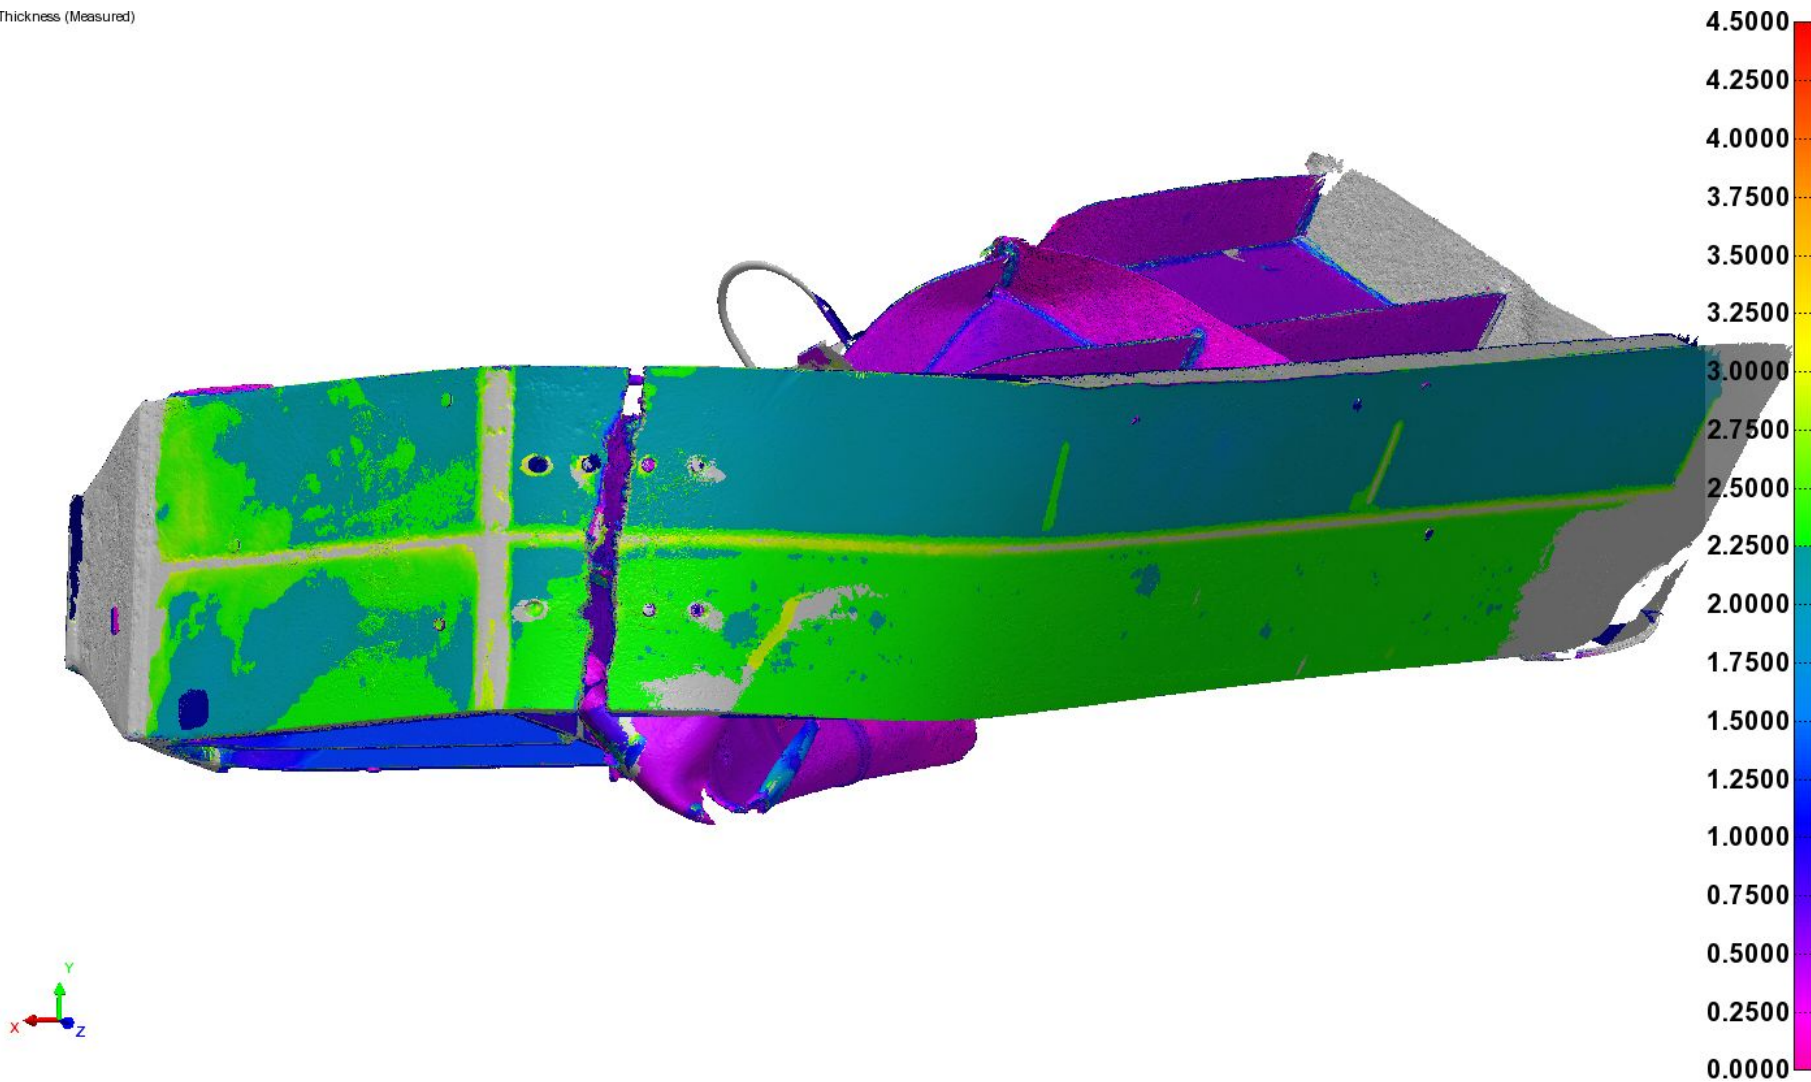
Flange Plate - Bottom (Upper flange is not available)

Thickness (Measured)

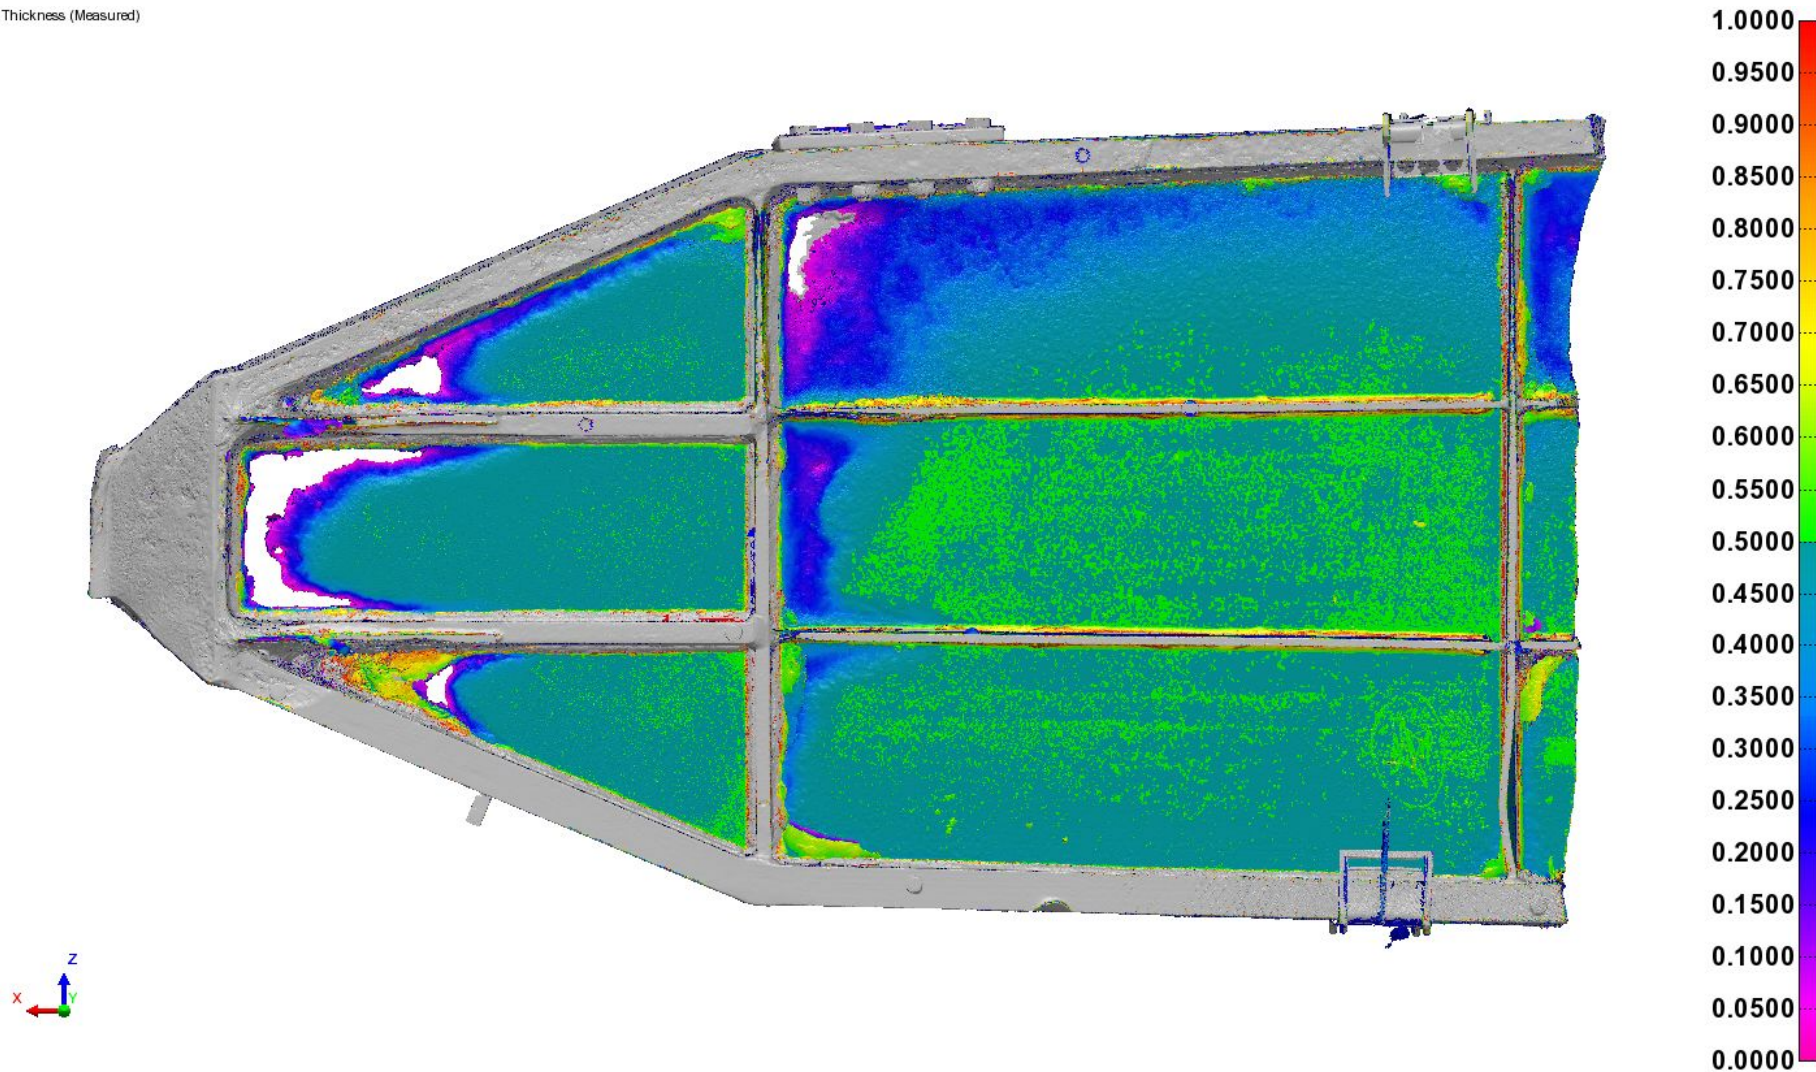
Elevation View - Front

Thickness (Measured)

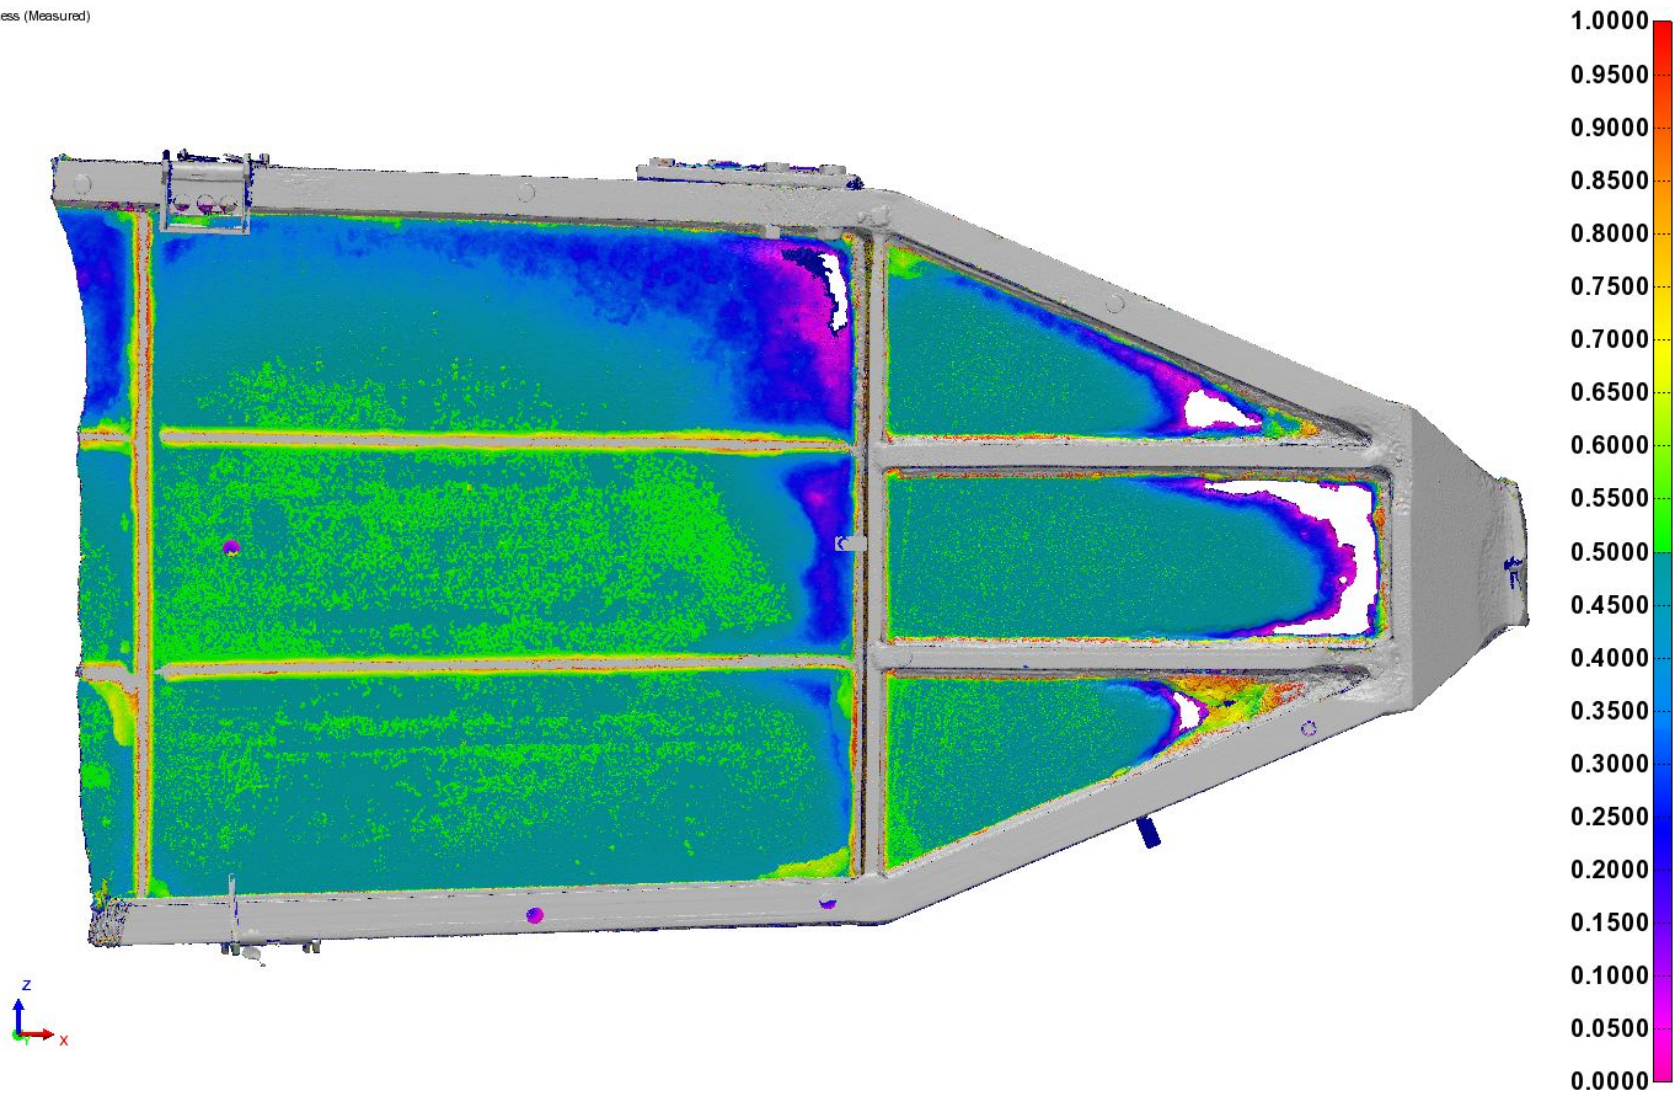
Elevation View - Back

Thickness (Measured)

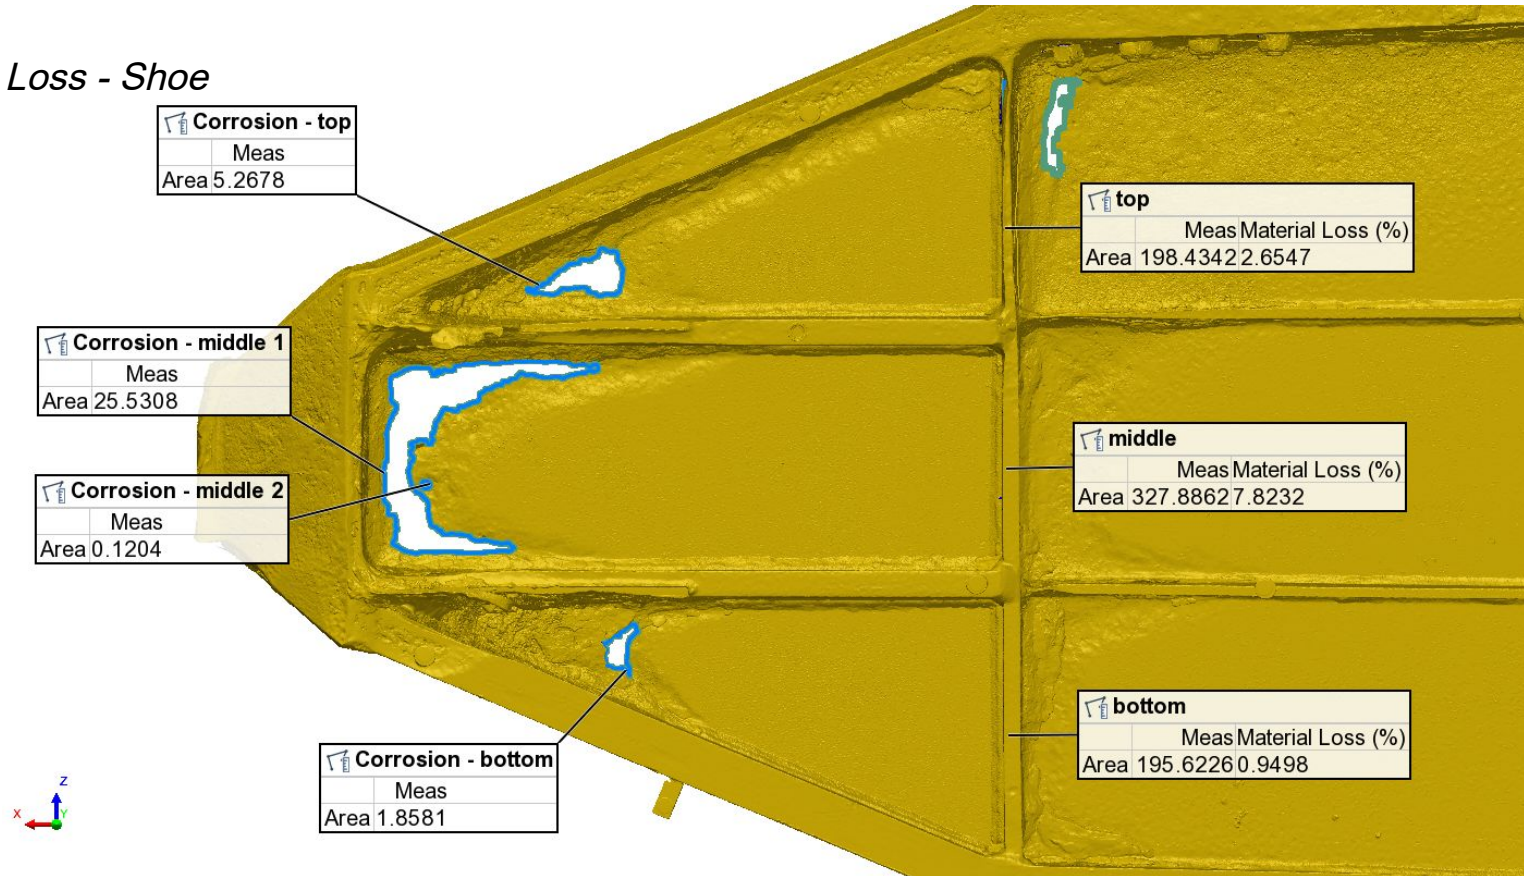
Material Loss - Shoe

Name	Control	Material Loss (%)	Meas
Corrosion - top	Area		5.2678
top	Area	2.6547	198.4342
Corrosion - middle 1	Area		25.5308
Corrosion - middle 2	Area		0.1204
middle	Area	7.8232	327.8862
Corrosion - bottom	Area		1.8581
bottom	Area	0.9498	195.6226
