Creaform Inspection Reports

Pittsburgh, PA

HWY22MH003

B1L Inspection Report

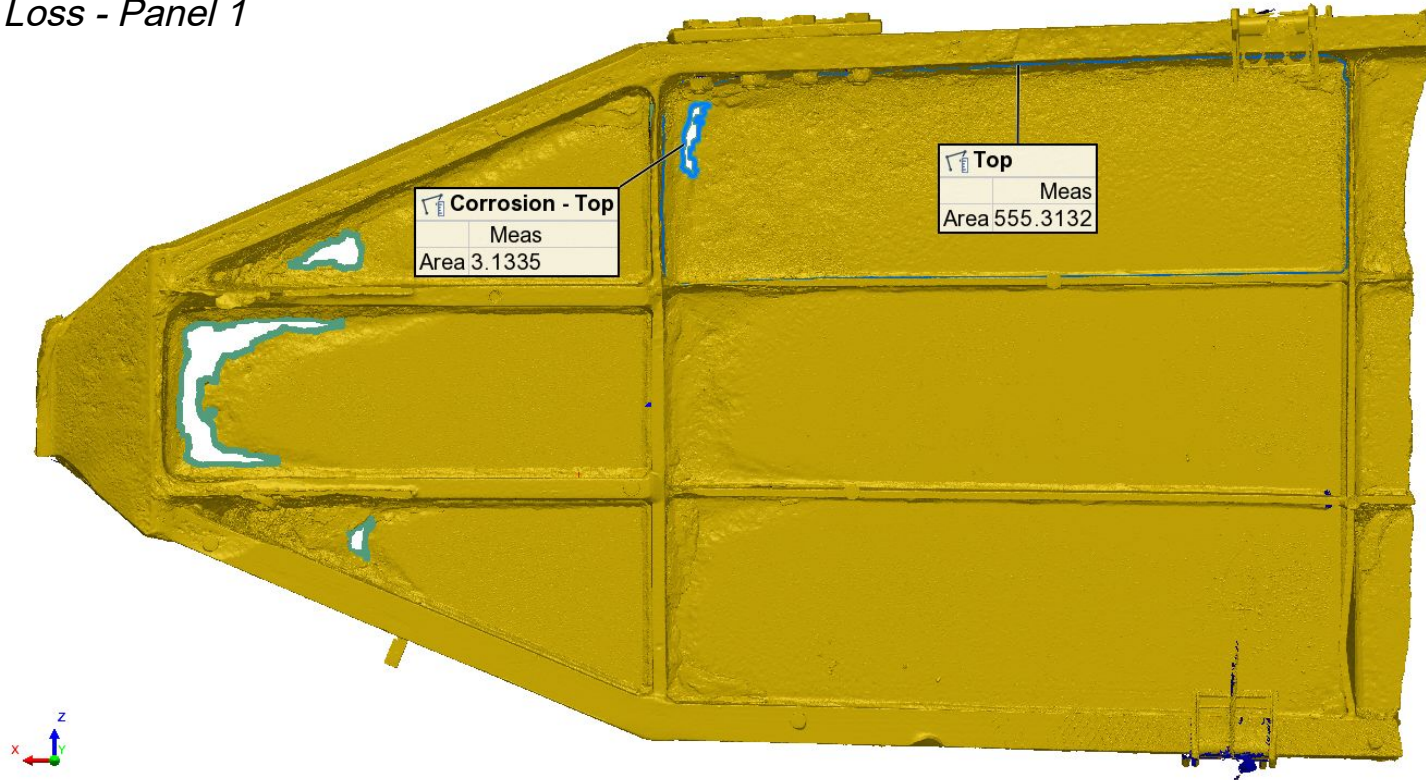
Material Loss - Panel 1

Name	Control	Material Loss (%)	Meas
Corrosion - Top	Area		3.1335
Top	Area	0.5643	555.3132

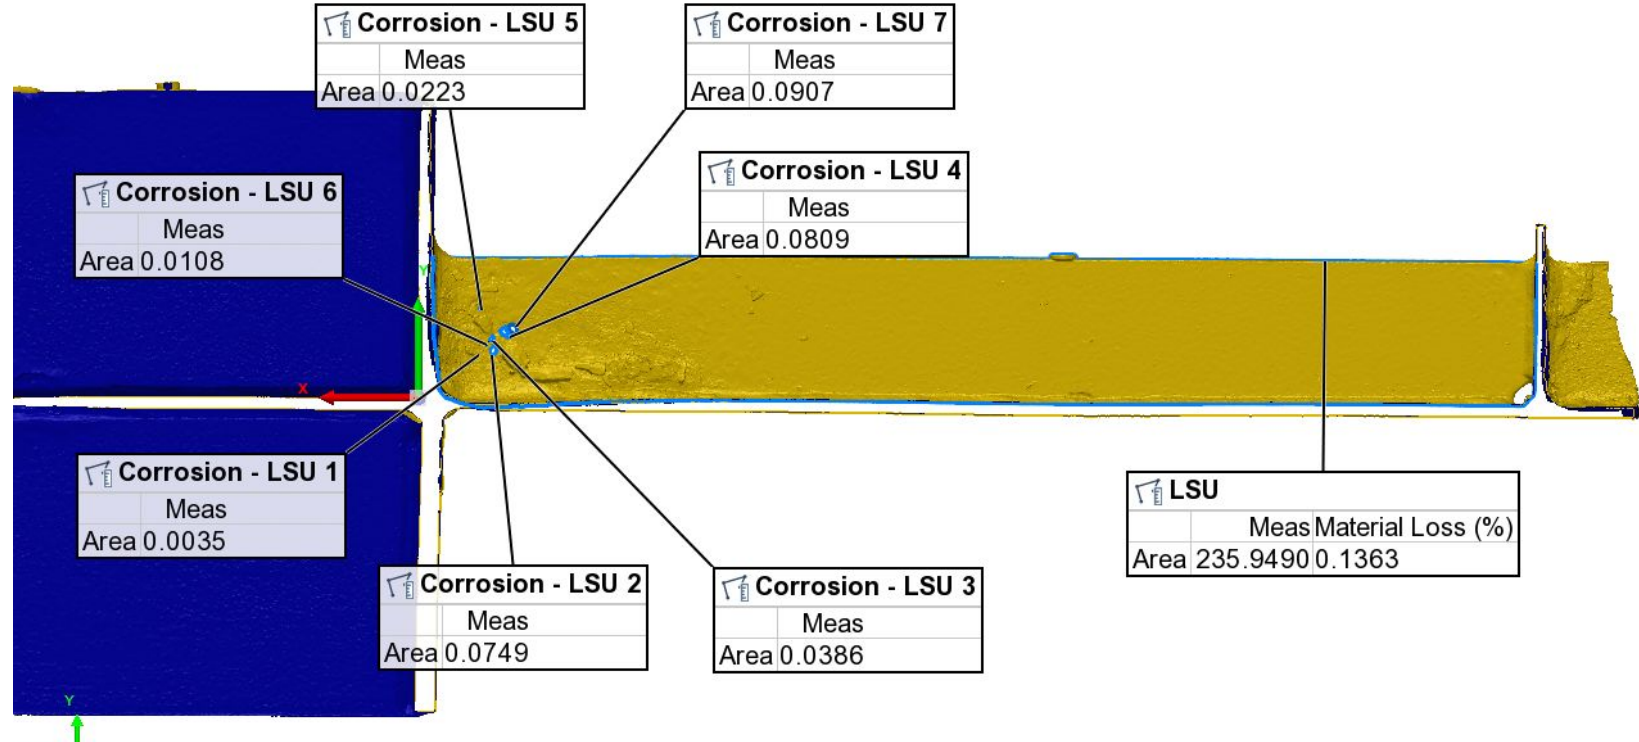
Matreial Loss - Longitudinal Stiffener - Panel 1 - Upper

Name	Control	Material Loss (%)	Meas
Corrosion - LSU 1	Area		0.0035
Corrosion - LSU 2	Area		0.0749
Corrosion - LSU 3	Area		0.0386
Corrosion - LSU 4	Area		0.0809
Corrosion - LSU 5	Area		0.0223
Corrosion - LSU 6	Area		0.0108
Corrosion - LSU 7	Area		0.0907
LSU	Area	0.1363	235.9490

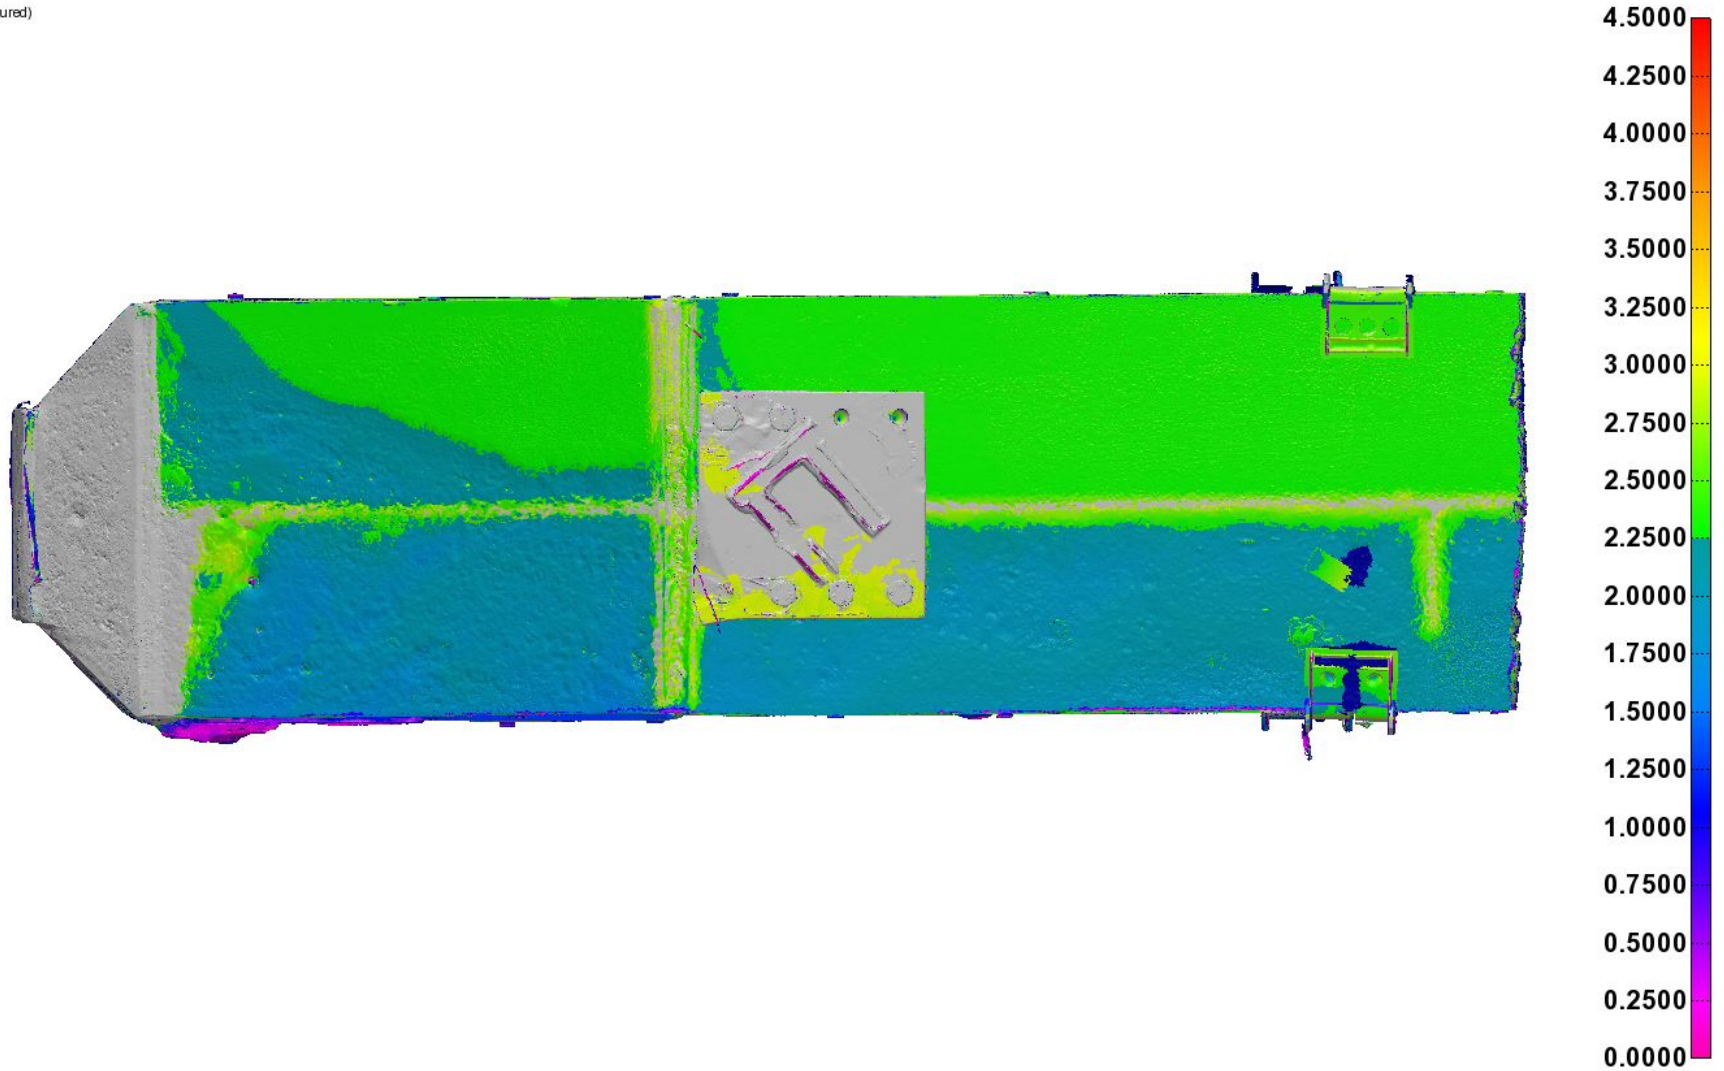
Flange Plate - Upper

Thickness (Measured)

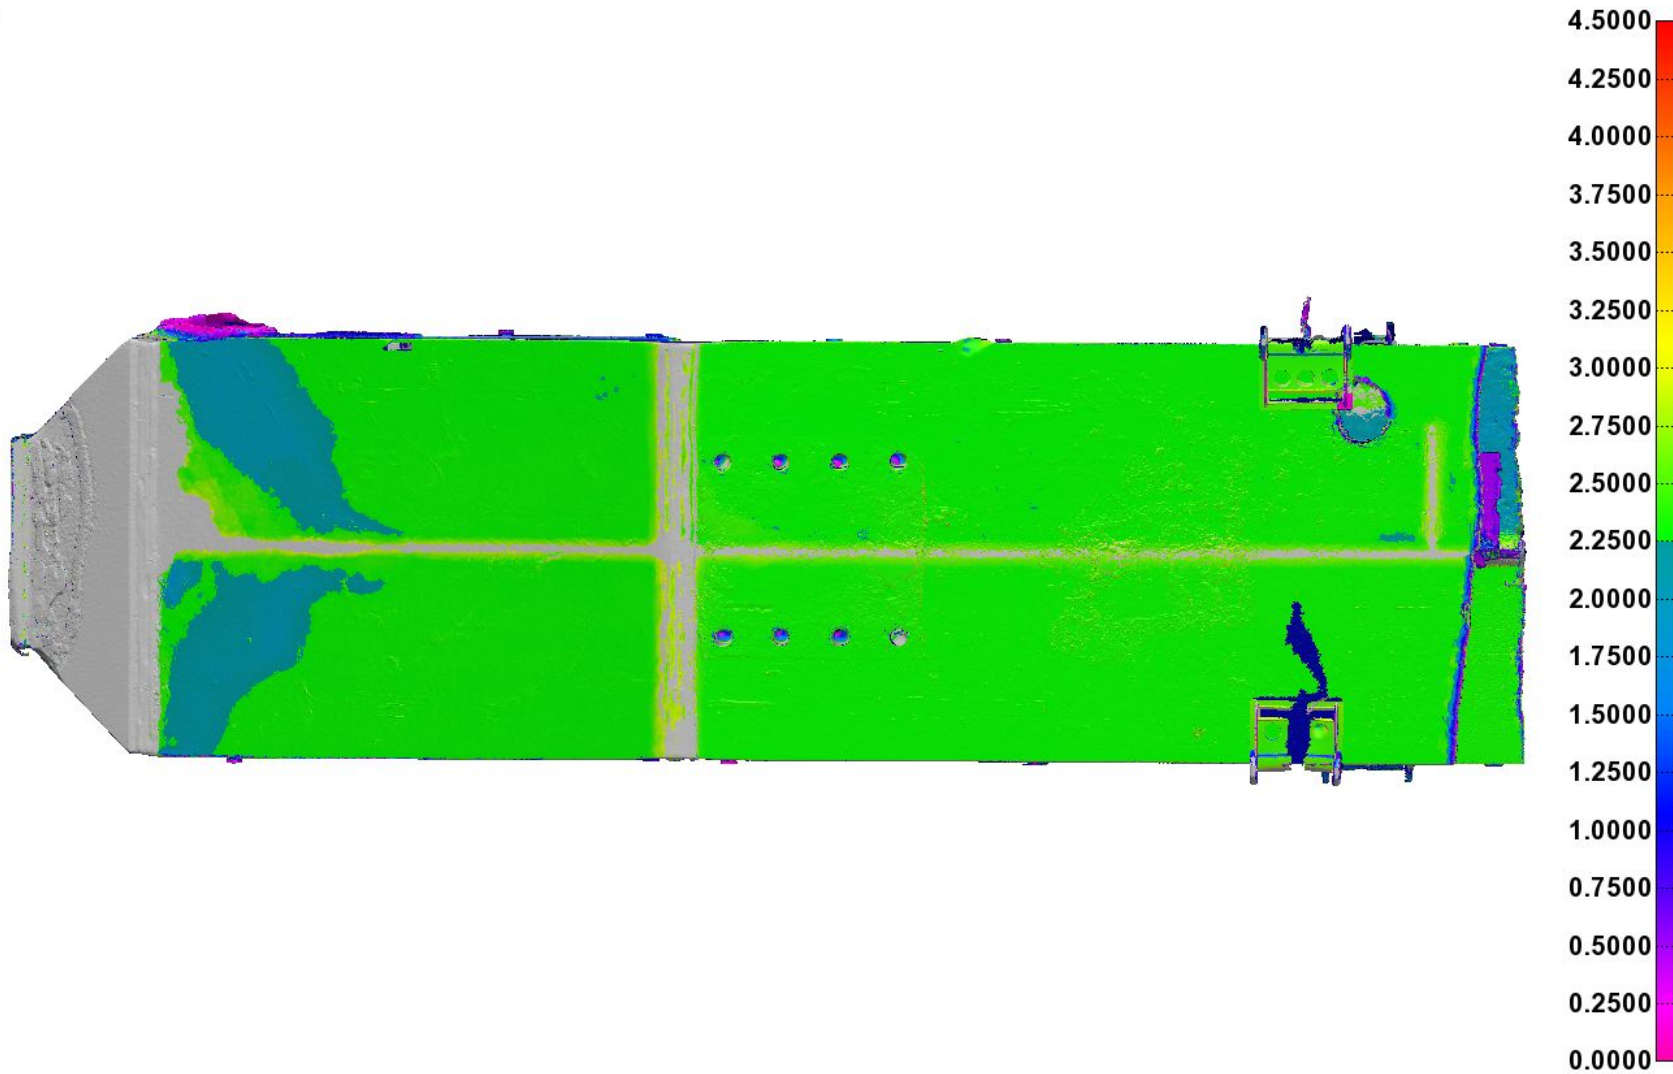
Flange Plate - Bottom

Thickness (Measured)

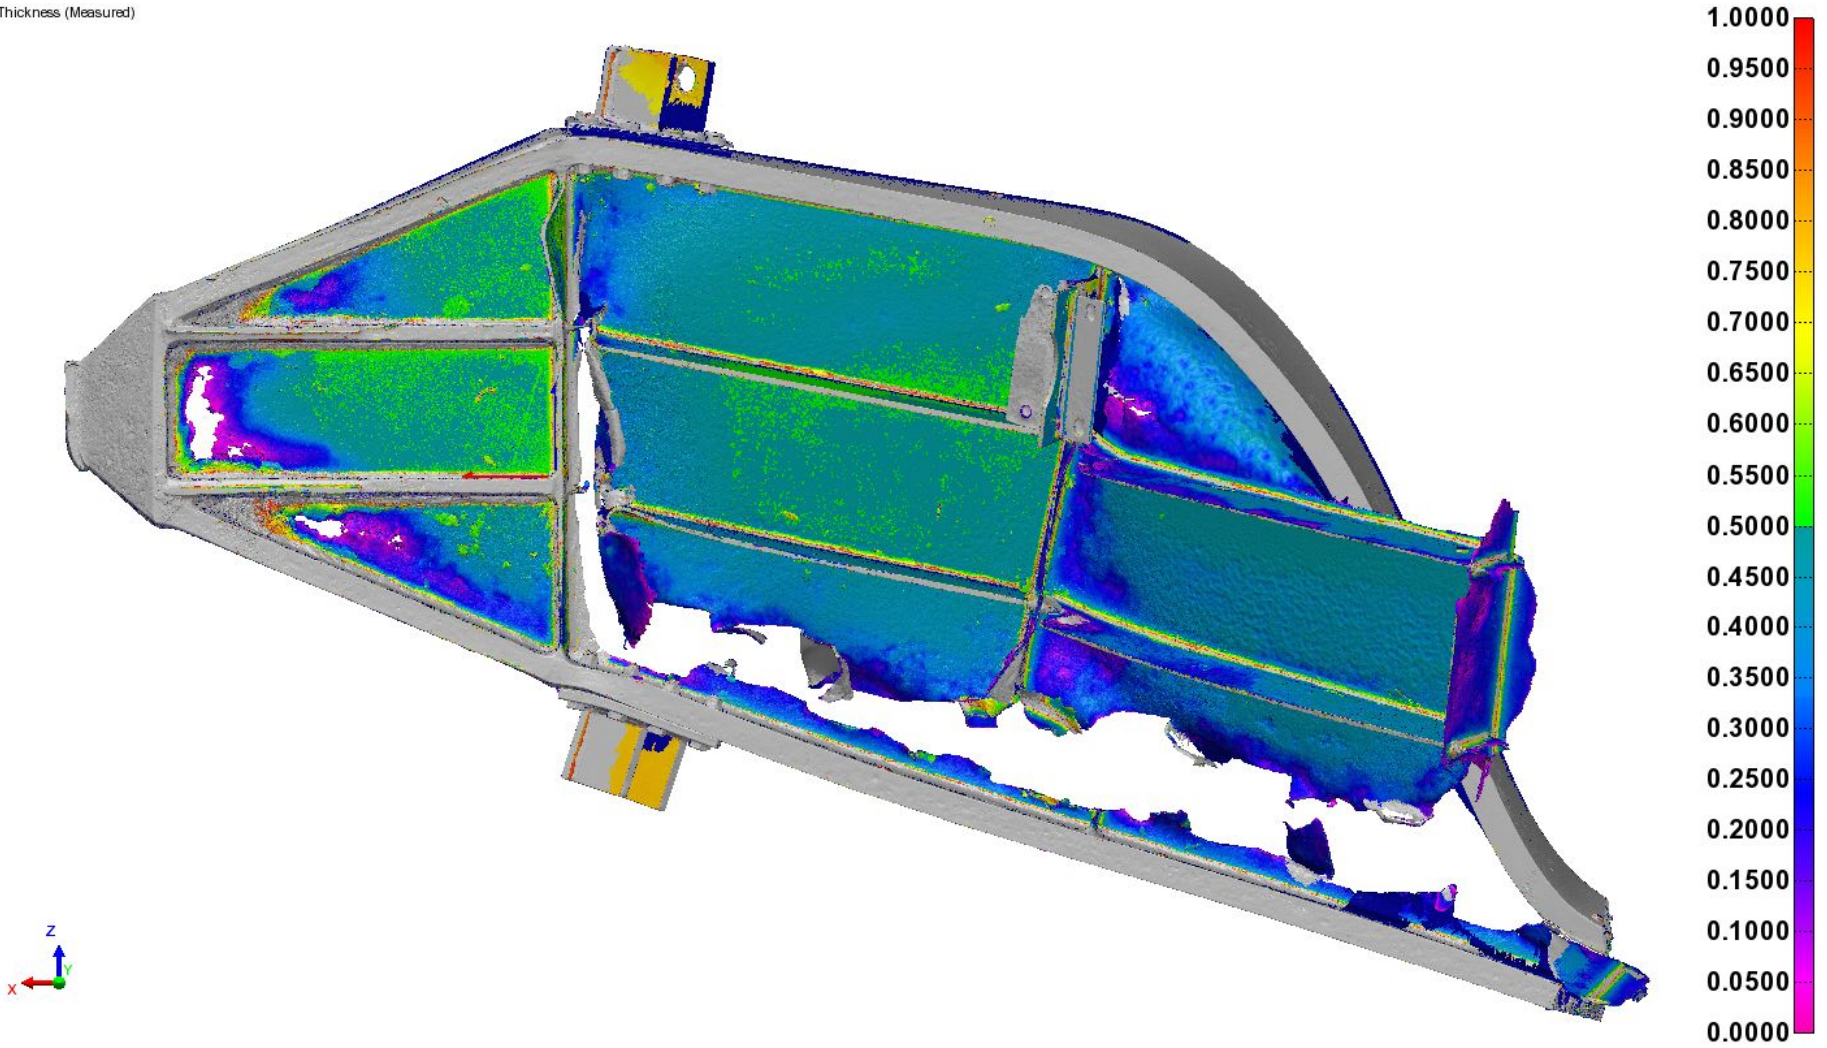
Elevation View - Front

Thickness (Measured)

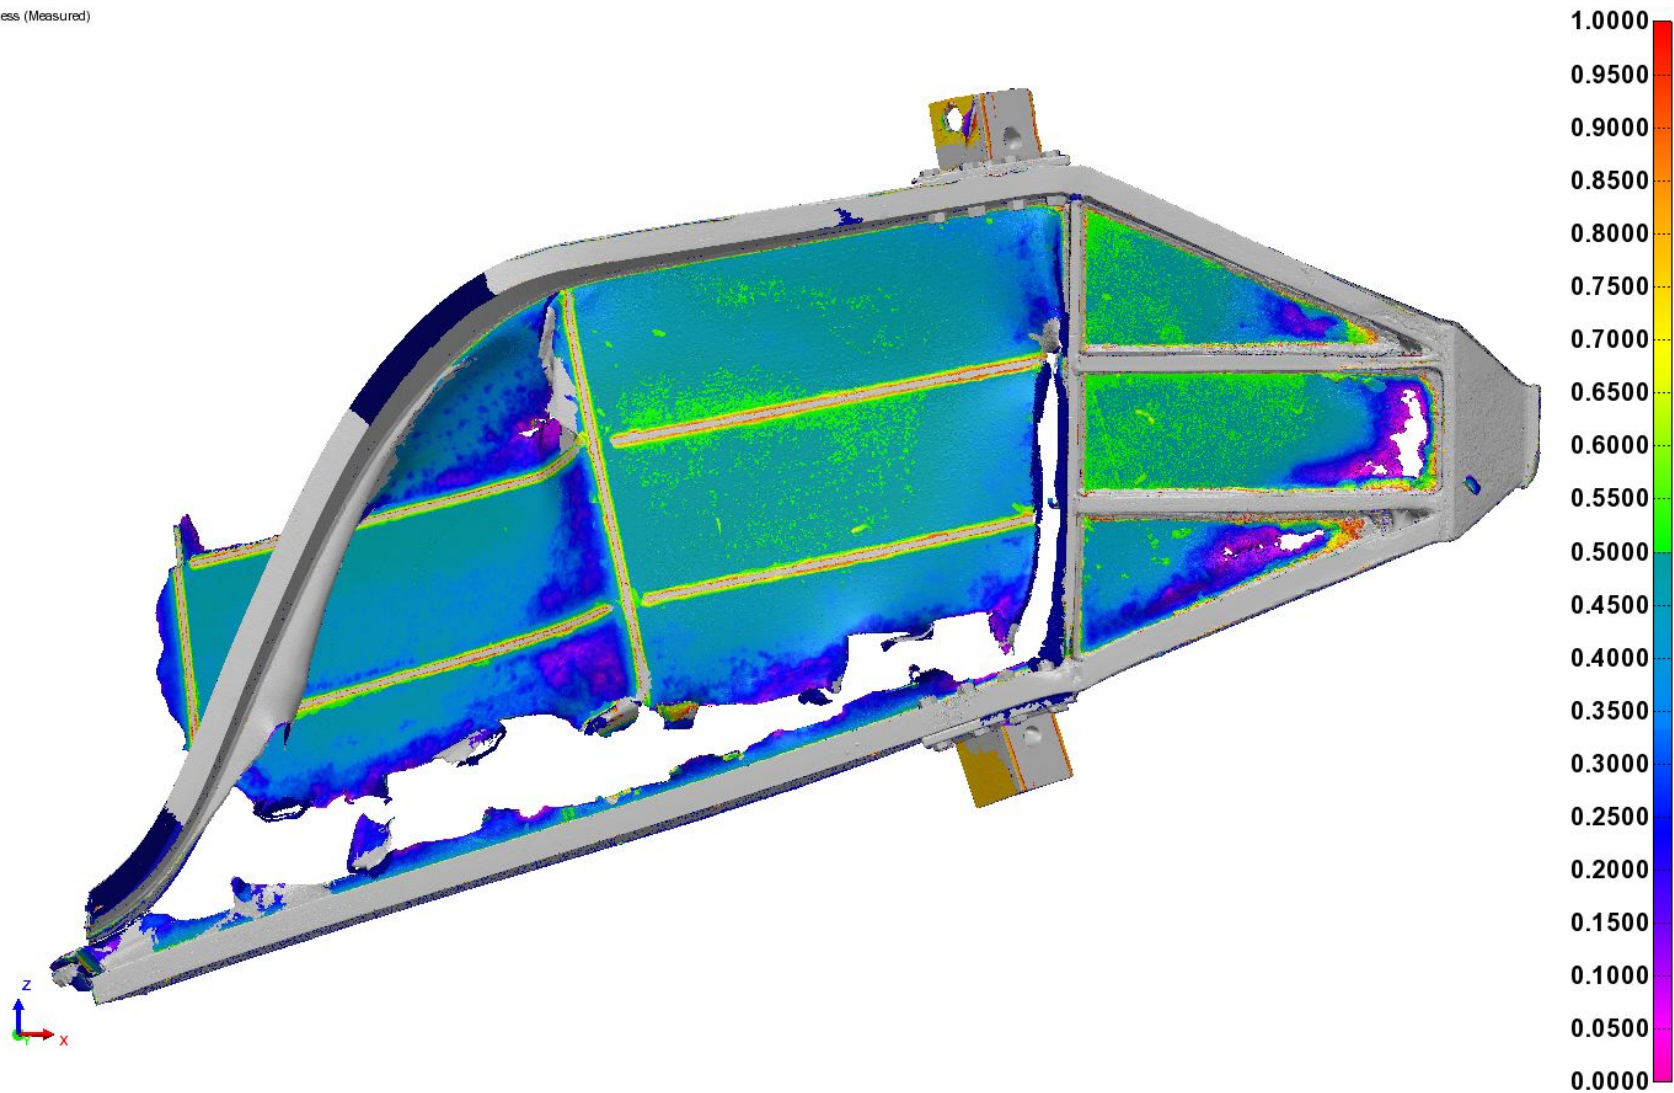
Elevation View - Back

Thickness (Measured)

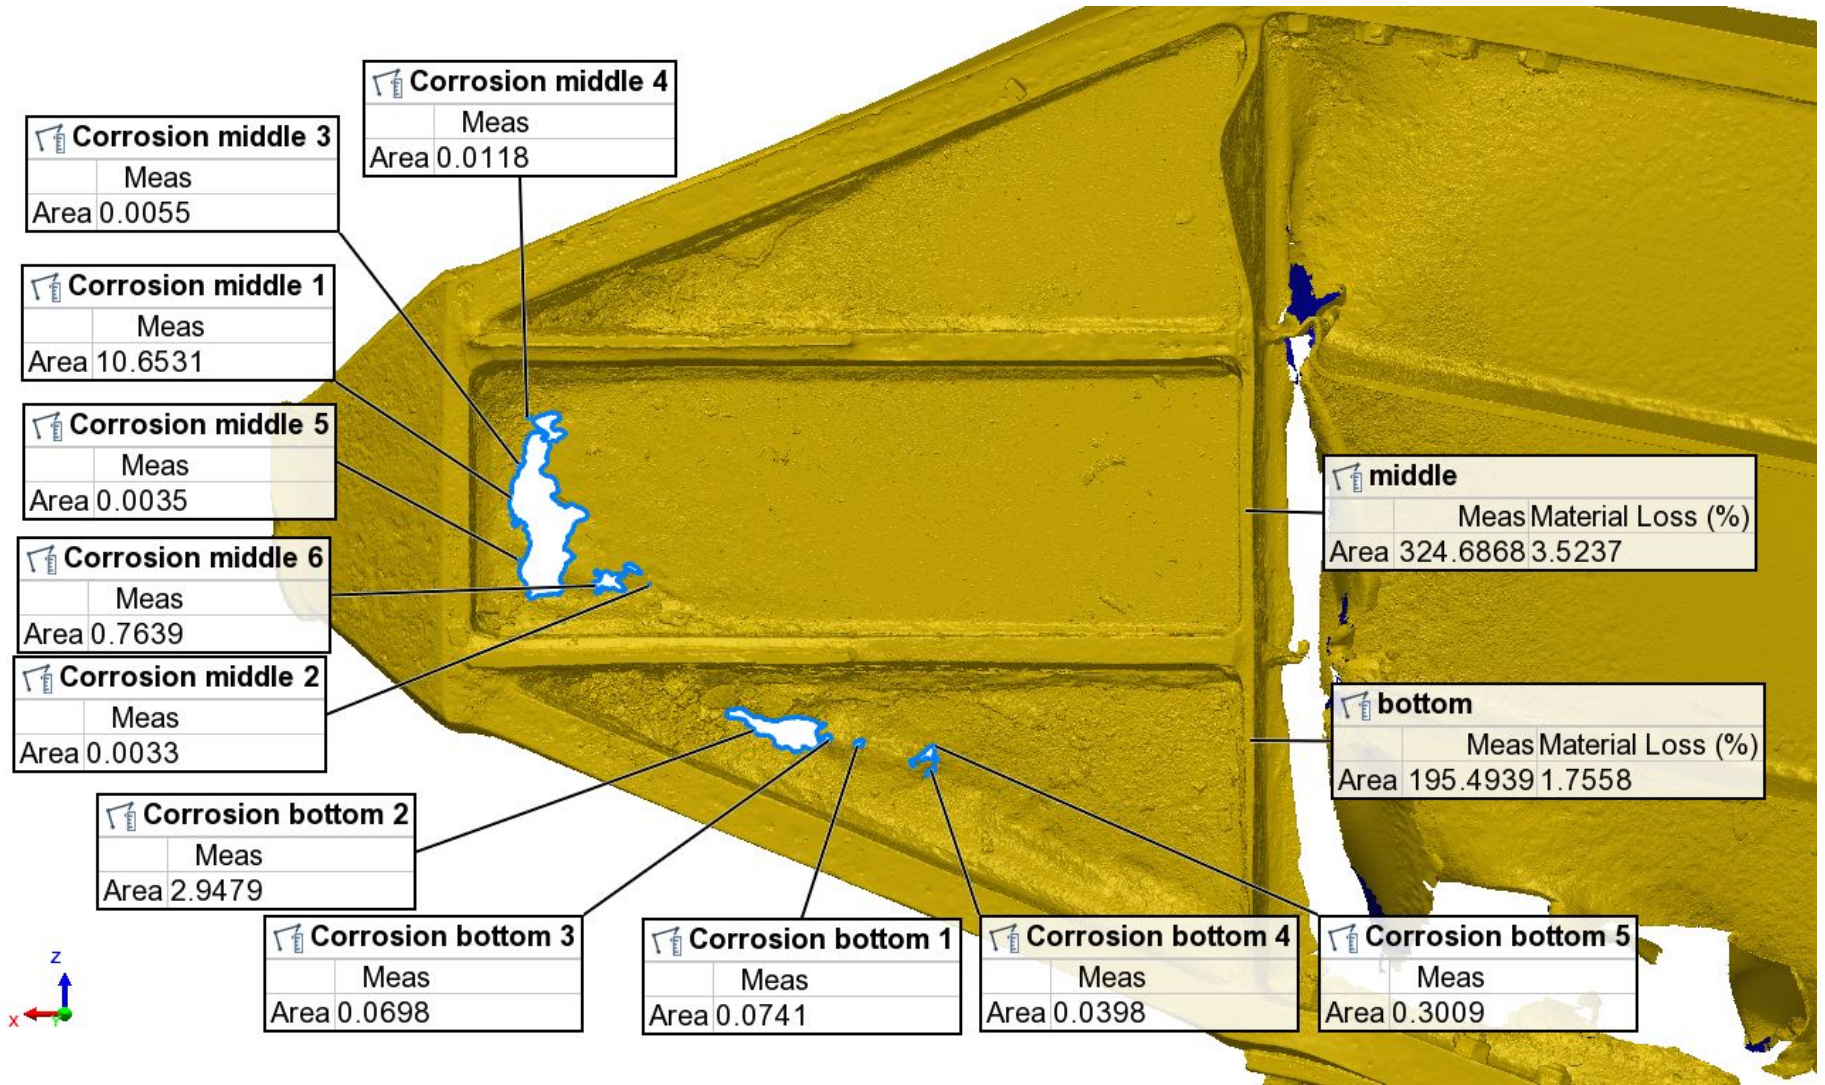
Material Loss - Shoe

Name	Control	Material Loss (%)	Meas
☞ Corrosion middle 1	Area		10.6531
☞ Corrosion middle 2	Area		0.0033
☞ Corrosion middle 3	Area		0.0055
☞ Corrosion middle 4	Area		0.0118
☞ Corrosion middle 5	Area		0.0035
☞ Corrosion middle 6	Area		0.7639
☞ middle	Area	3.5237	324.6868
☞ Corrosion bottom 1	Area		0.0741
☞ Corrosion bottom 2	Area		2.9479
☞ Corrosion bottom 3	Area		0.0698
☞ Corrosion bottom 4	Area		0.0398
☞ Corrosion bottom 5	Area		0.3009
☞ bottom	Area	1.7558	195.4939

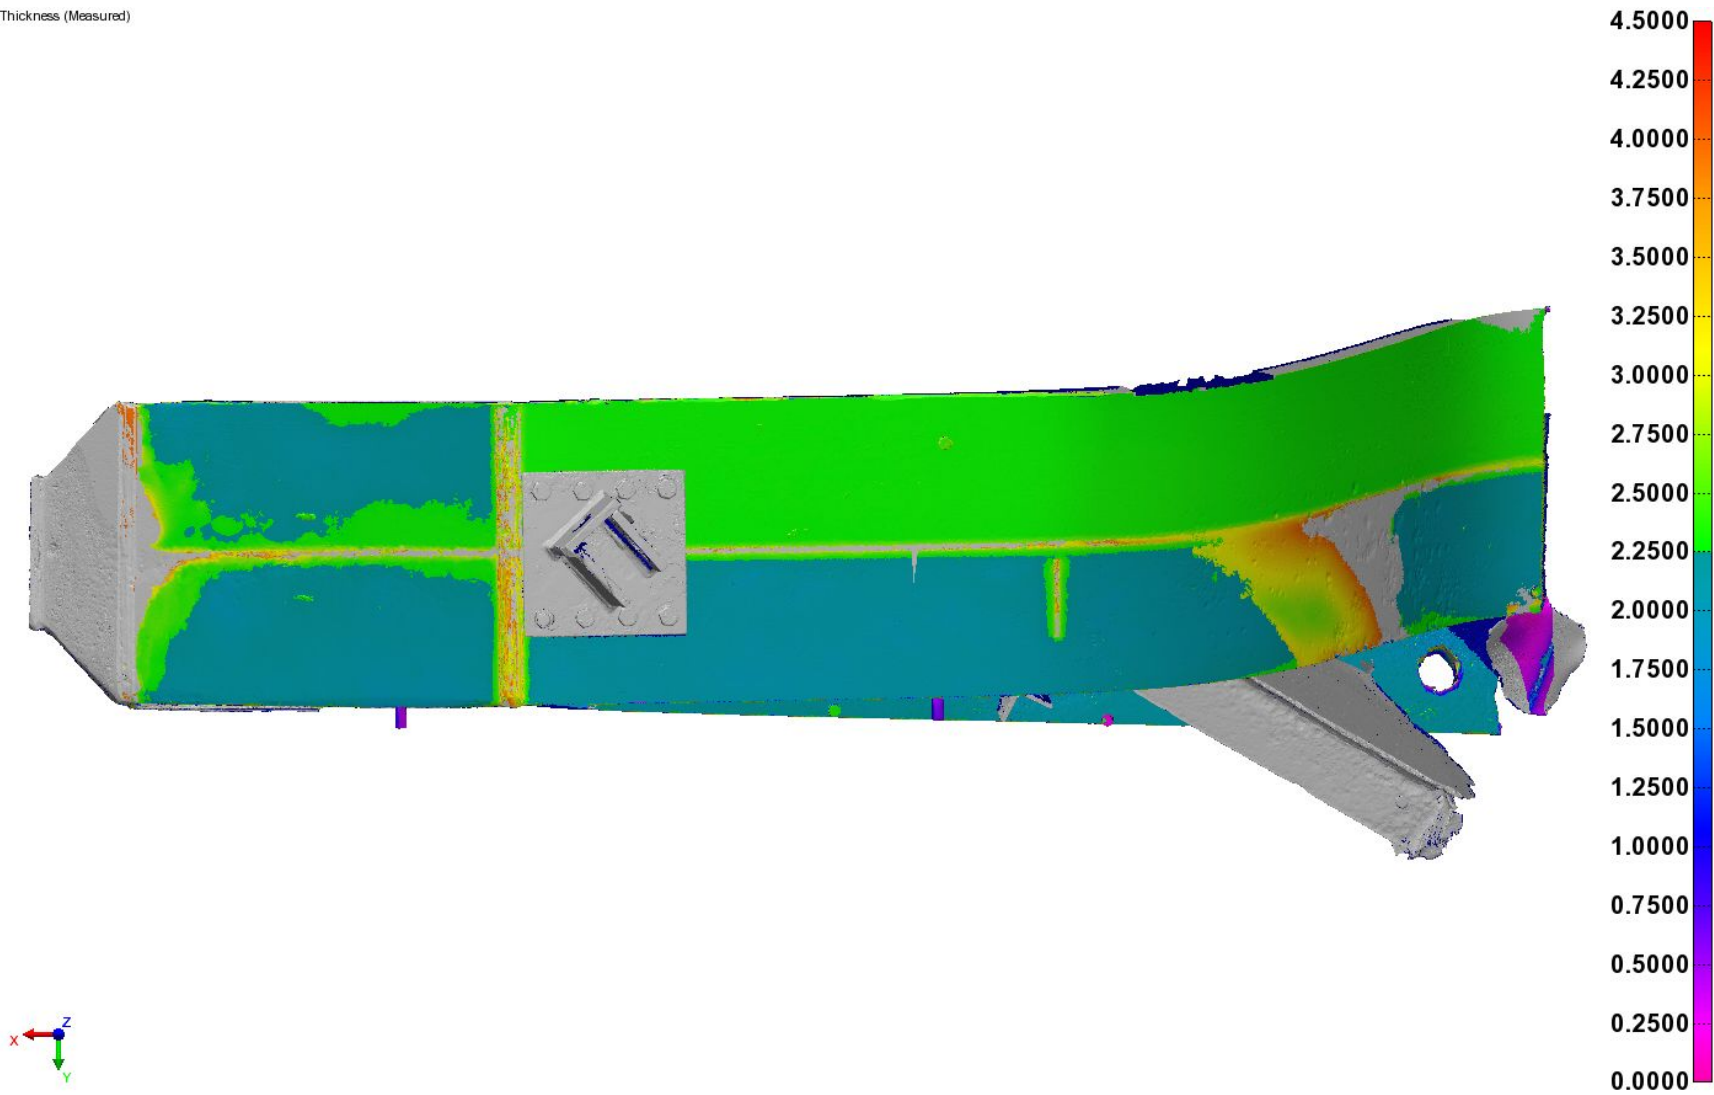
Flange Plate - Upper

Thickness (Measured)

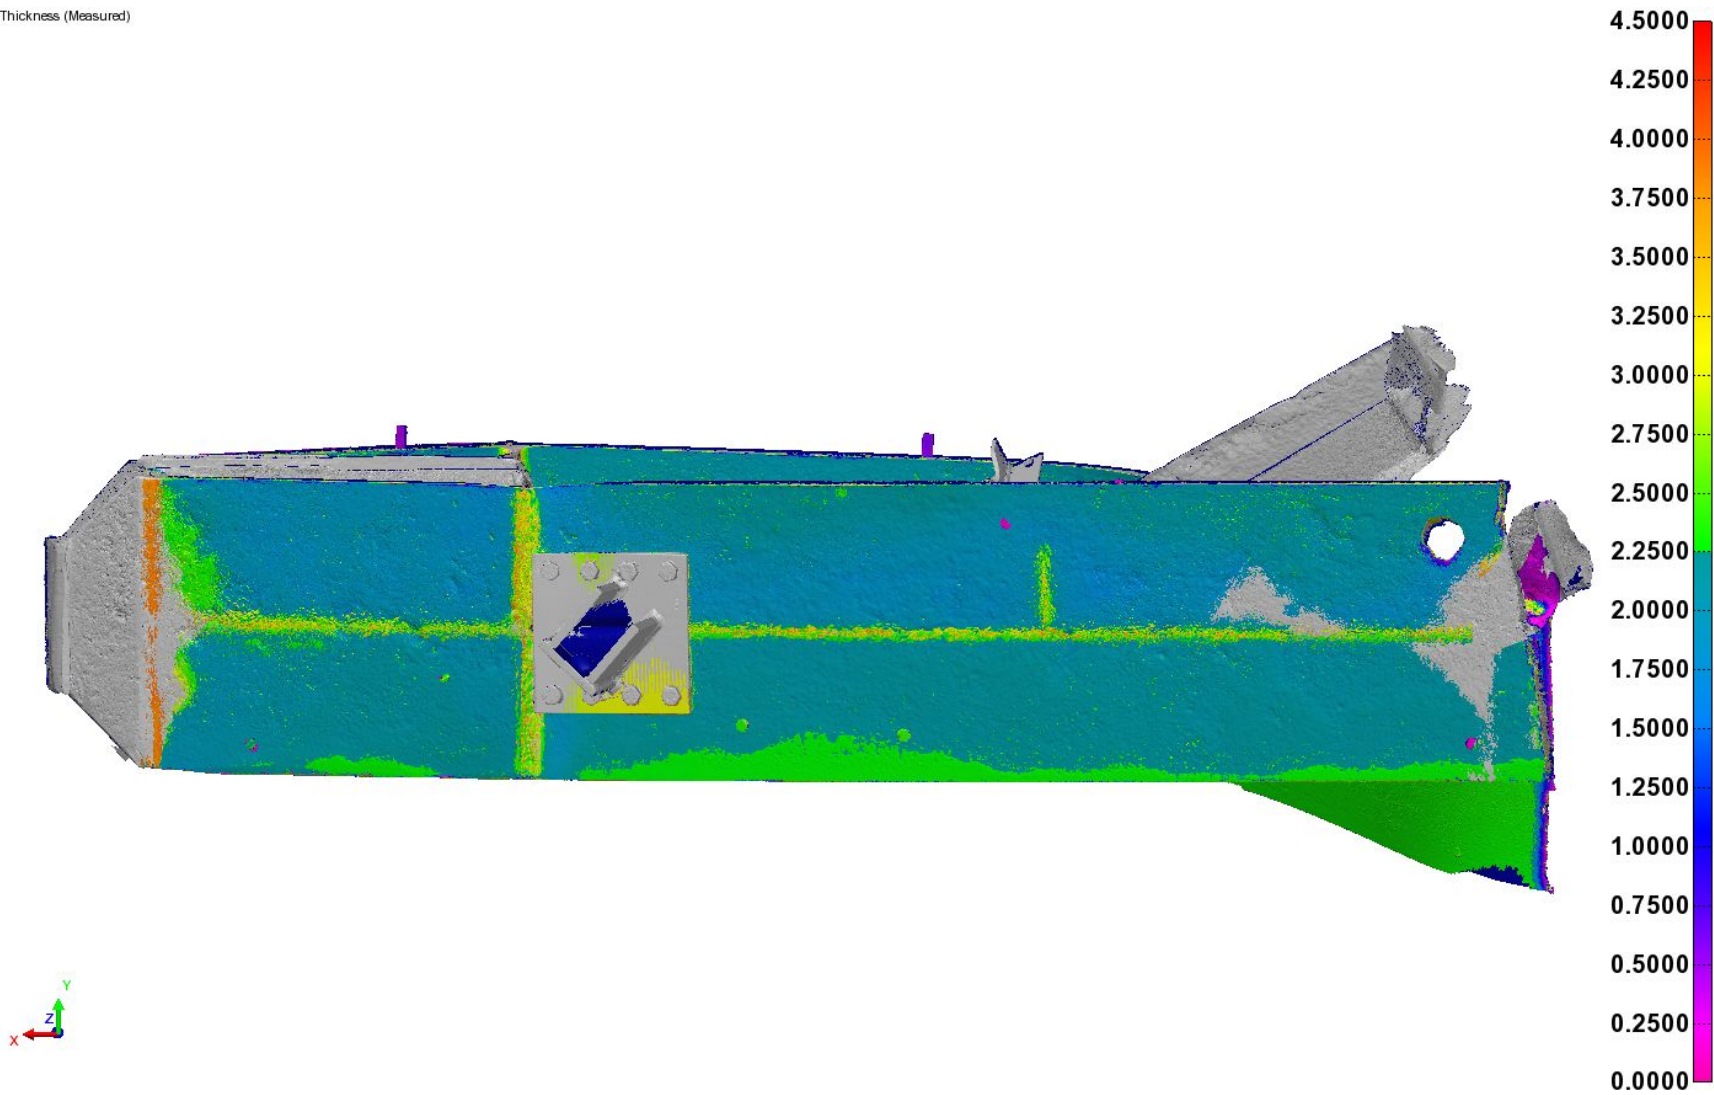
Flange Plate - Bottom

Thickness (Measured)
