**NATIONAL TRANSPORTATION SAFETY BOARD
OFFICE OF HIGHWAY SAFETY
WASHINGTON, D.C.**

FACTUAL REPORT OF INVESTIGATION

Location: Southbound Interstate 405 south of Washington Boulevard, Culver City,
Los Angeles County, California
Vehicle 1: 2014 Tesla Model S
Operator 1: Private Owner
Vehicle 2: 2006 Seagrave Custom Firetruck (pumper)
Operator 2: Culver City Fire Department, Culver City, California
Date and Time: January 22, 2018, at approximately 8:40 a.m. PST
Injuries: 0
Fatalities: 0
NTSB #: **HWY18FH004**

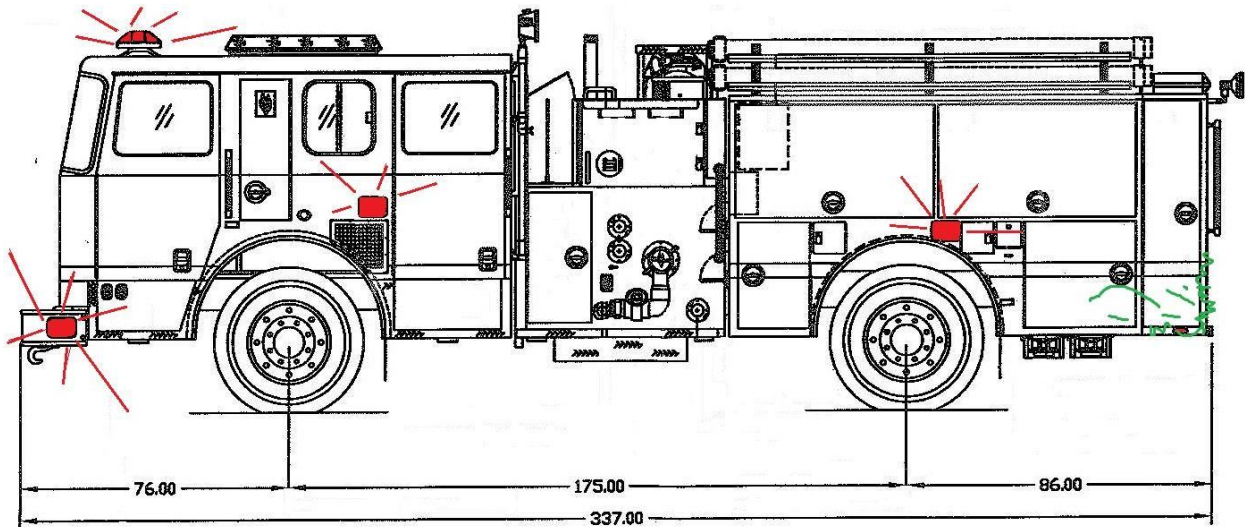
Figure 1: The Left Side of the Fire Truck

The crash damage sustained by the firetruck was contained to the left rear of the vehicle, see **Figure 1**. There were numerous gouges, scrapes, and black transfers (green marks), originating at the left-rear corner and extended forward approximately 40-inches along the two left-rear side equipment compartment doors. There was an arched-shaped scrape that apexes the bottom of the door handle on the second-to-last compartment door. The metal trim located on the bottom of the rearmost compartment was damaged and displaced forward. The lower portion of the left-rear corner sustained moderate crush damage.

The exterior lights of the fire truck were inspected for functionality. All of the lights were observed to be functional, including the broken light assembly on the left. In **Figures 1 and 2** above, the emergency lights which would be activated are indicated. The red and yellow markings on the rear compartment doors are comprised of reflective tape.

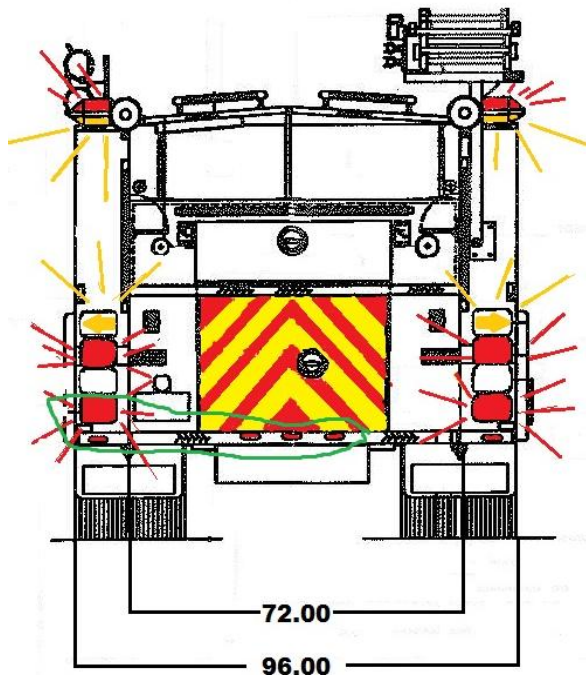
Figure 2: The Rear of the Fire truck

The rear of the fire truck sustained crash damage as well. Most of the damage was located to the left of center of the vehicle; see **Figure 2**. The lower portion of the equipment compartment door, the left of the rear deck, sustained impact damage. The left-lower, red, Light Emitting Diode (LED), lens was crushed. The rear deck, which was 72-inches wide, sustained crash damage from the left to the right, approximately 50-inches in width. The left side of the rear deck was distorted in an upward arch – preventing the rear compartment doors from opening. The three red LED

identification lights mounted to the rear deck, were displaced forward beneath the rear deck. The green outline in **Figure 2** illustrates the area of damage.
