Examination at Messier-Bugatti Dowty, Ajax, Ontario, Canada, November 2013:

C. SUMMARY

D. DETAILS OF INVESTIGATION

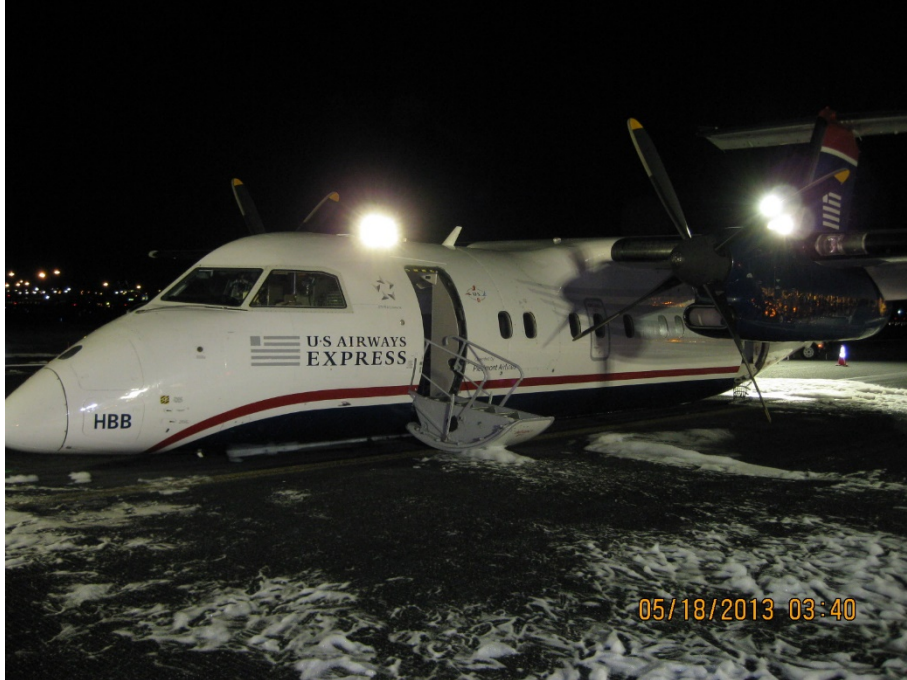
The airplane was landed without any of the airplane's three landing gears extended. The airplane landed (on its lower fuselage) on Runway 04L at Newark Liberty International Airport, New Jersey. See Figures 1 and 2.

Figure 1 -The airplane after landing without the nose or main landing gears extended. (Photograph courtesy of the FAA)

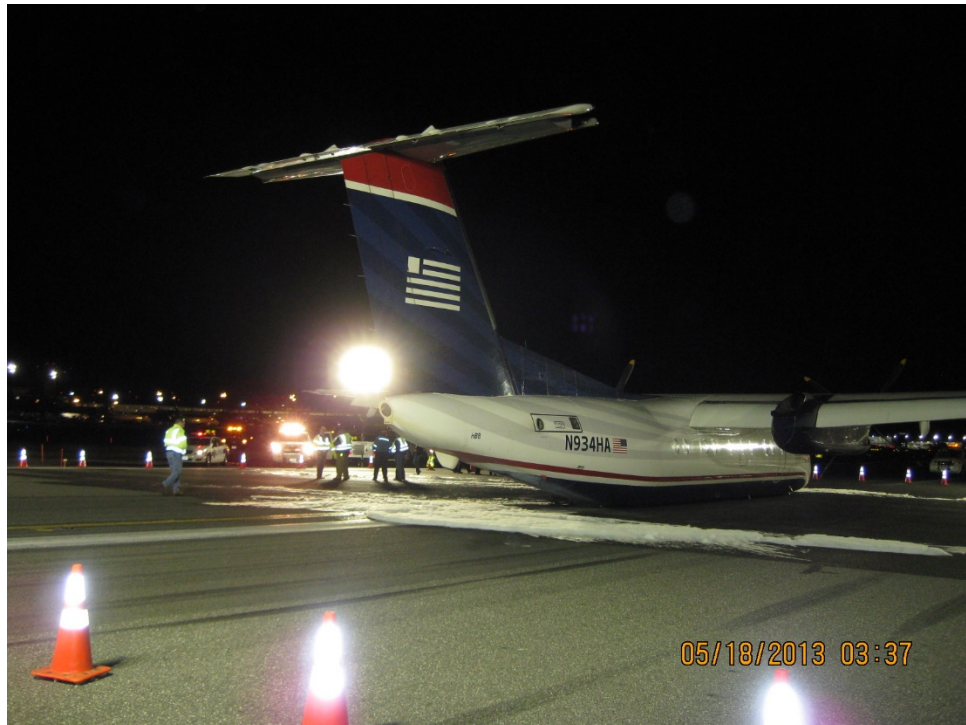
Figure 2 – Aft view of the airplane after landing without the nose or main landing gear extended. (Photograph courtesy of the FAA)

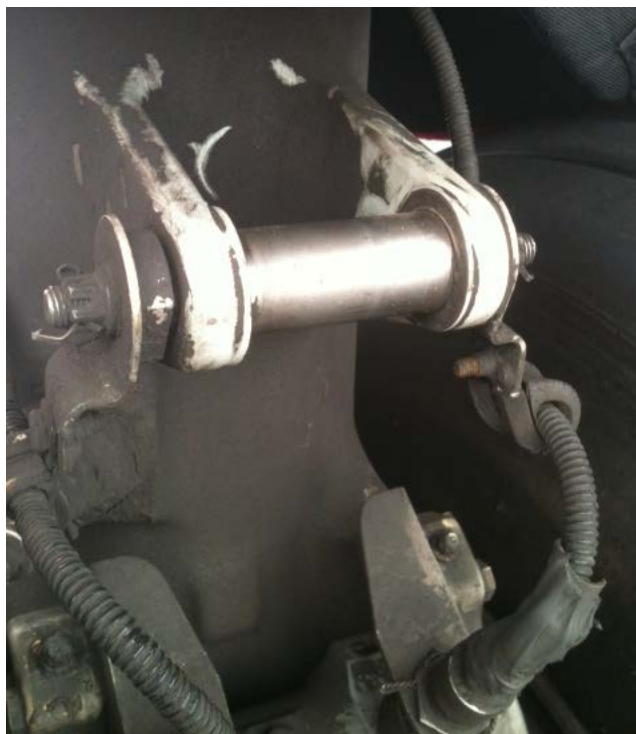
A visual examination of the left and right main landing gear was conducted. In general, neither landing gear displayed visible physical damage. However, the left main landing gear uplock roller was found seized and would not rotate by hand. See Figure 8.

Figure 8 - Left Main Gear Uplock Roller, as installed.

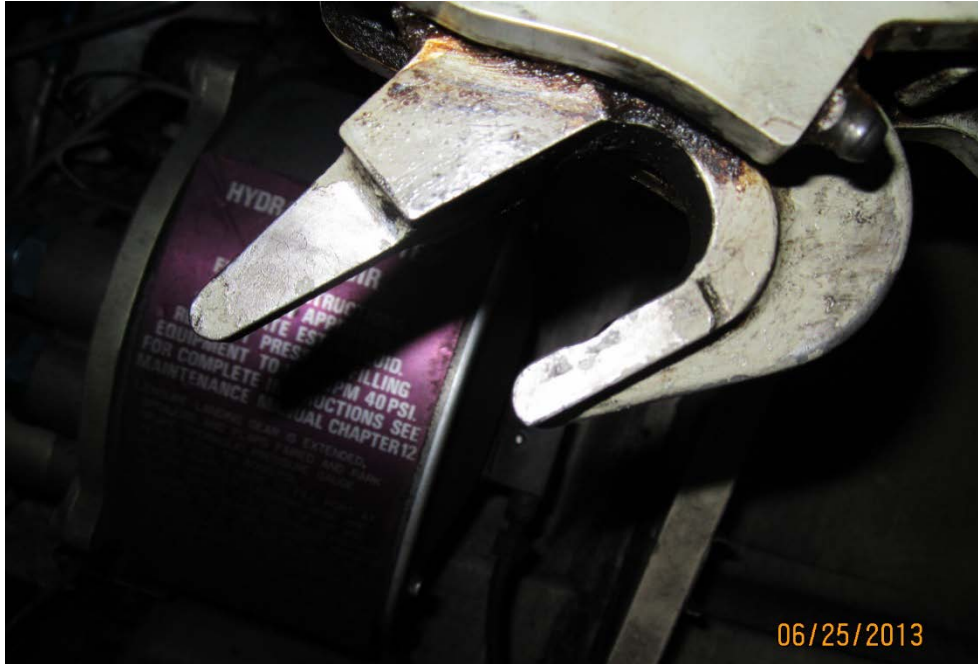
On the latch of both the left and right main gear uplocks a “worn” groove was noted on the lower surface of the latch. The groove in the left uplock latch appeared slightly larger than the groove in the right uplock latch. See Figure 9.

Figure 9 - Side View of Left Main Gear Uplock.

The measurements were taken per the Messier-Dowty Data Sheet. Comparing the measurements of the grooves against the specifications detailed on the Messier-Dowty Data Sheet, the group consensus was that the groove on the left main landing gear uplock latch was at or beyond wear limits, and the groove on the right main landing gear uplock latch was at or slightly below wear limits.

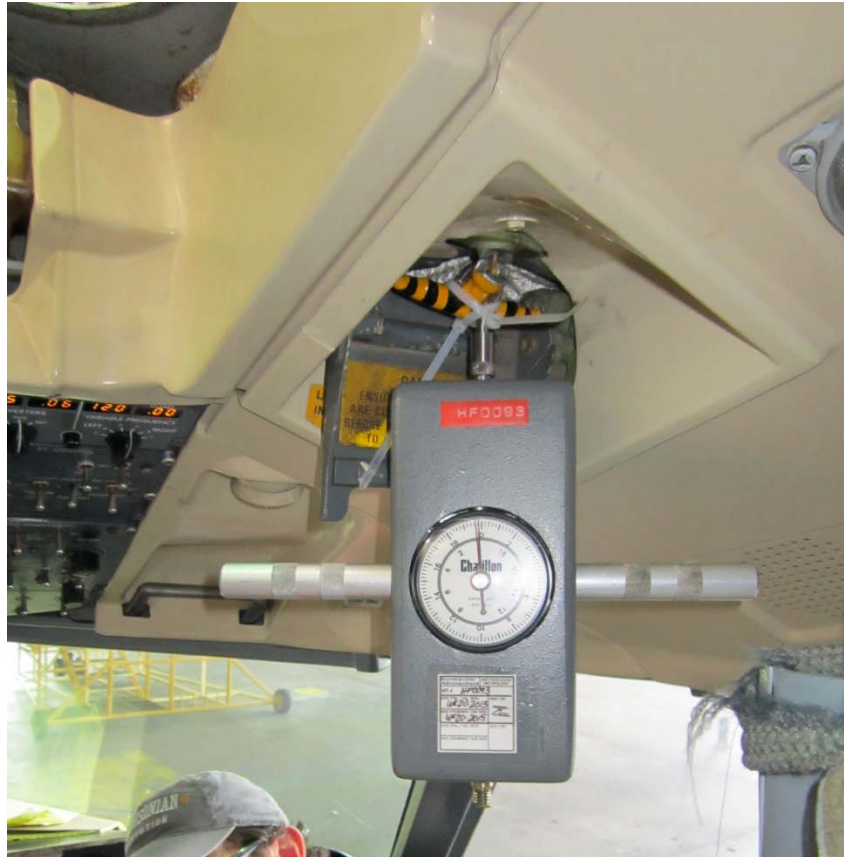
Figure 10 - The "fish scale" force gauge, as installed, connected to the Alternate Gear Release T-Handle.

The test was accomplished several times, at different rates (e.g. slow, fast) and by use of rapid, jerking, extensions of the force gauge handle. In general, the right main landing gear released with “normal” force and in sequence, but the force required to release the left main landing gear was more than 240 lbs.

- Left/Right main landing gear doors: ~16 lbs.
- Right main landing gear release: ~70 lbs.
- Left main landing gear release: ~240 lbs.

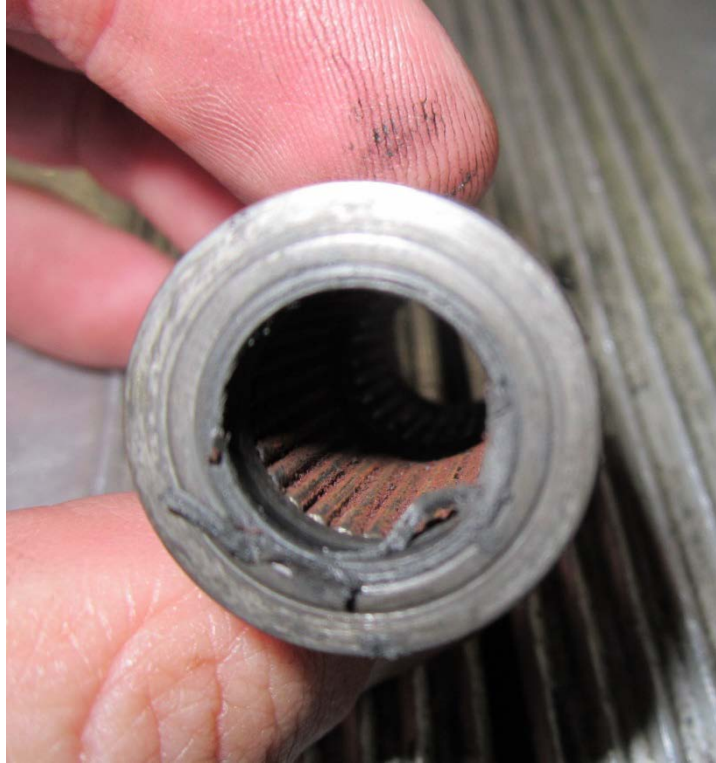
The left main gear uplock roller did not rotate by hand, but the right main gear uplock roller could be rotated by hand. The left main gear uplock roller was removed for inspection. Upon removal it was noticed that the internal roller bearings had rust-colored material on the internal surfaces (See Figure 11). The internal pin exhibited markings that appeared to be from the roller bearings. The bearing seal appeared compromised.

Figure 11 - The left gear uplock roller, after removal.

- One set of the bearings appeared out of alignment.
- Several needle bearings were noted to have flat spots and corrosion.
- The bearing assembly appeared to be devoid of lubricant.
- When placed onto the shoulder bolt and rotated, the bearing did not rotate smoothly.

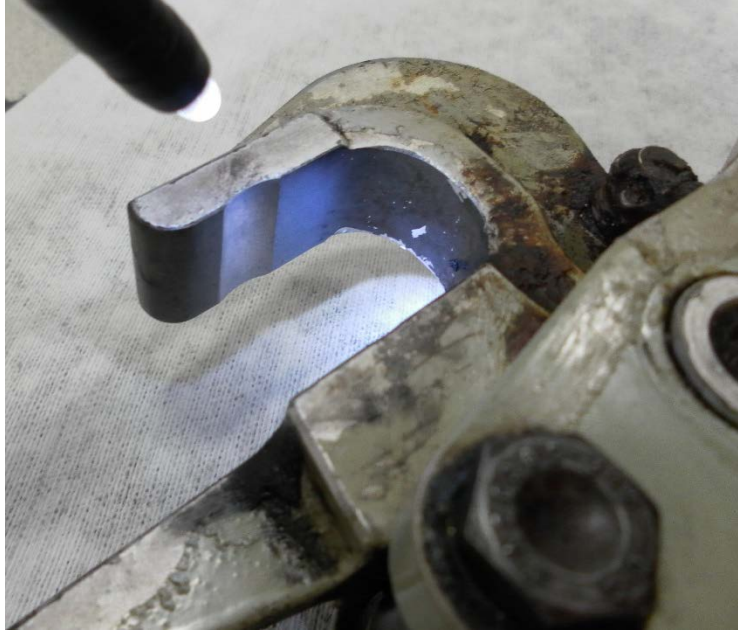
The main gear uplock assembly was visually inspected. The part number and serial numbers were confirmed. The hydraulic input junction was noted without a shipping cap. The input junction was removed from the unit and the exposed area wiped clean. In general, the uplock assembly was noted in good physical condition, with no visible damage; the component was dirty. The worn groove on the uplock latch was noted. See Figure 12.

Figure 12 - Left Main Gear Uplock Latch and Groove.

- Using Figure 802, dimension “D”, the width of the worn groove, was measured as 0.38”.
- Using Figure 802, dimension “A” (the gear pin offset) was measured on the uplock latch as 0.6565”.
- Using Figure 802 (Latch Working Surface - Wear Allowances) and Dimension “D”, Dimension “B” was determined to be 0.044”.
- Using Dimension “A” as the input to Figure 803 (Latch Working Surface-Wear Allowance Graph), the resultant permitted Maximum Indent Depth (Dimension C) was determined as 0.035”.
- Using Paragraph C.1 (page 8009), Dimension “B” was greater than Dimension “C”. Therefore, the uplock latch was determined to be beyond limits by 0.009”.
