National Transportation Safety Board

Performance Study

Specialist Report

Location:	Memphis, Tennessee
Date:	February 5, 2014
Time:	0015 CST, 0615 UTC
Airplane:	EMB145, N802HK
NTSB Number:	DCA14FA058

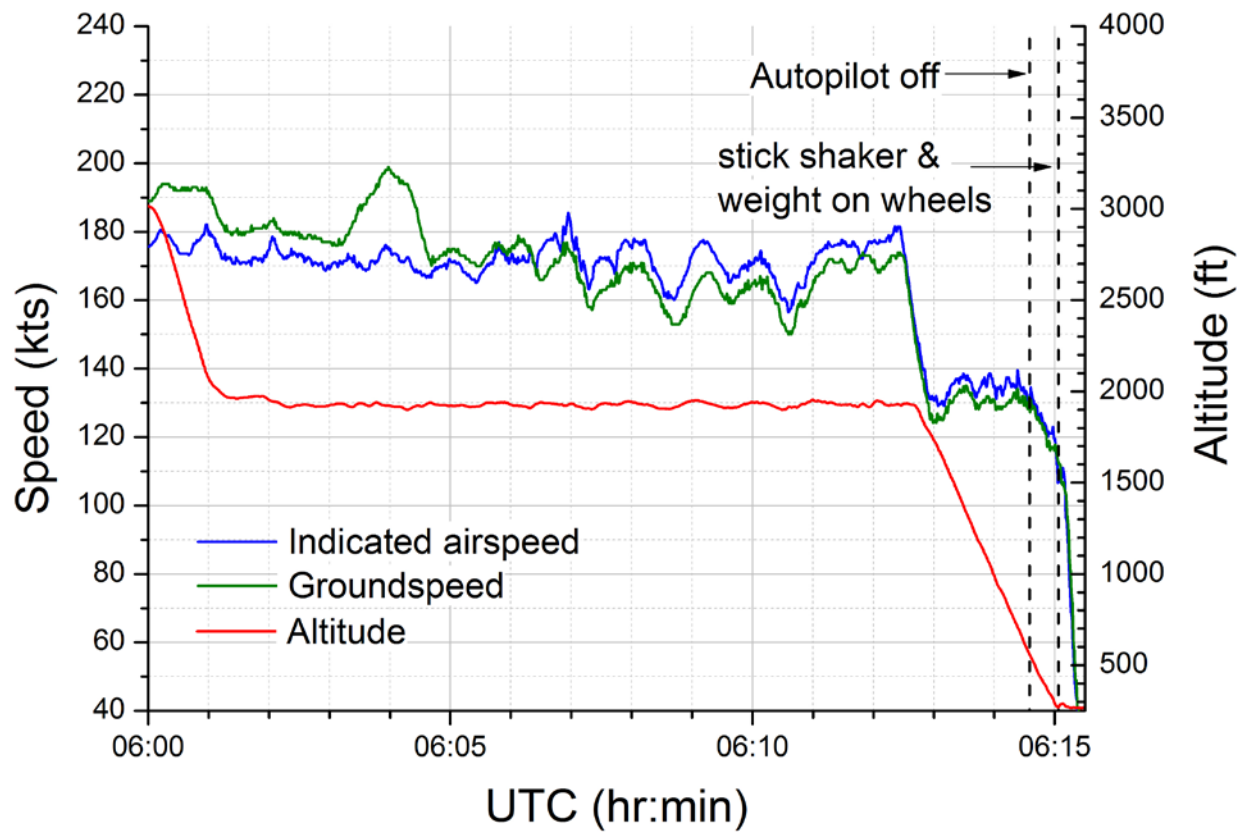
The aircraft's recorded indicated airspeed during the go-around was between 170 and 180 kts (see Figure 3). During the final descent to the runway, the aircraft's speed reduced to 130 kts. The autopilot (AP) was disconnected at 0614:35, about 300 ft above the runway and less than 30 seconds before touchdown. Embraer Standard Operating Procedures (SOP) guidance for instrument landing system (ILS) landings allows the autopilot to remain on until 200 ft above the ground [1]. Weight on wheels was recorded at 0615:03.

Figure 3. Aircraft airspeed, groundspeed, and altitude for the final 15 minutes of flight.

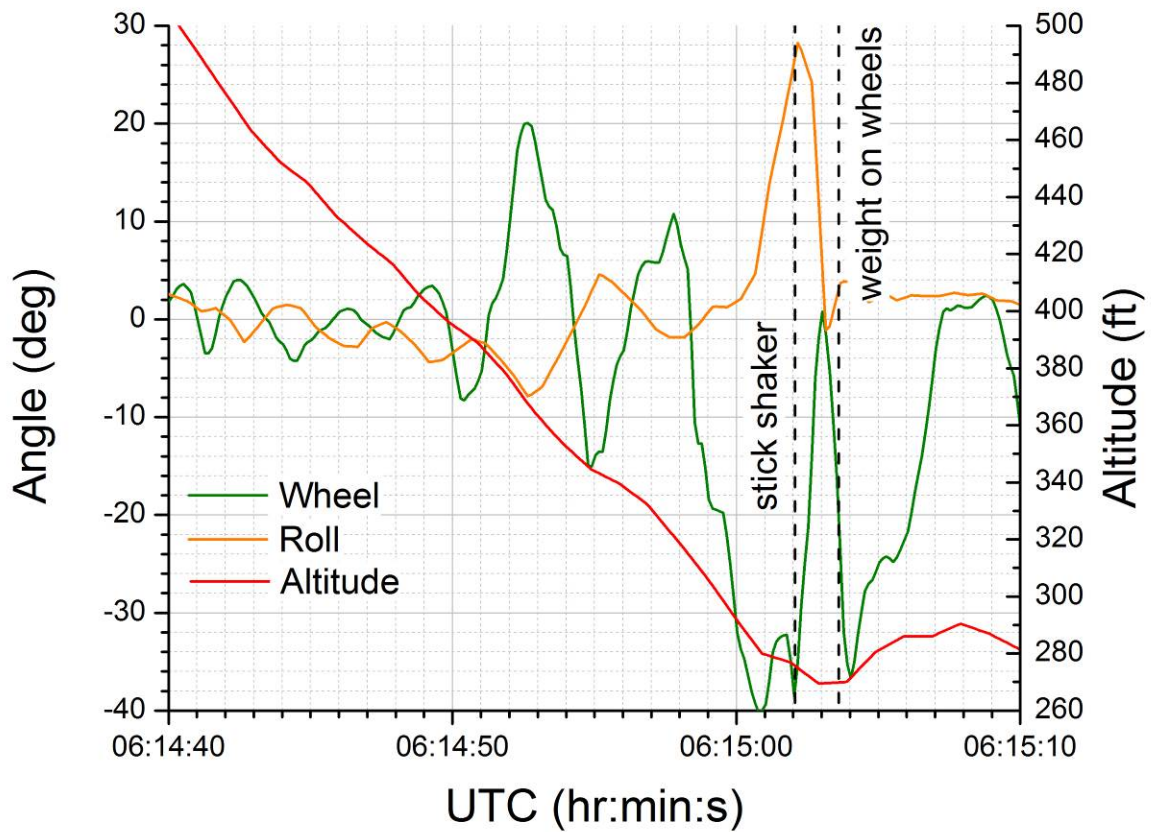
Just before 0615:00 the aircraft began to roll quickly to the right (Figure 4). At 0615:02, the stick shaker activated. The aircraft's maximum roll attitude, which coincided with the stick shaker activation, was 28° right wing down. The pilot was making substantial left wheel inputs to counteract the right roll, but the roll was ultimately stopped by the right wing impacting the ground. The aircraft rolled back to near wings level as it landed.

Figure 4. Aircraft wheel input, roll, and altitude for the end of the flight.

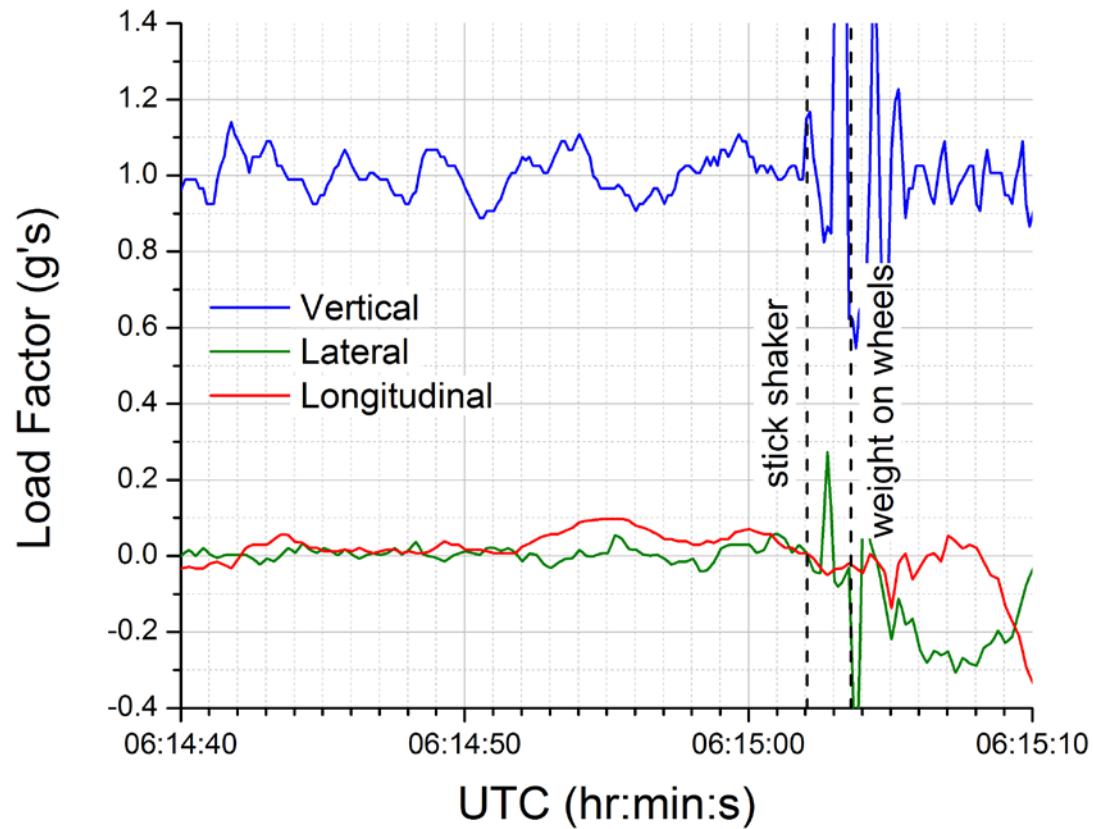
The aircraft's load factors were recorded and are shown in Figure 5. Only the longitudinal load factor showed a marked change just before touchdown, consistent with the final slowing of the aircraft. The vertical load factor stayed reasonably steady and did not indicate a full aircraft aerodynamic stall.

Figure 5. Aircraft vertical, lateral, and longitudinal load factors for the end of the flight.

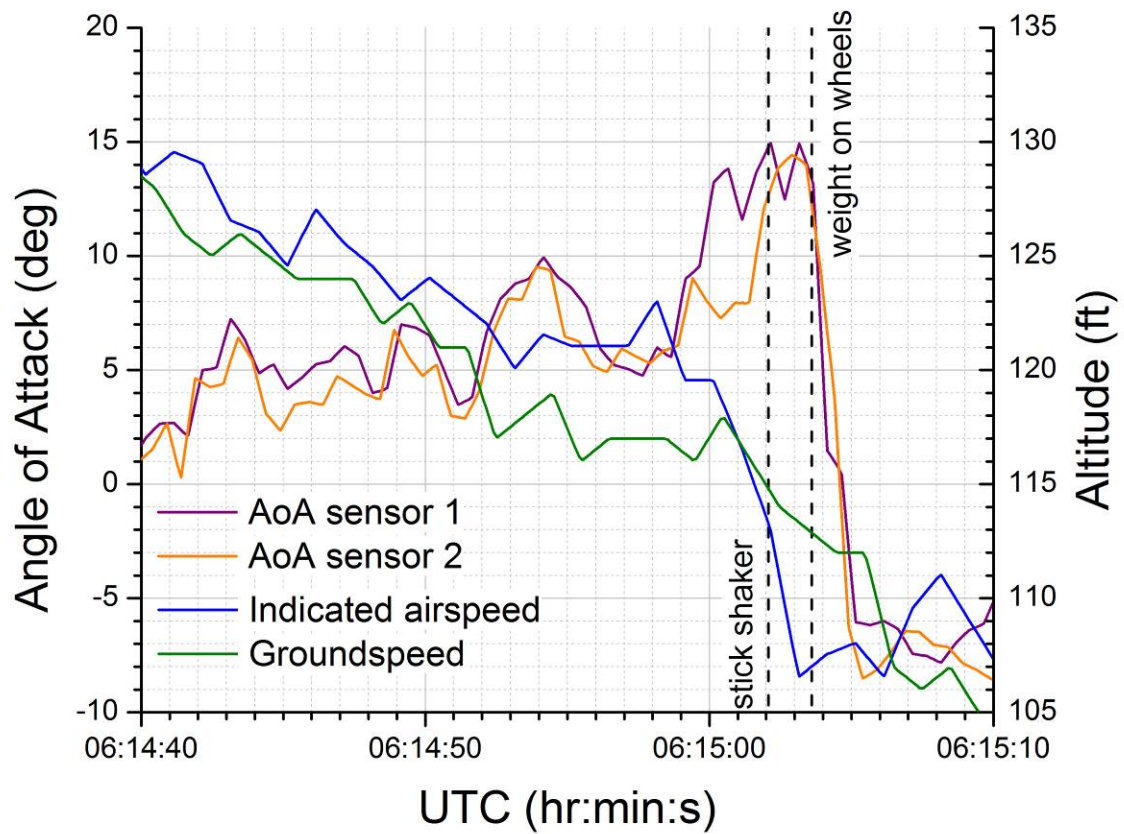
The stick shaker activated when one of the aircraft's two angle of attack (AoA) sensors reached 15° and the indicated airspeed was 113 kts as shown in Figure 6. The stick shaker activation point was not listed, but the Embraer 145 Flight Manual records that the stick pusher will activate at 105 kts for gear down, flaps 45° , and a weight of 41,100 lbs [4].

Figure 6. Aircraft angle of attack (AoA), indicated airspeed, and groundspeed prior to and after stick shaker activation.

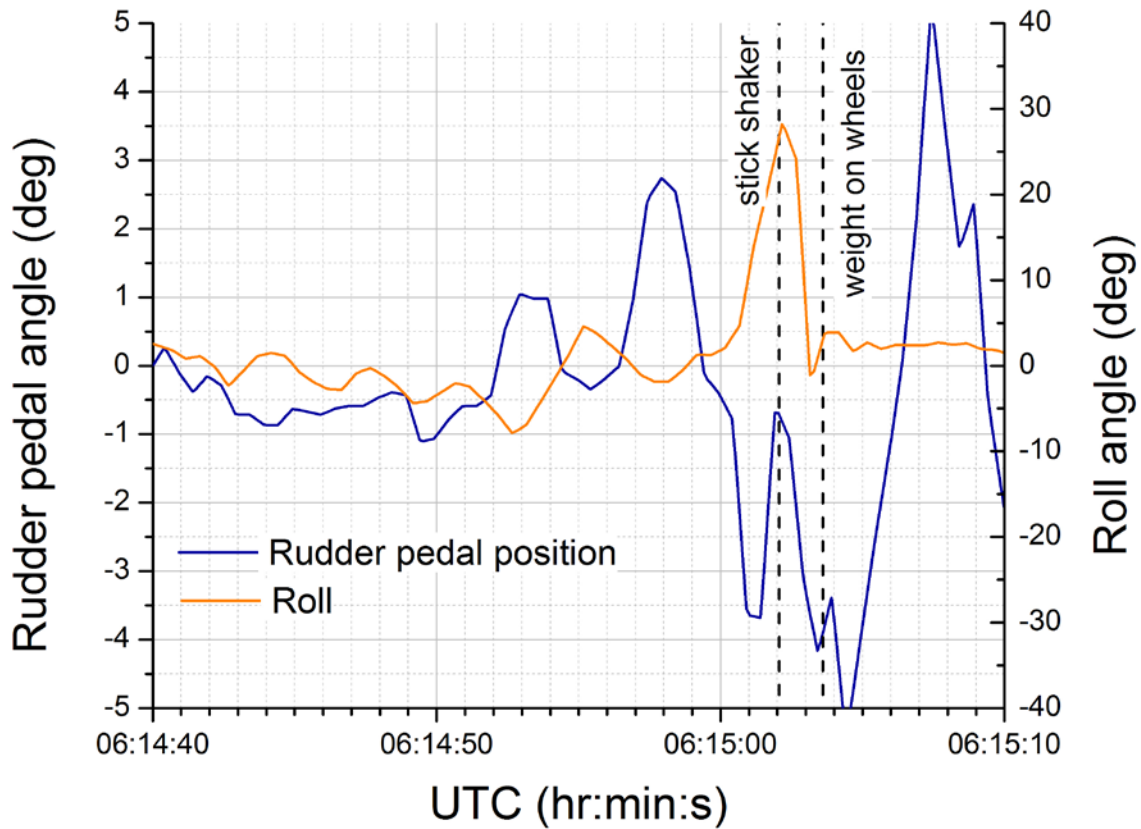
Figure 7 (which time correlates with Figure 4 and Figure 6) shows the rudder pedal movement during the final roll event and touchdown. The CVR and post-accident pilot statements showed that the pilots thought that the sudden right roll was caused by a rudder hard over [3]. Embraer confirmed that the rudder pedals would move if the rudder surface, the rudder trim, or the yaw damper move. The rudder pedal movement did not show evidence of a larger rudder surface deflection.

Figure 7. Rudder pedal application for final moments of flight.

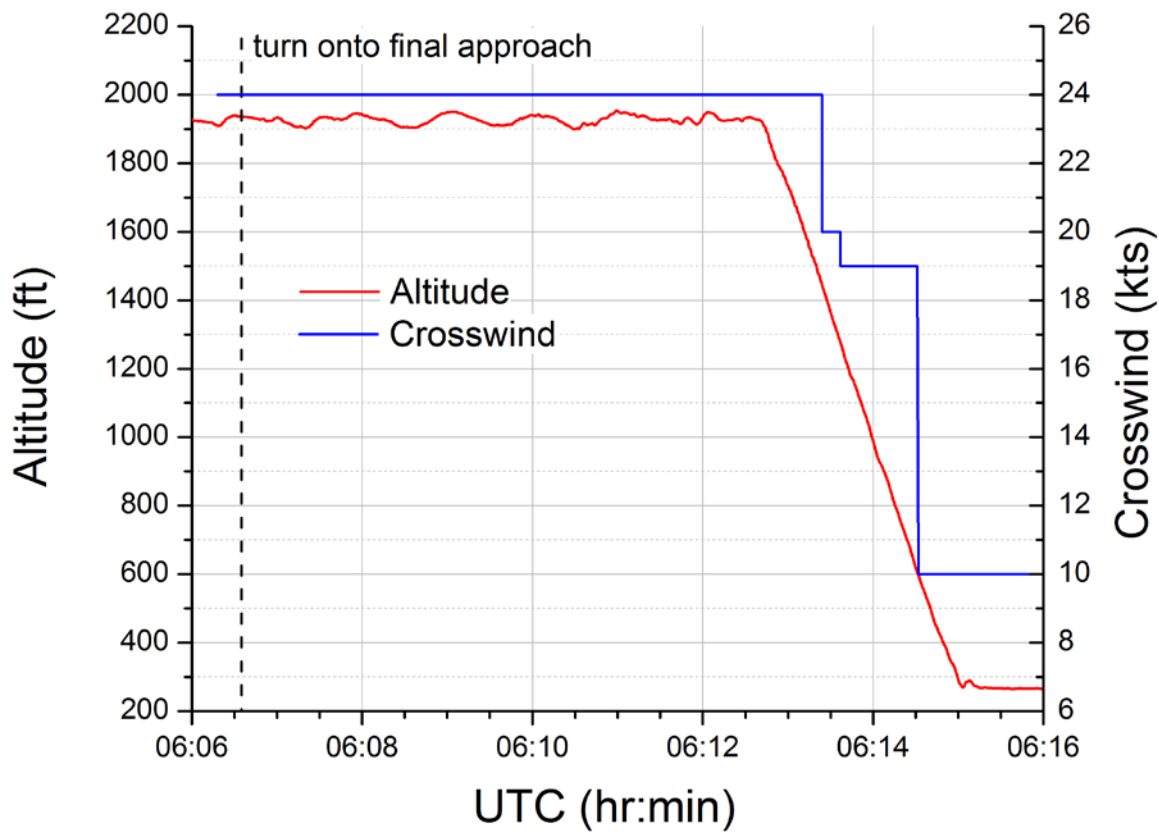
While on the approach heading, the aircraft experienced a crosswind with a magnitude of 24 kts when at 1,900 ft dropping to 10 kts on the final portion of the approach as shown in Figure 8. The crosswind data in this figure is calculated using the data from Table 1.

Figure 8. Altitude and crosswind component during final approach. Crosswinds are calculated using aircraft heading and the AMDARS wind data from Table 1.

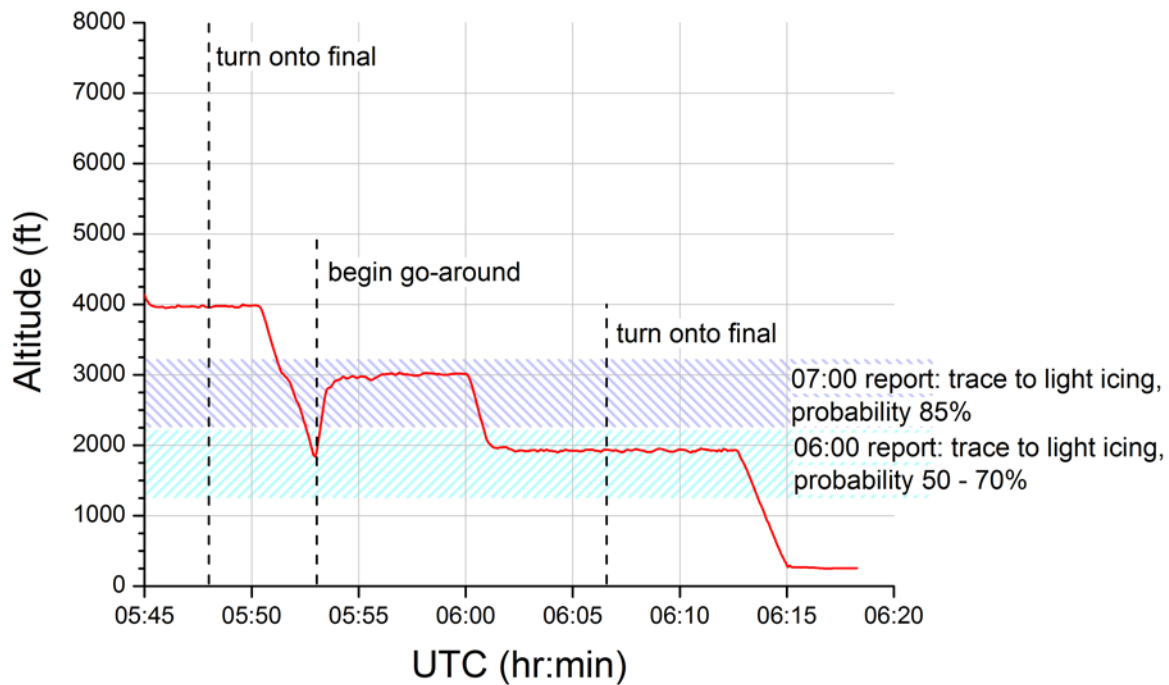
The NTSB Meteorology Factual Report states that the icing charts from the National Center for Atmospheric Research (NCAR) for 0600 UTC in the region of MEM indicated an increasing probability of trace to light icing conditions between 1,000 and 2,000 ft above ground level (AGL) with the probability between 50 to 70%. The charts for 0700 UTC (the next available time period) depicted light icing conditions below 3,000 feet AGL with the probability increasing to 85%. Figure 9, below, compares the aircraft's altitude with the icing probabilities discussed above. Note that the charts indicated an increasing probability of icing at increasing altitudes during the time while the airplane was executing the go-around.

Figure 9. Aircraft altitude with various flight points marked. Includes NCAR icing probabilities for 0600 UTC in blue and 0700 UTC in purple.

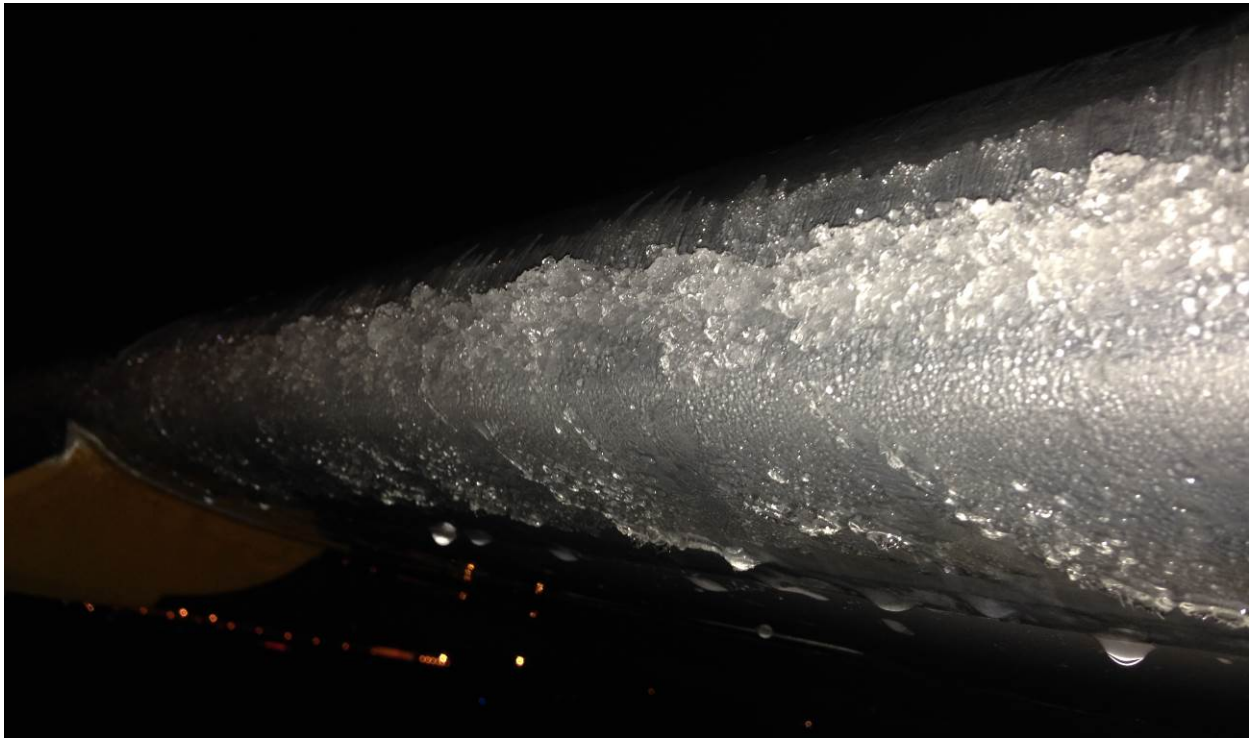
Due to the go-around, the aircraft spent an additional 19 minutes of time in an altitude region with an increased probability of icing. Upon landing at MEM, ice buildup on the leading edge of the wings was discovered and photographed (shown in Figure 10). The aircraft's automatic icing protection system did not activate and was not on during its approach into MEM.

Figure 10. Ice on the leading edge of the aircraft wing shortly after landing.

Ice buildup can cause aerodynamic stall as the ice disrupts airflow across aircraft lift surfaces. Buildup of ice on the leading edge can cause air flow to separate and lift to be lost across the whole or a portion of the wing.

While the aircraft had a definite build-up of ice on the leading edge of the wings, the vertical load factor record did not indicate that the aircraft experienced a full aerodynamic stall. The simulation performed by Embraer also did not provide evidence of measurable degradation of control authority during the approach. However, ice could cause the aircraft to roll by creating enough flow separation on one wing for it to lose lift without the initial ice build-up affecting the control of the aircraft in a measurable way.

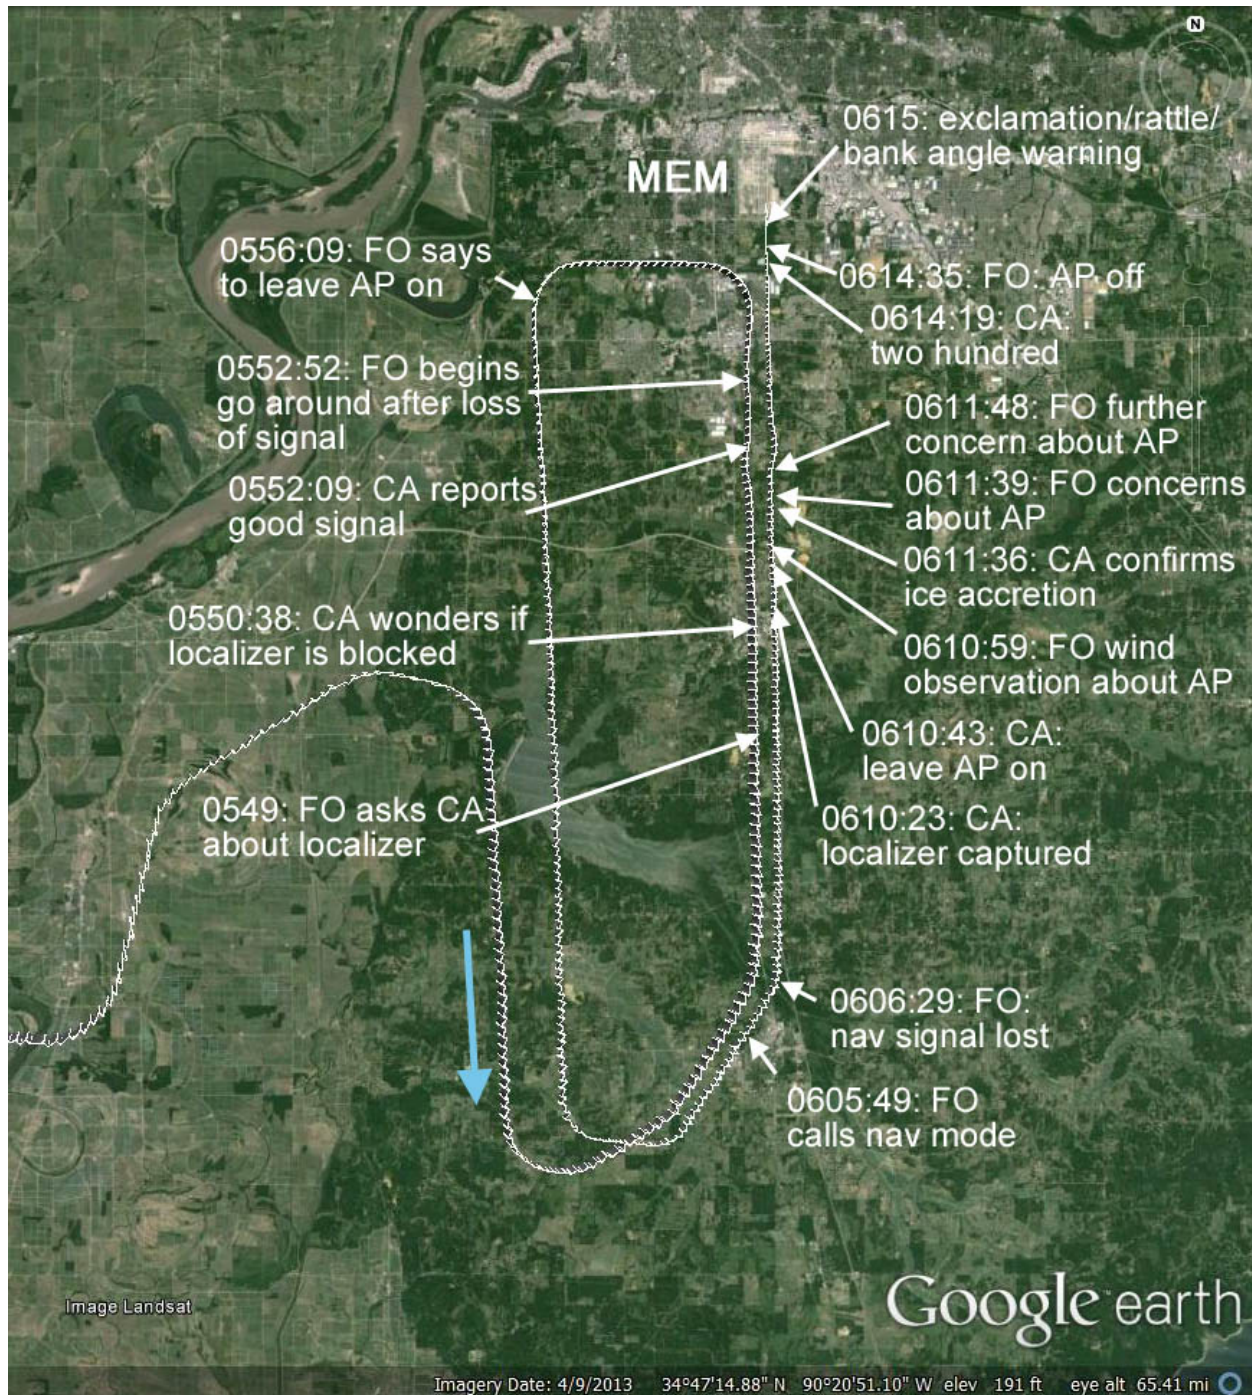
Figure 11. CVR paraphrasing overlay of go around and landing. FO denotes first officer speaking and CA denotes comments by the captain (flying pilot). Autopilot is abbreviated AP for space.

The pilots discussed the autopilot and possible ice accretion between 0610 and 0612 as shown in Figure 11. They also commented that the autopilot seemed to having trouble with the wind, but decided to leave the autopilot on.
