**NATIONAL TRANSPORTATION SAFETY BOARD**

**UAS Aerial Imagery Factual Report**

**A. ACCIDENT                    DCA17FR011**

Location:                    Hyndman, PA  
Date:                         August 2, 2017  
Time:                         0500 Local Time (EDT)  
Event:                        CSX train derailment

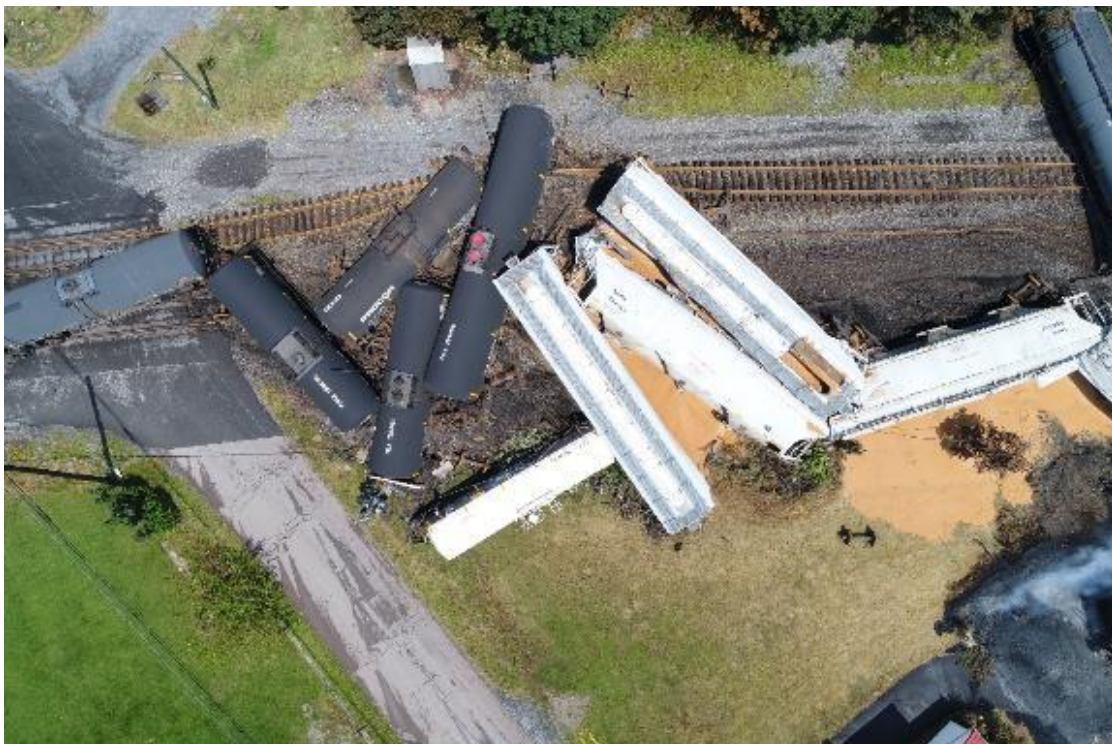
**Figure 4 – Sample source photo of Wreckage Day 1**

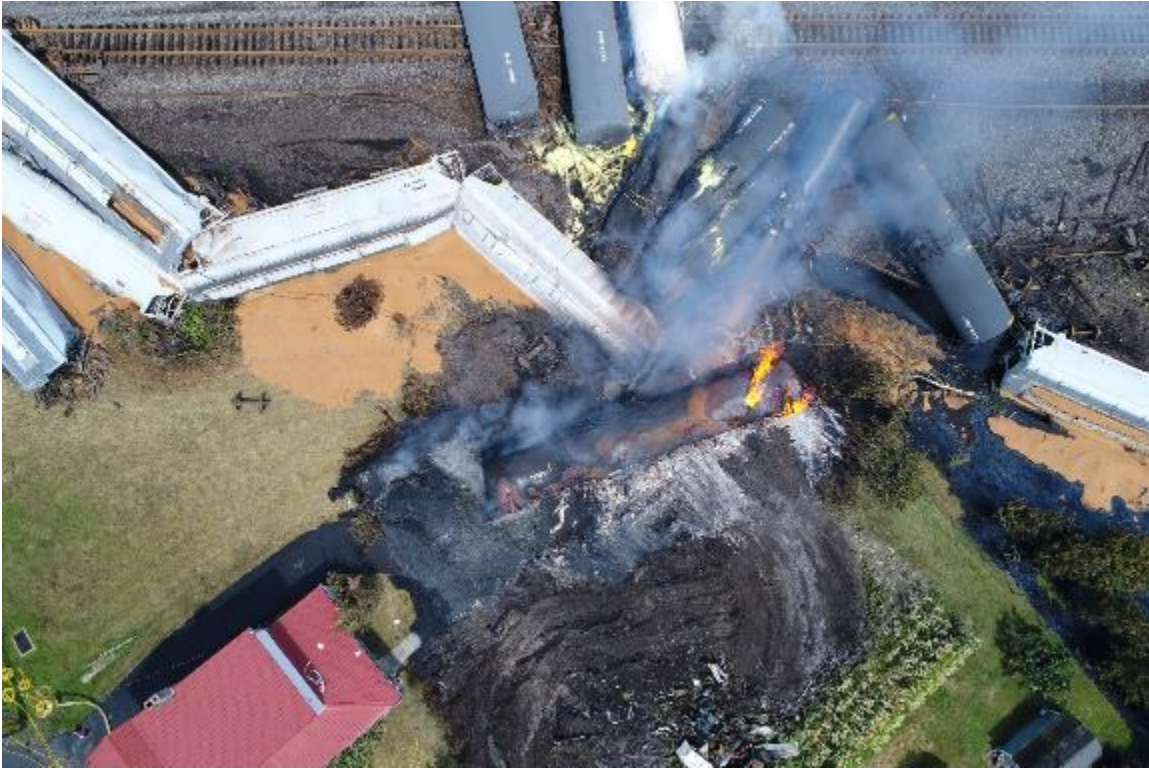
**Figure 5 – Sample source photo of Wreckage Day 1**

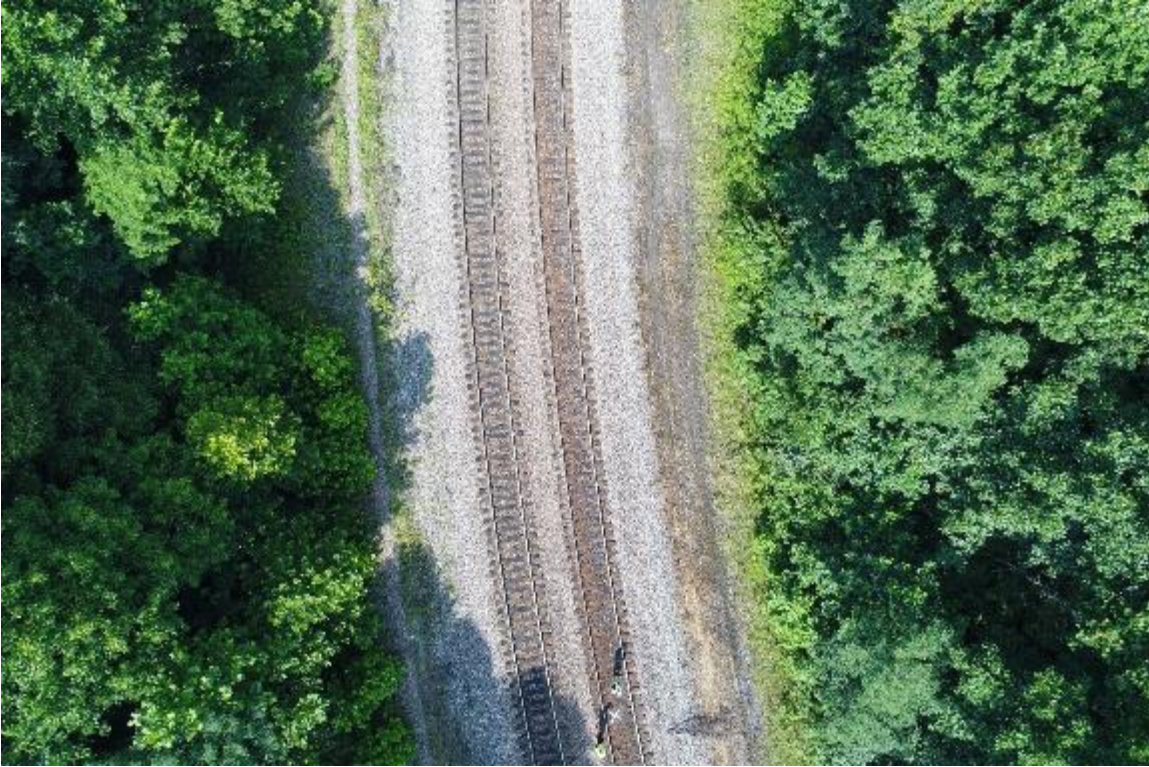
The Track Group Chairman accompanied the UAS team to document the section of rail leading up to the main wreckage. The initial point of derailment was approximately 1.8 miles northwest of the main site. Multiple sorties were flown over two days (weather required flights to stop near the end of day 1) and processed into orthomosaic maps of the rail. Figure 6 is a snapshot of a portion of the orthomosaic showing the initial point and witness marks. Figure 7 is a sample source photo showing the marks and initial point.

Figure 7 – Sample photo of initial point and witness marks

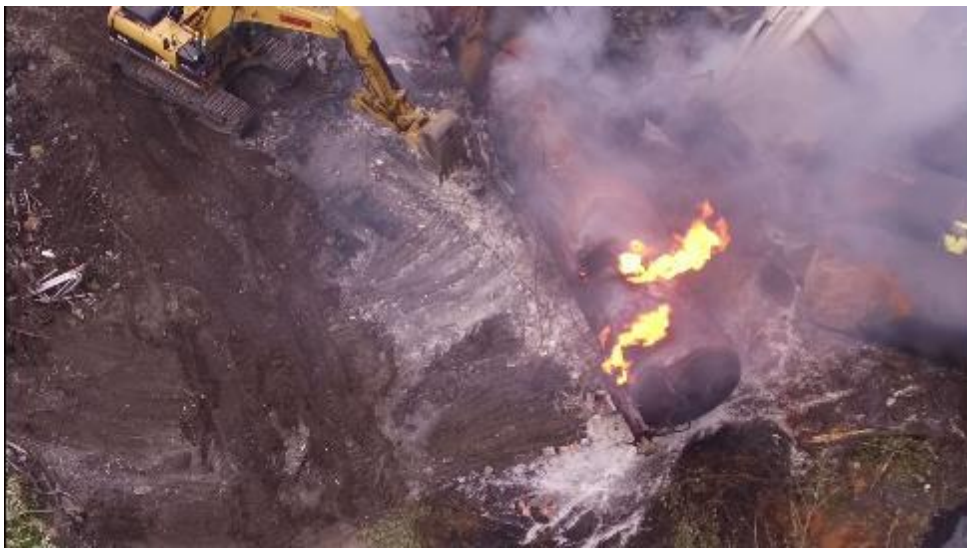
A number of sorties were flown to video document the removal of the protective jacket from a burning liquid propane gas (LPG) tank car under the direction of a CSX hazmat specialist. The video files are in the docket as attachments 8 and 9, an exemplar snapshot is shown in figure 8.

Figure 8 – Snapshot of jacket peel video

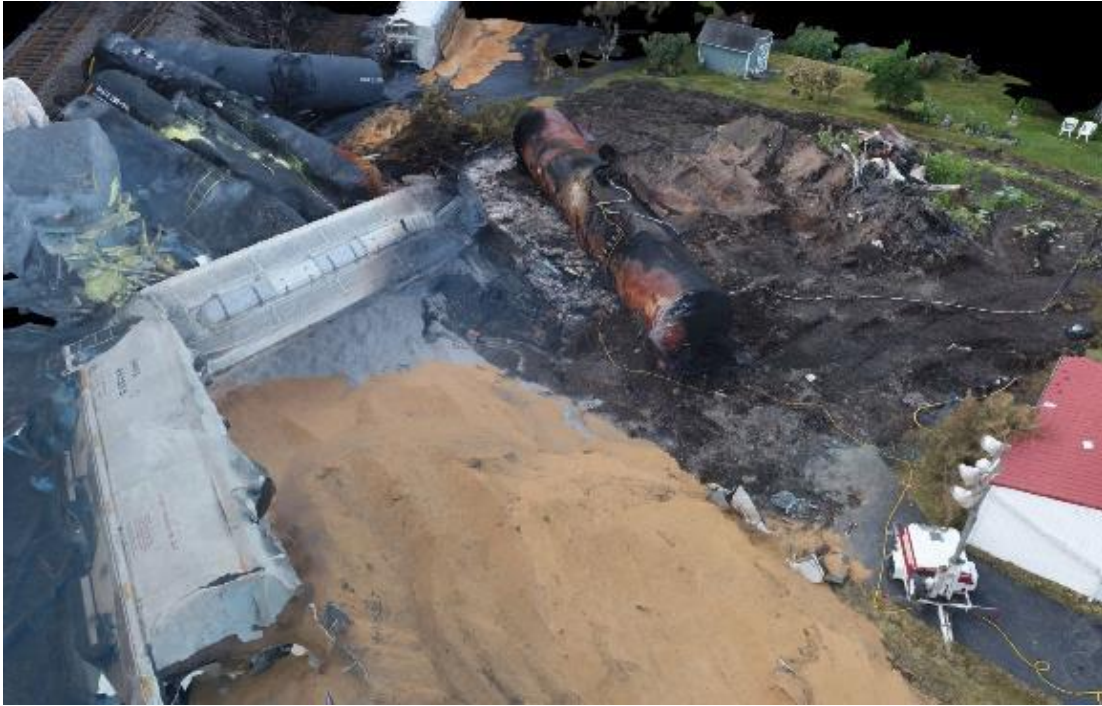
Numerous cars had been removed from the main wreckage site by day 2, sorties were flown to document and model the area of the main wreckage forward to the trestle where the initial derailed car had stopped. Figure 12 is a sample snapshot of the 3D model looking toward the trestle, attachment 12 is a virtual fly-through of the 3D model.

Figure 12 – Excerpt of wreckage 3D model day 2

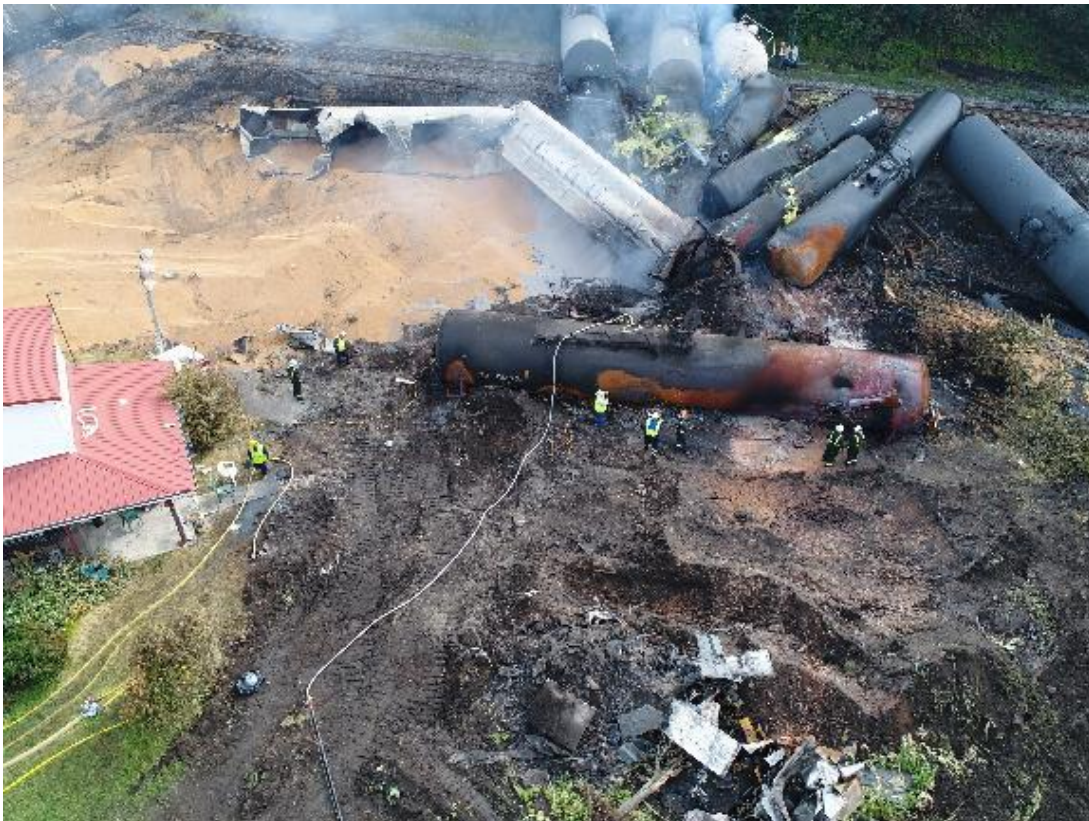
Figure 13 – Source photo main wreckage day 2
