NATIONAL TRANSPORTATION SAFETY BOARD
Office of Aviation Safety
Washington, D.C. 20594

AIRPORT SPECIALIST'S FACTUAL REPORT

A. ACCIDENT

NTSB # : DCA19FA089
Airplane : EMB-145XR, Flight 4933 [N14171]
Location : Presque Isle Airport, ME
Date : March 4, 2019
Time : 1129 eastern standard time (EST)¹
Operator : CommutAir

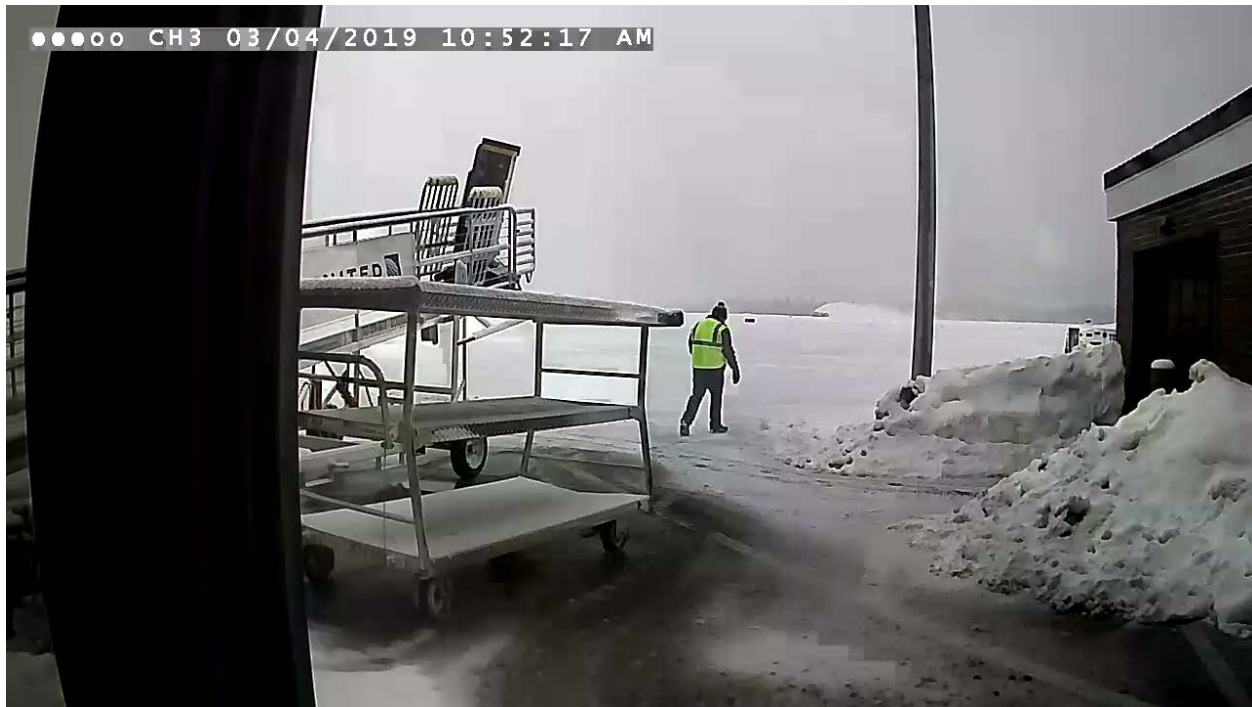
Photo 1. Surveillance video frame showing rotary plow casting snow traveling down runway 19 about 22 minutes before missed approach.

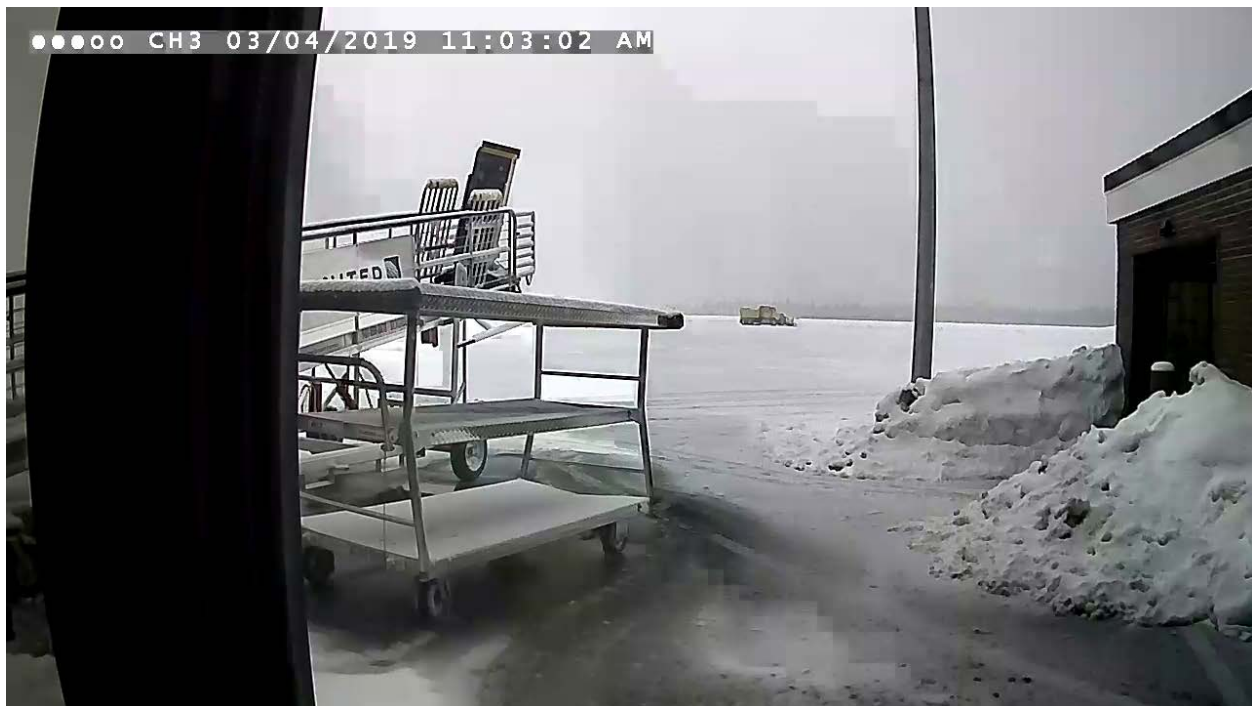
Photo 2. Surveillance video frame showing displacement plow traveling north on taxiway A about 11 minutes before missed approach.

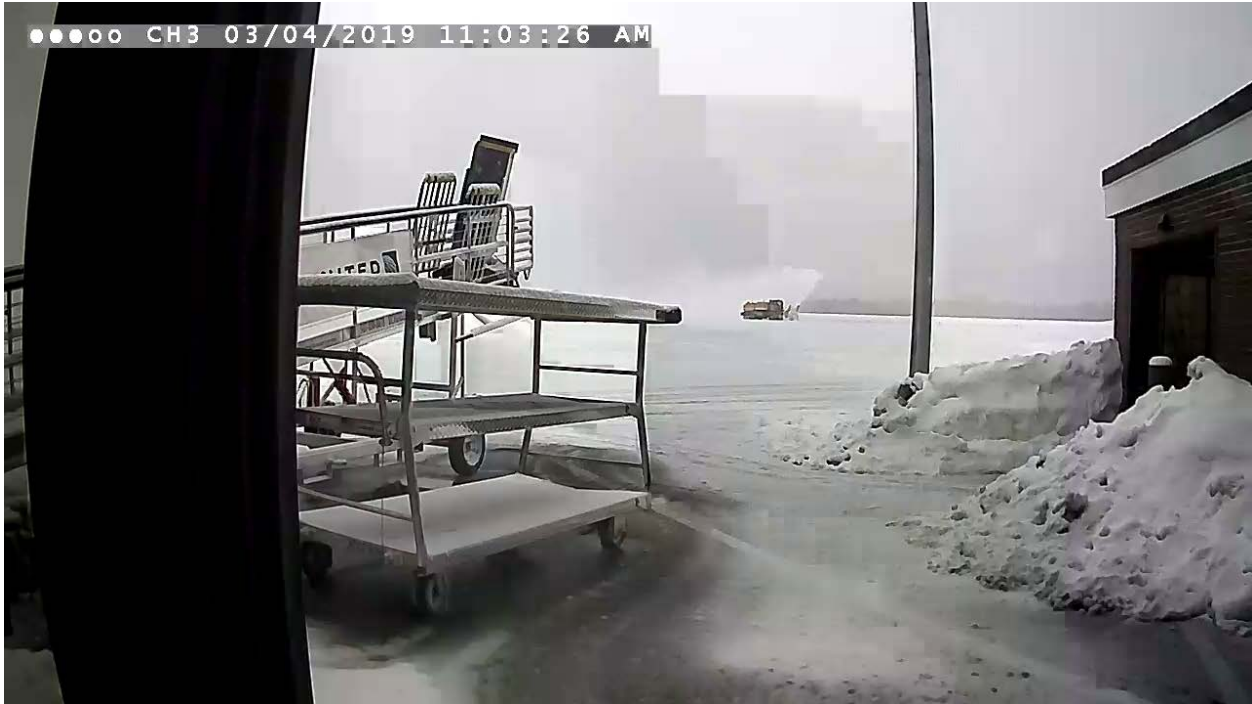
Photo 3. Surveillance video frame showing rotary plow traveling north on taxiway A about 11 minutes before missed approach.

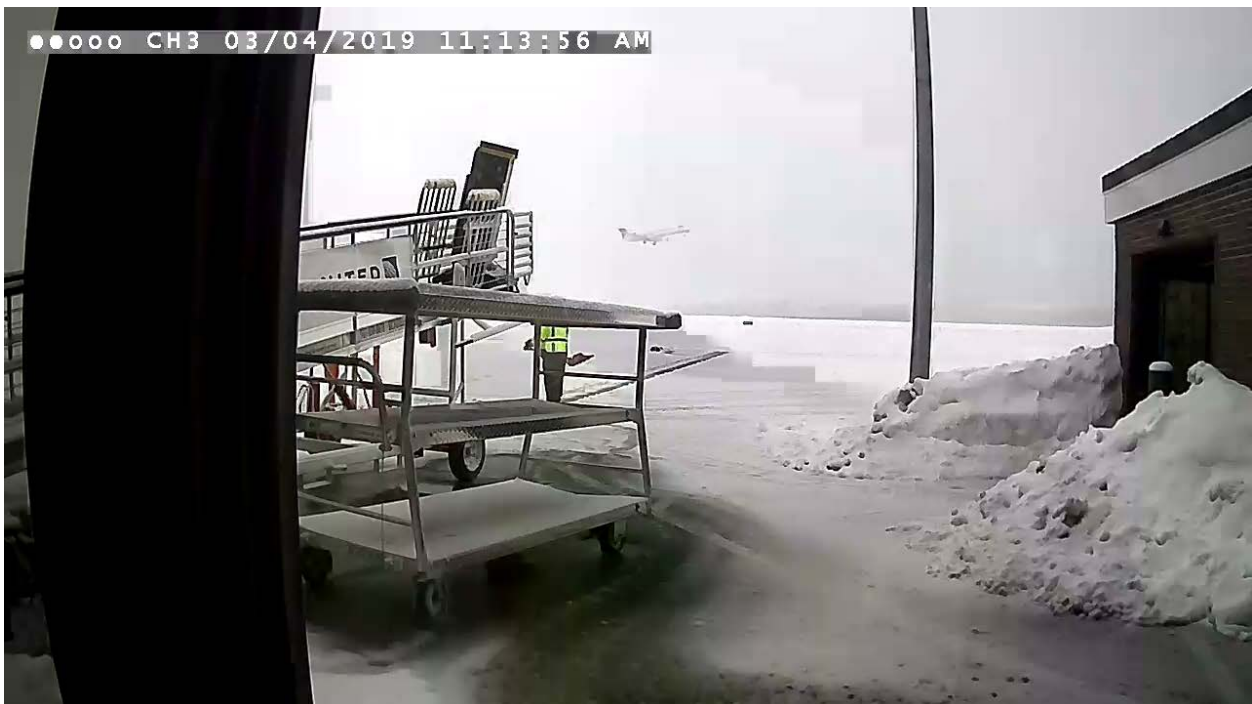
Photo 4. Surveillance video frame showing flight 4933 overflying the airport on first approach (about 11:03:37 per ADS-B track data).

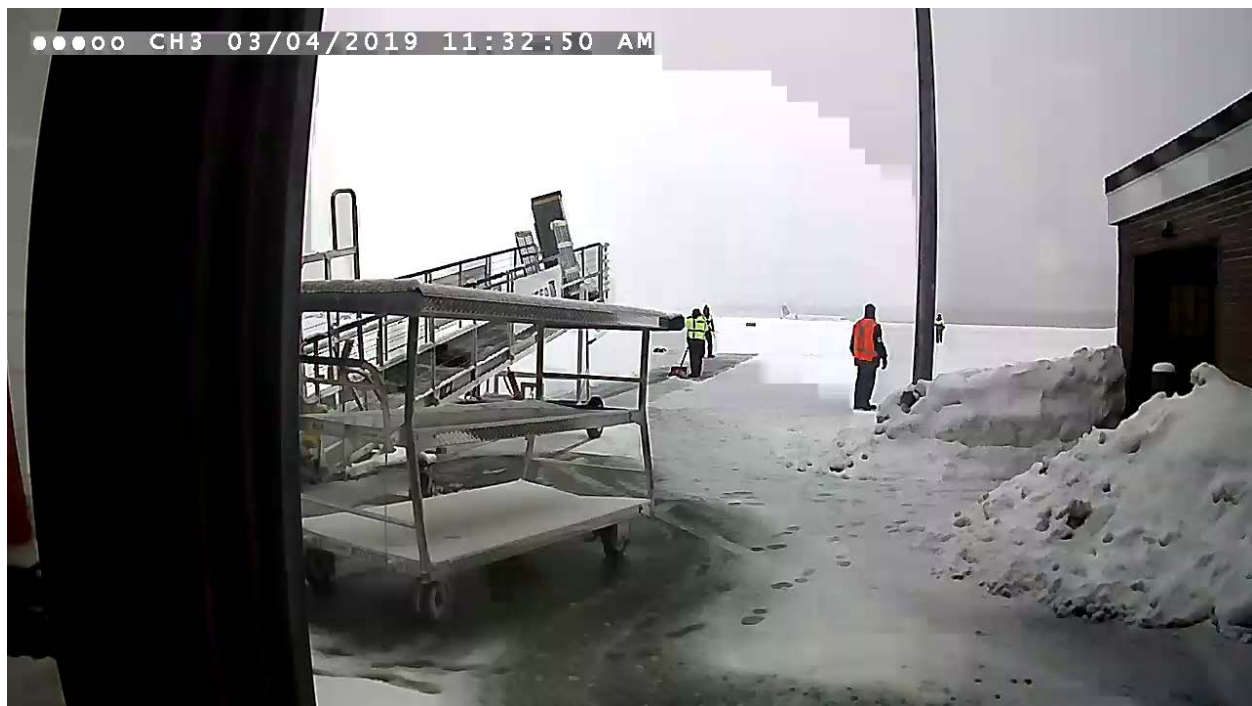
The maintenance foreman who was in a pickup truck behind the hold short line on taxiway C saw the airplane headed for him just after it had touched down in the infield snow. He drove his truck onto the runway to get away and saw the airplane had stopped about 150-200 feet from his original position on taxiway C. He estimated that at the time of the accident the visibility was about ½ mile based on what he could see from his truck and said that the accident happened about 30 minutes after they had last plowed the runway.

Photo 5. Surveillance video frame about the time flight 4933 stopped in the infield.

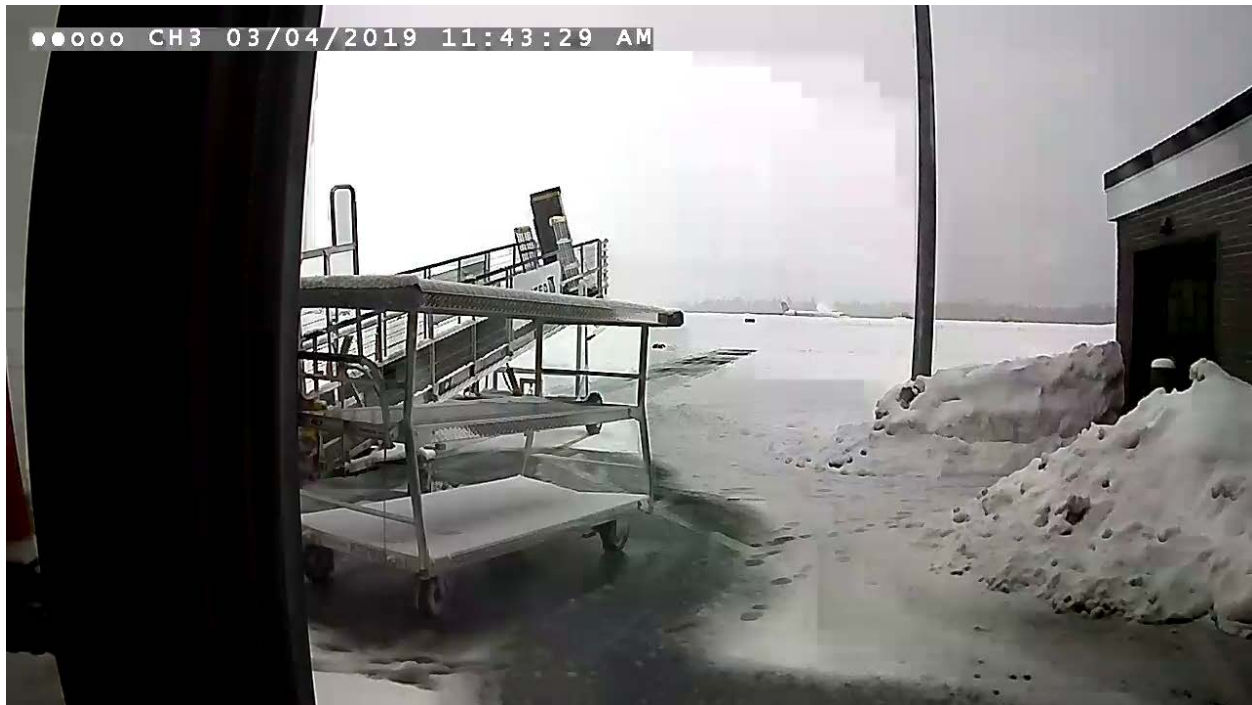
Surveillance video showed that about 3 minutes after the on-airport fire truck had stopped on the runway near the airplane the rotary plow arrived and started to cast snow. According to the maintenance foreman it was attempting to cut a road from the runway to the airplane in the infield but the snowbank was too hard. To help, the maintenance foreman retrieved a John Deer tractor with a 16-foot blade from the shop building. When he arrived about 3 minutes later he started clearing snow for the road to the airplane. He reported that when he arrived, the on-airport fireman had walked to the airplane, and while he was clearing snow the off-airport first responders arrived and boarded the airplane. The airport director had used the FBO pickup to go out to the airplane. He called the FAA regional operations center to alert them to the event and verify with them that the airport was closed. The first responders waited for the plowing of the access road to be completed before taking people off the airplane.

Photo 6. Surveillance video frame about the time when John Deere tractor (left of pole) starts to cut access. Rotary plow casting snow behind airplane and airport fire truck on runway.

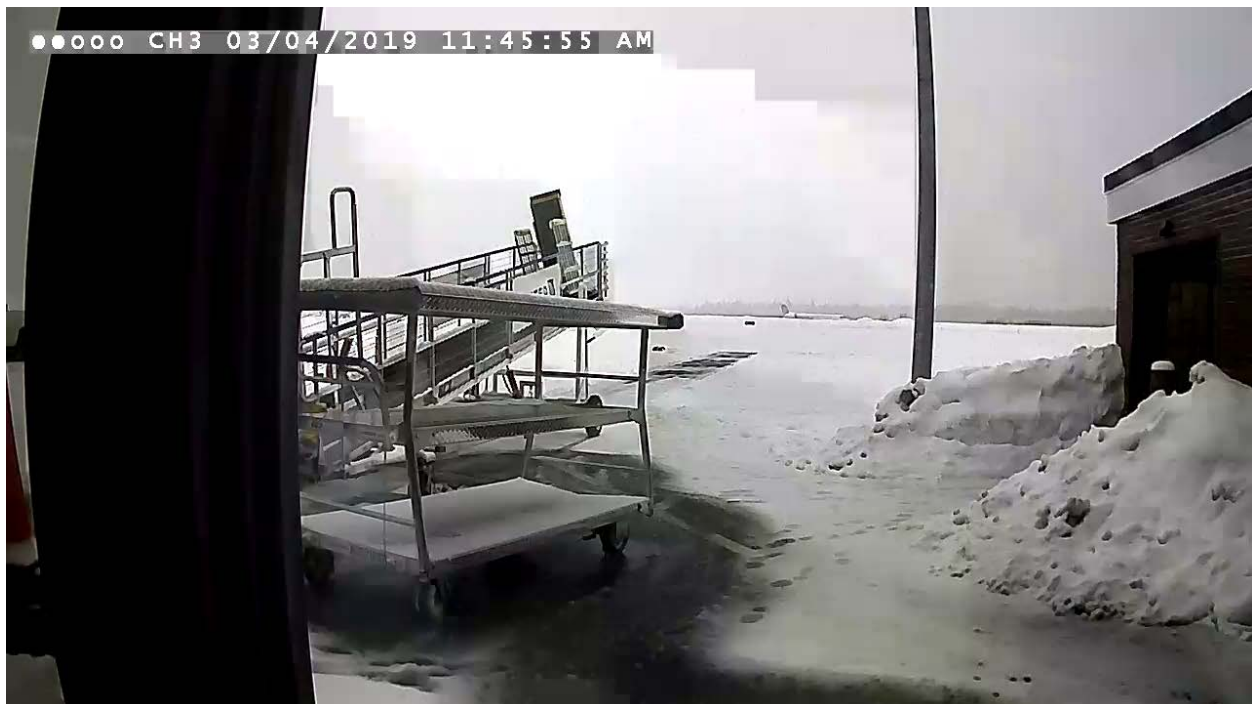
Photo 7. Surveillance video frame when additional vehicles arrived on the runway approximately 13 minutes after the accident.

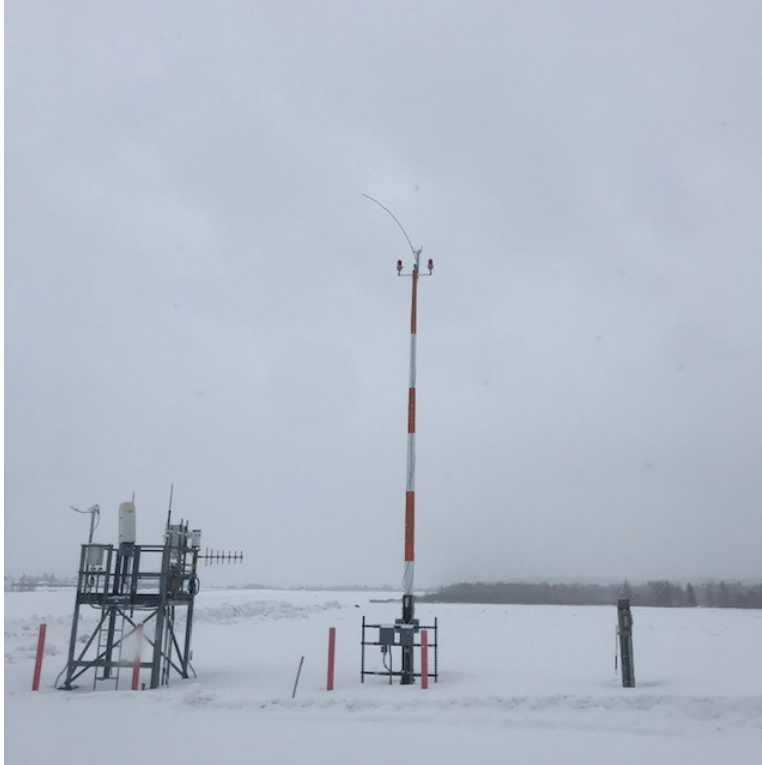
According to the airport director the lightning arrester on the AWOS wind sensor pole was found bent after the accident and the FAA issued a NOTAM stating the wind sensor was unreliable. The FAA installed a new wind sensor on March 13. An edge light was damaged during aircraft removal.

Photo 8. Bent lightning arrester on AWOS wind sensor pole (courtesy PQI).

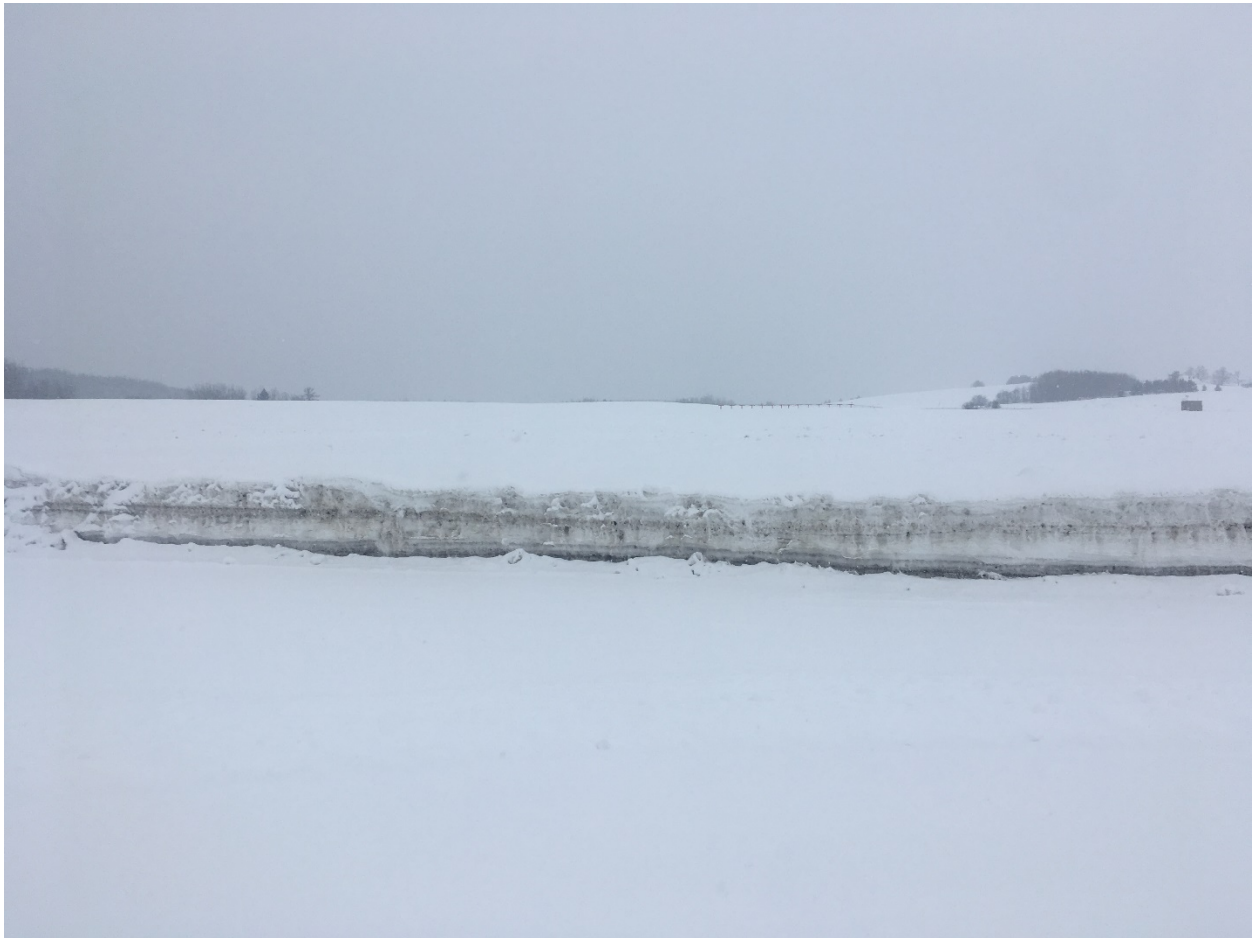
The runway 1 localizer and glideslope were NOTAMed out of service at 1234 on the day of the accident.¹⁵ On March 7 a FAA flight inspection was conducted and found that the localizer alignment was out of tolerance and a glideslope reversal was present at 890 feet.¹⁶ Subsequently snow removal was conducted around the areas around and in front of the localizer antenna, and the glideslope antenna.

Photos 9 and 10 show the snowfield around and in front of the localizer array the afternoon of March 4. Surveys taken in that area 2 days after the accident show snow depths ranging from 2.1 to 4.9 feet (see attachment 4).

Photo 9. Snowfield between localizer antenna and runway looking north from the approach end of runway 19 (courtesy PQI).

After the March 7 flight inspection, PQI scraped snow from the areas around the localizer array and glideslope antenna using 3 rented bulldozers and their own John Deer tractor. According to airport operations personnel the FAA did not know exactly how much snow needed to be removed. The airport cleared an area in front of the localizer array approximately 250 feet either side of runway centerline to the runway threshold (about 1000 feet in length). The area outside of the runway lights along the length of the runway was also cleared of snow.¹⁷ The glideslope snow clearance area was also scraped of snow per FAA Advisory Circular 150/5200-30D. According to the maintenance foreman the snow clearing effort took between 15-16 hours. Photos 11 and 12 show the area cleared of snow around the localizer antenna and along the runway.

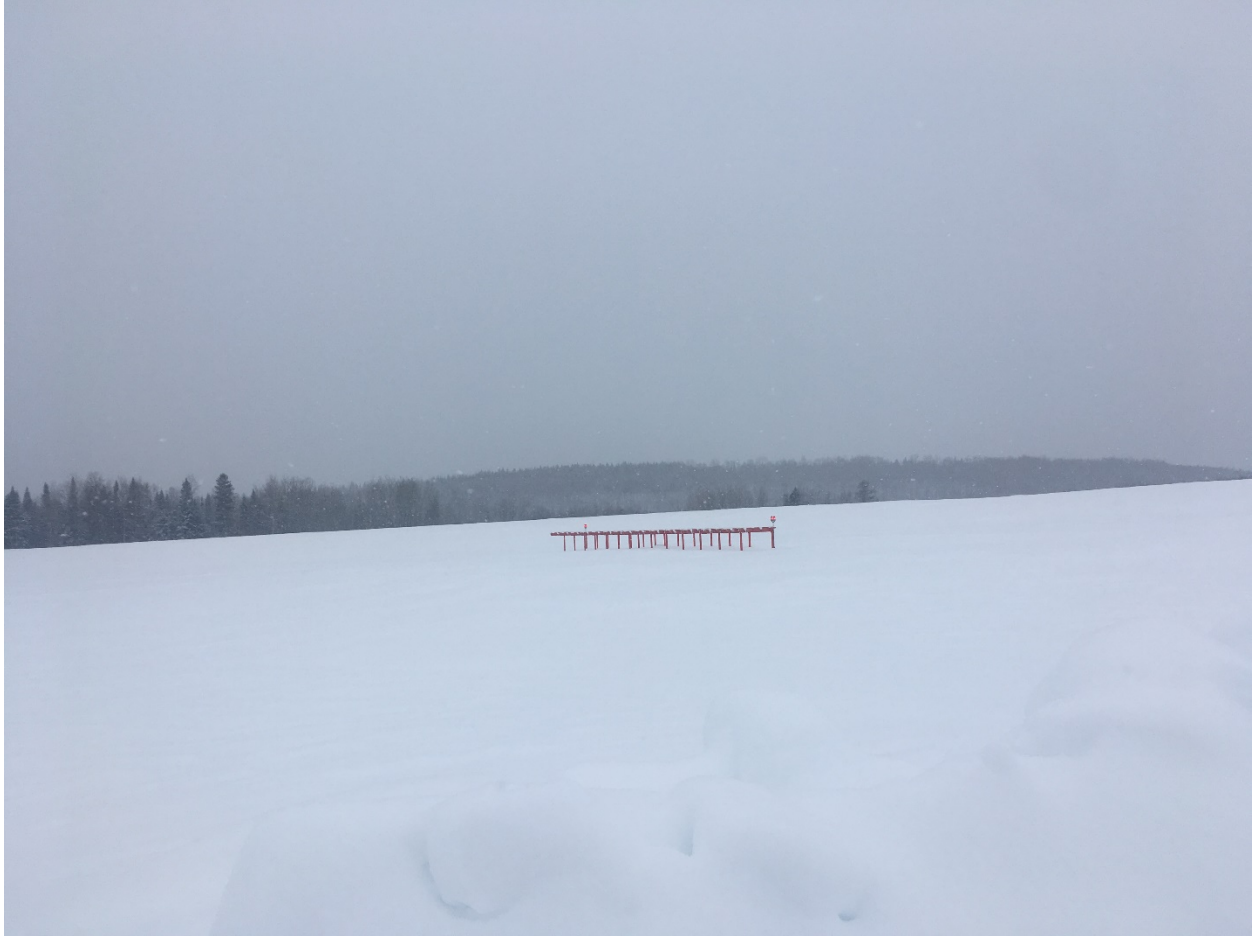
Photo 10. Snowfield around the localizer antenna from the localizer shack looking W-NW (courtesy PQI).

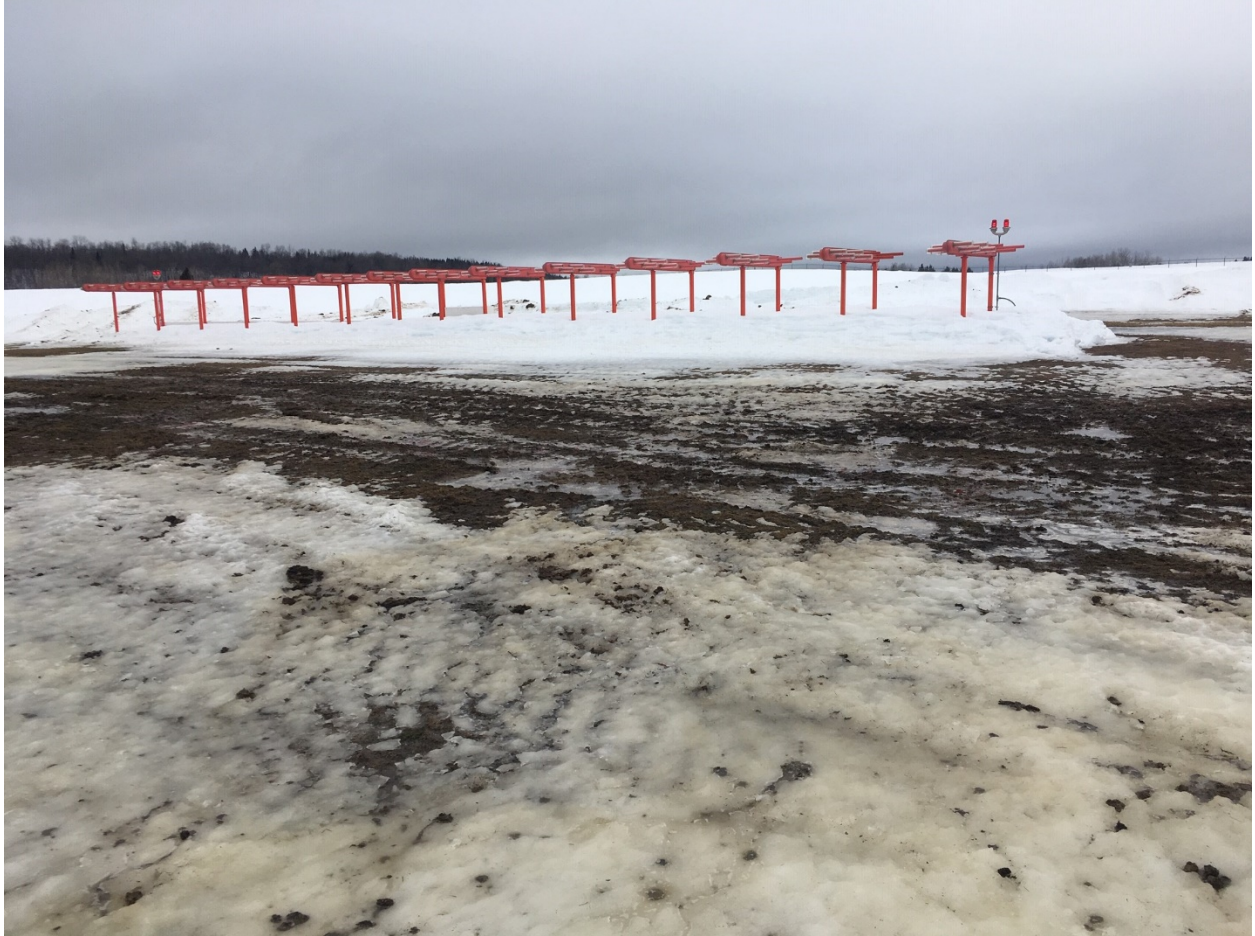
Photo 11. Snow cleared from around the localizer antenna (courtesy PQI).

On March 13, after the snow clearing operation was completed, a flight inspection found the localizer and glideslope signals to be within specified tolerances and the NOTAMs applicable to the ILS approach being out of service were canceled.

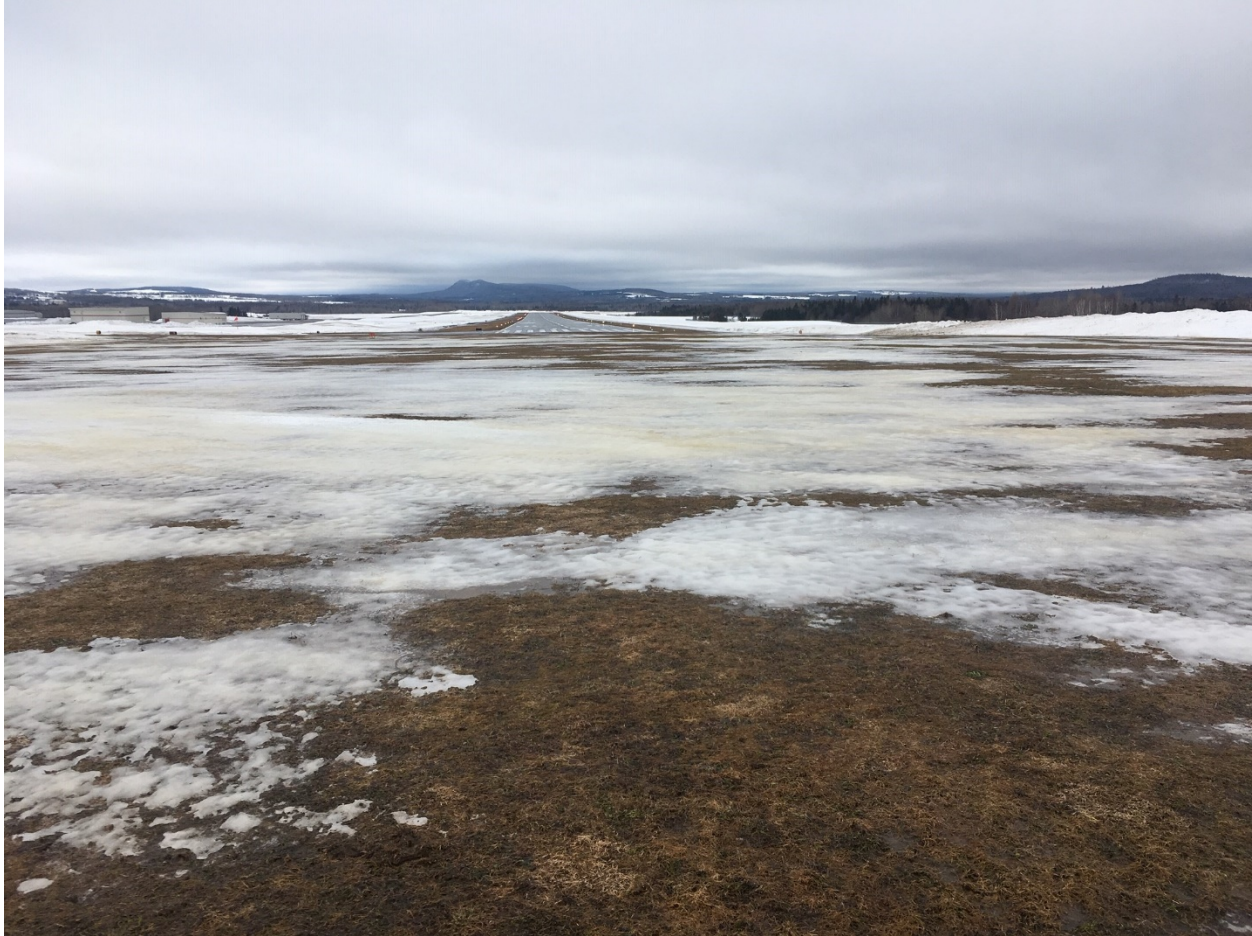
Photo 8. Snow cleared between the localizer antenna and runway (courtesy PQI).

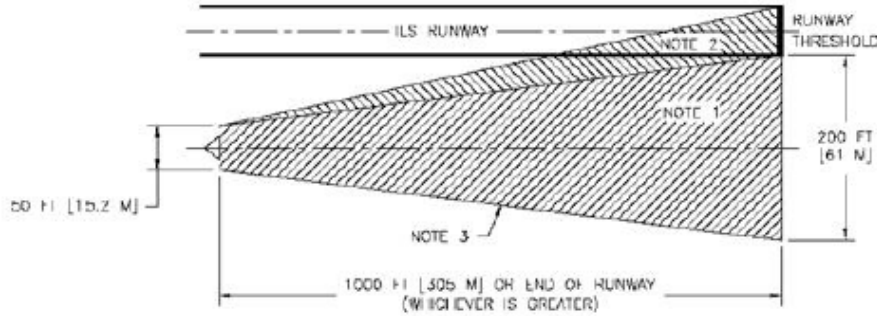
Figure 4-2. ILS CAT I and CAT II/III Snow Clearance Area Depth Limitations

Advisory Circular 150/5200-30D, Airport Field Condition Assessments and Winter Operations Safety, issued July 29, 2016 provided guidance to airports in developing their SICP, including clearing snow around ILS components. The version current at the time of the accident stated, "...any snow or ice that affects the signal of electronic NAVAIDs should be removed."²² However, it only discussed glideslope snow clearance areas (see figure 1).

Figure 1. Glideslope snow clearance area requirements outlined in AC 150/5200-30D.
